# Case Studies in Engineering Failure Analysis

## Case study

# Fractography of a neck failure in a double-modular hip implant

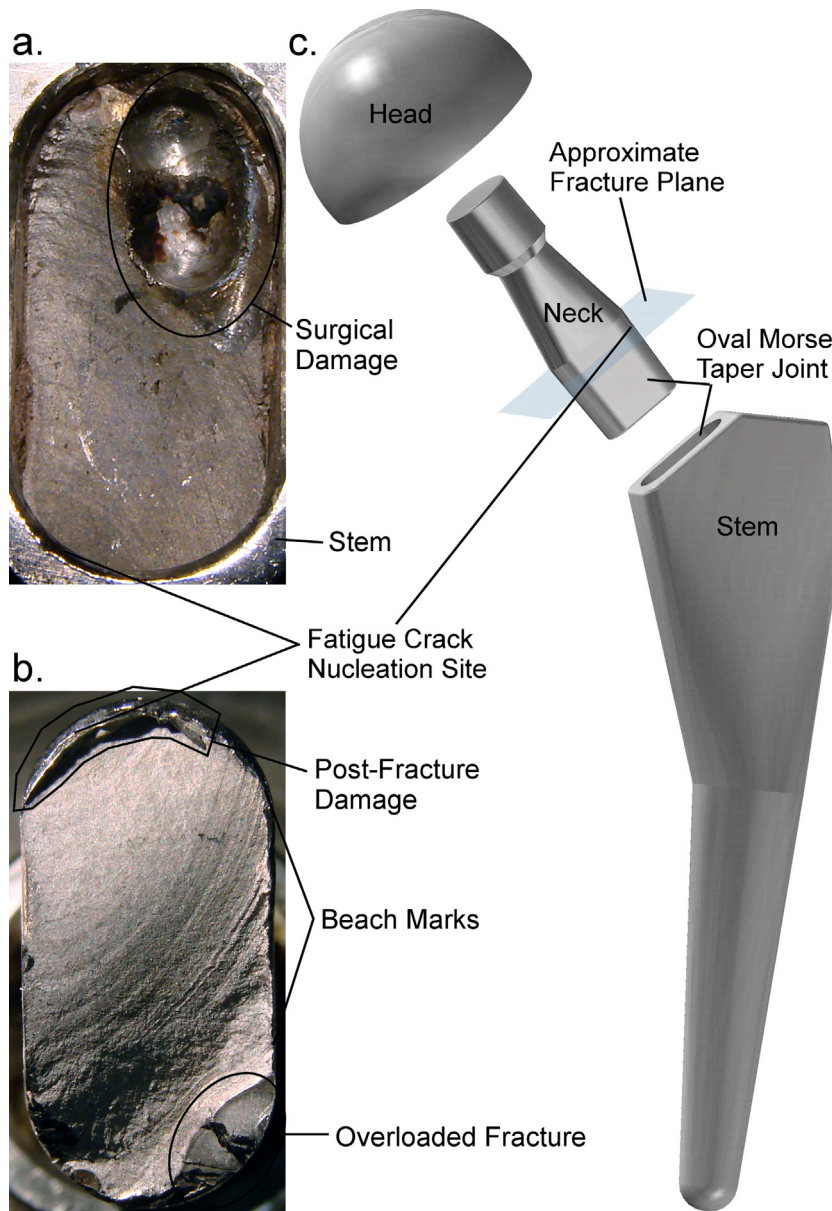
Fig. 1 shows optical photographs of both fracture surfaces, as well as a model of where fracture occurred in relation to the modular hip implant. After fracture, one piece of the neck remained inside the stem's female taper; the other piece remained

**Fig. 1.** (a) Optical photograph of the fracture surface of the neck that remained in the stem. The surgical damage was created by a tool used to remove the implant from the body. (b) Optical photograph of the fracture surface of the neck that remained attached to the head. Post-fracture damage occurred when the fractured neck slid across the inside of the stem's taper surface. (c) Exploded model of the modular hip implant, showing where neck fracture occurred. Both the neck and stem were made of Ti-6Al-4V.

attached to the head. The piece of the neck that remained in the stem was damaged by the surgeon during removal of the implant from the body. This surgical damage occurred near the overloaded portion of the fracture surface – the fatigue crack nucleation site remained pristine. In contrast, the piece of the neck that remained connected to the head was not damaged during surgery, but it was damaged when the fractured neck slid out of the stem's female taper after overload. Unfortunately, this post-fracture damaged ruined the areas of the taper surface and fracture surface that coincided with fatigue crack nucleation. Thus, only the stem-side neck was examined further for crack nucleation causes. The head-side neck was used to assess the extent of fretting and corrosion between the surfaces of the Morse taper joint.

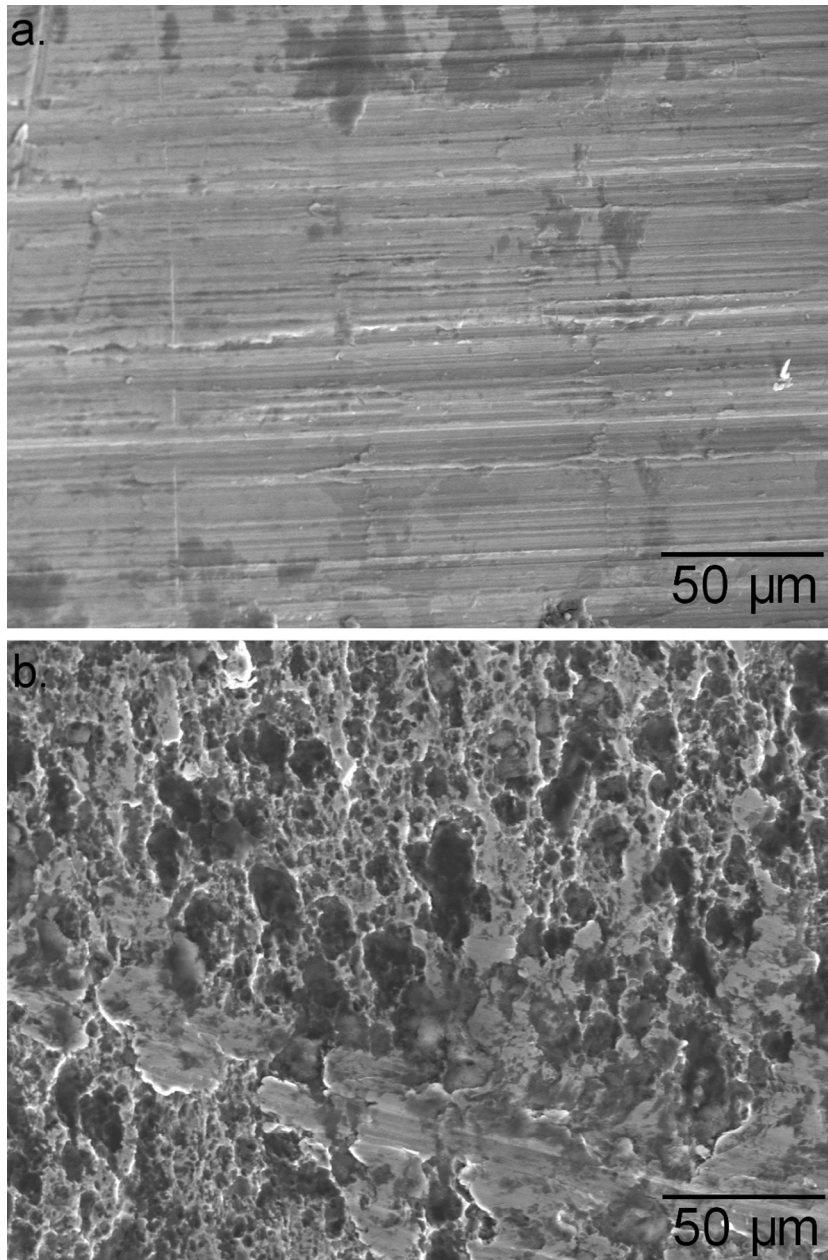
Visually, the neck surfaces that remained outside of the tapered joint were shiny, with no obvious signs of corrosion. The neck surfaces inside the Morse taper, however, were darkened and appeared corroded. SEM images of these surfaces are shown in Fig. 2 and confirmed the visual inspection. Outside the tapered joint, the surfaces were uniform with original

**Fig. 2.** (a) Secondary electron image of the surface of the neck's Morse taper located outside the joint's contact area. This surface was uniform and showed original machining marks, which run perpendicular to the long axis of the neck (the long axis of neck runs from top to bottom in this image, with the head side at top). (b) Secondary electron image of the surface of the neck's Morse taper located inside the joint's contact area. Most of the surface was corroded and fretted. (Orientation is same as in (a).)

machine marks evident. Inside the joint, the surfaces were extremely non-uniform and roughened, indicative of crevice-corrosion. Areas of fretting were also observed, somewhat less frequently than corroded areas. As mentioned earlier, however, the anterolateral portion of the taper surface that was expected to contain the highest degree of fretting was damaged after fracture as the neck slid out of the stem. Only a very small fraction of the tapered surface that was inside the joint was free of fretting or corrosion.

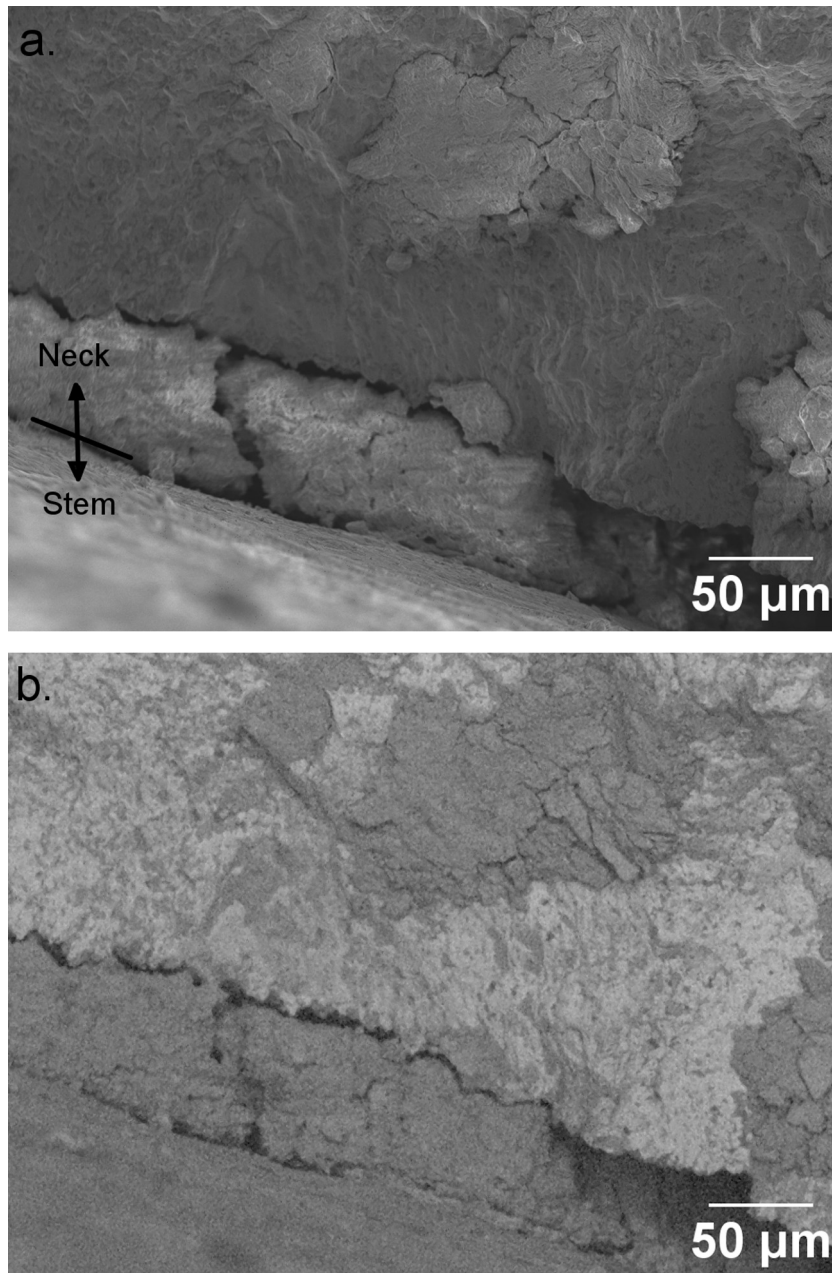
Signs of corrosion were also observed while imaging the fracture surface. Fig. 3 shows secondary and backscattered electron images of the fracture surface, taken at the interface between the neck and the stem. The brightest phase in the backscattered image is the titanium alloy. It is unclear whether the darker phase at the joint interface is a solid corrosion product or residue left after desiccation of body fluids. No EDS was performed because the fracture surface of the neck was recessed too far into the stem to yield quality X-ray spectra at this joint interface. Regardless, the jagged edge of the titanium neck and the gap between the neck and stem is indicative of corrosion. The entire circumference of the fracture surface was separated from the stem by 10–80  $\mu\text{m}$ , giving an average corrosion rate of about 15  $\mu\text{m}/\text{yr}$ .

**Fig. 3.** (a) Secondary electron image of the stem–neck joint interface at the fatigue-fracture plane. (b) Backscattered electron image of the same area. The entire circumference of the neck along the fatigue-fracture plane was corroded.

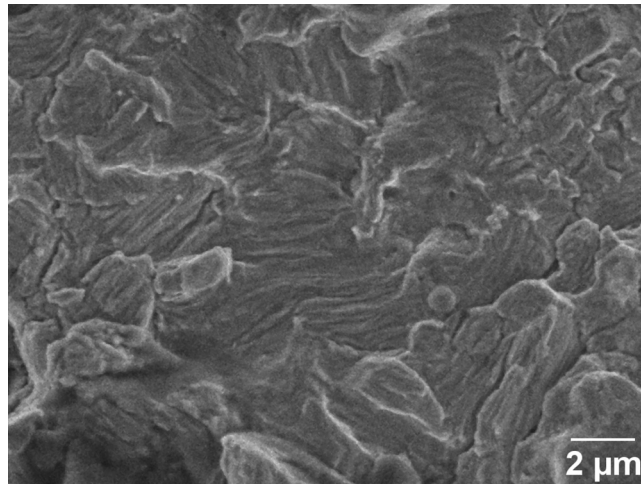
Fig. 4. Secondary electron image of the fatigue-fracture plane showing fatigue striations. The striations were present throughout the beach-marked area shown in Fig. 1b.

Based on the optical photographs (Fig. 1), approximately 94% of the fracture surface area consisted of beach marks indicative of fatigue crack growth. Only 6% of the area was from the final overloaded fracture. SEM images confirmed the presence of a fatigue crack. In secondary electron images (Fig. 4), fatigue striations were clearly seen throughout the beach-marked area of Fig. 1b. Also, a distinct crack nucleation site was found (Fig. 5). The site appears to be a crack oriented perpendicularly to the fatigue crack and surrounded by a region different in chemical composition to that of the base alloy. Although it may have been a pre-existing flaw, the crack was likely created by fretting; and the zone surrounding it appears to be the result of corrosion that was enhanced by the presence of this crack. If it were a preexisting flaw, one would expect to find similar flaws on the surface of the taper outside the joint or on central areas of the fracture surface – neither was observed during this study. The penetration depth of corrosion at this nucleation site is more than twice that of all other areas along the circumference of the fracture surface. Tapered joints in a variety of common engineering applications are never considered leak tight without the use of an additional sealing mechanism (o-ring, grease, etc.). Given that no sealant is used in hip implants, some degree of fluid penetration into the joint is inevitable.

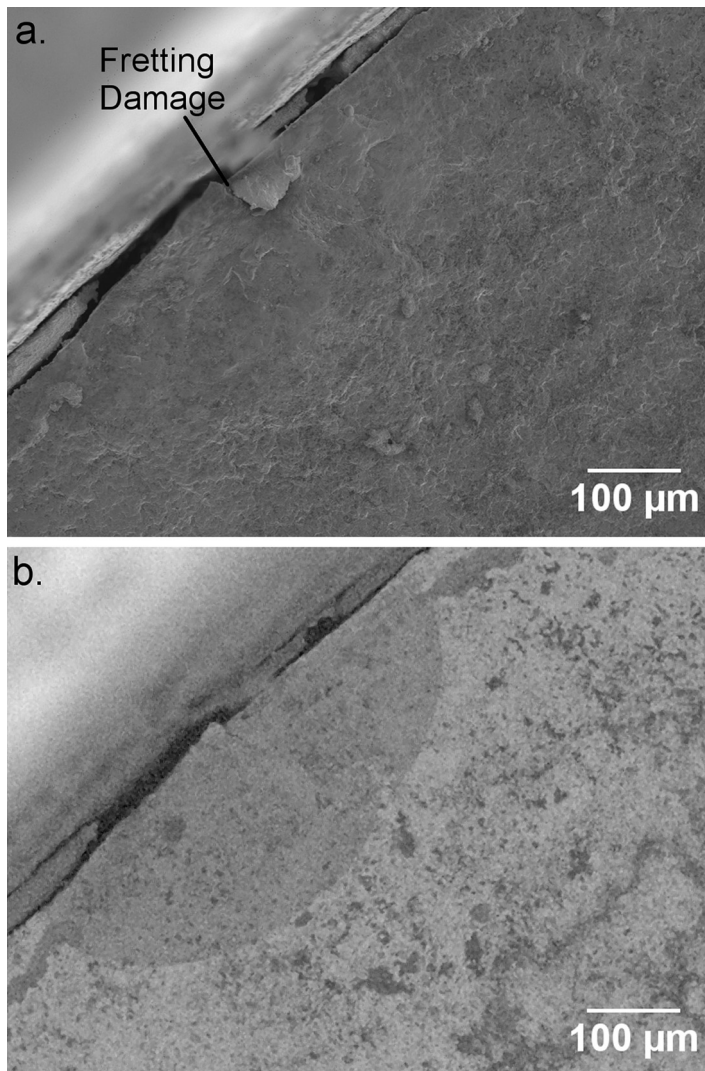
Fig. 5. (a) Secondary electron image of the fatigue crack nucleation site. (b) Backscattered electron image of the same area. The site includes fretting damage at the anterolateral surface of the neck and corrosion which has penetrated more than twice as deeply as other areas of the stem–neck joint interface.
