Failure and Degradation Modes of PV modules in a Hot Dry Climate:

Results after 16 years of field exposure

Karan Rao Yedidi

ARIZONA STATE UNIVERSITY

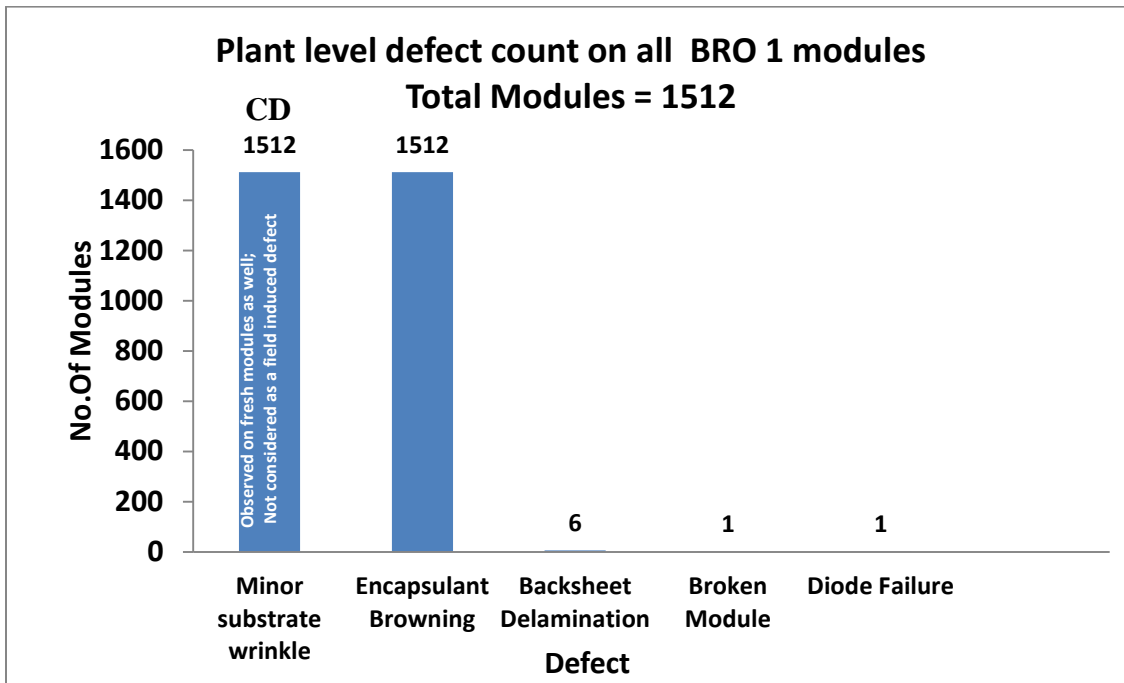
Figure 40 Bar graph on defects for all BRO 1 modules

The bar graph shown above in Figure 40 accounts for the defects recorded for Site 4A, all 756 modules have back sheet substrate warping between the J-box and the edge of the module and around the edges. This trend is typically seen in glass-polymer frameless modules because of the absence of a frame and thus a sealant between the back skin and the frame. Encapsulant browning covered 30-40% of every cell at the center on all modules. 6 modules had moderate to severe back sheet peel. Only 1 of 2 bypass diodes for a single module failed in the entire system.

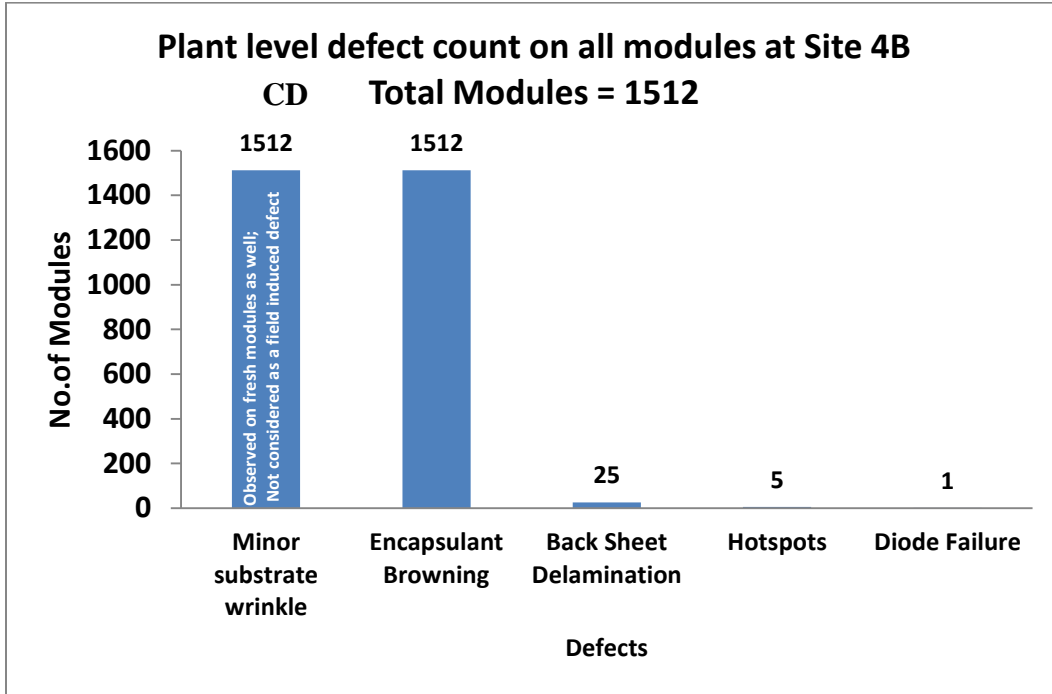
Figure 43 Bar graph on defects for all modules Site-4B.

The pie charts in Figure 44 and Figure 45 indicate a durability loss and reliability failure percentage similar to that of modules in site 4A, but a higher safety failure percentage of 1.7 because of 5 modules with back sheet delamination and one bypass diode failure.

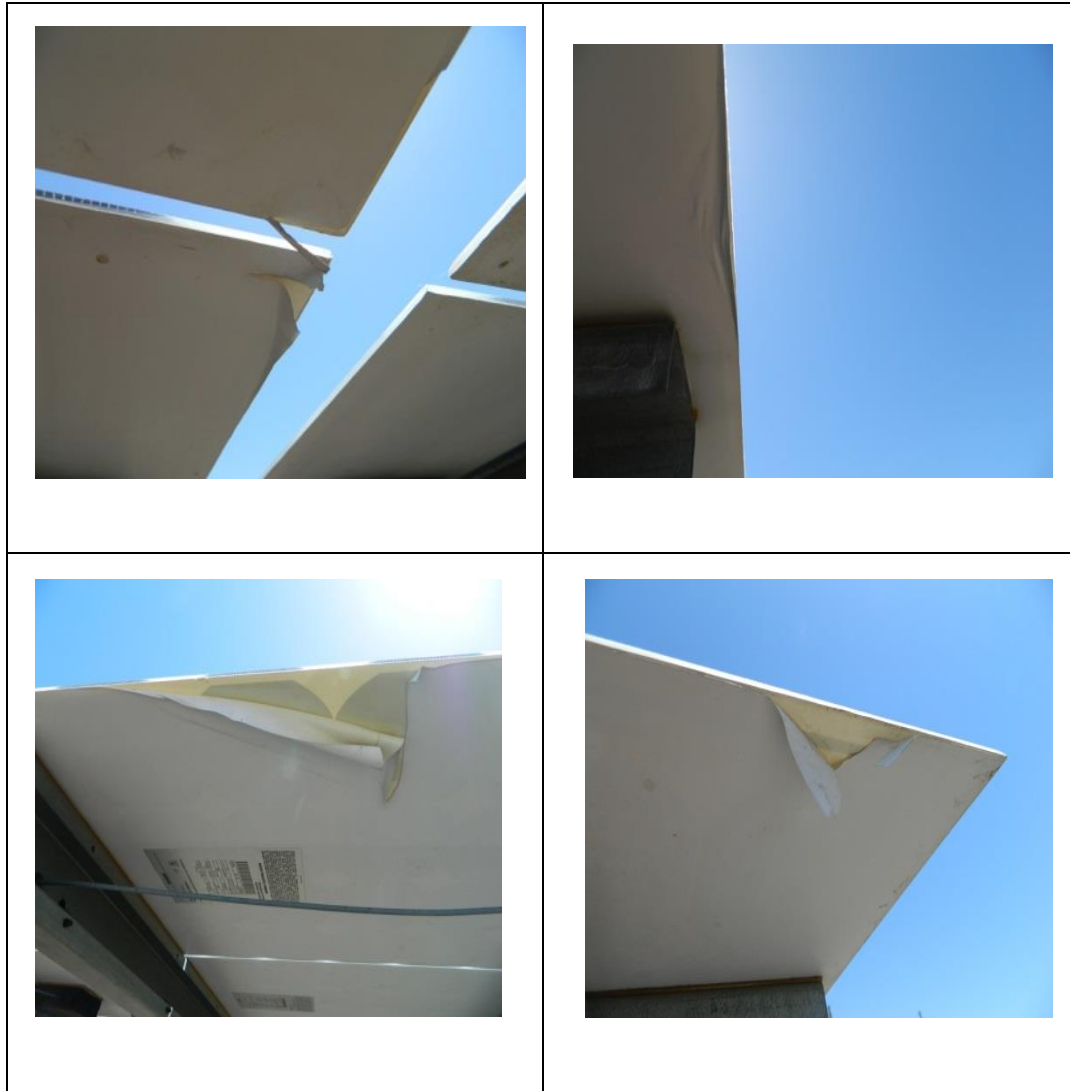
Table 9 Back sheet Delamination typically seen on the edges of frameless models.

The back sheet delamination shown in the images above have been considered as electrical safety hazards because the exposed surfaces can shock a person in the presence of moisture.

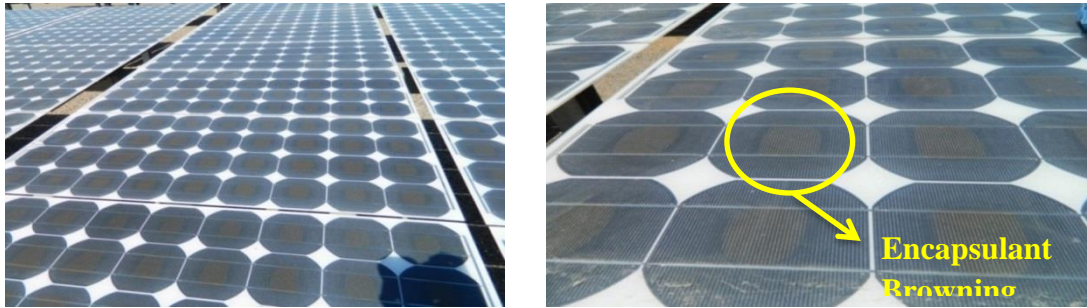
Figure 48 Encapsulant Browning

Figure 48 showing the significant amount of encapsulant browning on the cells that is affecting transmissivity of light. Browning occurs when UV rays begin to degrade the EVA. Eventually as the EVA degrades, it can form acetic acid that corrodes internal cell ribbons.

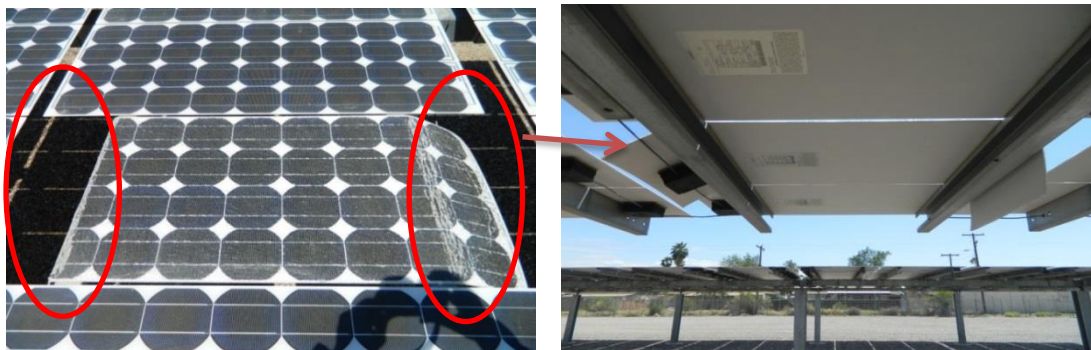
Figure 49 Broken Module in Site 4A

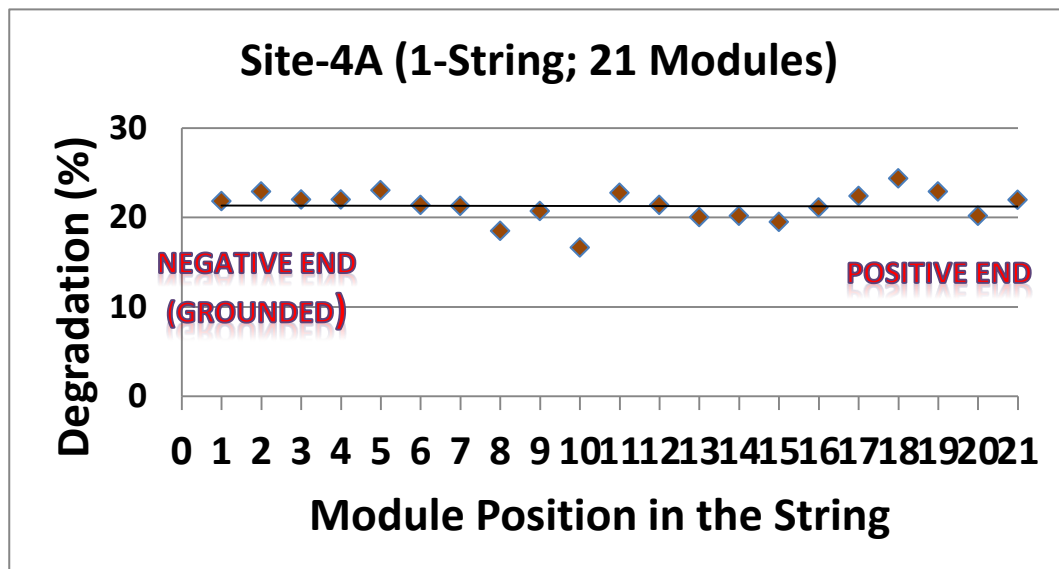
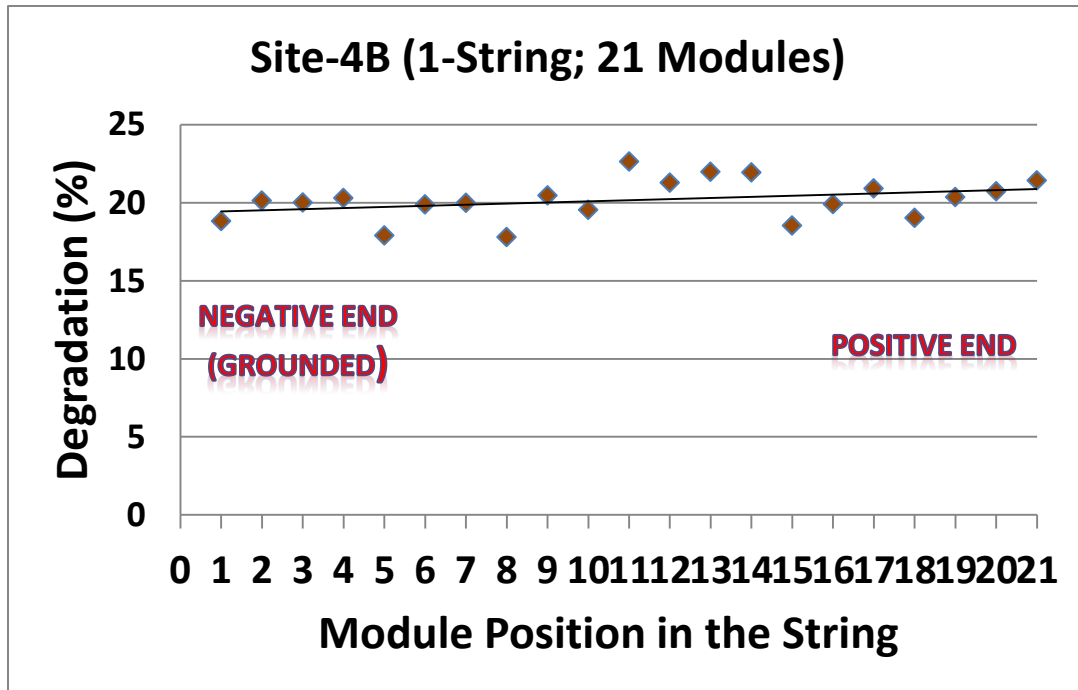
Figure 50 Absence of PID in Site 4A

From Figure 50 and Figure 51 these plots indicate that the modules haven't undergone any potential induced degradation due to high system voltages. A higher degradation rate was observed at the positive end.

Figure 51 Absence of PID in Site 4B

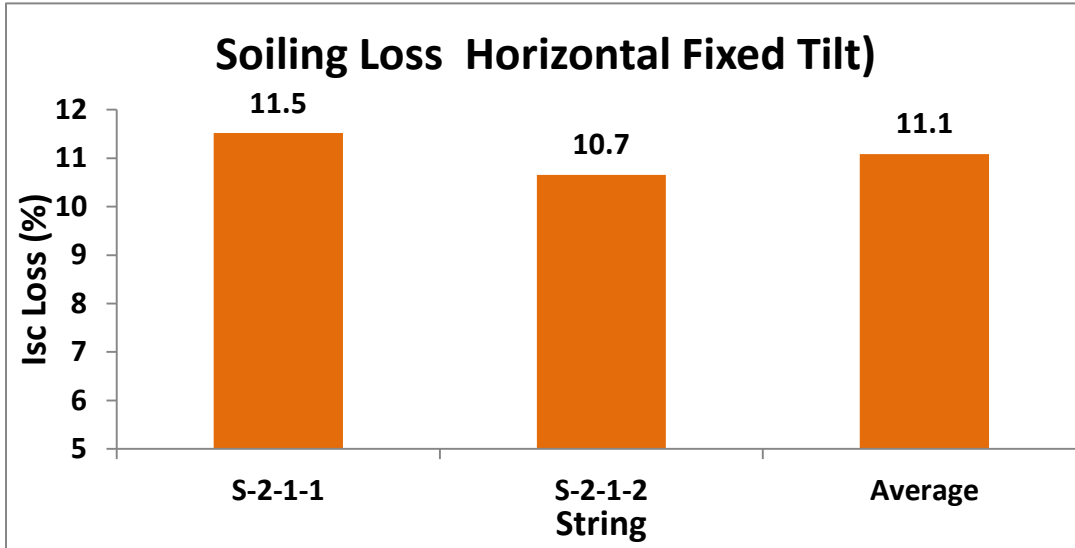
Figure 52 Soiling loss in site-4B
