26+ Year Old Photovoltaic Power Plant: Degradation and Reliability

Evaluation of Crystalline Silicon Modules – South Array

A Thesis Presented in Partial Fulfillment
of the Requirements for the Degree
Master of Science in Technology

ARIZONA STATE UNIVERSITY

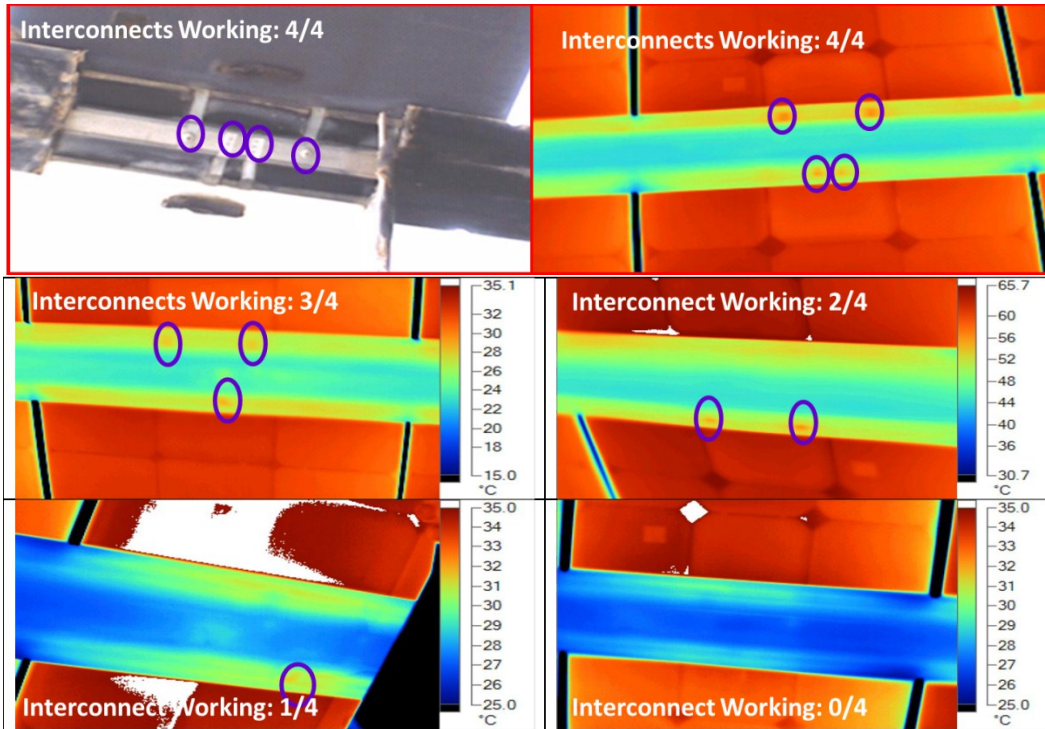
Figure 4.9 IR scans for determination of interconnect breakages

connection point has a higher temperature than the surrounding surface on the bus bar. This method was very useful in finding broken interconnects without the need to open any bus bar cover within the PV array. Figure 4.9 below show sample IR images of interconnect damages.

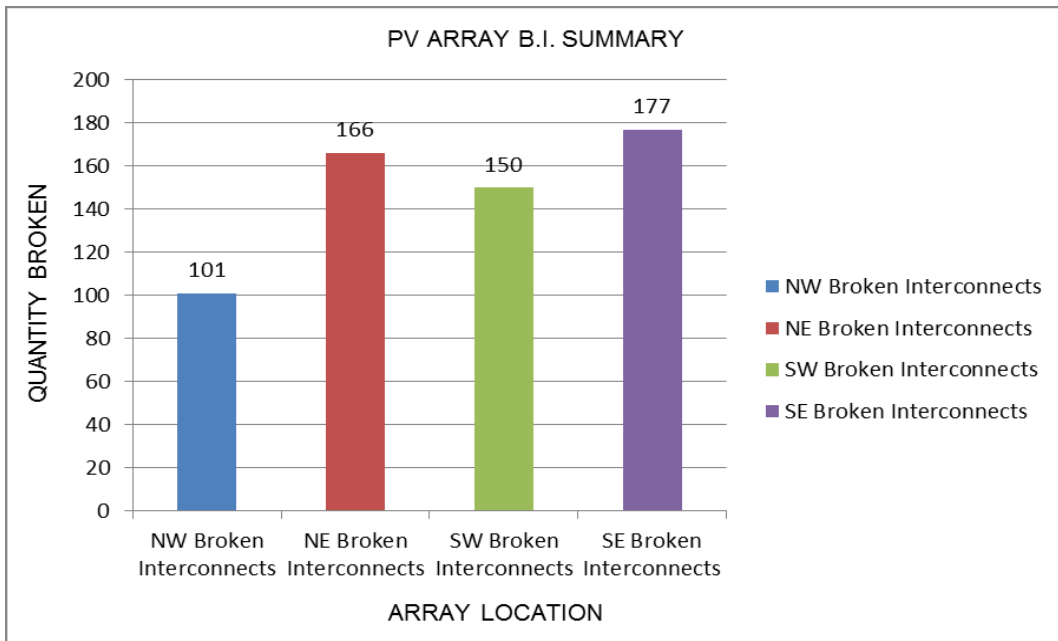
Figure 4.10 Summary of broken interconnects on PV array

A summary of total broken interconnects is shown in the Figure 4.10 below. The east sub arrays have more detected broken interconnects. Performance degradation increases when more current is forced through fewer interconnections causing higher series resistances in the affected panel groups. The panel groups in the east array have lower fill factors than the panel groups in the west side of the array.

The reason for higher level of broken interconnects on the east array is not known but a possible hypothesis could be due to improper sealing of the back cover over the interconnect-bus bar area after the replacement of failed modules with new modules in early 1990's. The improper sealing would lead to severe corrosion of interconnects during rainy days leading to interconnect breakages. The Google aerial photograph indicates that more modules had been replaced in the east sub arrays as the encapsulant discoloration was found to be less than that of the original modules. Higher module replacement would have led to higher interconnect breakage due to improper sealing of the back cover in early 1990's.

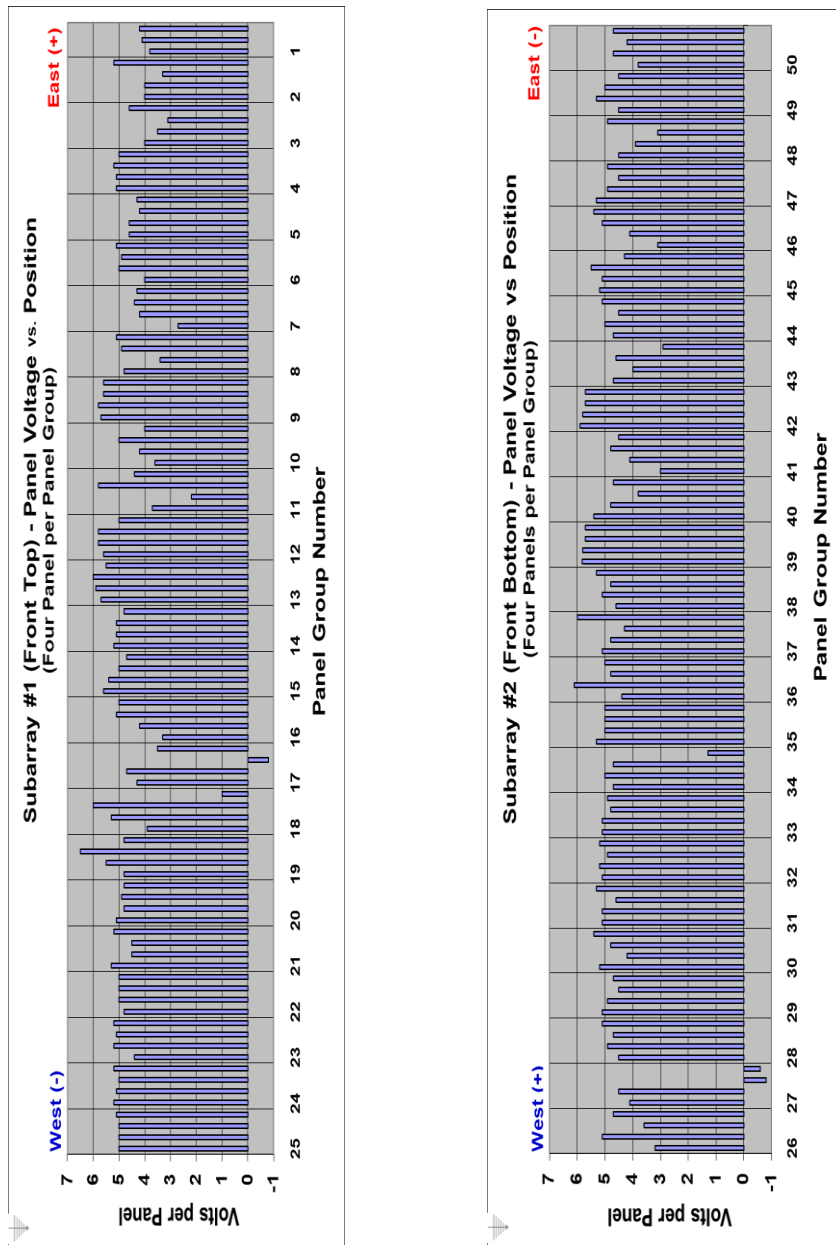
Figure 4.12 South array panel voltages measured under load

Sub arrays with positive bias have 13 PGs or 52 panels and negative bias sub arrays have 12 PGs or 48 panels all connected in series. As

panel voltages add up in series, the last panels on either ends of a sub array have open circuit voltages (V_{oc}) of approximately +380 V and -350 V respectively. These are under ideal conditions. As degradation occurred in the system, shunt resistances caused V_{oc} drop in affected panels. Two bypass diodes are externally wired into the panel group as shown in Figure 4.13 below. The wiring is permanently attached to the bus bars within the panel group. With this configuration, panels 1 or 2 failure due to shunting or hotspot failure will cause bypass diode 1 to conduct and if panels 3 or 4 fail, bypass diode 2 will conduct. Panel group 53 in the north array was found to have a conducting bypass diode. Other panels shown to have negative voltages had conducting bypass diodes as well.

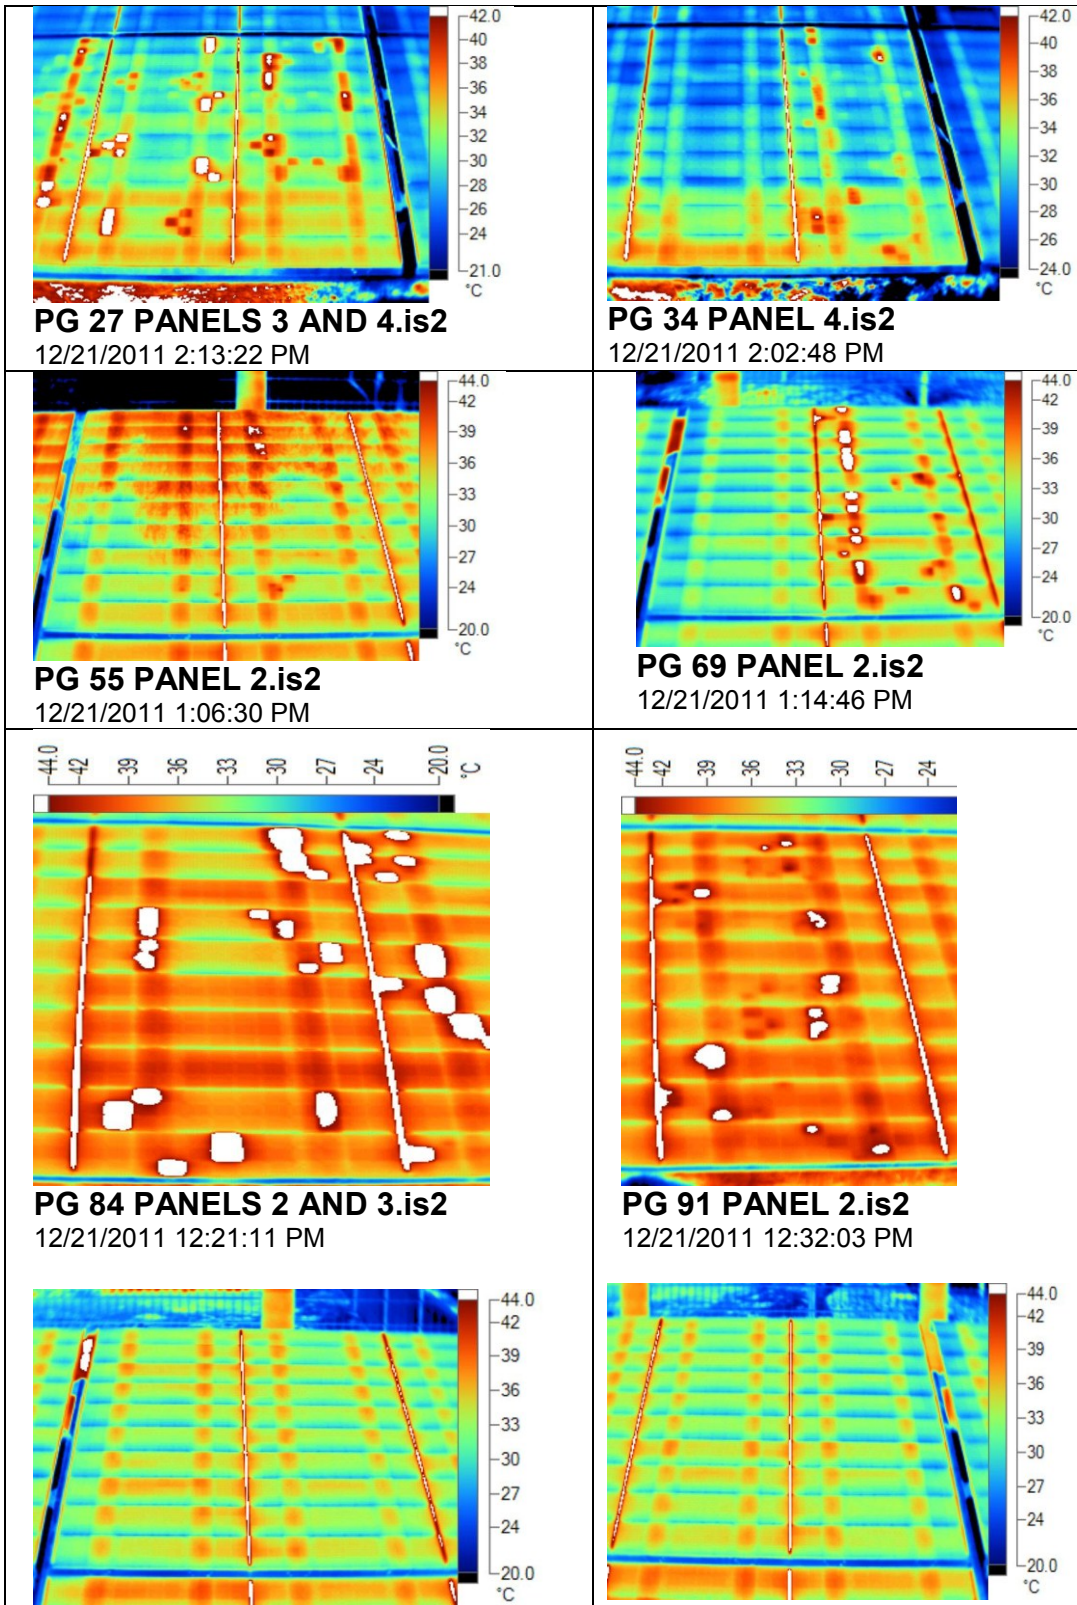
Infrared (IR) image of panel groups were taken while the array is under load, to determine the extent of degradation from hot areas. The panels with high hot areas observed were also low in panel voltages. The images of the specific panels below can be compared with the above panel voltages in Figure 4.12. Some of the panel voltages affected are found to be reversed biased. Panel IR images from panel groups 27, 34, 55, 69, 84 and 91 shown in Figure 4.15 below with more severe hot areas are shown and the 4 panels of panel group 58 which has mild hot areas are shown for comparison. The affected panel samples have low panel voltages and corresponding power outputs.

PG 58 PANELS 1 AND 2.is2
12/21/2011 1:08:41 PM

PG 58 PANELS 3 AND 4.is2
12/21/2011 1:08:28 PM

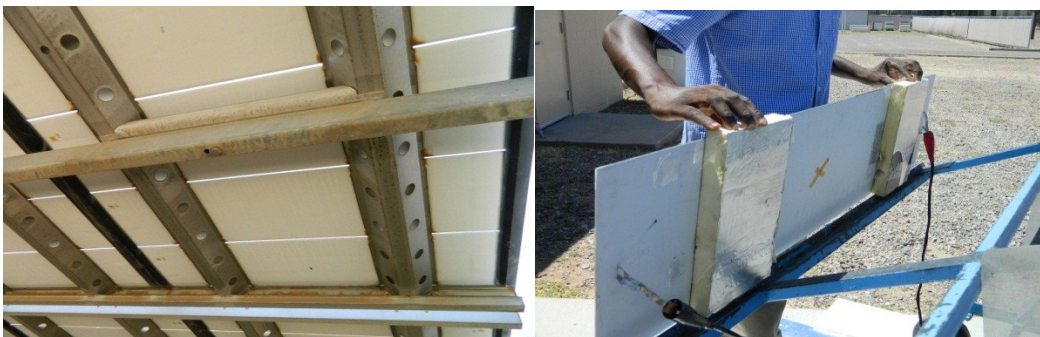
Figure 4.16 Hot area cell effects on modules back side (Left: In the field. Right: Simulated in the lab)

Hot areas for the whole array generally developed on the module cells just above the steel frame supporting the modules on the structural support for the array. The back side of the module in Figure 4.16 highlights this observation, as the cells do not have enough ventilation on the backsheet in the area enclosed by the supporting frame. A lab experiment was carried out to be verify effect of high temperatures on cells with low ventilation (or high thermal insulation) on the PV array as shown in Figure 4.16 below.

The result showed an average of 1.6 W power drop from a partially insulated sample module SM54 with 41.6 W measured peak power without insulation, results given in the Table 4.4 below:

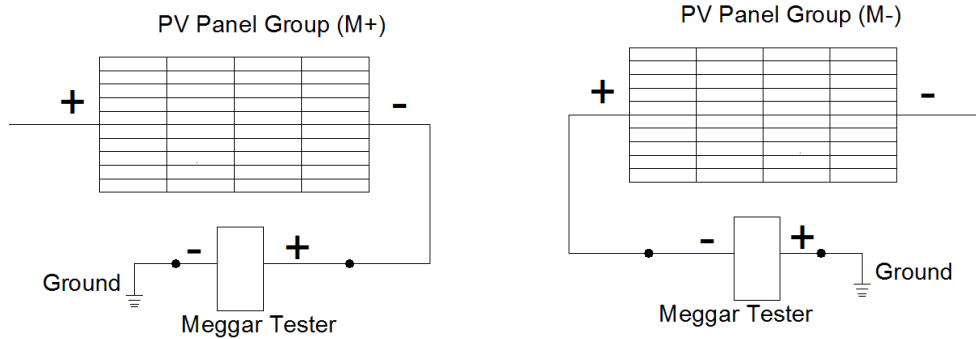
Figure 4.17 Hi-Pot Insulation Test wiring for positive (left) and negative (right) polarities above ground

- High leakage current on rainy days
- Inverter shutdown will most likely occur
- Most leakage on PG with broken module
- PV system not safe when wet

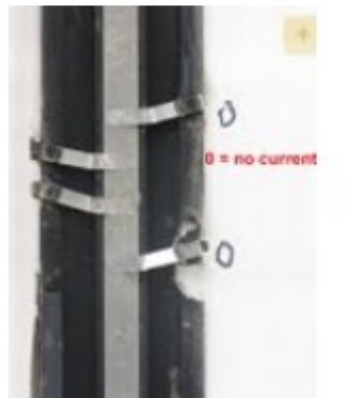
Figure 4.19 Bus bar and panel pre-assembly error

It was observed that the installation of the bus bar which contains the terminal for the bypass diode connection was moved or displaced about a quarter inch in order for the hole on the bus bar cover to fit the diode terminal. This displacement was performed after the modules interconnection ribbons have been pre-fabricated thus causing some stresses on the ribbons as a result of this displacement from the fixed module position. The detail of displacement is shown in the Figure 4.19.

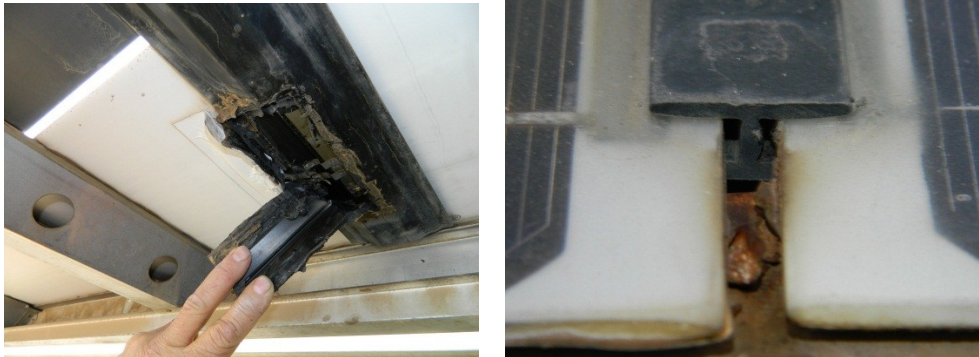
Figure 4.20 Left: Bus bar cover repairs after module replaced. Right: Corrosion observed on B.O.S. front side due to moisture intrusion

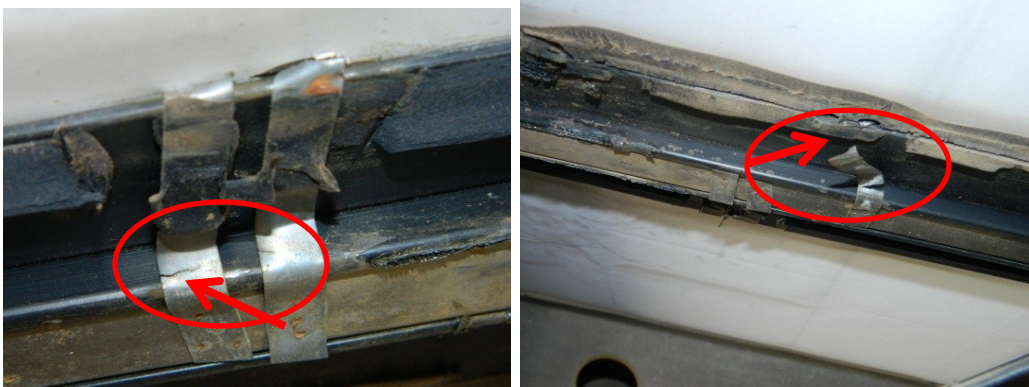
Also, several stress cracks on the module ribbon tabs are evident as observed on panel group 53. 80% of the modules were found to be in open circuit. The IV curve of PG53 shows diode activity as a result of interconnects failure.

Figure 4.21 Left: cracks on module interconnect. Right: breakages observed in module interconnects in the PV array

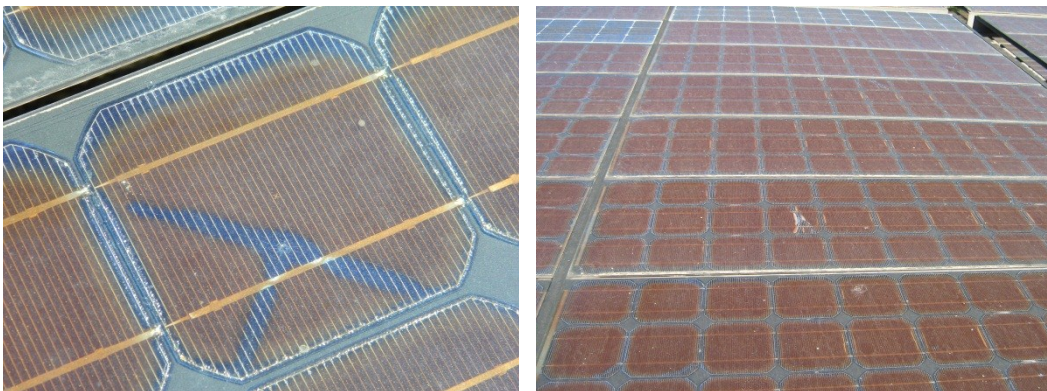
Figure 4.22 Left: cell browning with oxygen bleaching at edges and around cell cracks. Right: commonly observed extensive browning of the original PV modules

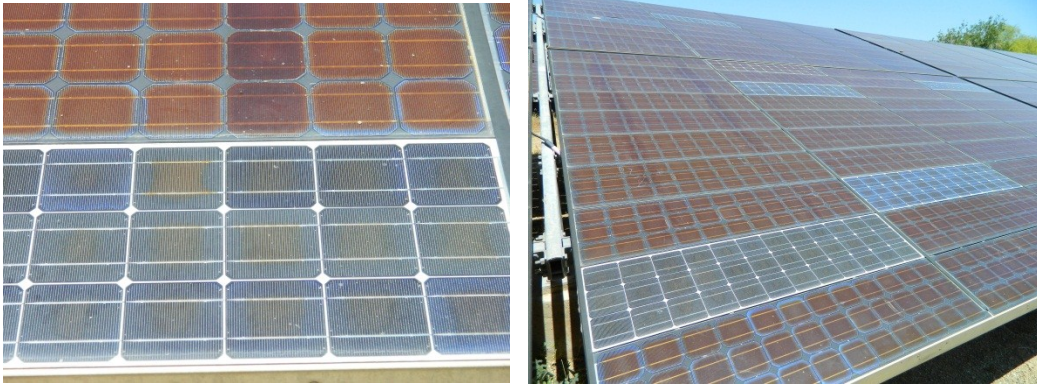
Figure 4.23 Left: Original module on top, replaced module at bottom. Right: Panel group with multiple replacement modules.
