26+ Year Old Photovoltaic Power Plant: Degradation and Reliability

Evaluation of Crystalline Silicon Modules – North Array

Jonathan Belmont

A Thesis Presented in Partial Fulfillment  
Of the Requirements for the Degree  
Master of Science in Technology

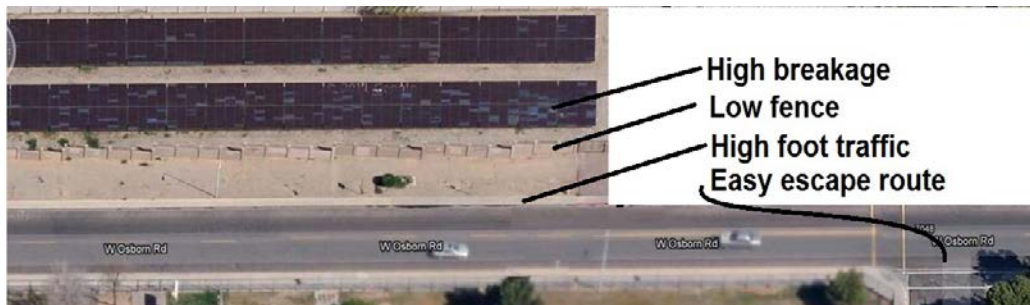
Figure 5- East Side of Array With Heavy Vandal Impact

There are a few factors that could possibly contribute to increased vandalism. A high level of pedestrian traffic creates a greater opportunity for damage. As an example, an elementary school was built directly across the street from the array around the year 2000. It is interesting to note that in Figure 5 a large number of broken modules can be seen on the south array, and especially the south east corner. These panels are closer to the fence and easier to hit with rocks or other objects tossed by vandals. Broken and replaced modules show up as the lighter color rectangles. The city of Philadelphia solar guidebook [5] states that “ground-mounted arrays are more susceptible to vandalism than pole or roof mounted systems.” It also states that solar designers need to consider a safe location and that the array should be protected from vandalism without “compromising energy production.”

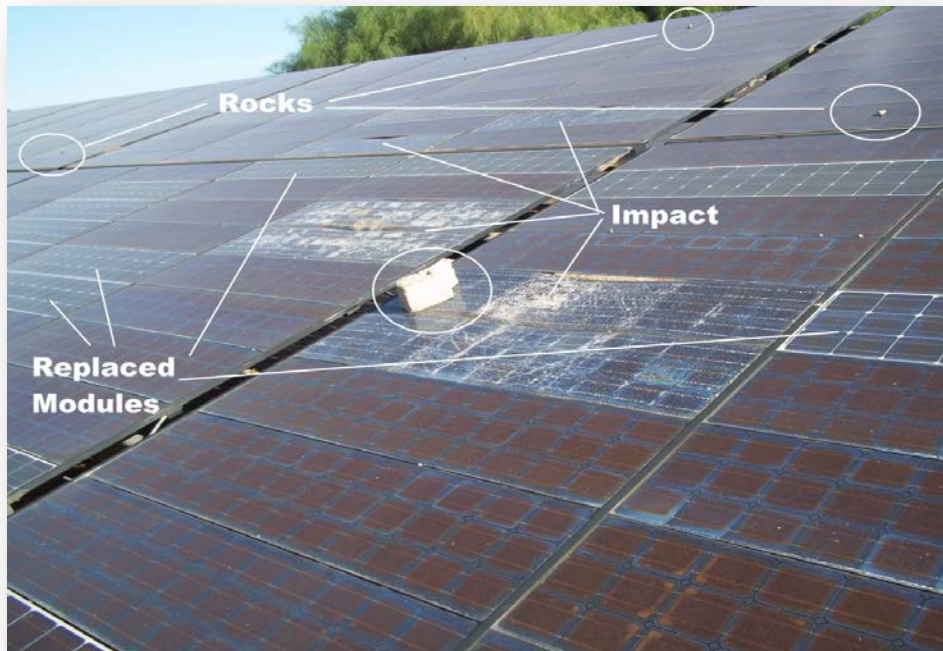
Figure 6- East Side of Array with Vandalism Evidence

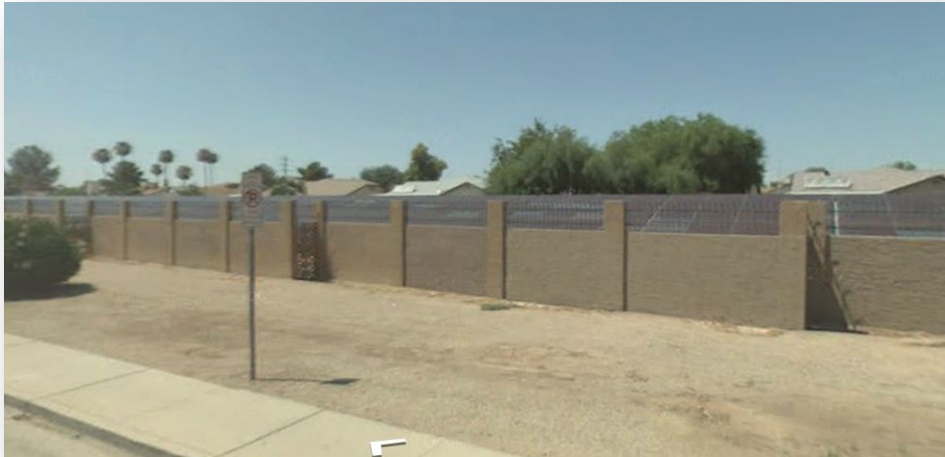
Considering that there were a high number of broken and replaced modules over the years and there was a fence, a low fence would appear to lack the security necessary to prevent damage from vandalism. Perhaps a simple remedy would have been a higher fence that would obscure the array.

Figure 7- Low Fence

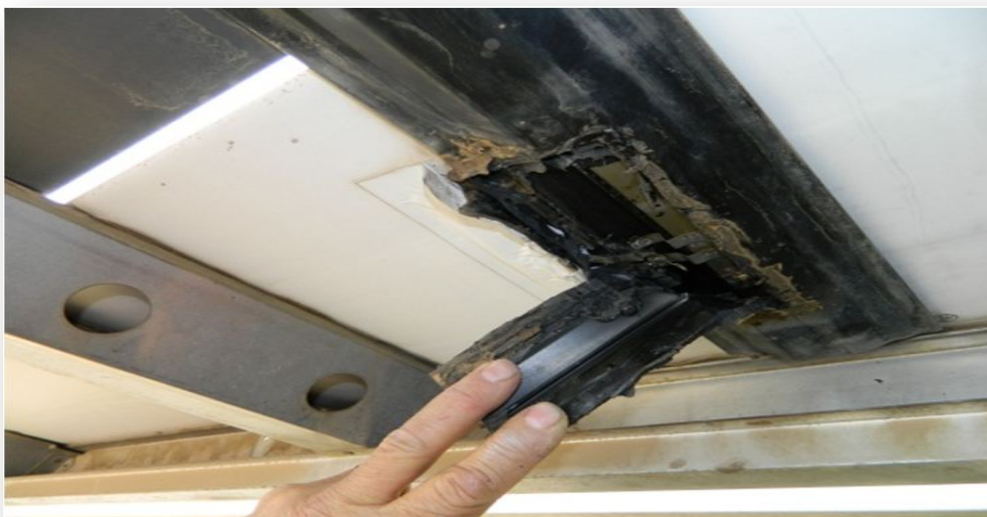
Figure 10 Failed Busbar Seal

A failure of the seal can be shown by the photo in Figure 10. It clearly shows that the type of seal used degraded over time and failed.

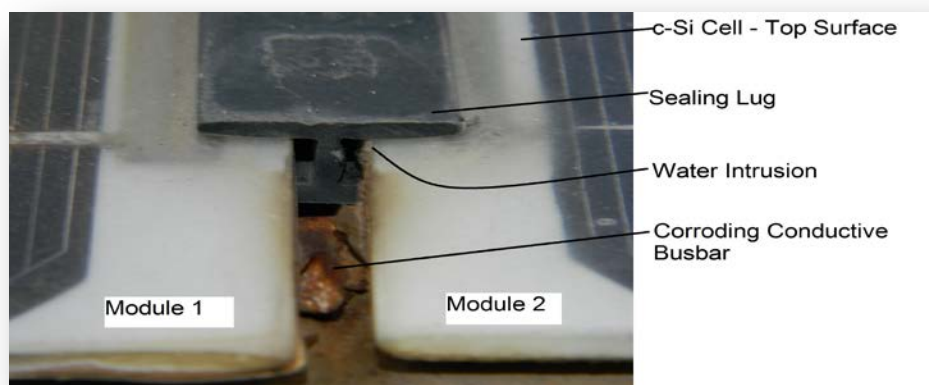
The busbar shown in Figure 11 is covered with a protective seal that can degrade over time. During the Arizona rain, water can intrude into and onto busbar. This seal was proven to be ineffective on the three panel groups that we examined during wet Megger testing.

Figure 11- Busbar Sealing Lug and Corrosion

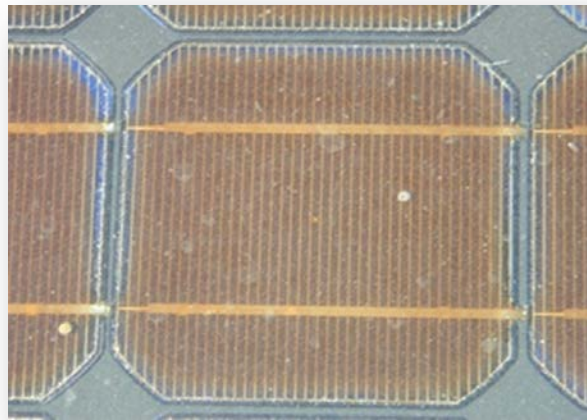
Figure 12- Typical EVA Browning

One common degradation condition comes from EVA browning. Most modules use a polymer as an encapsulate between the glass cover and the PV cells called Ethylene Vinyl Acetate (EVA.) Appropriate EVA formulation is a good choice because it can withstand UV and, transparent sealer for the solar PV cells and internal conducting ribbons. However, EVA browning becomes an effect when UV rays begin to degrade the EVA [9]. Additionally, as the EVA degrades it can form acetic acid that corrodes internal cell ribbons.

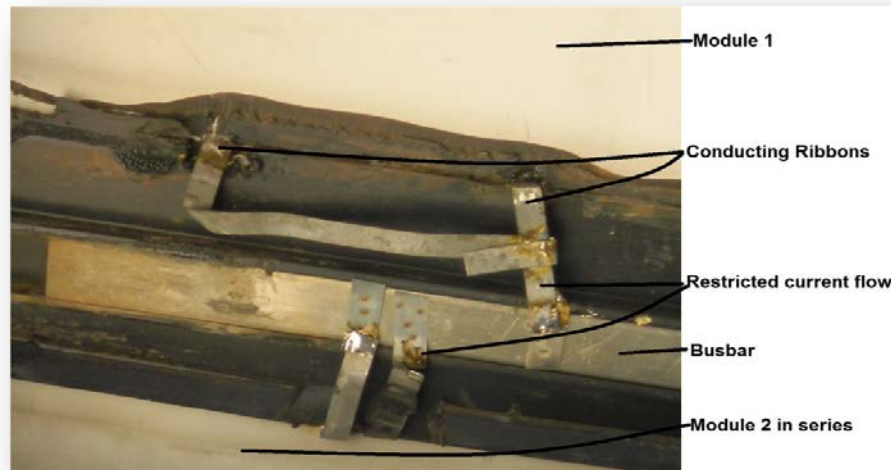
Our visual inspection found that some busbar covers were opened, making the module ribbon connections to the busbar visible. Some of these ribbons were fully or partially broken. This finding prompted us to investigate the entire array for broken ribbons.

Figure 26 – Example of Incorrect Ribbon Connection

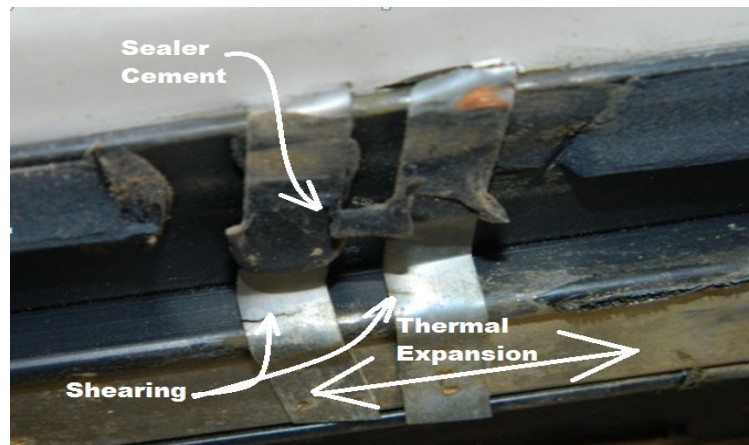
The photo in Figure 34 below shows evidence of the broken interconnect problem at the Solar One site. This shows that it is more than a metal fatigue problem but also a shearing stress problem resulting from the sealer restricting movement.

Figure 35- Busbar Expansion and Conducting Ribbon Failure

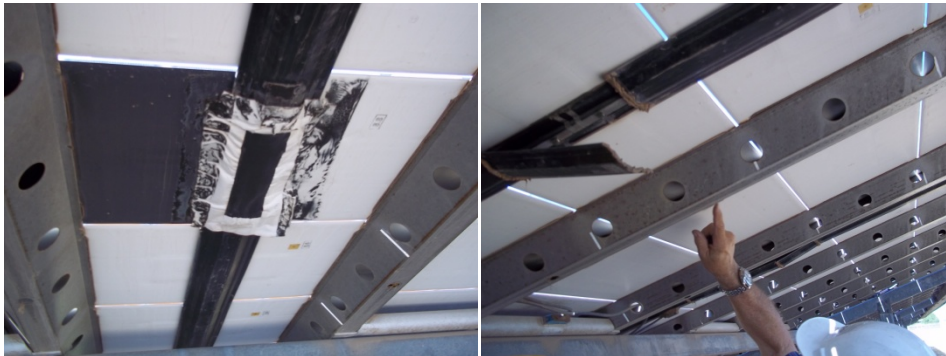
Figure 36- Examples of Busbar Seal Failure

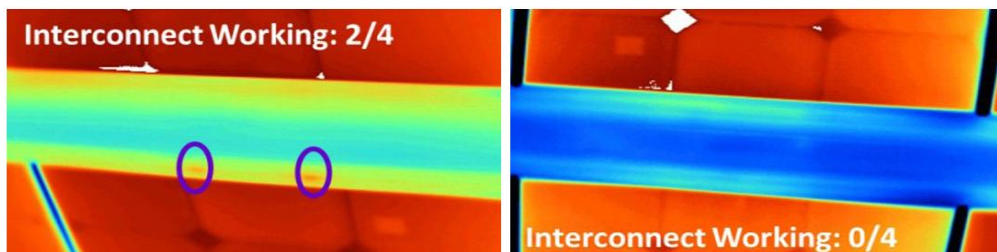
Figure 40 - Broken Interconnect Comparison

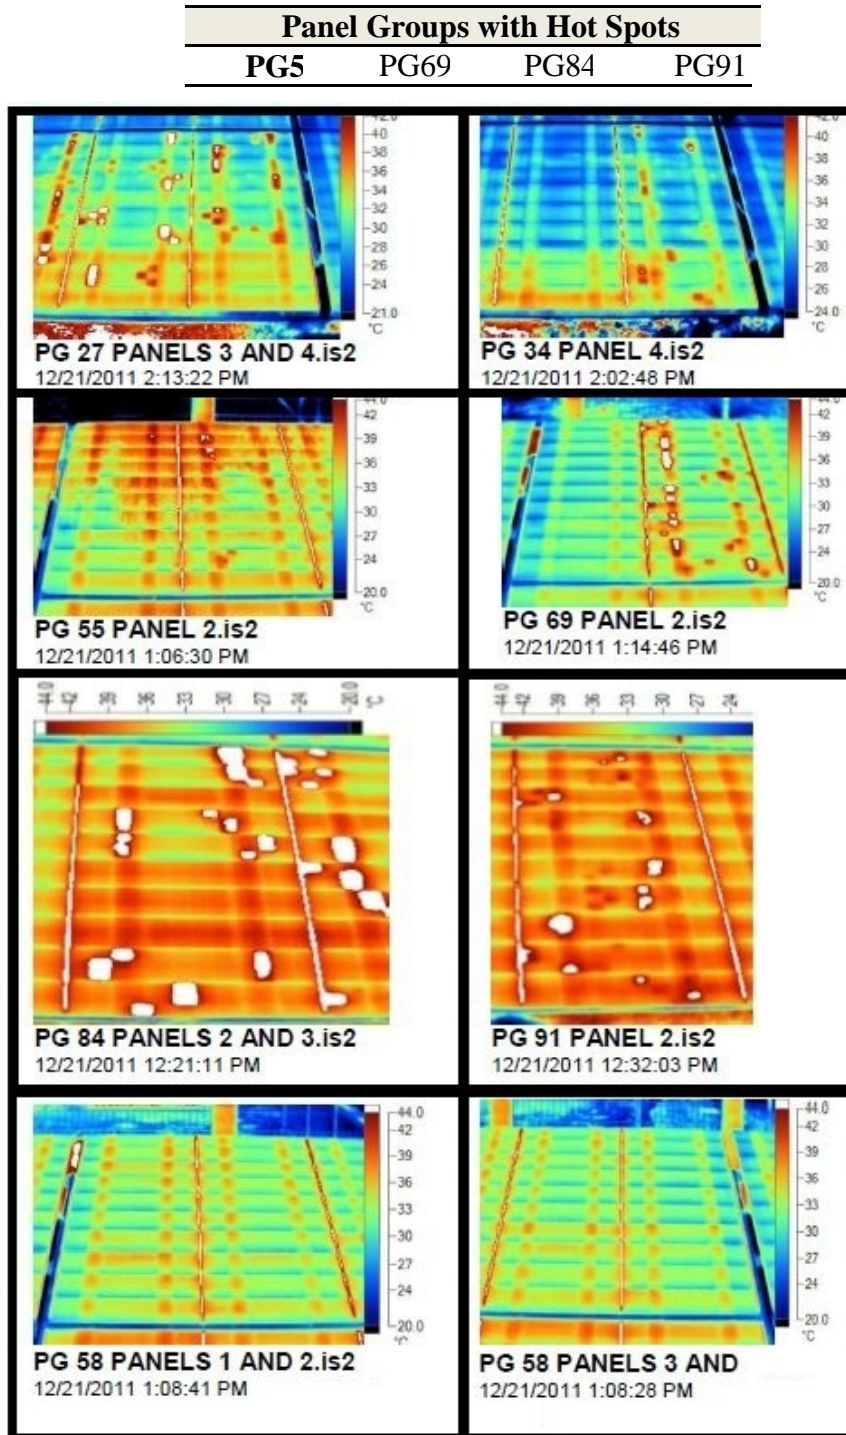
Figure 47 - Hot Spots Shown in Infrared

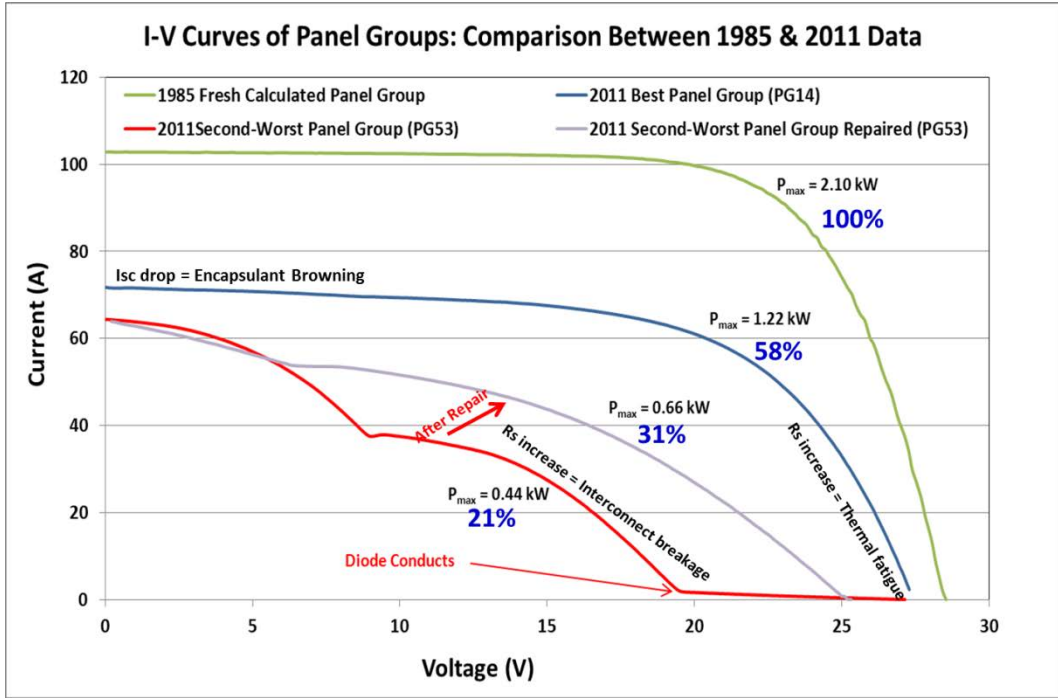
58% of the original power. This indicates that the power drop (42%) is primarily caused by encapsulant browning and series resistance increase probably due to solder bond fatigue of the cells.

Figure 49- IV Comparison and Repair Experiment

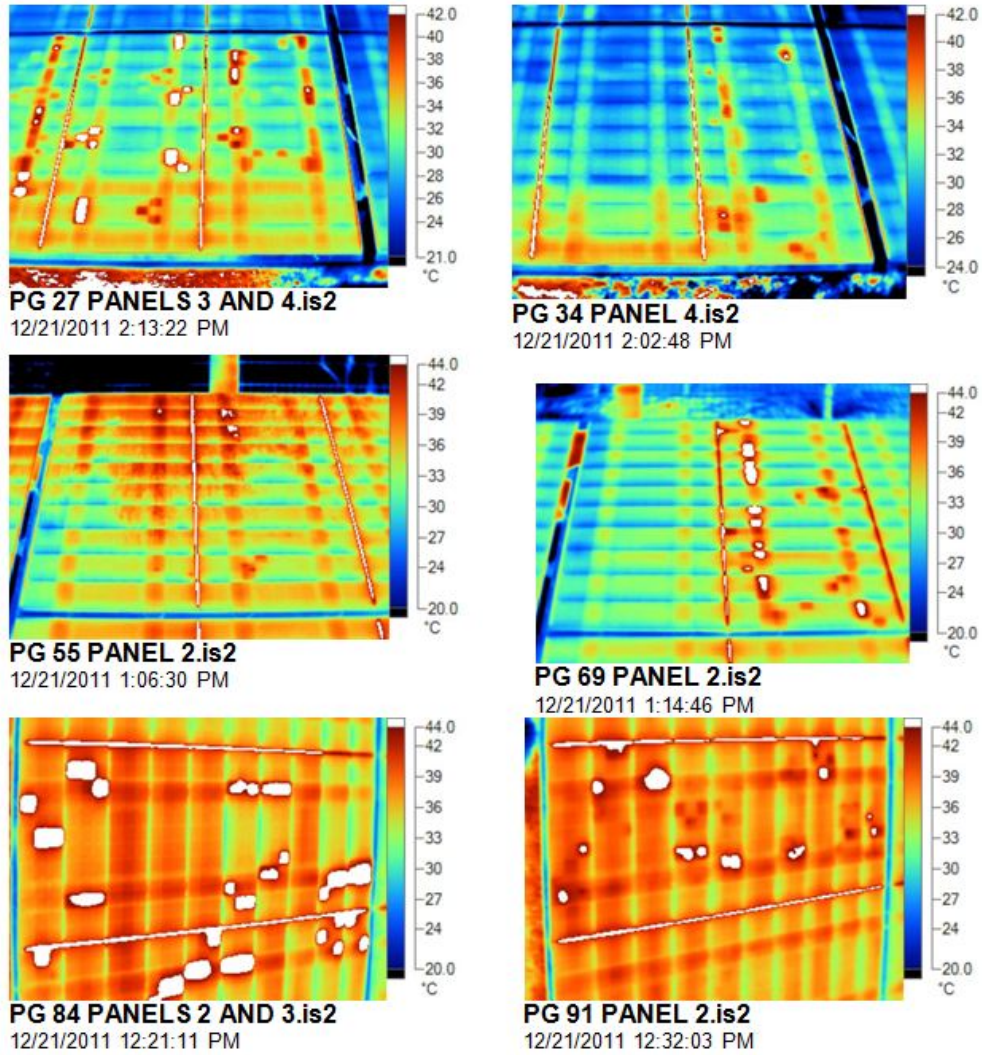
Figure A39 Infrared Photos Showing Hot Spots

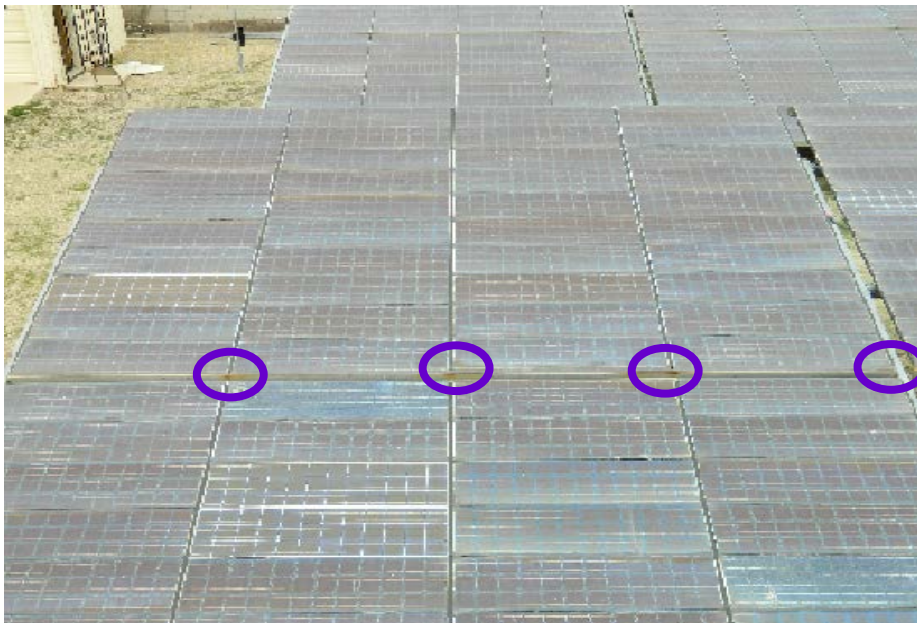
Figure A46 Corrosion Evidence Under Busbar Locations
