# Recent Vegetation Changes Along the Colorado River Between Glen Canyon Dam and Lake Mead, Arizona

GEOLOGICAL SURVEY PROFESSIONAL PAPER 1132

By RAYMOND M. TURNER *and* MARTIN M. KARPISCAK

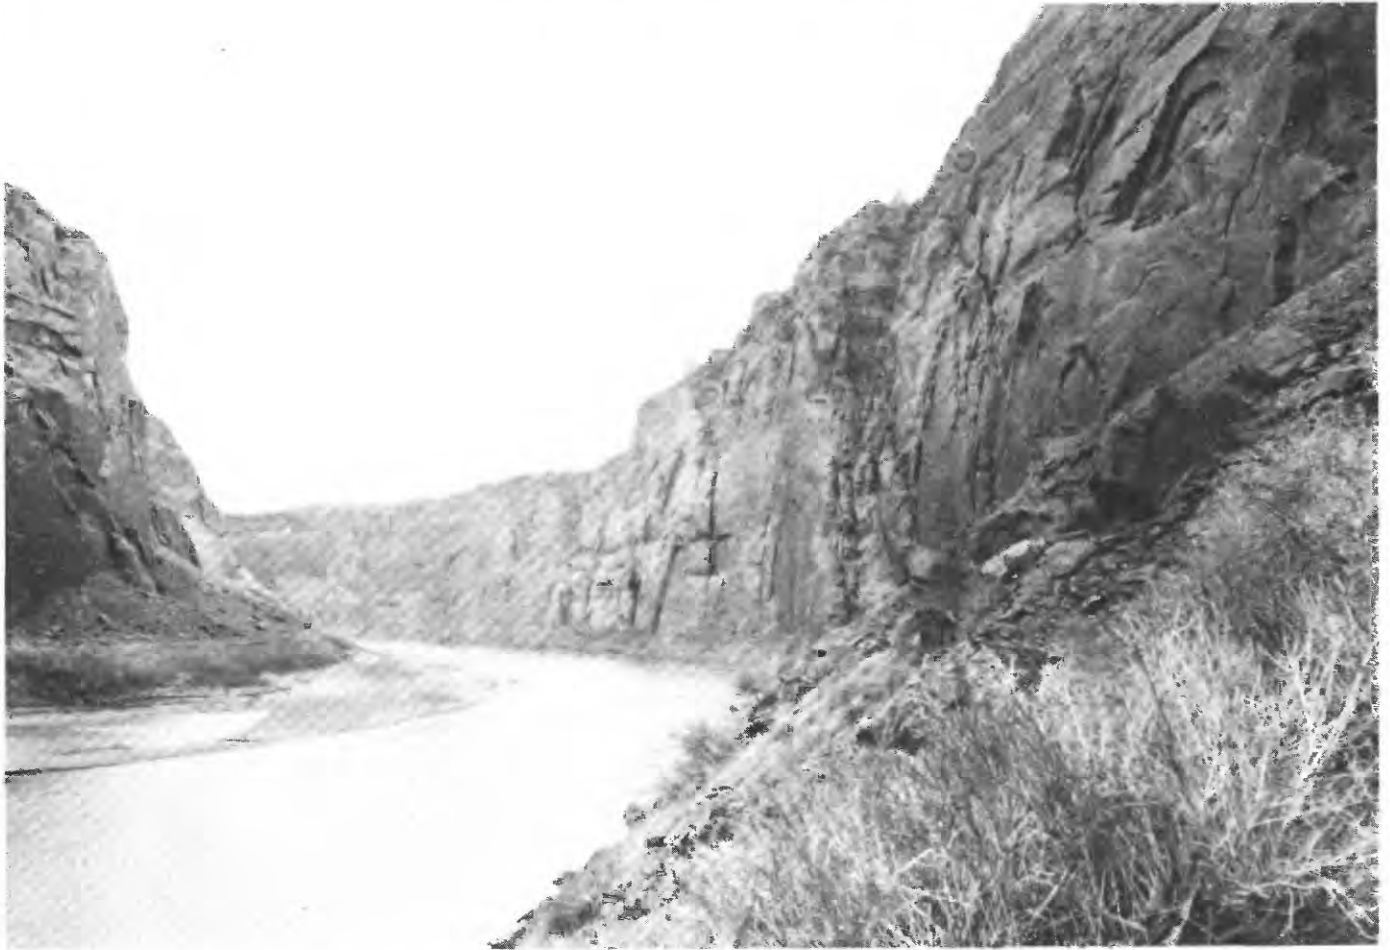
FIGURE 26A.—(1889). F. A. Nims, photographer with the Stanton-Brown railroad survey expeditions, took this photograph looking upstream from a point 1.6 kilometers below the present site of Glen Canyon Dam (24.4 kilometers above Lees Ferry). Woody vegetation on the far bank appears as a dense thicket separated from the water at this river stage by a barren sand bar. The thicket appears to be rabbitbrush. The high sandy terrace supporting the dense growth was a common feature above Lees Ferry but uncommon below. Only in years of extremely high floods would there be overbank flow sufficient to scour out these plants. The sharp lower boundary results from the scouring action of floodwaters. At the base of the distant cliffs above the river in center background are clumps of what appear to be netleaf hackberry. (Altitude 957 meters.)

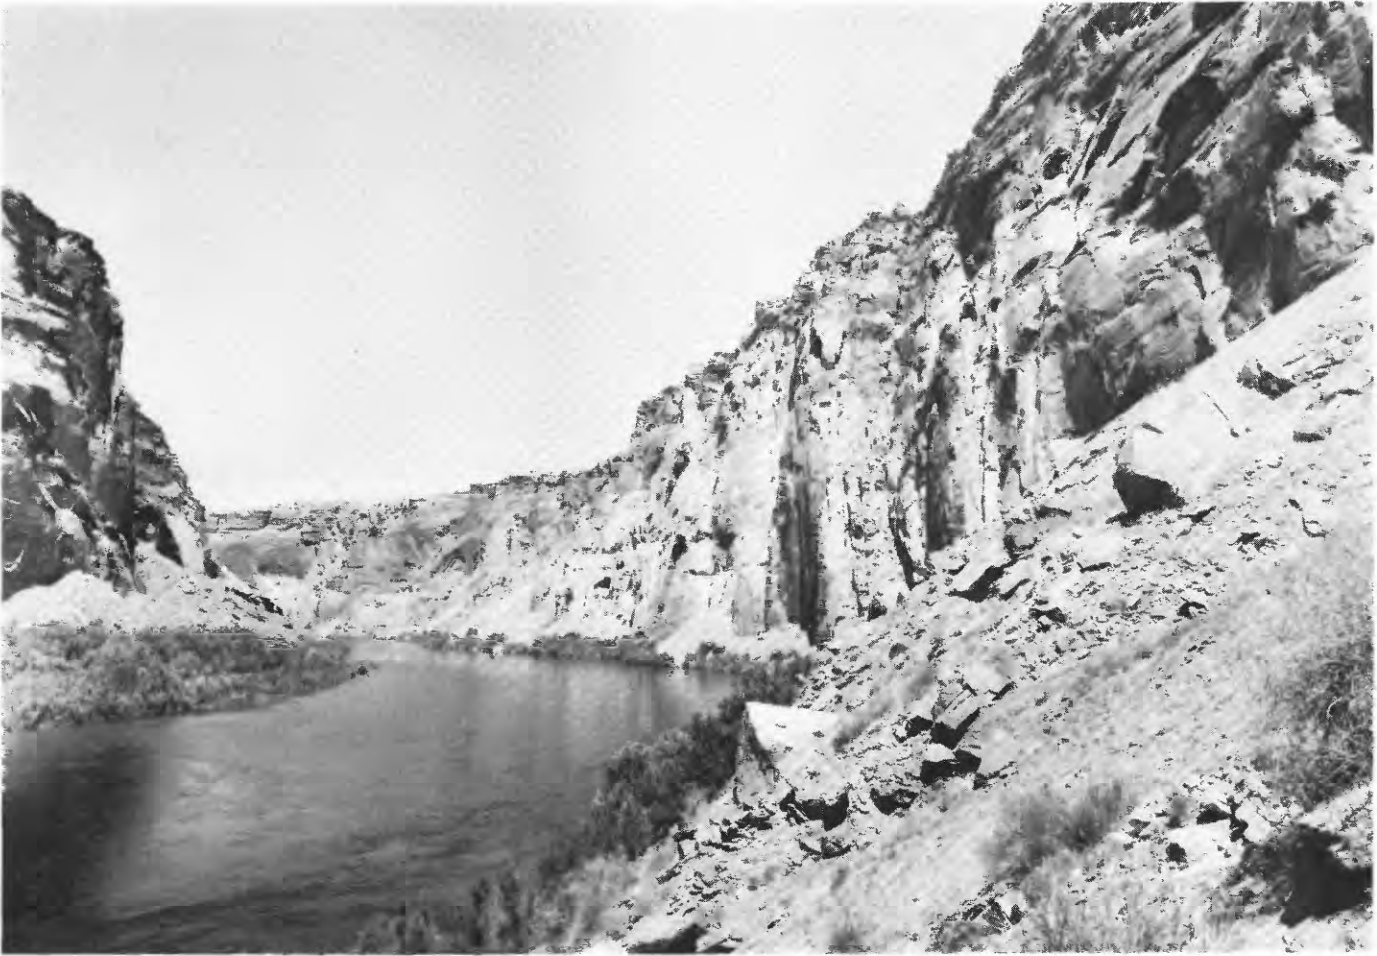
FIGURE 26B.—(1975). Glen Canyon Dam lies just out of view around the bend of the river. Construction activity related to the dam has considerably altered the steep slopes of the left bank. The netleaf hackberry seen in the previous view has been covered by rubble piles below tunnels drilled into the cliffs above. The netleaf hackberry has not reoccupied the niche at the cliff bases, although saltcedar relatively quickly became established along the base of the rubble piles. The foreground has also been altered by rubble from above, although many of the rocks carry over from the older view. The thicket on the opposite bank has enlarged, and its composition has changed—saltcedar dominates today and has spread downward over the barren skirt as far as fluctuations in river level will permit. The photograph was taken at 1330 hours, a time of peak-load demand, and the river is probably at near maximum stage. Large saltcedars dominate on the left bank also, forming a narrow almost continuous streamside band along the base of the steep slopes below the cliffs. Maximum lowering in mean streambed elevation (1.83 meters) occurred during the 1956-59 period at a point near the far bend in the river. Subsequently the channel has been stabilized by gravel and cobble-size armor, eliminating continued degradation (Pemberton, 1976).

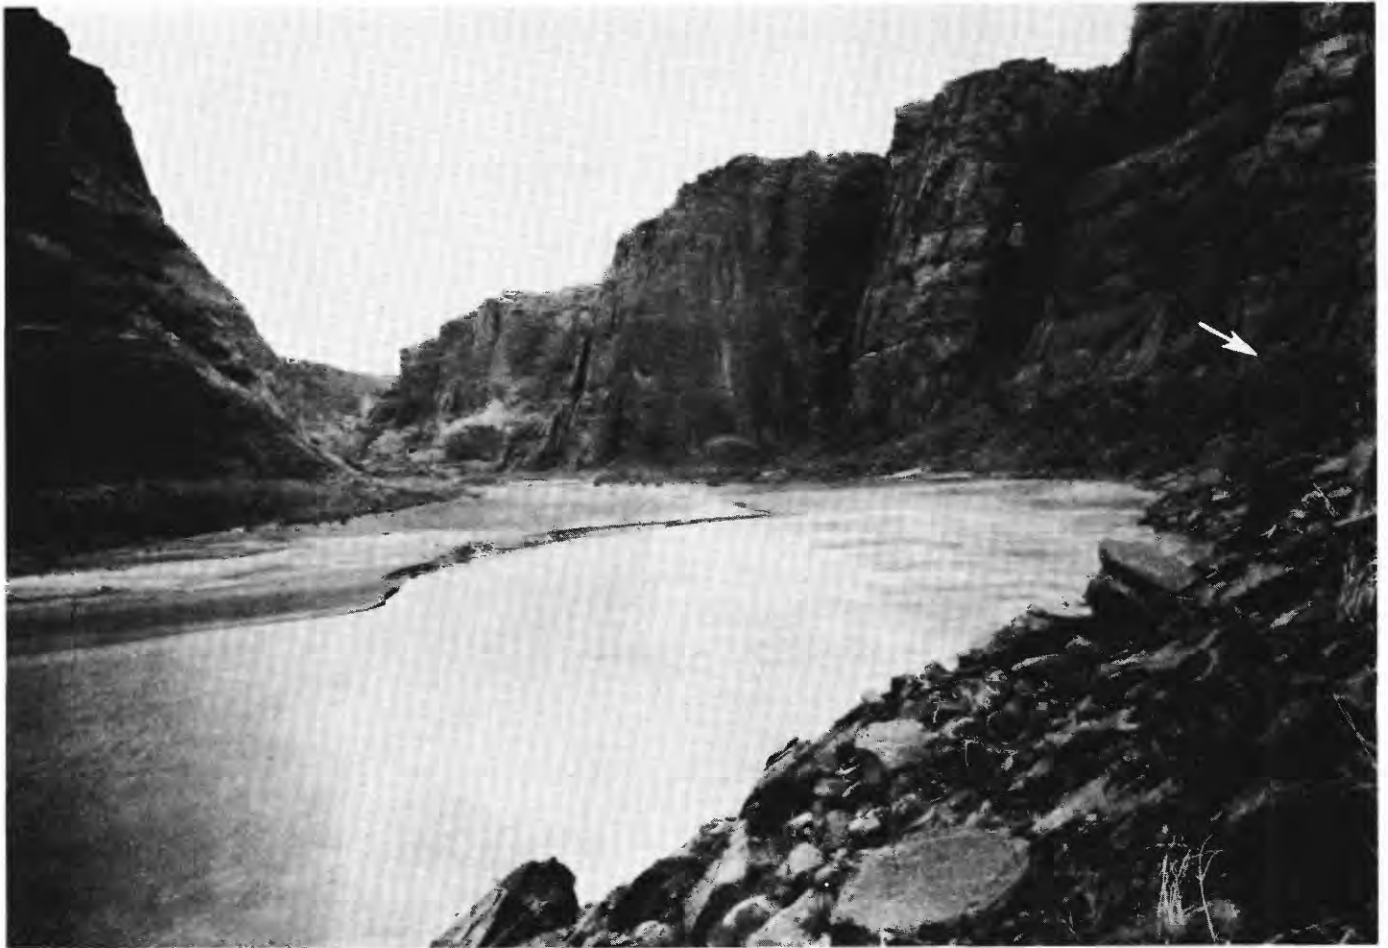
FIGURE 27A.—(1889). The Colorado River is deeply entrenched in the Upper Triassic(?) and Jurassic Navajo Sandstone through the lower section of Glen Canyon between Glen Canyon Dam and Lees Ferry, 20.6 kilometers above Lees Ferry. The view is upstream. The camera station is located near the level of maximum river stage. A single netleaf hackberry (arrow) is at the same level a few hundred feet upstream from the camera. The coarse material of the foreground supports little more than a few grasses and forbs. On the far bank is a thicket of what is probably rabbitbrush. (Altitude 956 meters.)

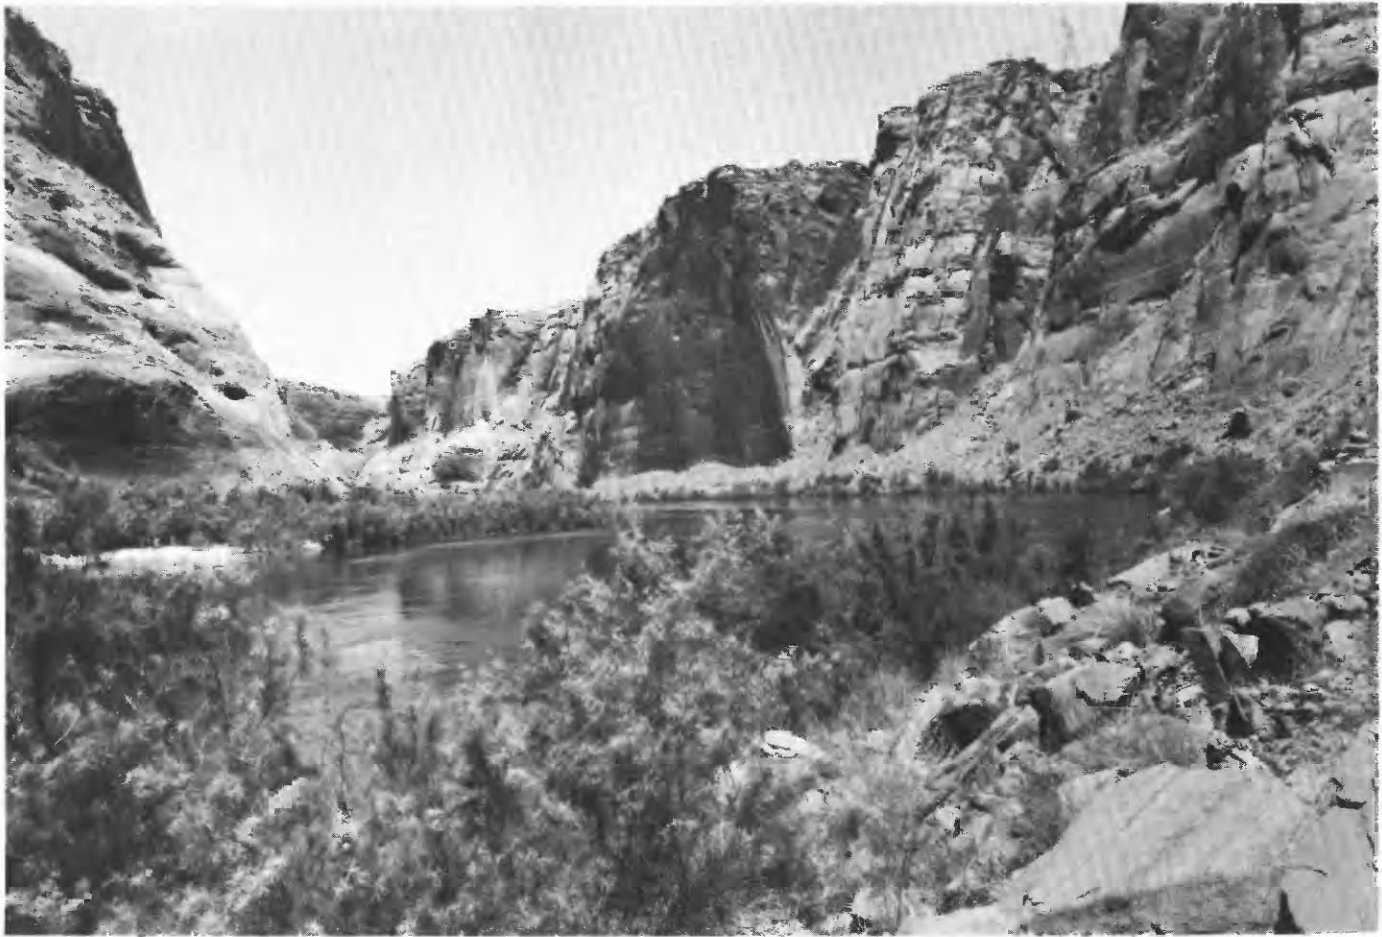
FIGURE 27B.—(1975). Although not an exact match, the new camera position is probably within a few feet of the old. Two towers near the brink of the canyon wall support lines that carry power generated at Glen Canyon Dam. Saltcedar has overgrown both banks and in the vicinity of the camera station occupies what is probably the predam highwater level. Several nearby saltcedars at this level have died. Longleaf brickellia is common on the steep slopes of coarse rubble in the foreground. The sandy bar on the opposite bank is covered by plants to lower levels now than in the earlier view. The deposit is partly submerged by the river, which is at higher stage than before, making difficult any estimate of erosion since the earlier photograph.

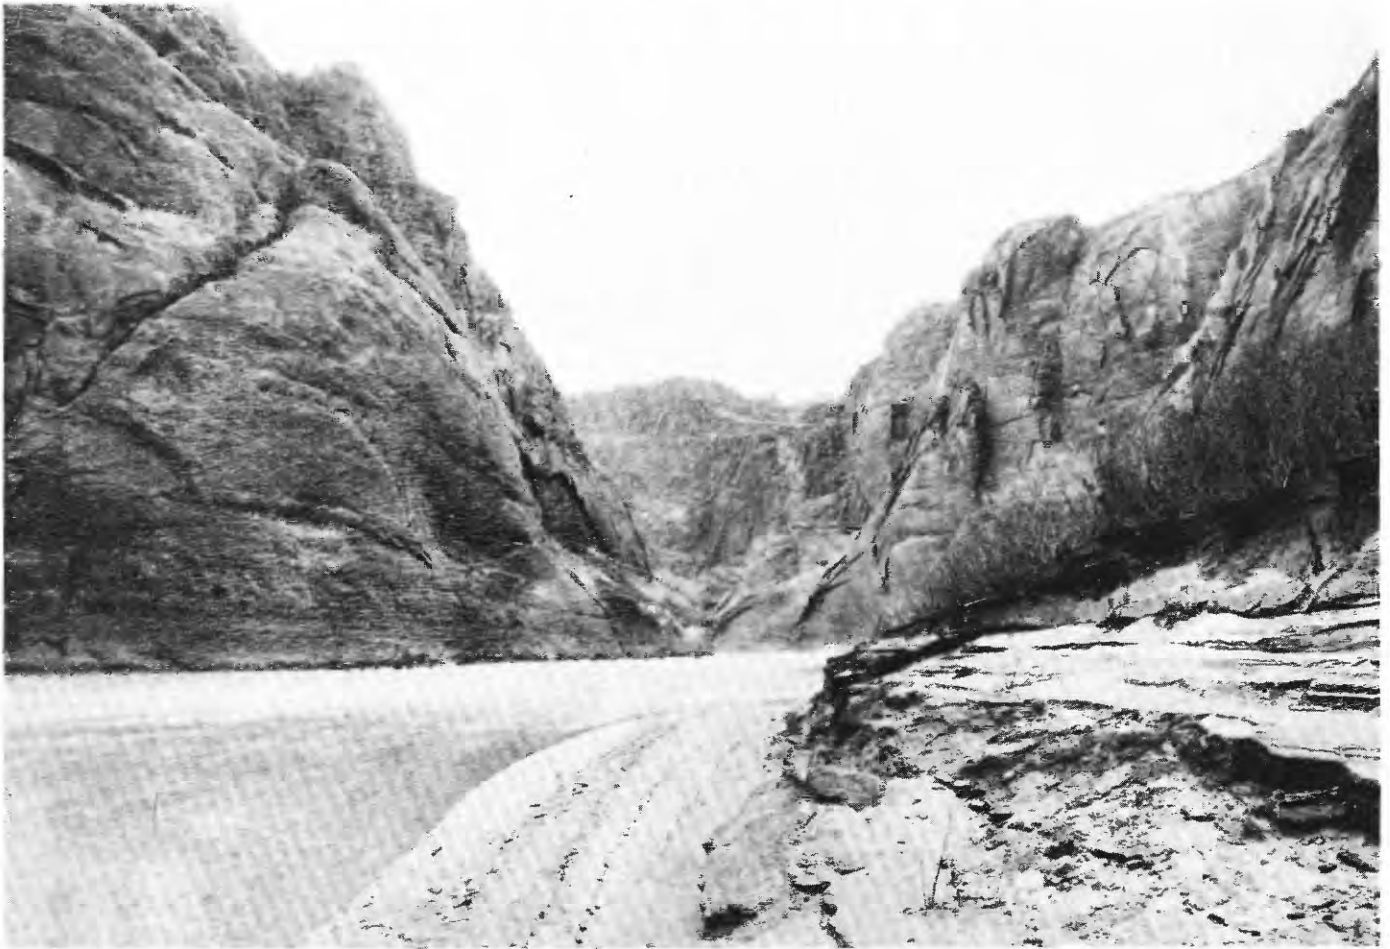
FIGURE 28A.—(1889). This downstream view was taken below the crest of an actively eroding alluvial deposit, 11.3 kilometers above Lees Ferry. Scattered seedlings have become established on the unstable surface marked by horizontal banding. This photograph was taken at a time of low river stage. At the top of the bank can be seen a dense cover of what is probably rabbitbrush. The dense community has been undercut by the river. (Altitude 954 meters.)

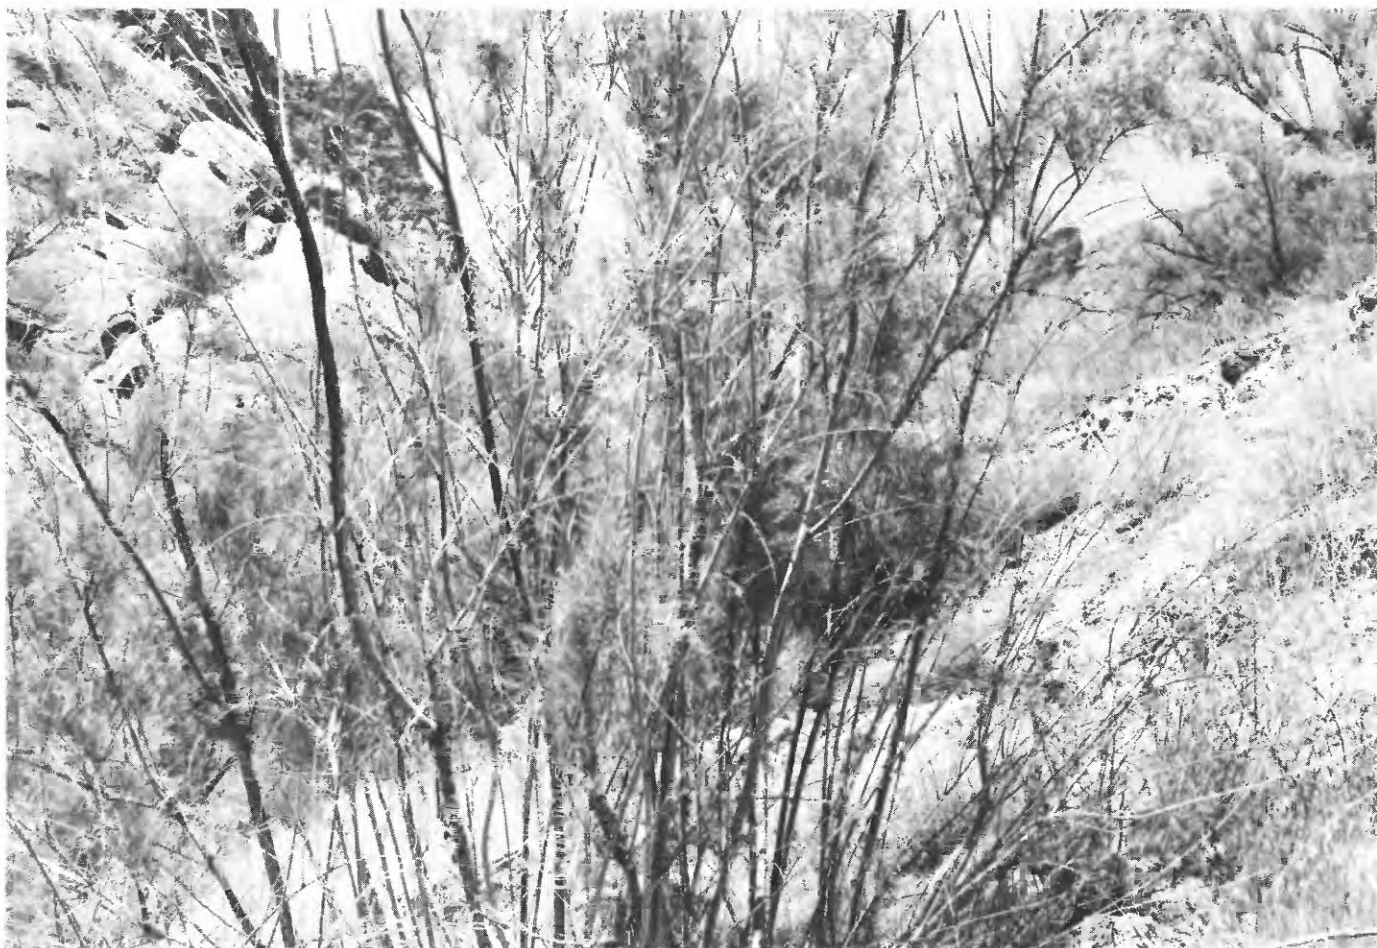
FIGURE 28B.—(1975). The old camera position cannot be exactly located so dense is the vegetation now growing on the alluvial deposit. Saltcedar, arrowweed, and sandbar willow occur from the river's edge up the steep bank, and on to the flat surface above. Rabbitbrush still occurs on top of the terrace where it is mixed with the other riparian species. The dense growth of vegetation providing stability to the steep bank is undoubtedly new since completion of Glen Canyon Dam.

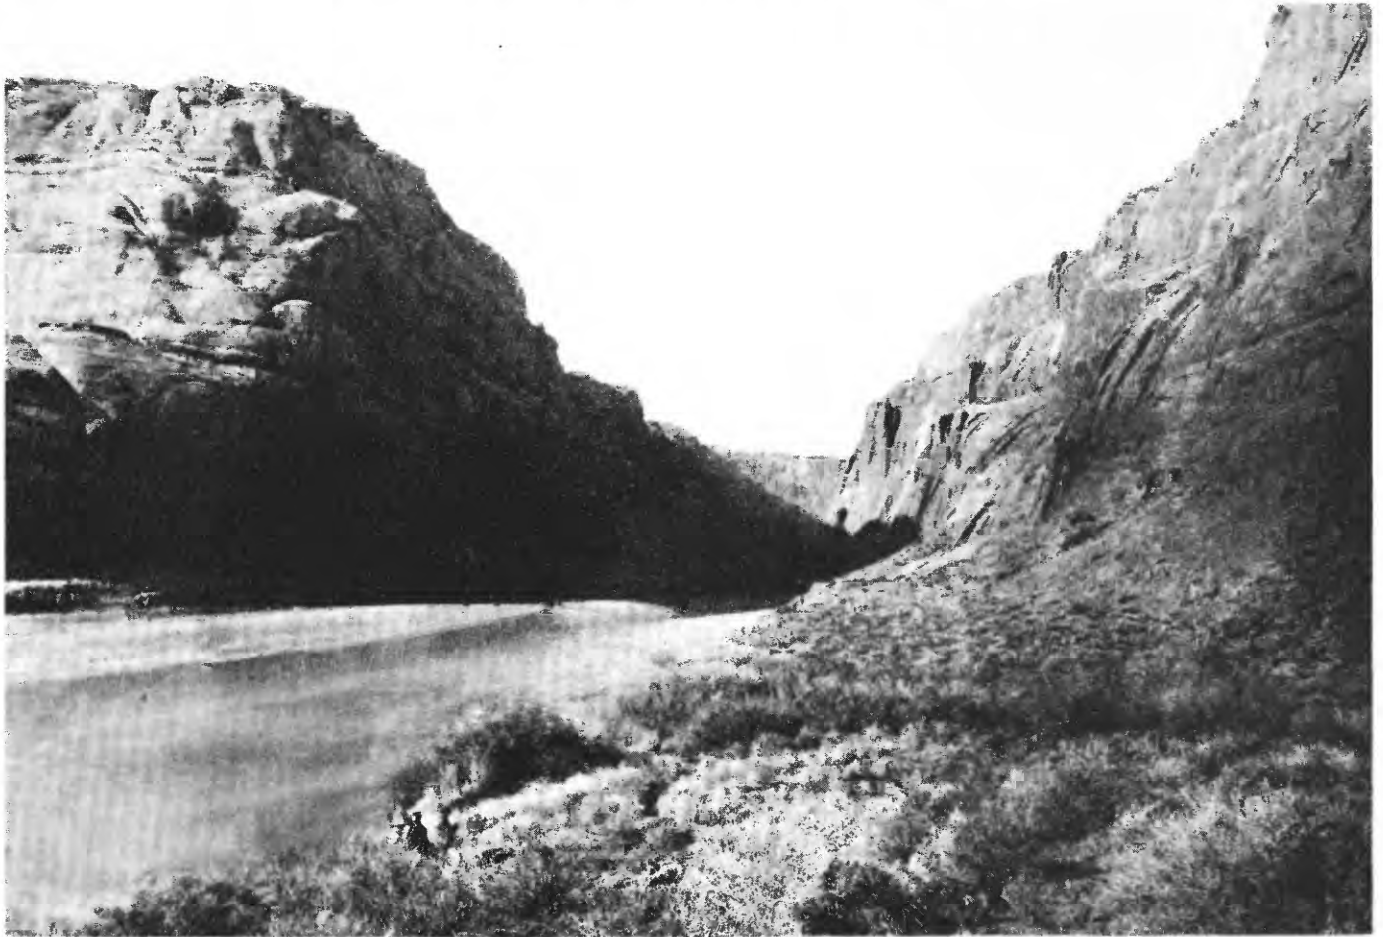
FIGURE 29A.—(1889). Members of the Stanton-Brown railroad survey team are seen in this upstream view, 6.4 kilometers above Lees Ferry. The vegetation on the foreground terrace is Great Basin Desertscrub (Brown and Lowe, 1974a, b). The dense vegetation crossing the picture in the right midground occupies the arroyo leading from Water Holes Canyon. The river is at low stage exposing a sandy bar near the far shore. (Altitude 953 meters.)

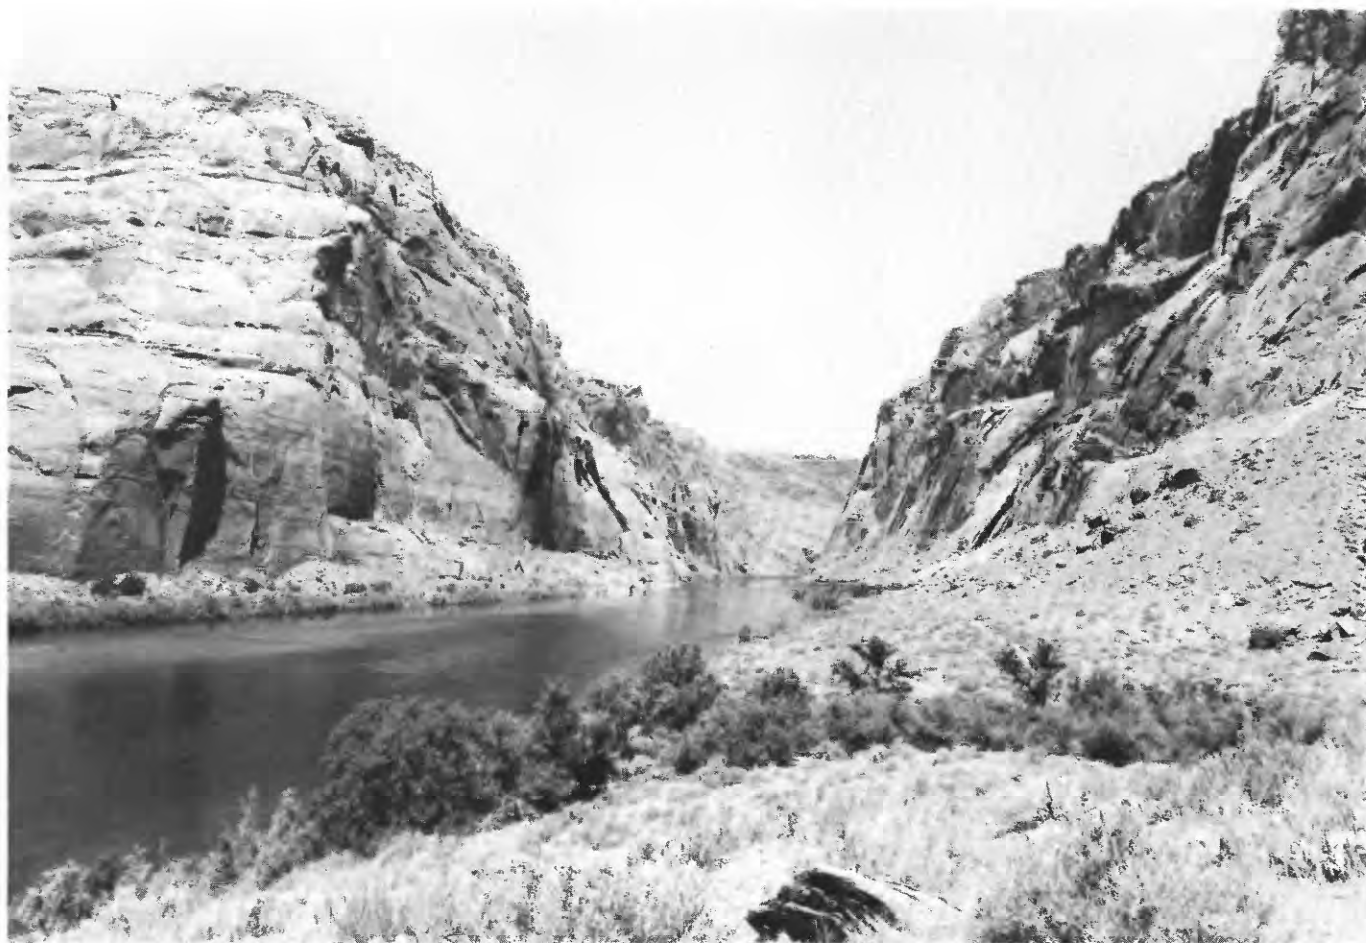
FIGURE 29B.—(1975). This photograph is not an exact match of the earlier one but is probably off less than 8 meters. The foreground vegetation is much the same as in the 1889 view and comprises jointfir, fourwing saltbush, beavertail cactus, coldenia, and various grasses. The tallest plants along the midground arroyo are shrub liveoak and netleaf hackberry. Shrub liveoak is rare at river level downstream from this site. The netleaf hackberry is common along the canyon for about 80.5 kilometers below Lees Ferry. It is rare below that station although it can be seen near the river 318.6 kilometers below Lees Ferry. The sandy bar of the preceding view persists to the present and is shallowly inundated at this river stage. Saltcedar now occurs as a narrow band on both sides of the river.

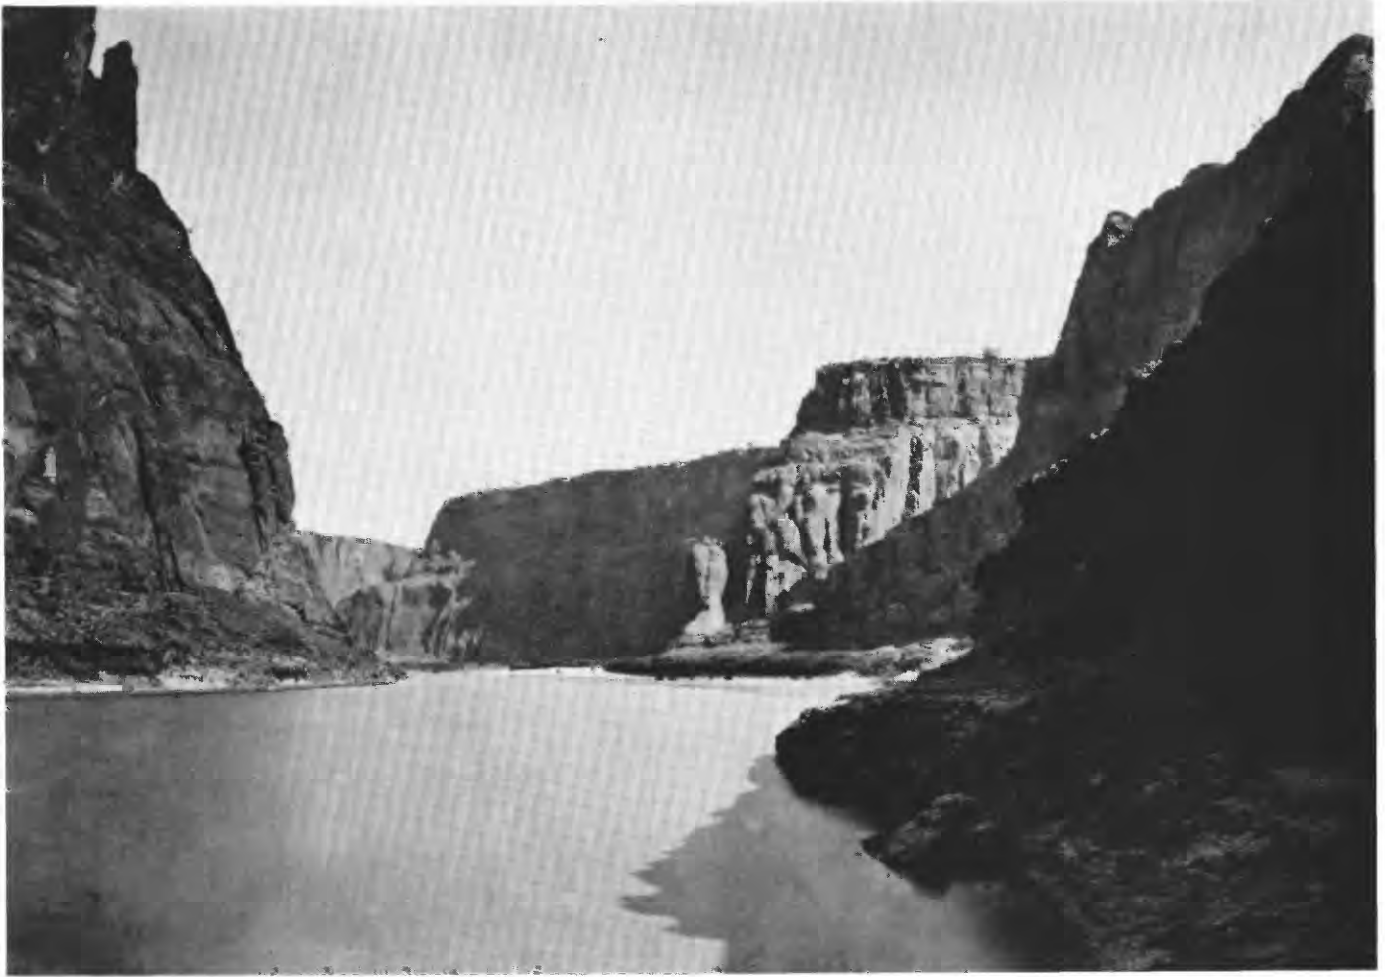
FIGURE 30A.—(1872). This upstream view was taken by William Bell, photographer with the Wheeler Survey. The dense riparian vegetation seen in the background on both banks is typical of beach deposits along this section of the river, 4.8 kilometers above Lees Ferry. At the river stage shown in this picture, the riparian community and the river are separated by bare beach.

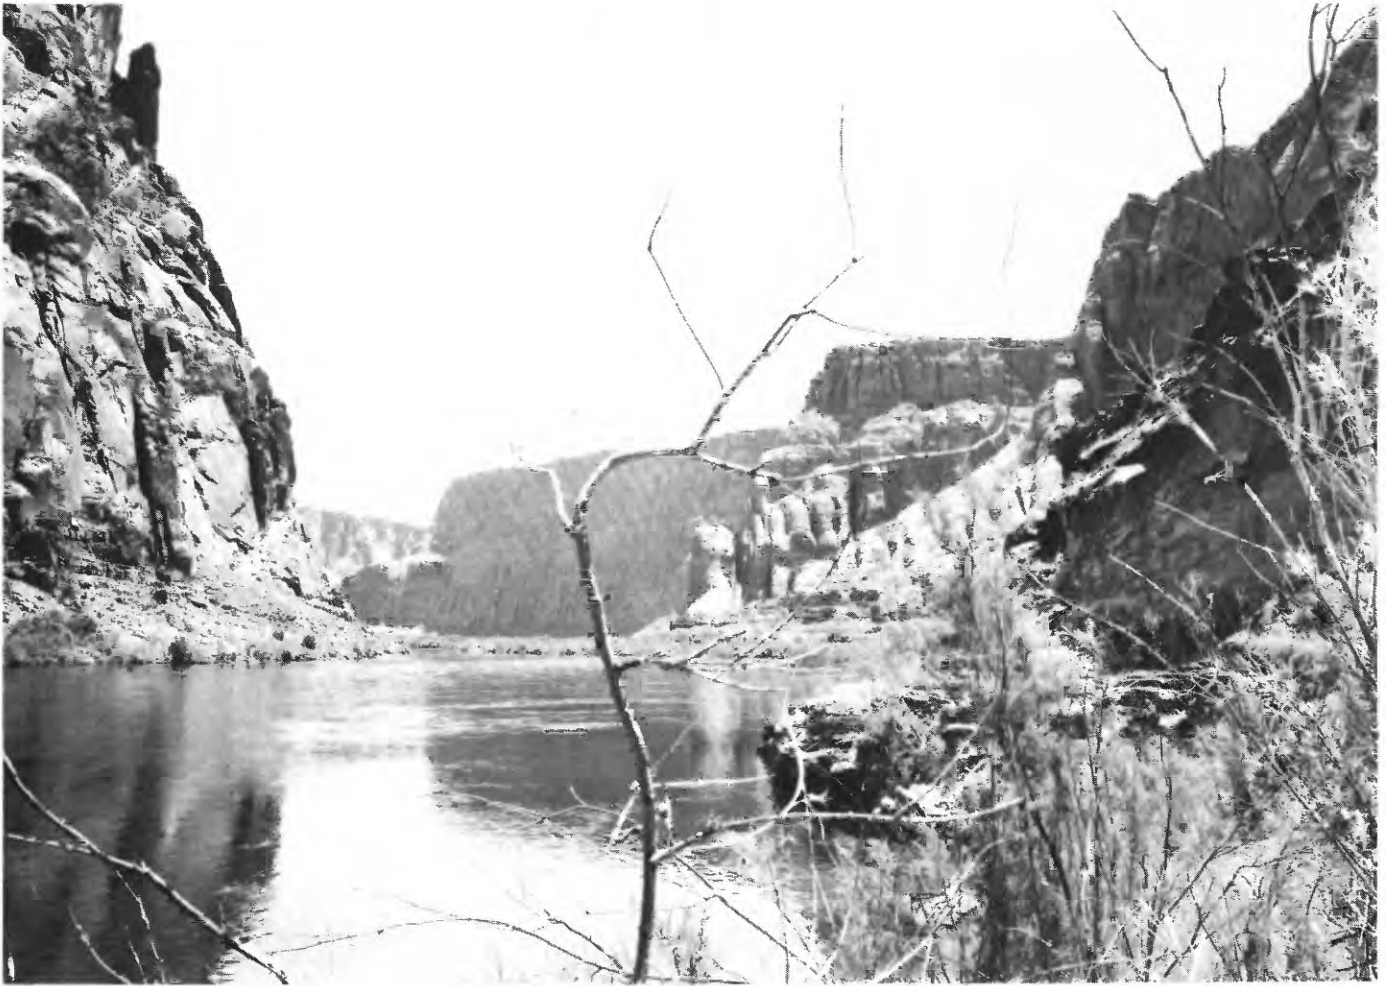
FIGURE 30B.—(1975). The old camera location is overgrown with bushes and lies about 3.0 meters upslope to the right. Judging from the position of the water relative to the rocks at the right, the river stage is roughly the same in the two views, and unlike most of the photograph pairs taken along the river, the river level can therefore be used as a datum for judging changes. Saltcedar and sandbar willow (both visible in the right foreground) grow along the section of the beach that was formerly bare. The large trees at the upper edge of the riparian zone are saltcedars. Cattails grow in a few areas at the river's edge.

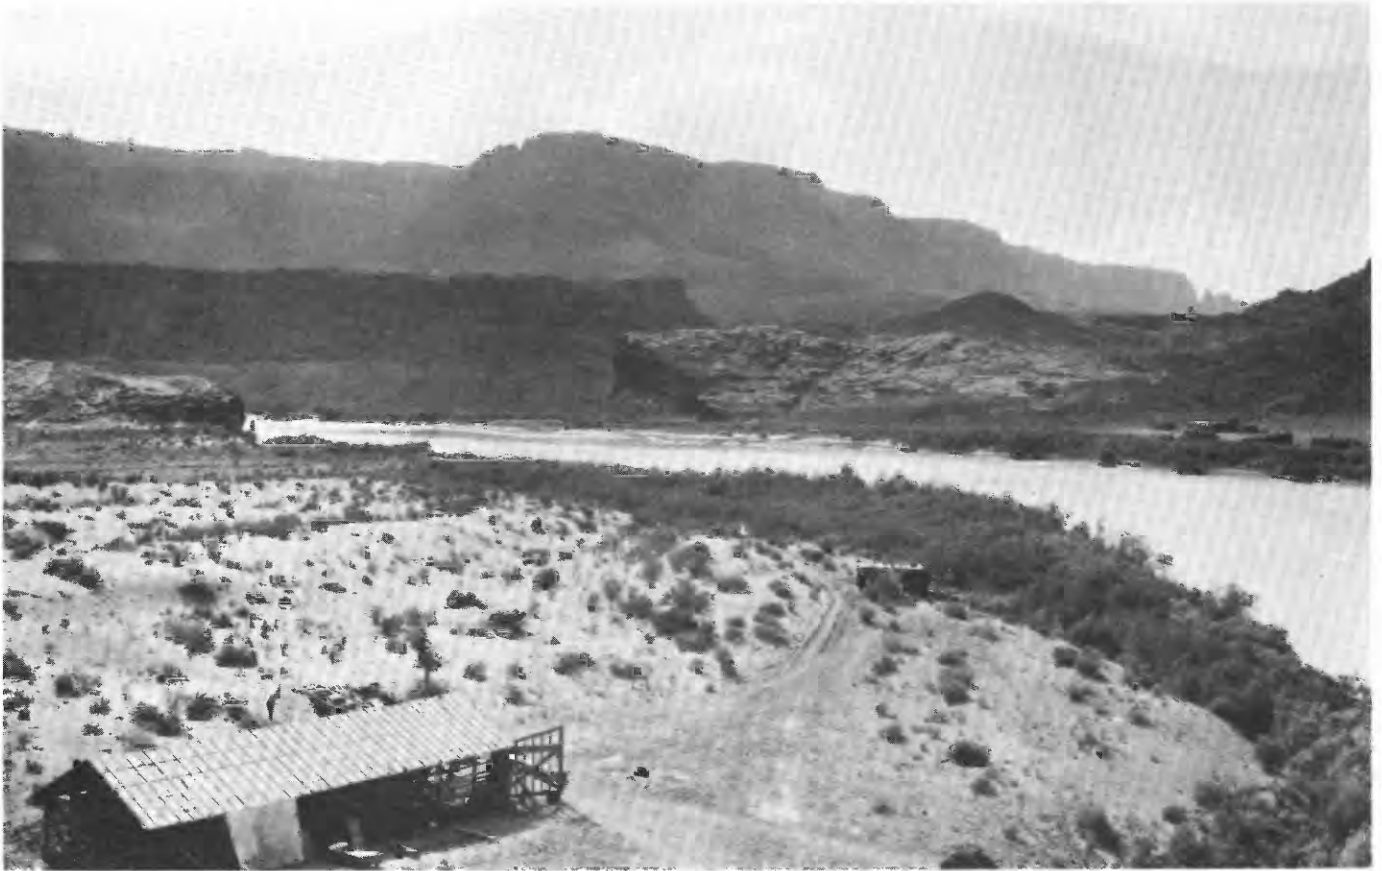
FIGURE 31A.—(1923). The building in left foreground is a boathouse. The cluster of buildings across the river on the right is Lees Ferry. The U.S. Geological Survey river-stage recorder is housed in the cylindric structure standing near the river at the left. This gage marks "Mile 0" in the system used for assigning mileages along the reach of the Colorado River from Lees Ferry to Lake Mead. The Upper Triassic Shinarump Member of the Chinle Formation near the gage and on the opposite side of the Colorado River dips below the level of the river at an inclination of  $15^{\circ}$  to the east. The plants in the dense thicket near the river cannot be positively identified but included are probably arrowweed, rabbitbrush, and sandbar willow. Saltcedar may be established here, although no record exists of its presence at Lees Ferry until 1938 (Clover and Jotter, 1944). At any rate, no plants on the near shore have reached heights typical of mature saltcedar. (Altitude 951 meters.)

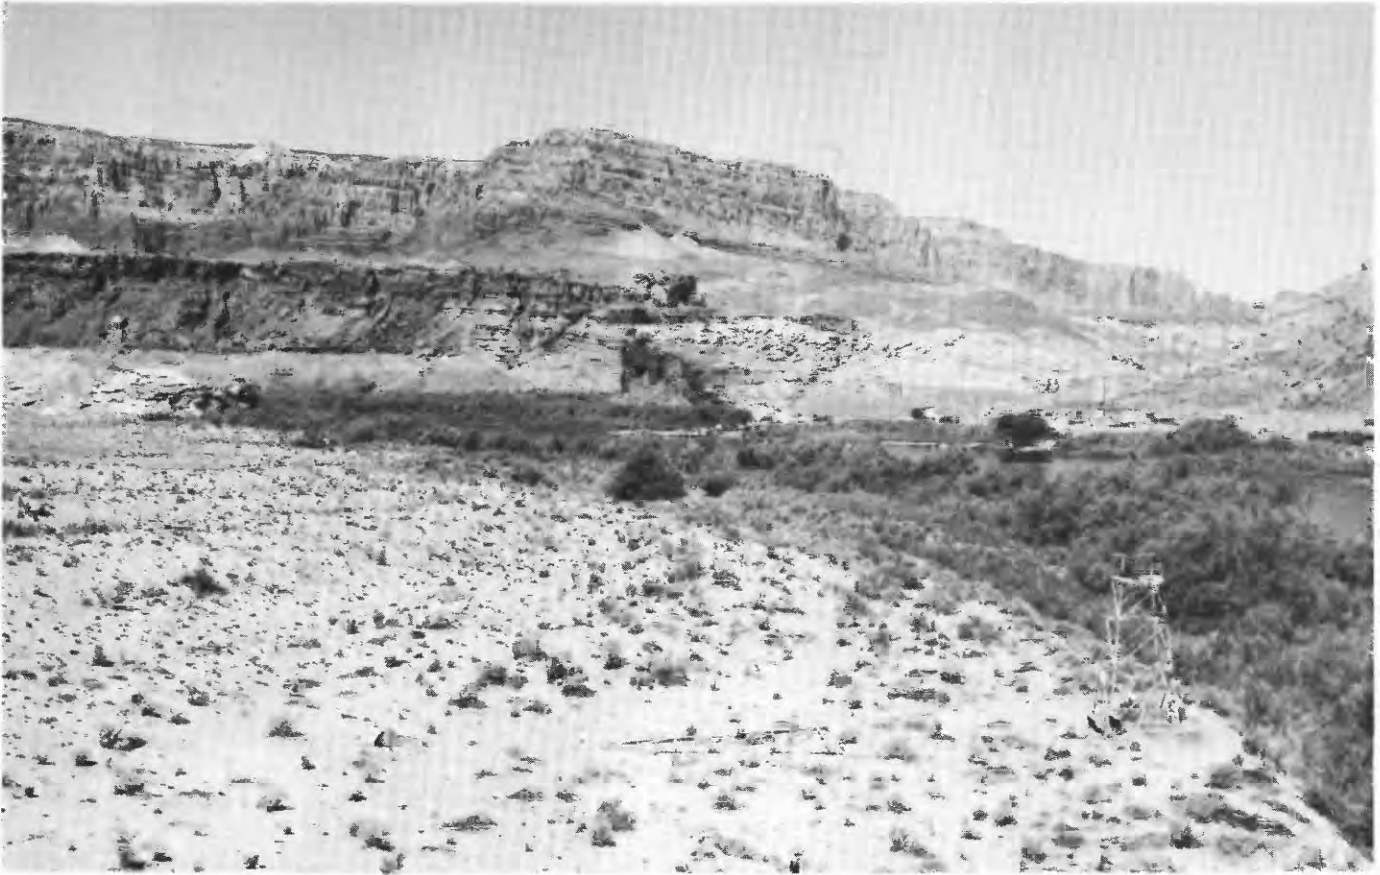
FIGURE 31B.—(1972). Lees Ferry has grown. The large inflated rafts (center) are evidence of the town's main industry as a launching facility for boat and raft trips. Saltcedar is the main plant along the near shore, and because of its height, much of the river is screened from view. The cable from which measurements of streamflow are made by the U.S. Geological Survey has been moved from the abandoned tower in the foreground and is now located upstream from the camera station.

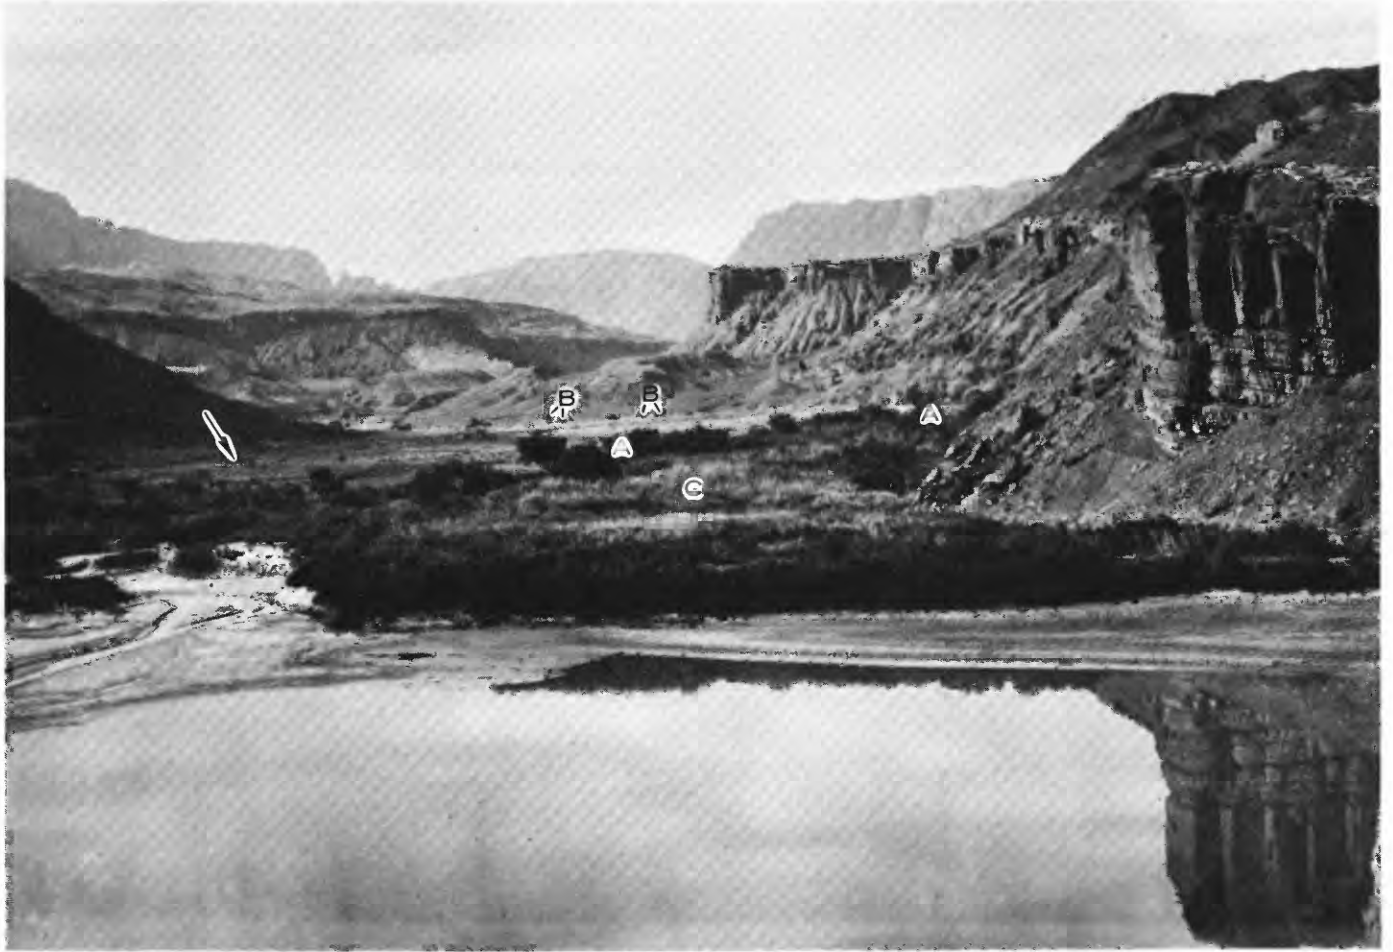
FIGURE 32A.—(1873). The mouth of the Paria River is seen on the left in this northwesterly view looking across the Colorado River and up the valley of the Paria. The main ferry crossing, still little used by the date of this photograph, lies about 2 kilometers upstream from the Paria. This photograph was taken by T. H. O'Sullivan, photographer with the Wheeler Survey (Bartlett, 1962). In 1872, J. D. Lee, his seventeenth wife, Emma, and their children built a house (arrow) and began farming on the broad, flat floor of the Paria River valley, becoming the first permanent residents of the area (Rusho and Crampton, 1975). In 1776 the Spanish padres Dominguez and Escalante camped at the base of the cliff of the Upper Triassic Shinarump Member of the Chinle Formation on the right (Rusho and Crampton, 1975). The large trees lining the Paria are probably willows (A) and Fremont cottonwoods (B). The dense shrub community (C) extending up the Paria on the right is probably mainly rabbitbrush (see fig. 33A). A bare sandy bank slopes from the thicket (of sandbar willow?) to the Colorado River. (Altitude 949 meters.)

By 1973, the fringe of saltcedar has become pronounced along some sections of the shoreline. The fan and the plants it supports is shown from another perspective in figure 32 which was taken from point marked C in the 1952 aerial view. Most of the fan surface is probably below the level of maximum flooding, yet some plants have become established there, apparently surviving all but the most severe floods.

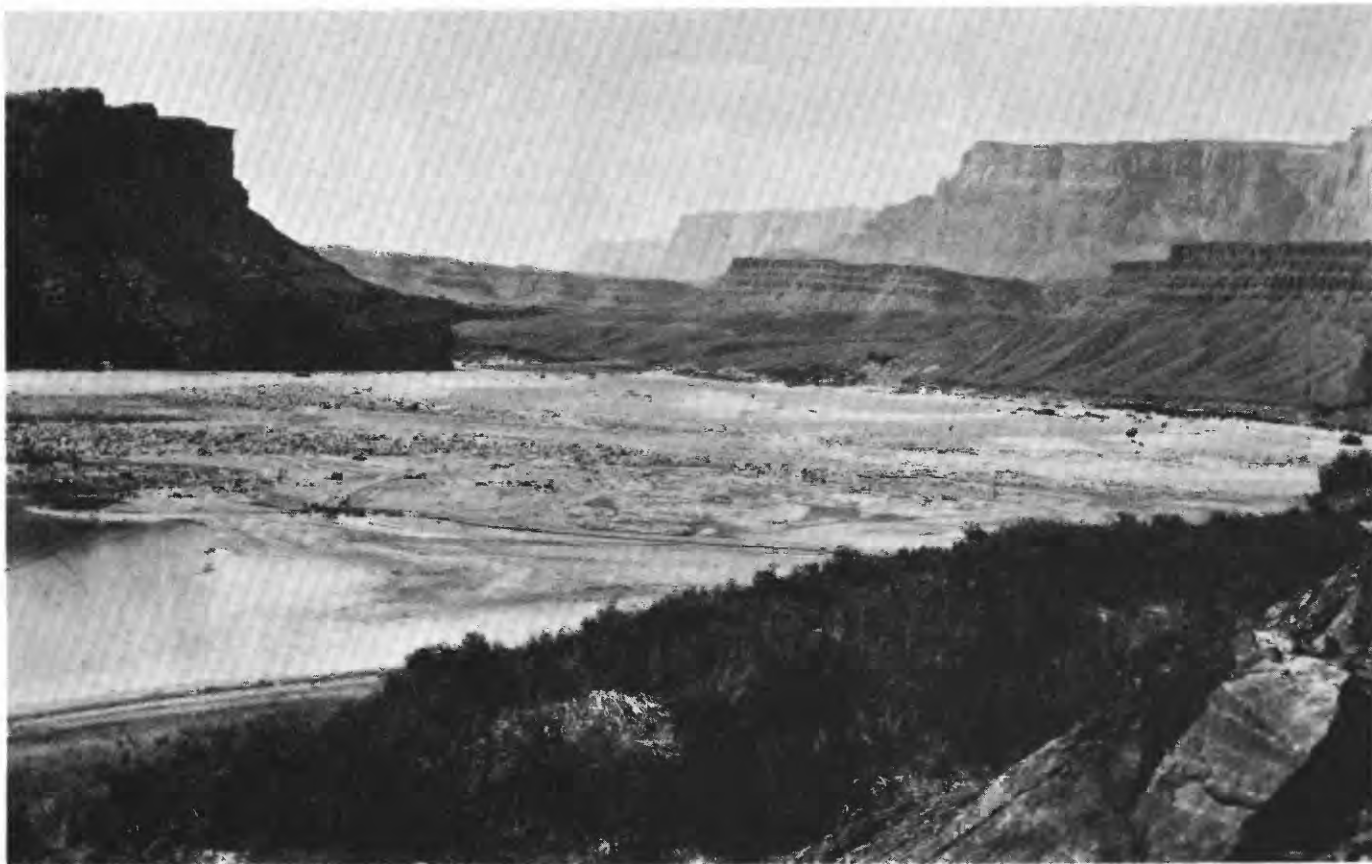
FIGURE 33A.—(1873). In this classic view looking down the Colorado River from a vantage point 0.5 kilometers below Lees Ferry, the Vermillion Cliffs define the distant skyline at right. The low cliffs in the mid-distance are the Chocolate Cliffs, comprising the Upper Triassic Shinarump Member of the Chinle Formation above and the Triassic Moenkopi Formation below. A band of riparian species (probably rabbitbrush) occupies the right bank across the foreground. Evidence of overbank flooding is seen in the piles of debris scattered in the dense thicket. Flow from the mouth of the Paria River, just out of view on the right, crosses at midground along the edge of the fan. This fan, formed by the Paria River, forces the Colorado River toward the left bank. The near shore (left foreground) and the fan are mostly devoid of plants. For scale, note the figure at the bottom, just right of center. (Altitude 949 meters.)
