# Recent Vegetation Changes Along the Colorado River Between Glen Canyon Dam and Lake Mead, Arizona

GEOLOGICAL SURVEY PROFESSIONAL PAPER 1132

By RAYMOND M. TURNER *and* MARTIN M. KARPISCAK

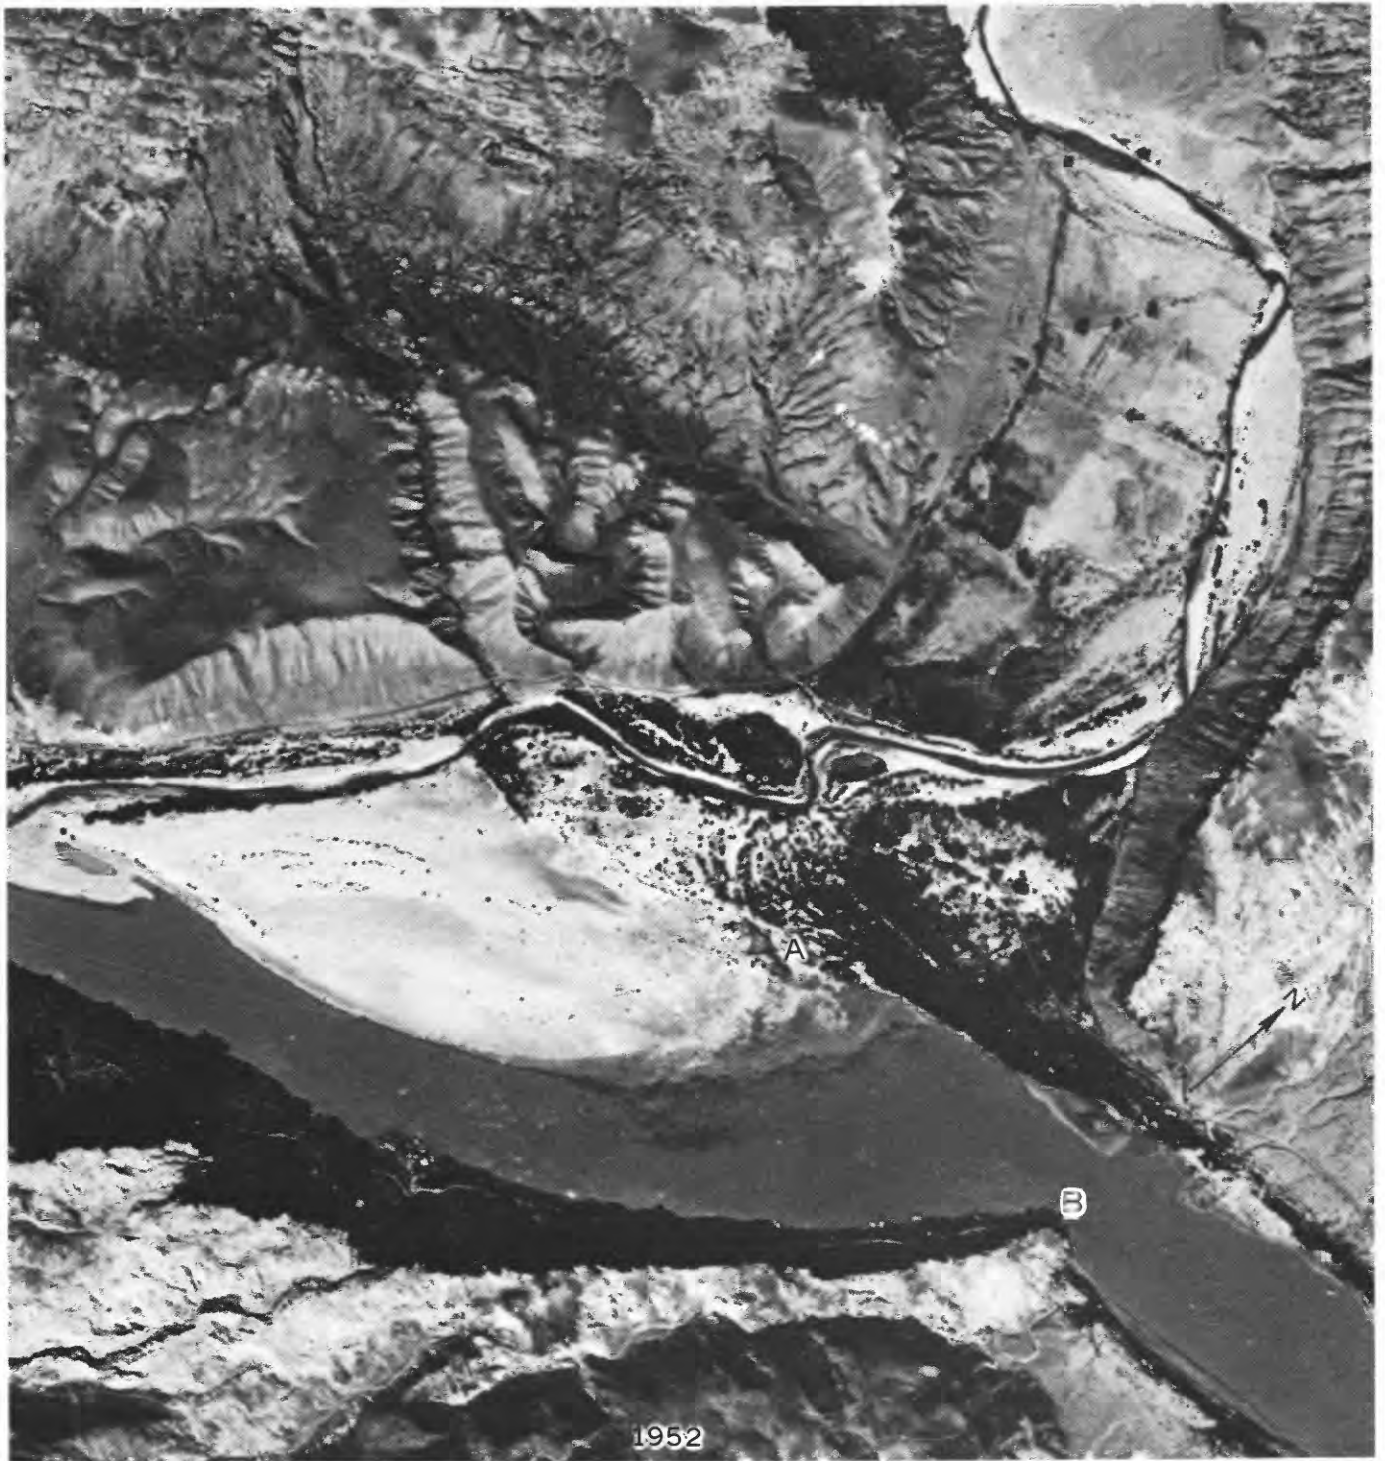
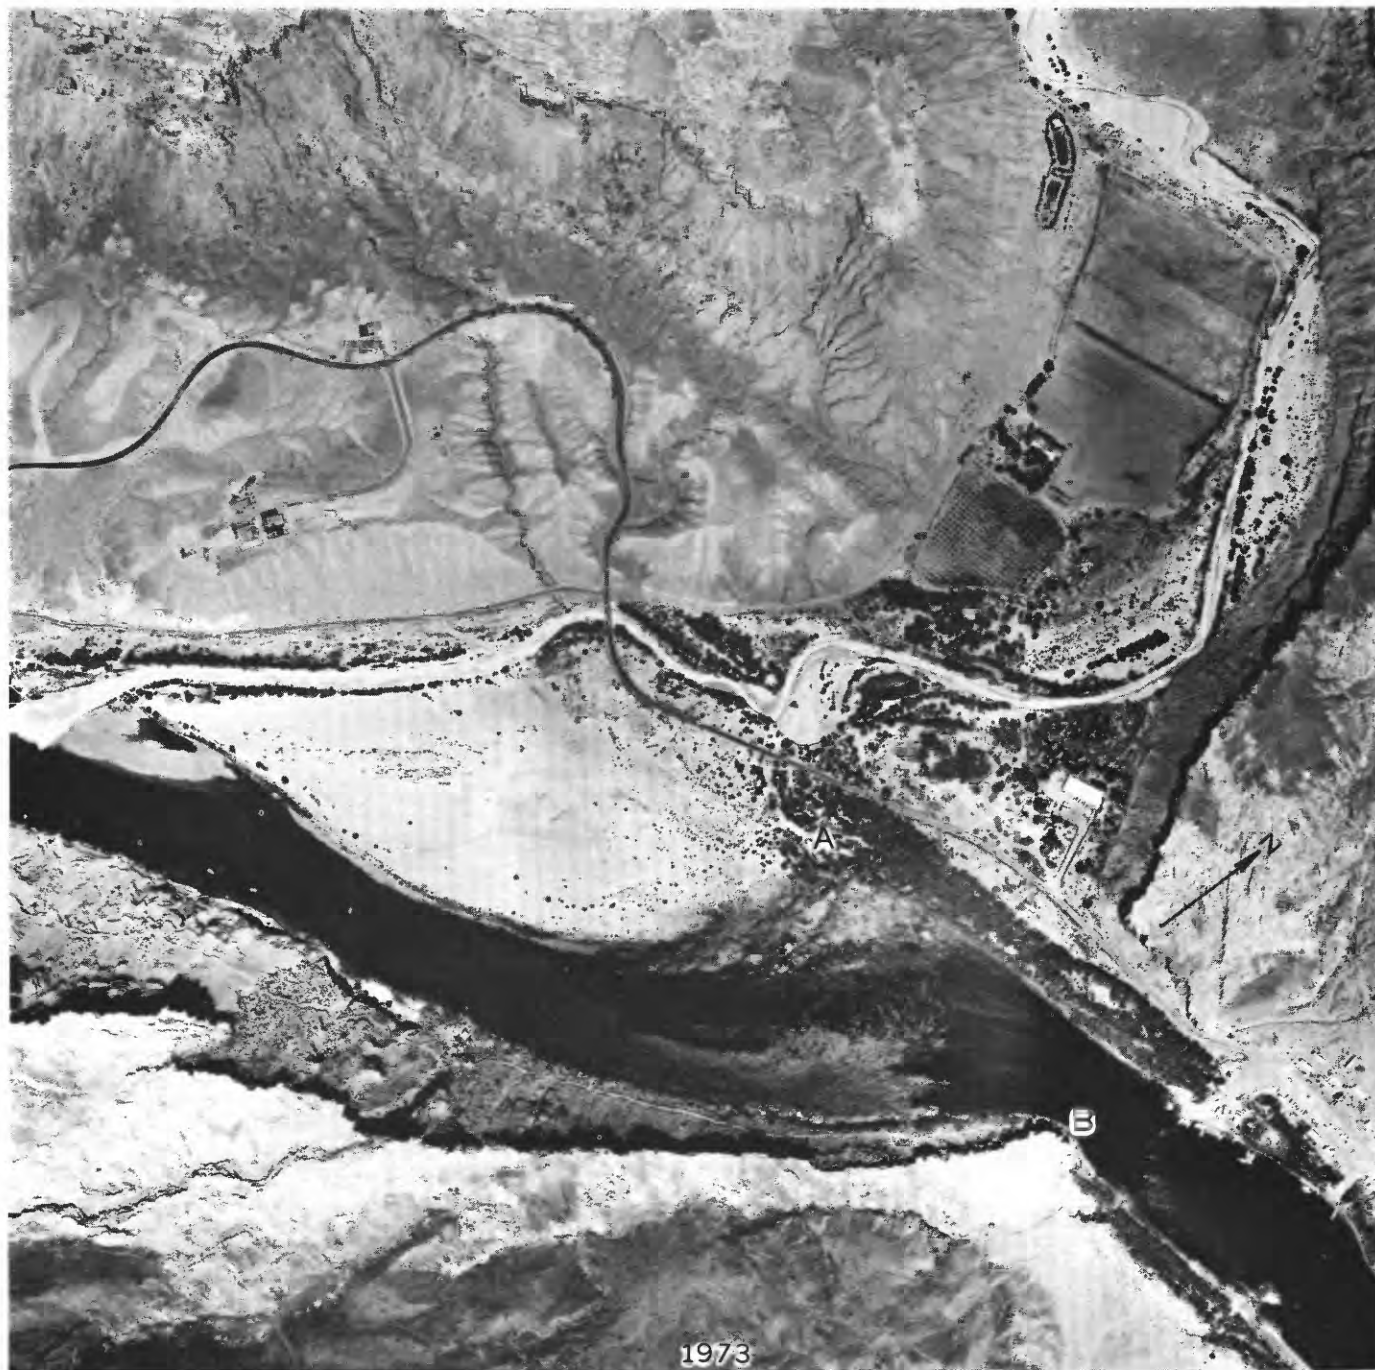
FIGURE 34.—Three aerial photographs, spanning a 21-year period, record conditions at the mouth of the Paria River near Lees Ferry. The photographs were taken on September 24, 1952; May 14, 1965; and June 16, 1973. Many features shown in figures 31 through 33 can be seen in this series of aerial views. The Echo Monocline forms the cliffs to the right of the Paria River which flows toward the Colorado from the upper right of the photographs. The approximate location of the 1873 channel of the Paria (see fig. 33A) is marked with the letter A. The dugway road that was in use until the ferry was abandoned in 1929 can be seen running from point B toward the west above the left bank of the river. The U.S. Geological Survey stream gaging station is located at point B. This is also near the location from which figure 33 was taken.

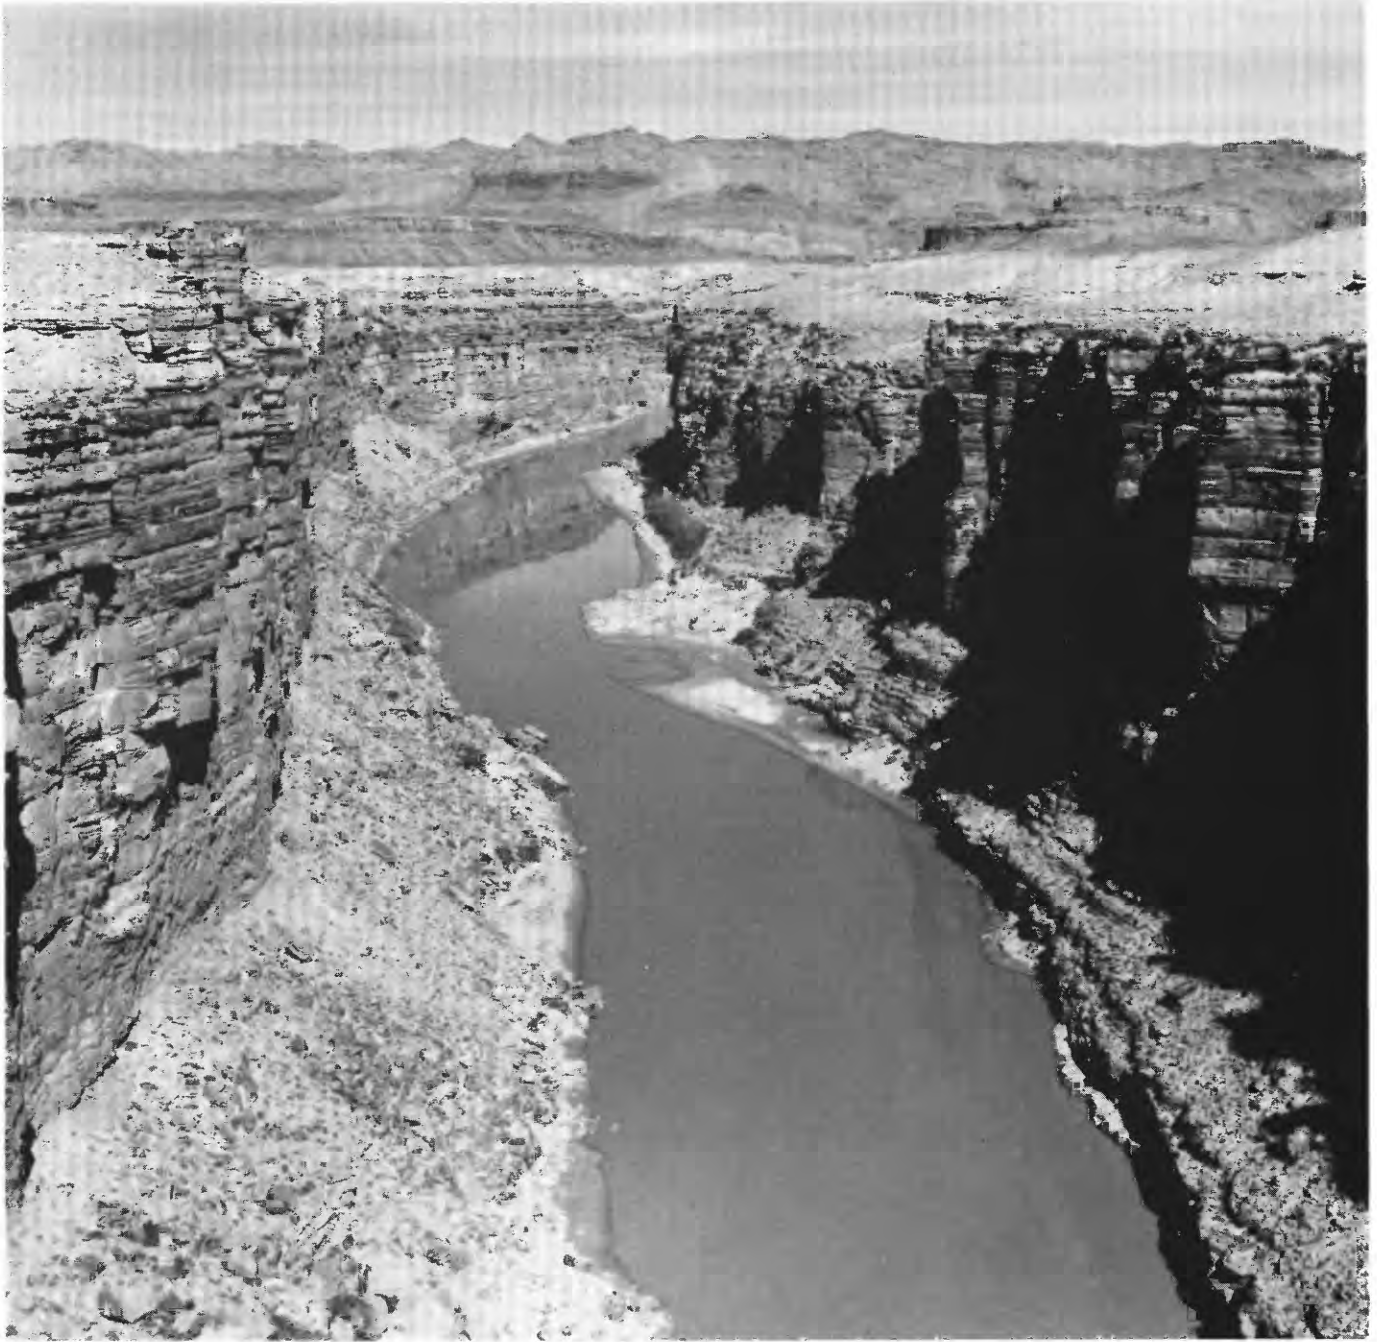
FIGURE 35A.—(1952). This upstream view of the river is from the Navajo Bridge on U.S. Highway 89, 6.9 kilometers below Lees Ferry. The bridge was completed in 1928, after which the ferry at Lees Ferry was abandoned. The vertical cliffs expose rocks of the Lower Permian and Toroweap Formation overlying Kaibab Limestone. The interrupted dense thicket is immediately above the infrequently flooded high water level and is composed of netleaf hackberry and Apache plume. Bare beaches of sand appear at this river stage. (Altitude 942 meters.)

Apache plume is an evergreen shrub found from western Texas to southeastern California and south into Mexico. It is normally found at altitudes from 1,065 m to 2,285 m. It reaches its lower elevational limit in the Grand Canyon and distinctly marks the old flood line from Glen Canyon downstream to about kilometer 93.3; it is rare below that locality (pl. 2, fig. 10). Its position of dominance in the old flood-line community has not changed during the postdam period (fig. 35).

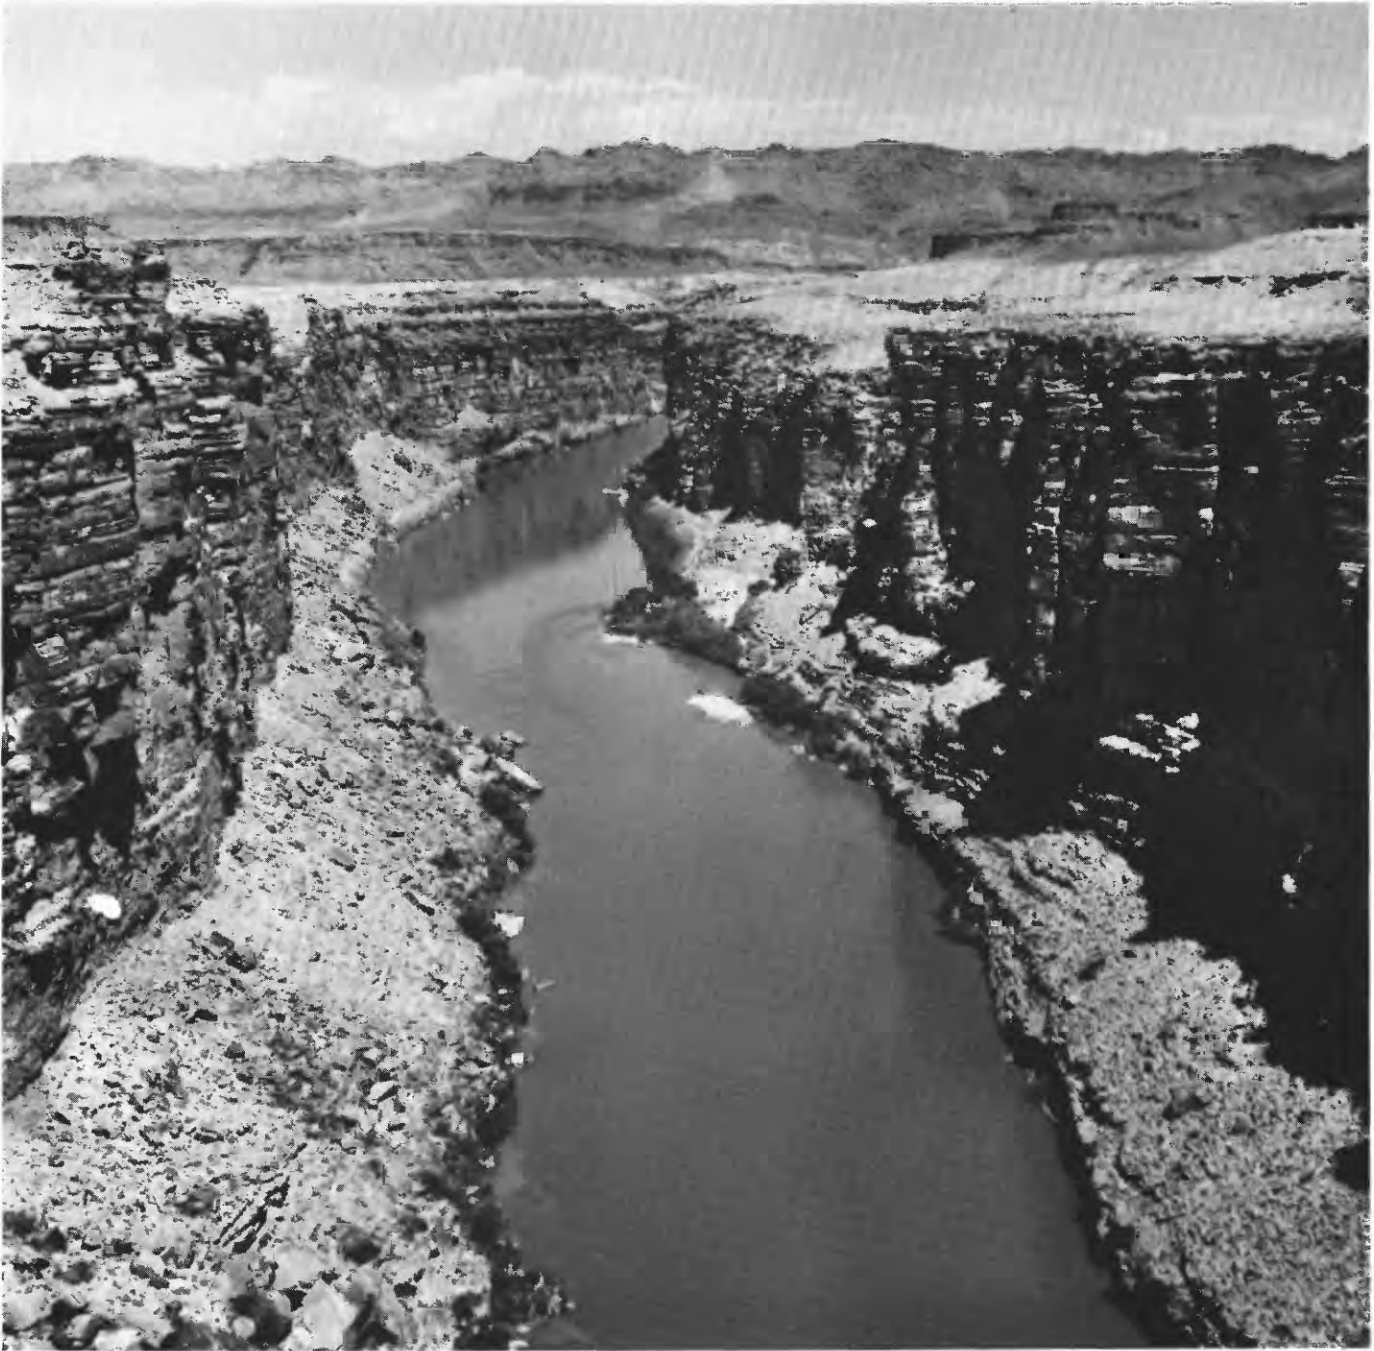
FIGURE 35B.—(1972). The river is at higher stage here than in the 1952 view, and many of the former sandy areas are covered with water. The new dense riparian community is mainly saltcedar, sandbar willow, and Apache plume with infrequent stands of cattails.

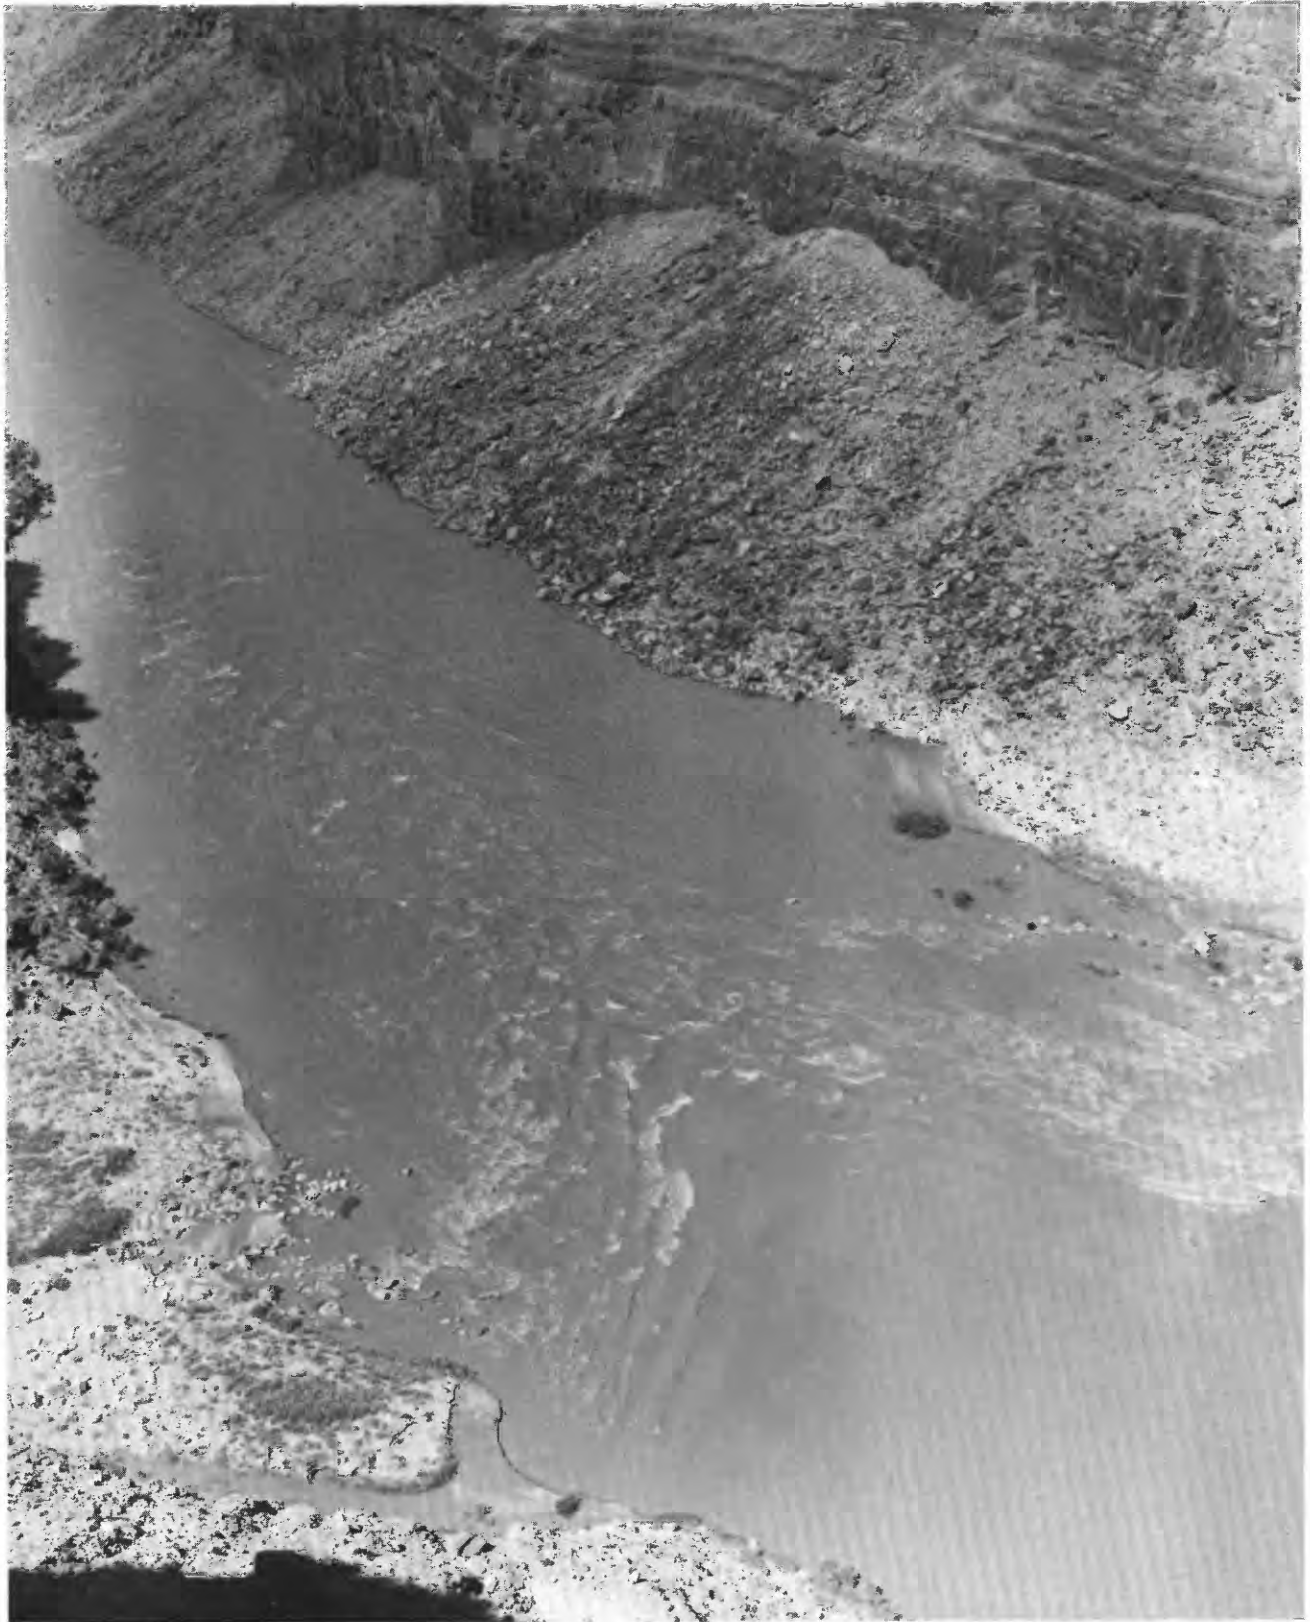
FIGURE 36A. —(1952). Overlooking Badger Creek rapids from a point above the left bank just north of Jackass Creek, 12.6 kilometers below Lees Ferry. Slopewash blankets the Hermit Shale Formation at river level here. The cliffs visible above consist of the Lower Permian Coconino Sandstone and overlying Toroweap Formations. At the time of this photograph (June 19), the discharge for the day at Lees Ferry was 2,799 m<sup>3</sup>/s (U.S. Geol. Survey, issued annually). Note the large shrub surrounded by water just off the right bank. This shrub persists in the 1972 photograph. (Altitude 939 meters.)

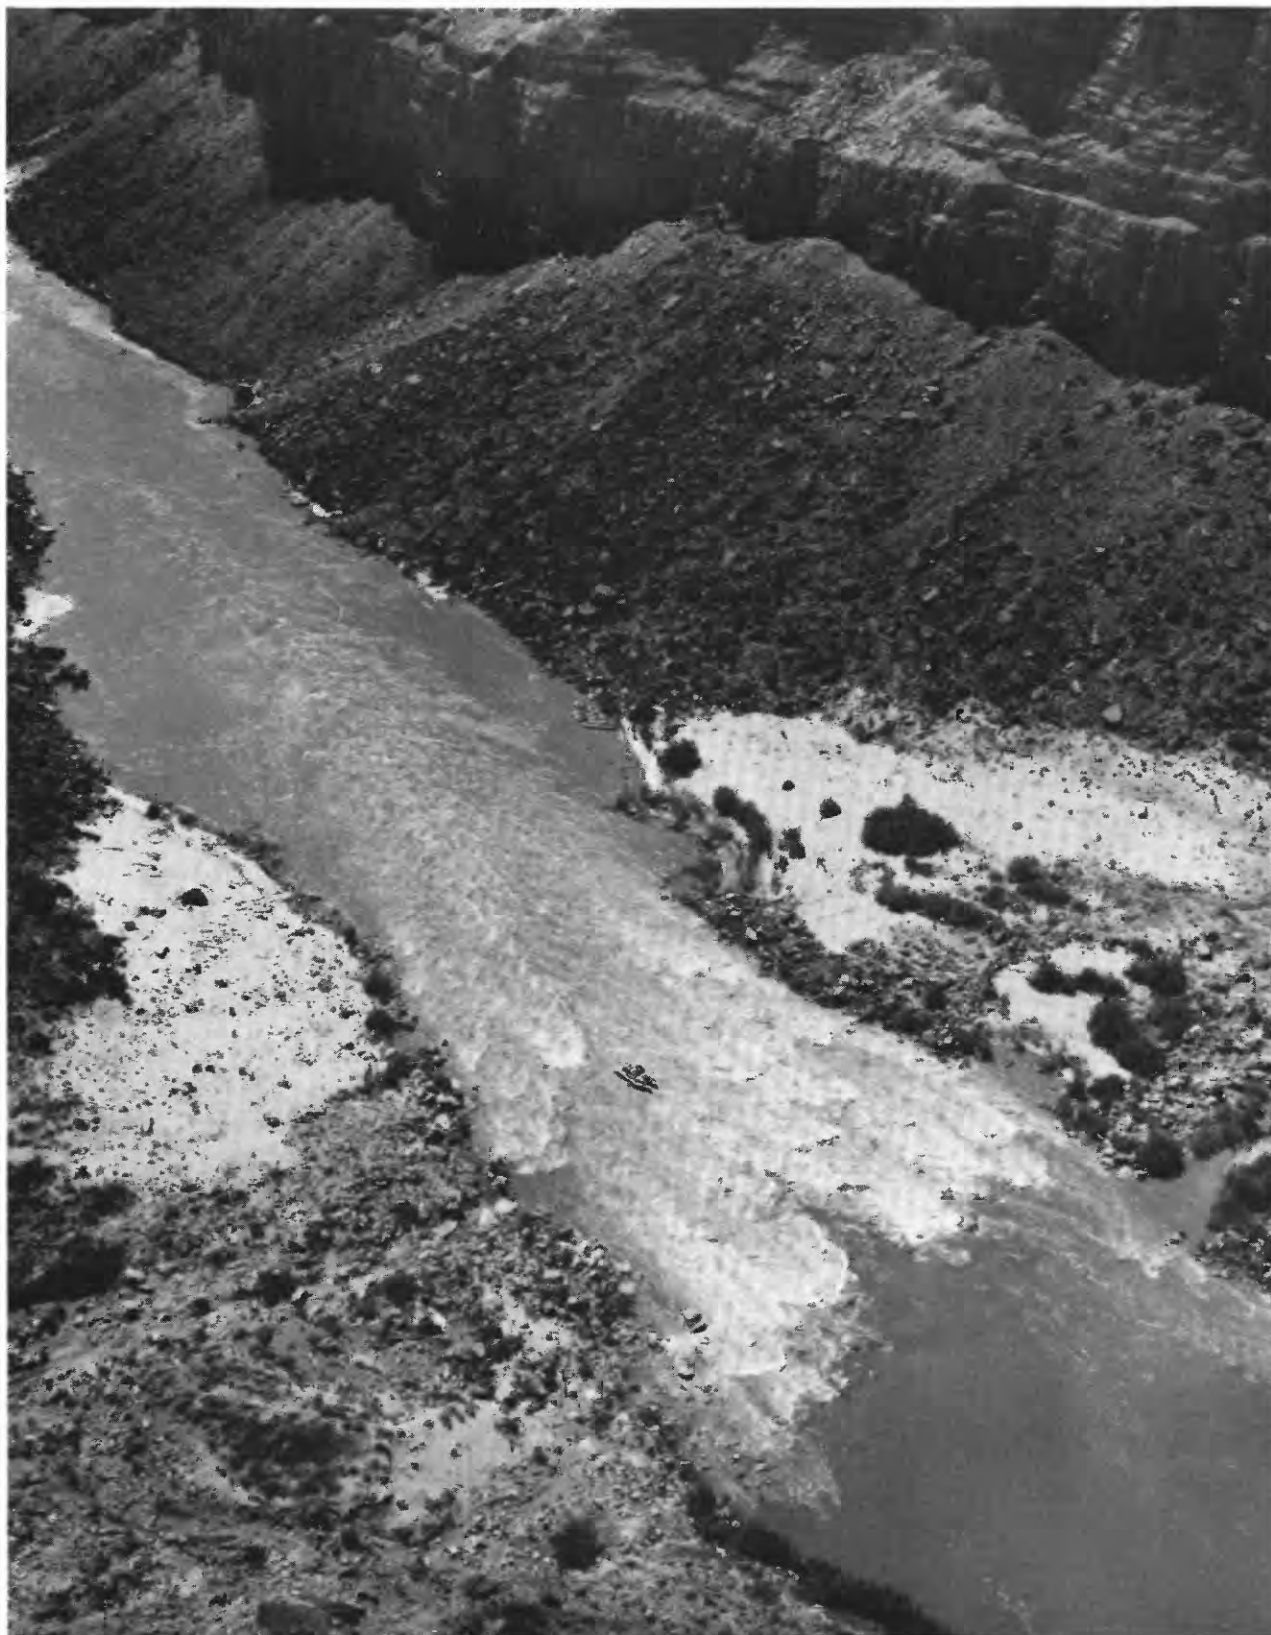
FIGURE 36B.—(1972). The 24-hour discharge at Lees Ferry on the day of this photograph (August 21) was  $529.6 \text{ m}^3/\text{s}$ , approximately one-fifth the volume for the date of the previous photograph (U.S. Geol. Survey, issued annually). Note the raft passing the Badger Creek rapids and several other rafts near the right bank below the rapids. The water through the rapids is obviously more turbulent at this low stage than at the high stage in the 1952 view. The large shrub of the early view is visible and is saltcedar. This plant was present along the river at many places through the Grand Canyon as early as 1938 (Clover and Jotter, 1944), but it probably grew only at scattered localities at or slightly above the contour of maximum river stage. In this view, saltcedar occurs as an interrupted band along both banks of the river.

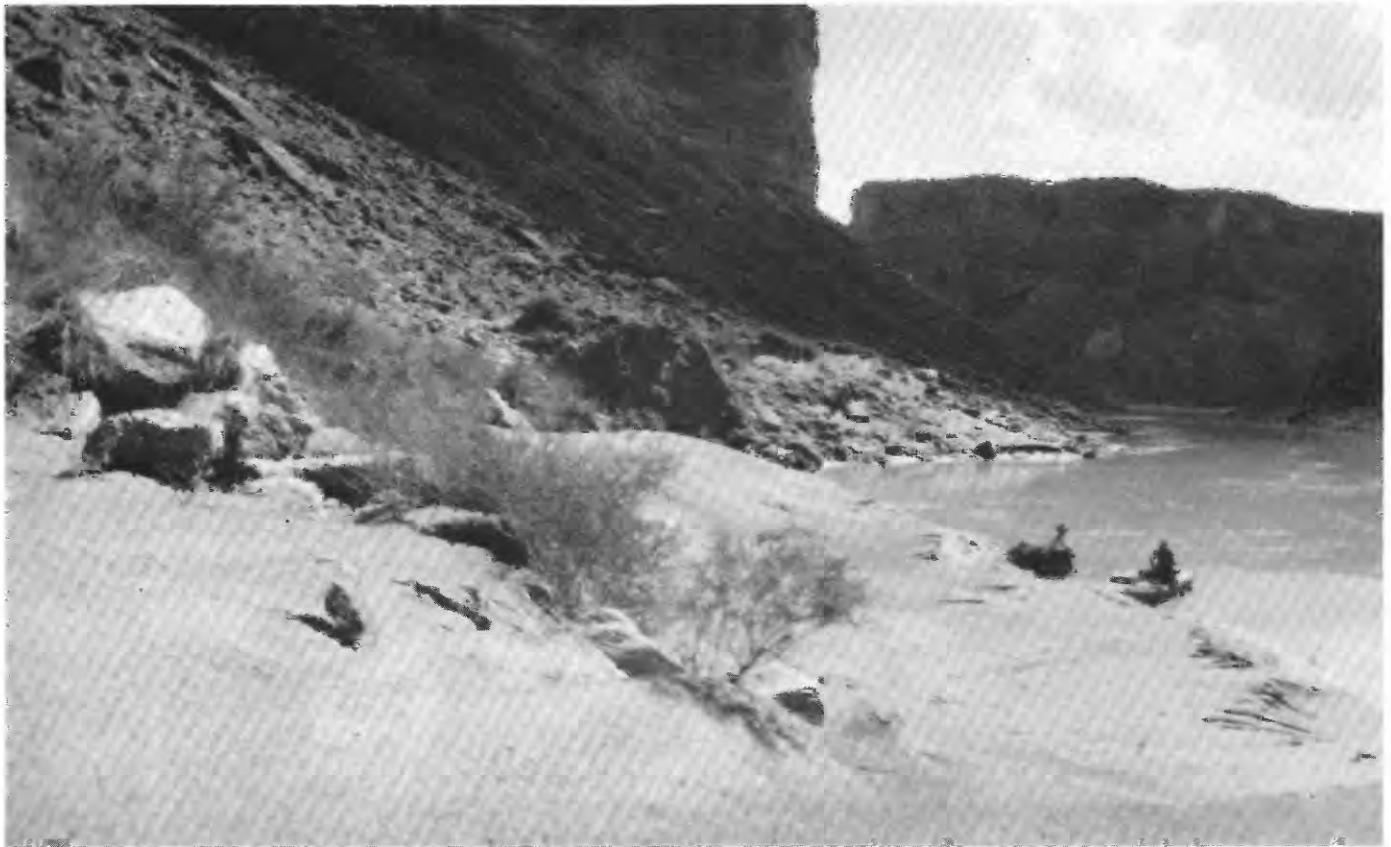
FIGURE 37A.—(1923). This downstream view shows the stretch of quiet water above Soap Creek rapids, 17.7 kilometers below Lees Ferry. The alluvium near the river is devoid of plants. A few outcrops of the Lower Permian Hermit Shale on the slope above the river are exposed through the covering of debris that has fallen from above. (Altitude 933 meters.)

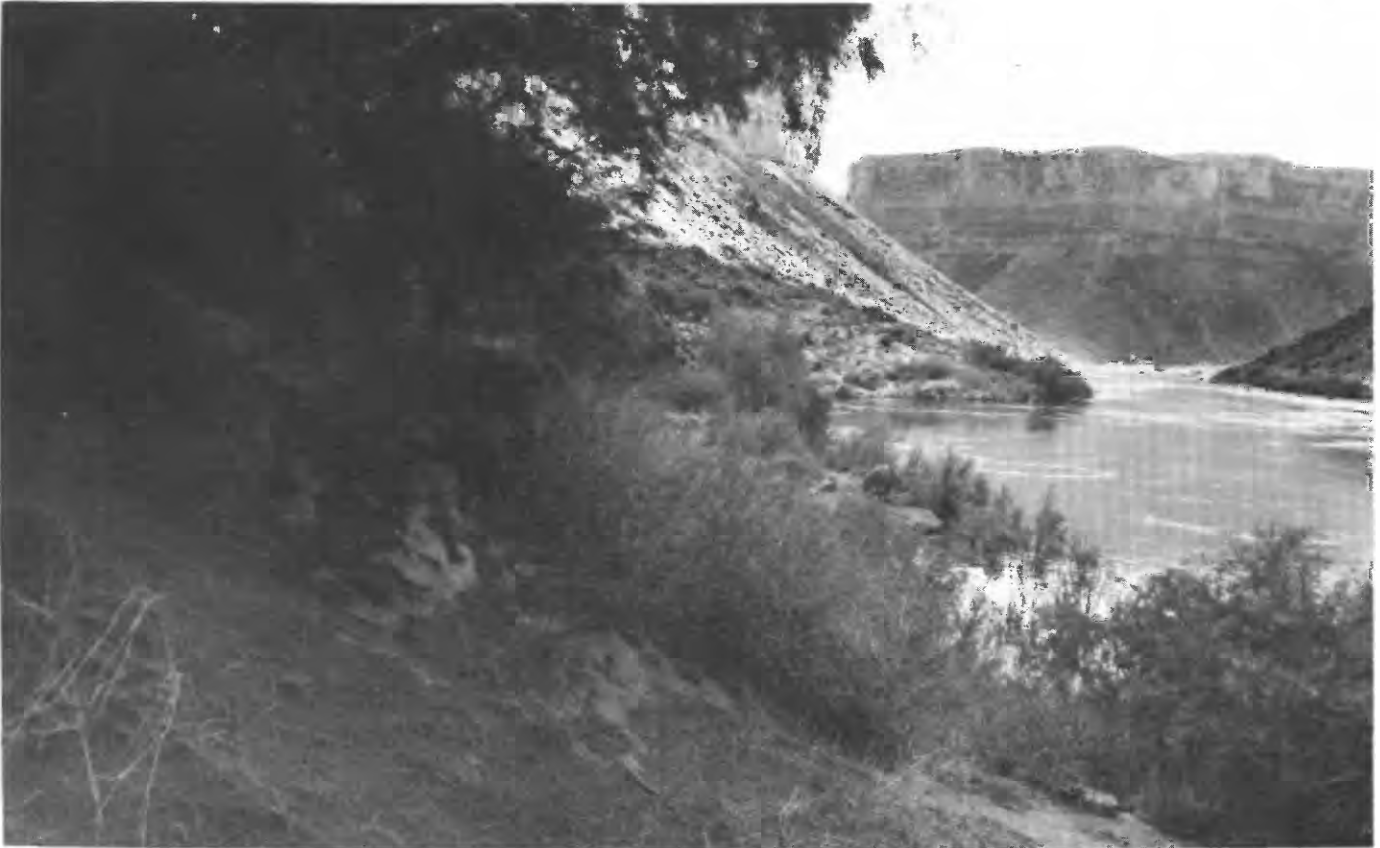
FIGURE 37B.—(1972). The large saltcedar shading this spot had a stem diameter (at ground level) of nearly 46 centimeters in 1976. This tree may have become established before the dam during a time of sustained high water. The river no longer reaches this level. Cattails grow in the protected embayment in the foreground. Because the new camera position is too far right for an exact match, judgments concerning erosion of the foreground alluvium cannot be made.

and we could not see the plants on the shore clearly enough for identification. The two are ecologically similar and are not separated in our records (pl. 3, fig. 21). These plants are practically limited to aquatic situations with quiet water; the rhizome requires complete and permanent immersion (Ridley, 1930). These plants are important food for beavers and muskrats, the seeds are eaten by some waterfowl, and the dense cover produced by these plants provides shelter and nesting cover for marsh birds, waterfowl, and songbirds. Stands of these plants were probably rare or absent in the predam period but are common today (figs. 37B, 65B, and 68B) and contribute importantly to the new postdam ecosystem along the Colorado River.

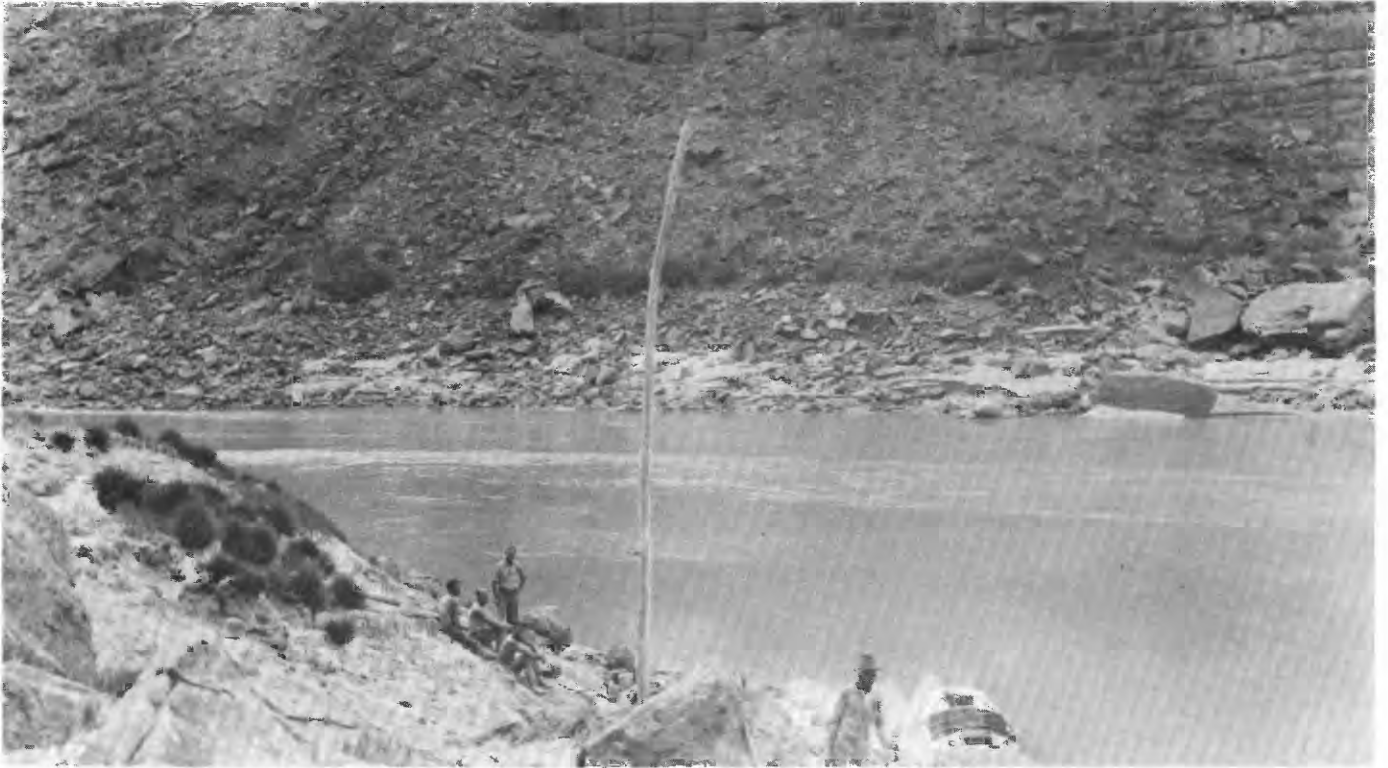
FIGURE 38A.—(1923). The U.S. Geological Survey team camped on the right bank, August 6, 34.6 kilometers below Lees Ferry. A portion of the Pennsylvanian and Lower Permian Supai Group is here exposed at the upper right. The stick in the foreground is a mast for a radio antenna. The conspicuous plants on the sandy knoll behind the four men are probably wire lettuce and spiny aster. On the opposite bank, a discontinuous line of shrubs, probably Apache plume, marks the level of maximum river stage. (Altitude 907 meters.)

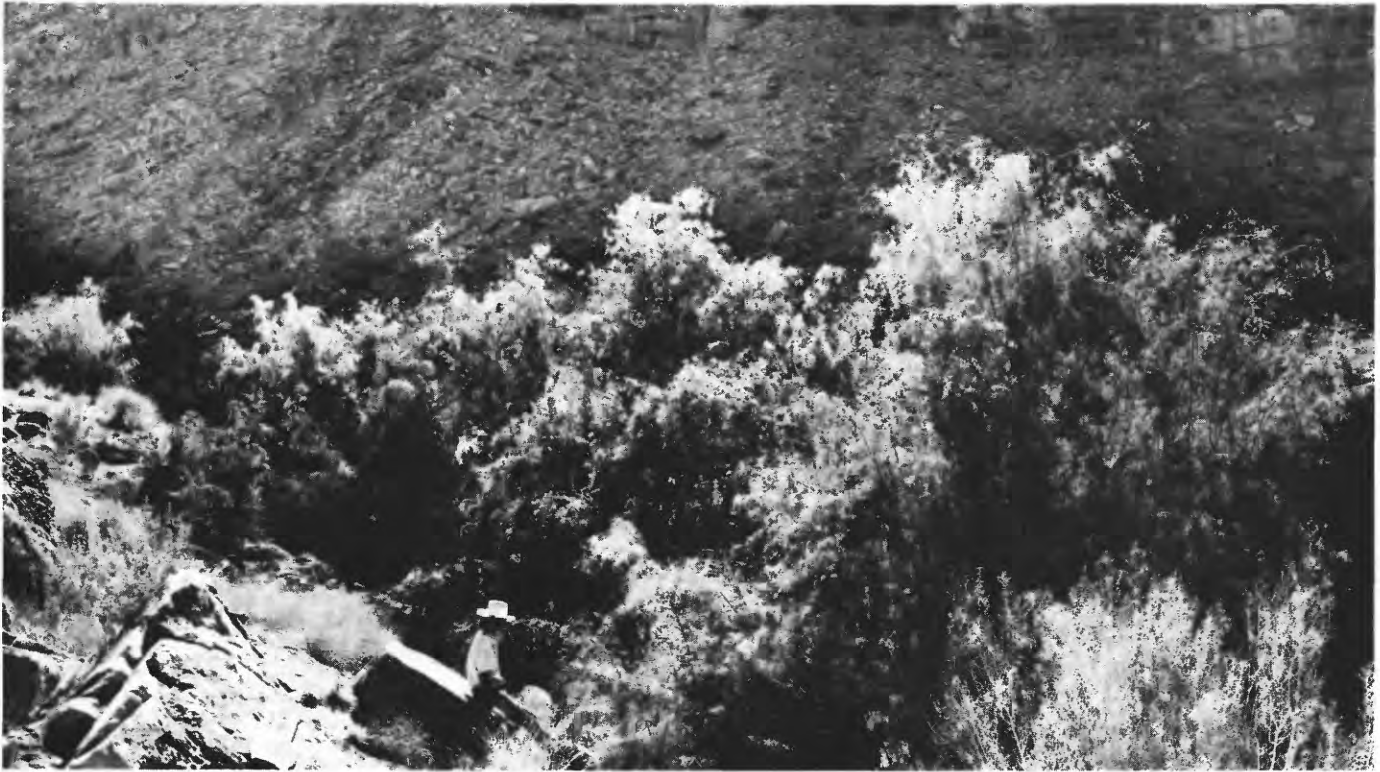
FIGURE 38B.—(1972). Saltcedar, growing to heights of 6 meters, is the dominant plant on the site. Longleaf brickellia (right foreground), wire lettuce, and spiny aster are also present.

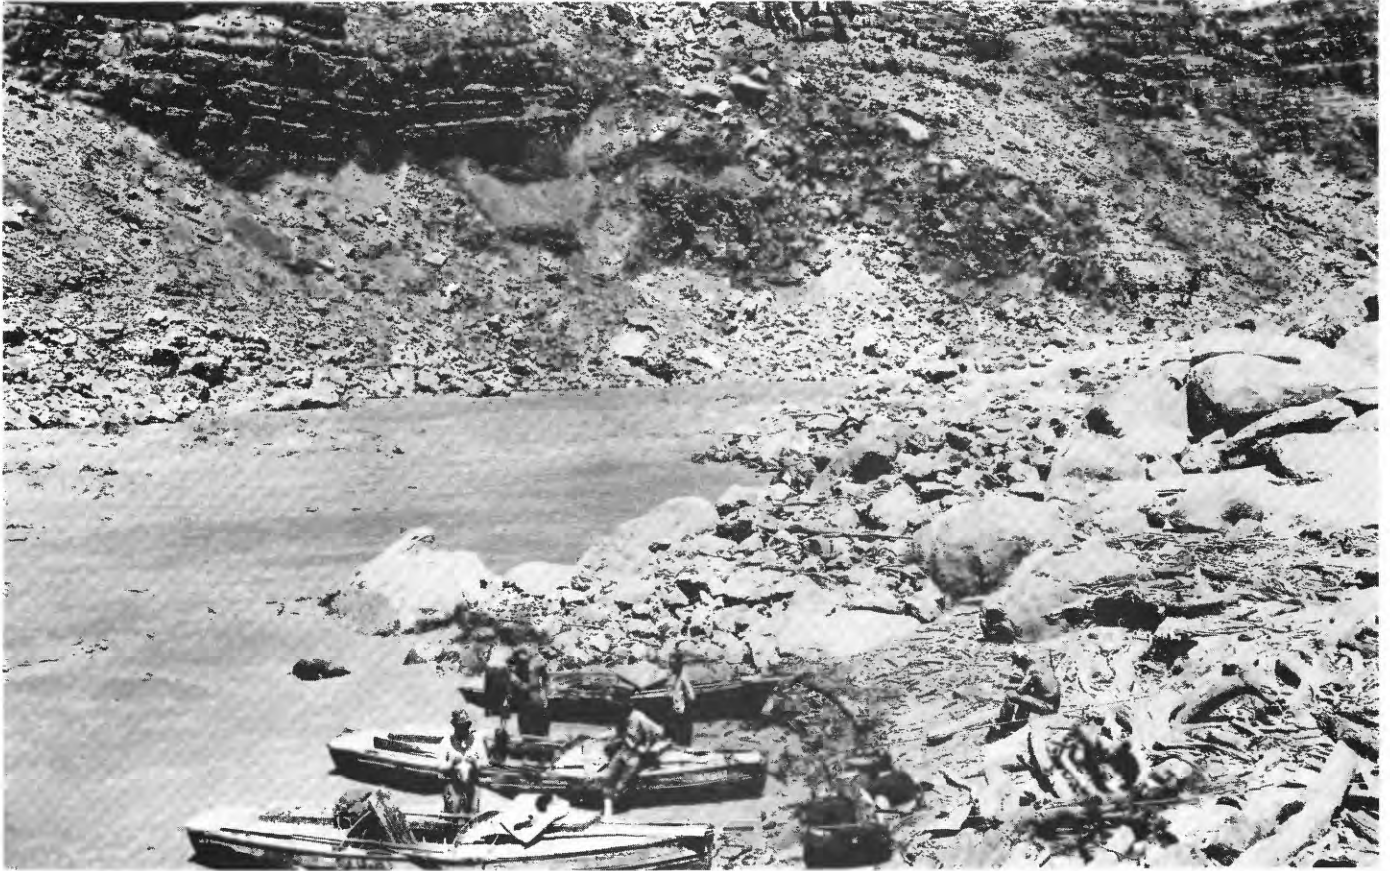
FIGURE 39A.—(1923). E. C. LaRue, a member of the 1923 U.S. Geological Survey team, took this upstream view at the lower end of Tanner Wash rapids, 39.4 kilometers below Lees Ferry. These rapids have been difficult to navigate in the past: Powell posted and lined here in 1869; two members of the Brown-Stanton party drowned here in 1889; Bert Loper's boat capsized here in 1939, and he was never seen again (Hamblin and Rigby, 1969; Péwé, 1969). A large pile of driftwood has accumulated on the silt deposit in front of the boats. Pre-Glen Canyon high-water surges probably overflowed the uppermost boulders. Roughly 2 kilometers upstream from this station recent river silts 6–7.5 meters above river level remain as evidence of the height of predam flows in this reach of the canyon (Hamblin and Rigby, 1968). No vegetation can be seen along this section of the river. (Altitude 893 meters.)

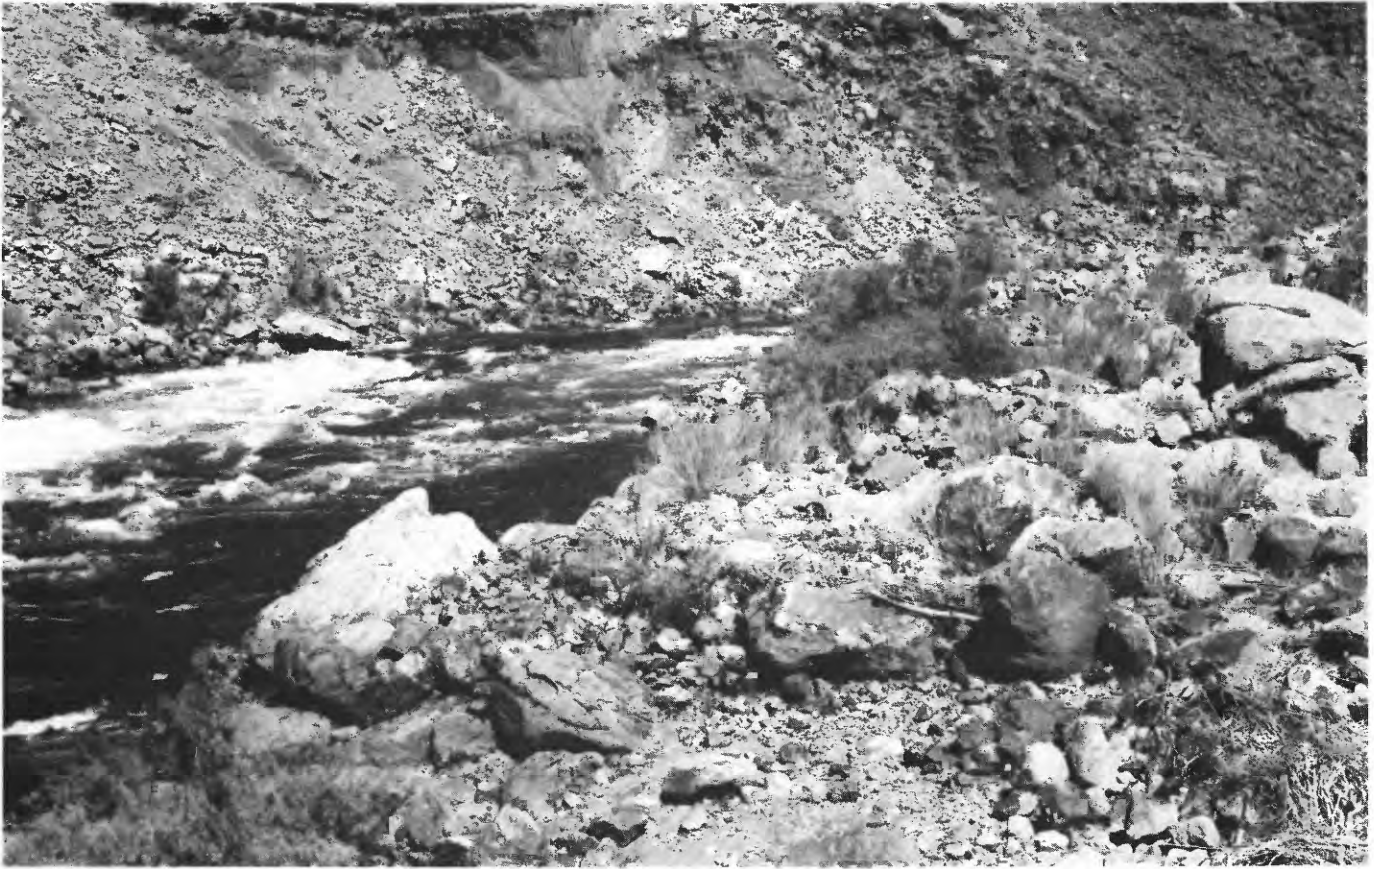
FIGURE 39B.—(1974). Most of the boulders seen in 1923 are still in place on the debris fan at the mouth of Tanner Wash. The large pile of driftwood seen in the earlier view is gone as is the deposit of fine alluvium beneath it. Saltcedar is growing near the river, and longleaf brickellia is the common shrub at higher levels on the beach. The camera for this photograph is located slightly too far left for an exact match.

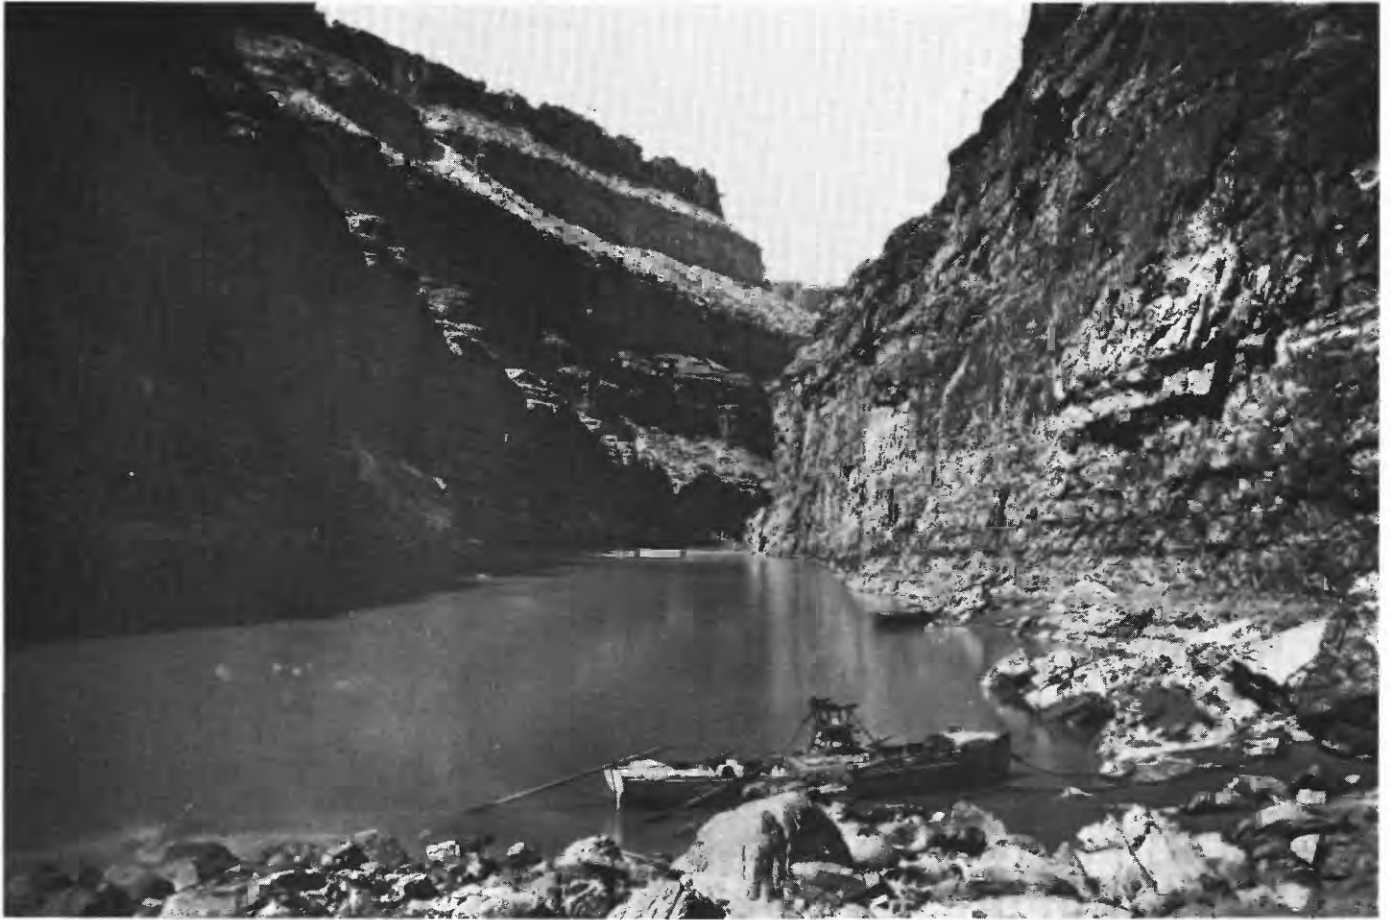
FIGURE 40A.—(1872). J. W. Powell's boat, the Emma Dean, with Powell's armchair strapped to the deck, is seen in this upstream view at 45.5 kilometers below Lees Ferry. The photograph was taken from a small fan at the mouth of a minor side canyon. The narrow canyon and vertical walls of the Mississippian Redwall Limestone promote high velocities and attendant scouring during times of large streamflow volume. This section of Marble Canyon appears to support no vascular plants. (Altitude 884 meters.)
