# Recent Vegetation Changes Along the Colorado River Between Glen Canyon Dam and Lake Mead, Arizona

GEOLOGICAL SURVEY PROFESSIONAL PAPER 1132

By RAYMOND M. TURNER *and* MARTIN M. KARPISCAK

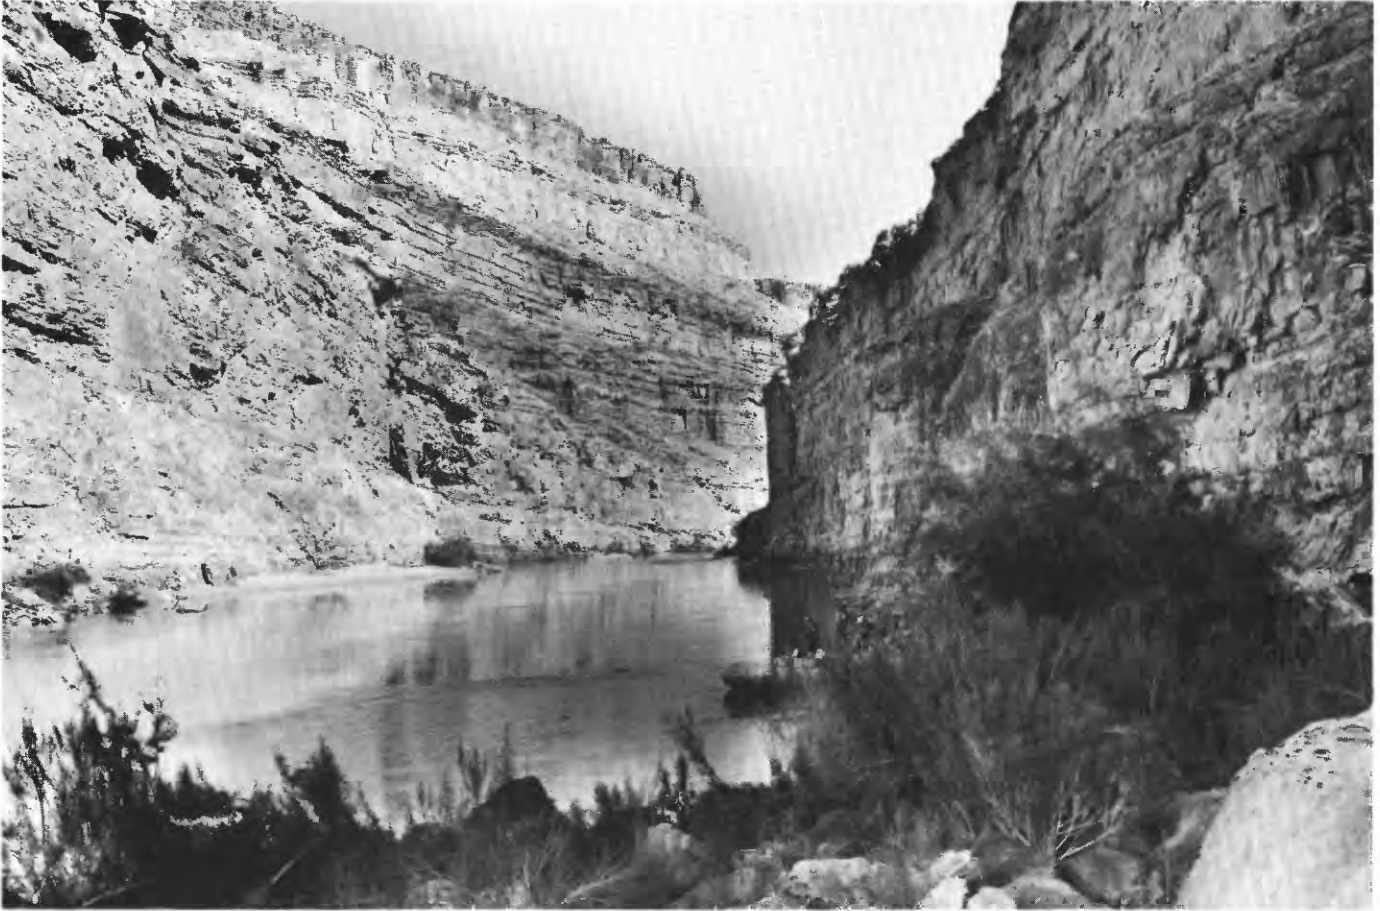
FIGURE 40B.—(1972). The tree on the right is saltcedar. The dominant small shrub on the fan is longleaf brickellia. Shrubs occur at scattered localities on the opposite side of the river. Since Powell's trip, there has developed in this short reach of the canyon an open terrestrial biotic community.

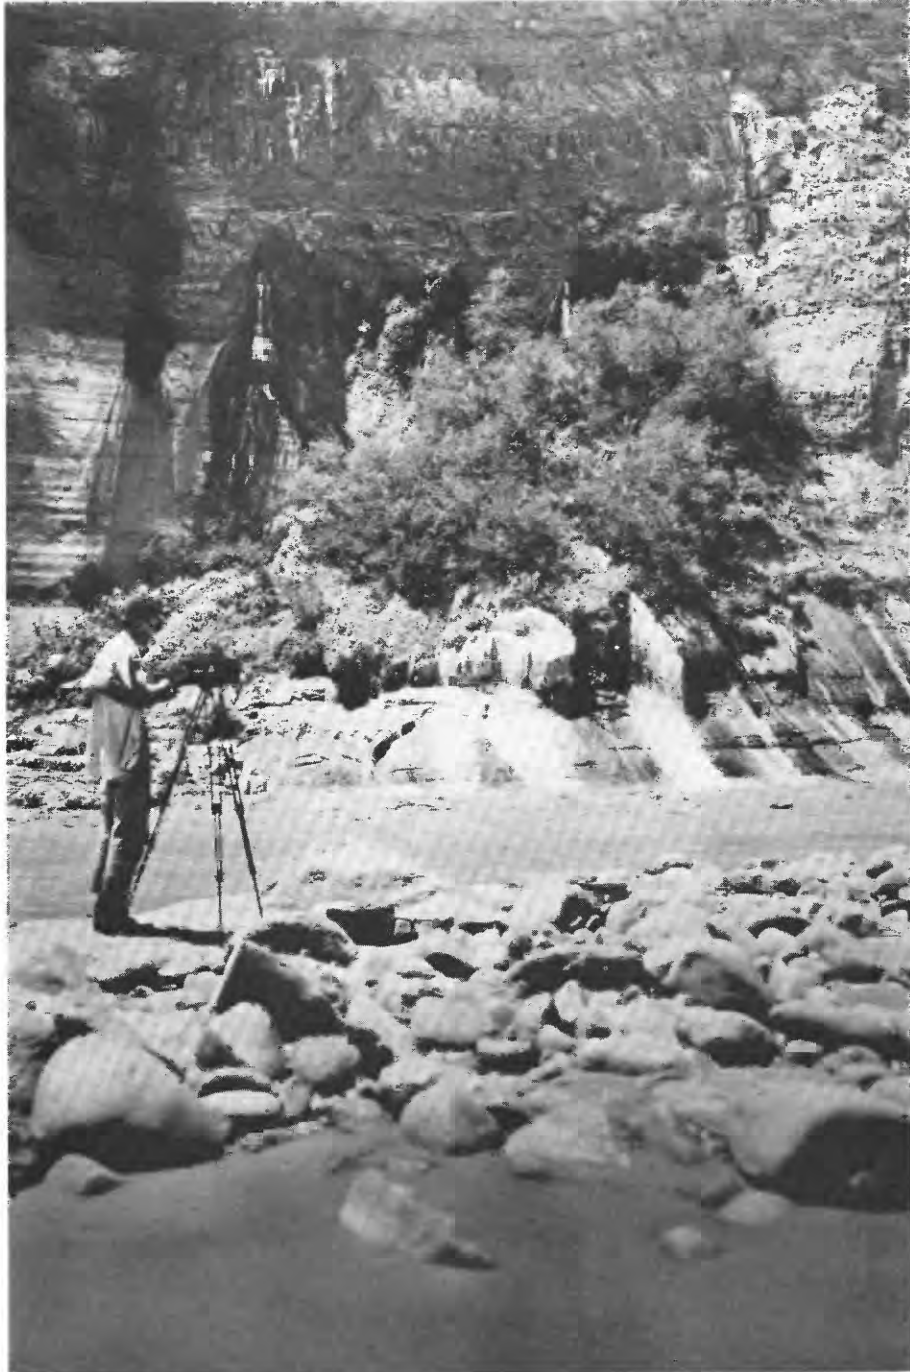
FIGURE 41A.—(1923). L.R. Freeman, a member of the 1923 U.S. Geological Survey team, took this picture of E.C. LaRue photographing Vaseys Paradise, 51.5 kilometers below Lees Ferry. This is one of the better known springs along the Colorado River and was named by Powell for Dr. G. W. Vasey, a botanist (Powell, 1961). Stanton Cave, where members of the Brown-Stanton expedition cached their equipment when they abandoned their first trip in 1889, lies only a few hundred meters upstream. Stanton Cave and the cave system from which springs flow at Vaseys Paradise are evidence of the susceptibility of Mississippian Redwall Limestone to solution. The moist area in the scene is generally northeast facing and supports a dense growth of redbud and poison ivy. A bare skirt just above the river marks the strip scoured periodically by heavy flow. (Altitude 875 meters.)

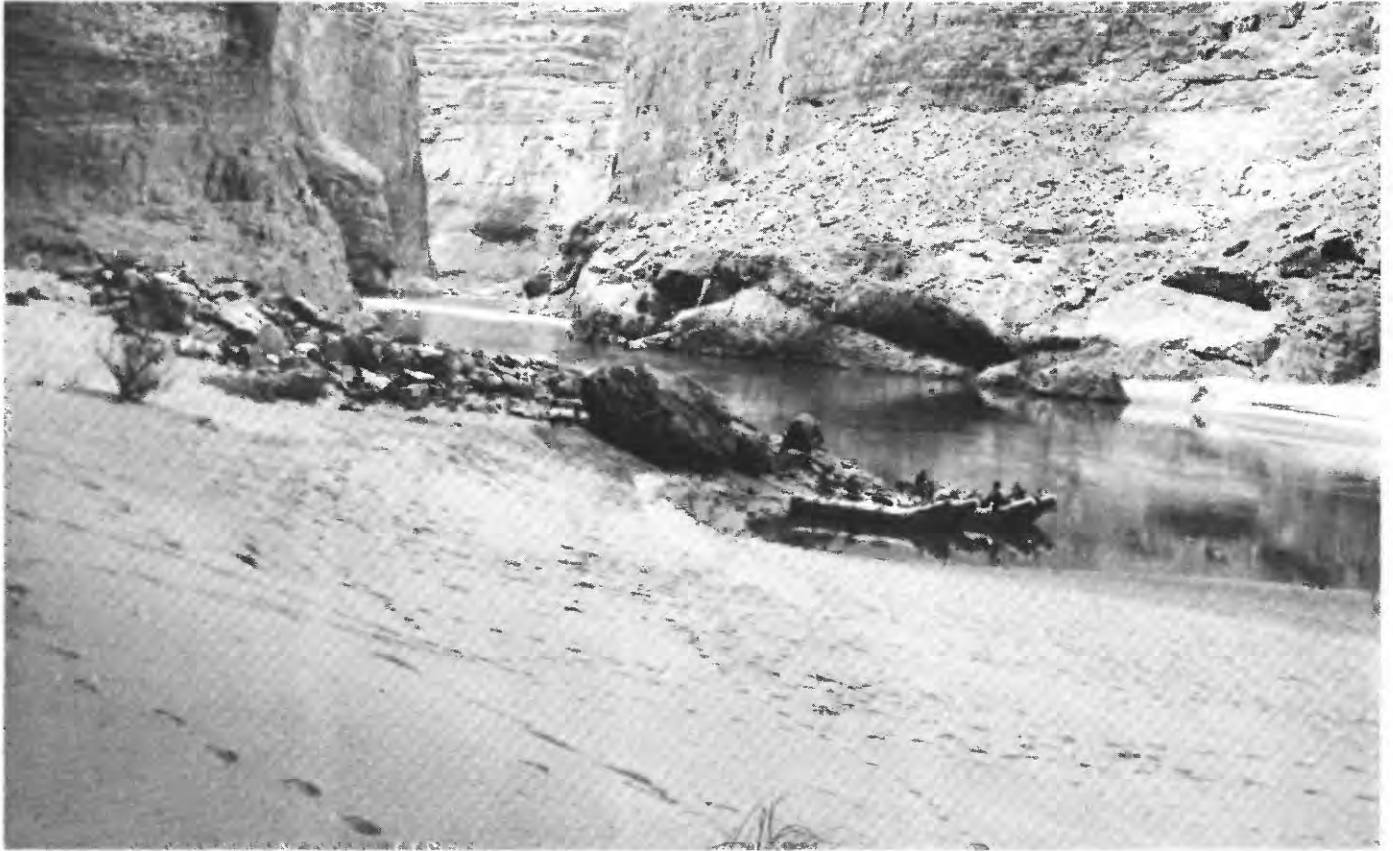
FIGURE 42A.—(1923). This photograph provides a downstream view of the Grand Canyon from within Redwall Cavern, 53.3 kilometers below Lees Ferry. The cavern, formed by solution of the Mississippian Redwall Limestone (Hamblin and Rigby, 1968) is one of the major attractions of the Grand Canyon. Prior to the construction of Glen Canyon Dam, the river entered the cavern during high flows producing conditions too unstable for plant establishment. Powell camped here during a rainstorm and noted that the floor would be inundated during periods of peak flow by a "raging flood" (Powell, 1875). Waves during an earlier period of high water have produced marks in the sand that are high above the river level in this 1923 view. Erosion of the alluvium is apparent from the vertical bank near the edge of the water. The large blocks on the far side of the cavern and in the foreground have fallen from the roof. The plant in the foreground is dogbane. (Altitude 873 meters.)

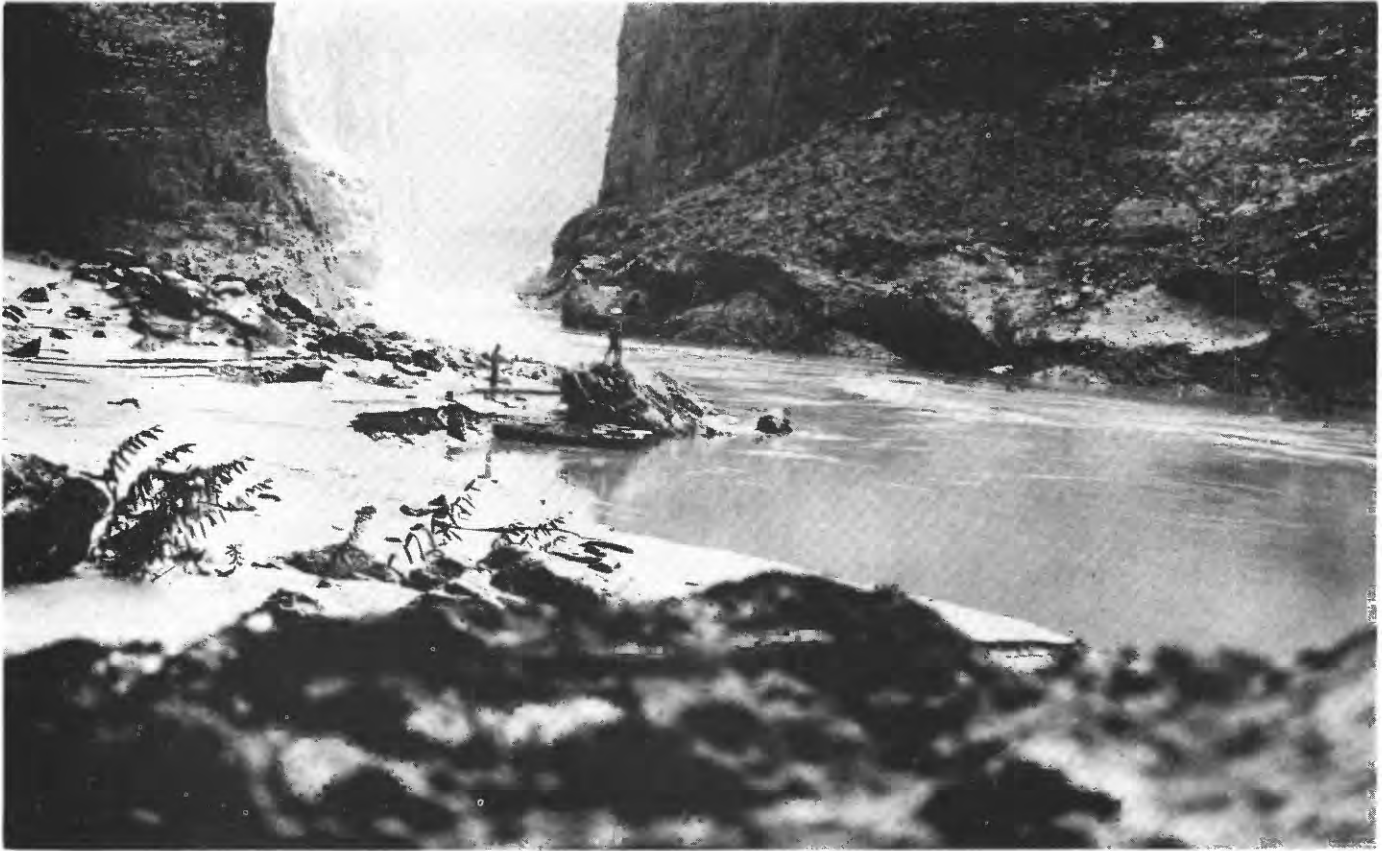
FIGURE 42B.—(1974). Comparison of this photograph with the earlier one reveals several changes. The impact of wave action is no longer apparent away from the river, but wind ripples are evident in the sand of the foreground. Using the collapse blocks as references, it is apparent that aggradation, perhaps from wind, has occurred on the higher parts of the beach and erosion has reduced the sand deposit toward the base of the sloping beach. The sand bar across the river to the right appears new. The only plants visible are scattered saltcedars. The lack of more vegetation probably results from the low light intensity within the cavern and trampling by the thousands of visitors that stop here each year.

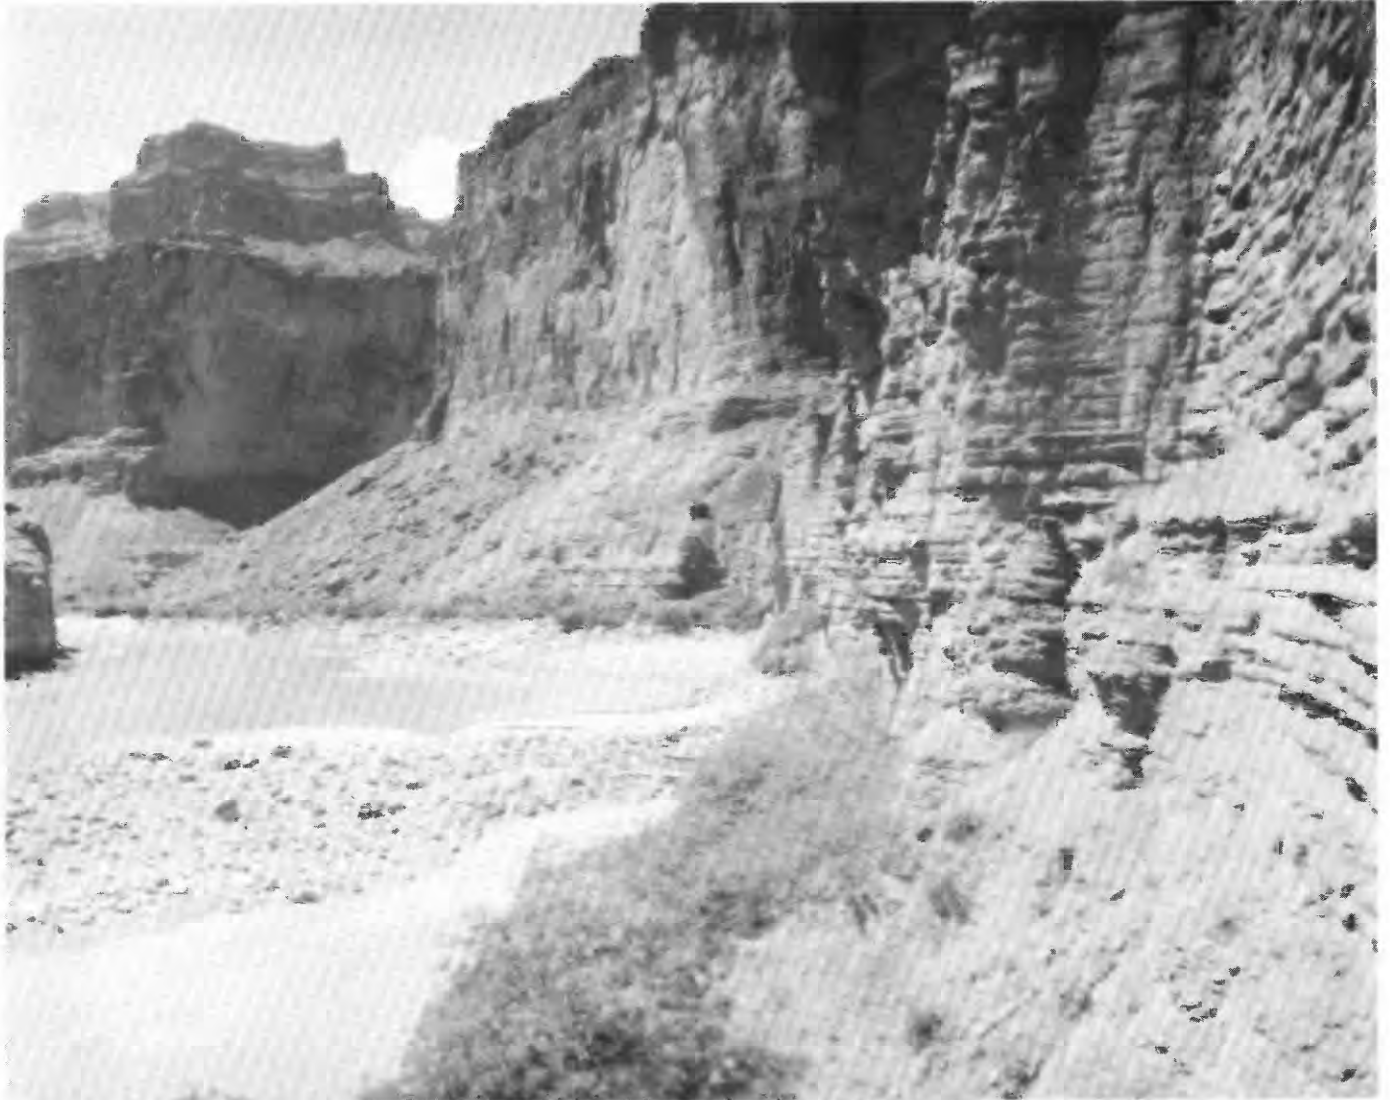
FIGURE 43A.—(1923). This view was taken from the top of a talus slope on the right bank a short distance above Triple Alcoves, 74.8 kilometers below Lees Ferry. The vertical outcrops with conspicuous bedding at right foreground are the Middle Cambrian Muav Limestone. The Mississippian Redwall Limestone forms the vertical cliffs above the Muav. The flood-line vegetation is especially well developed on the talus slopes on the right bank. A few logs of driftwood can be seen along the upper part of the boulder-strewn beach; elsewhere on the beach, there are no signs of plants. (Altitude 858 meters.)

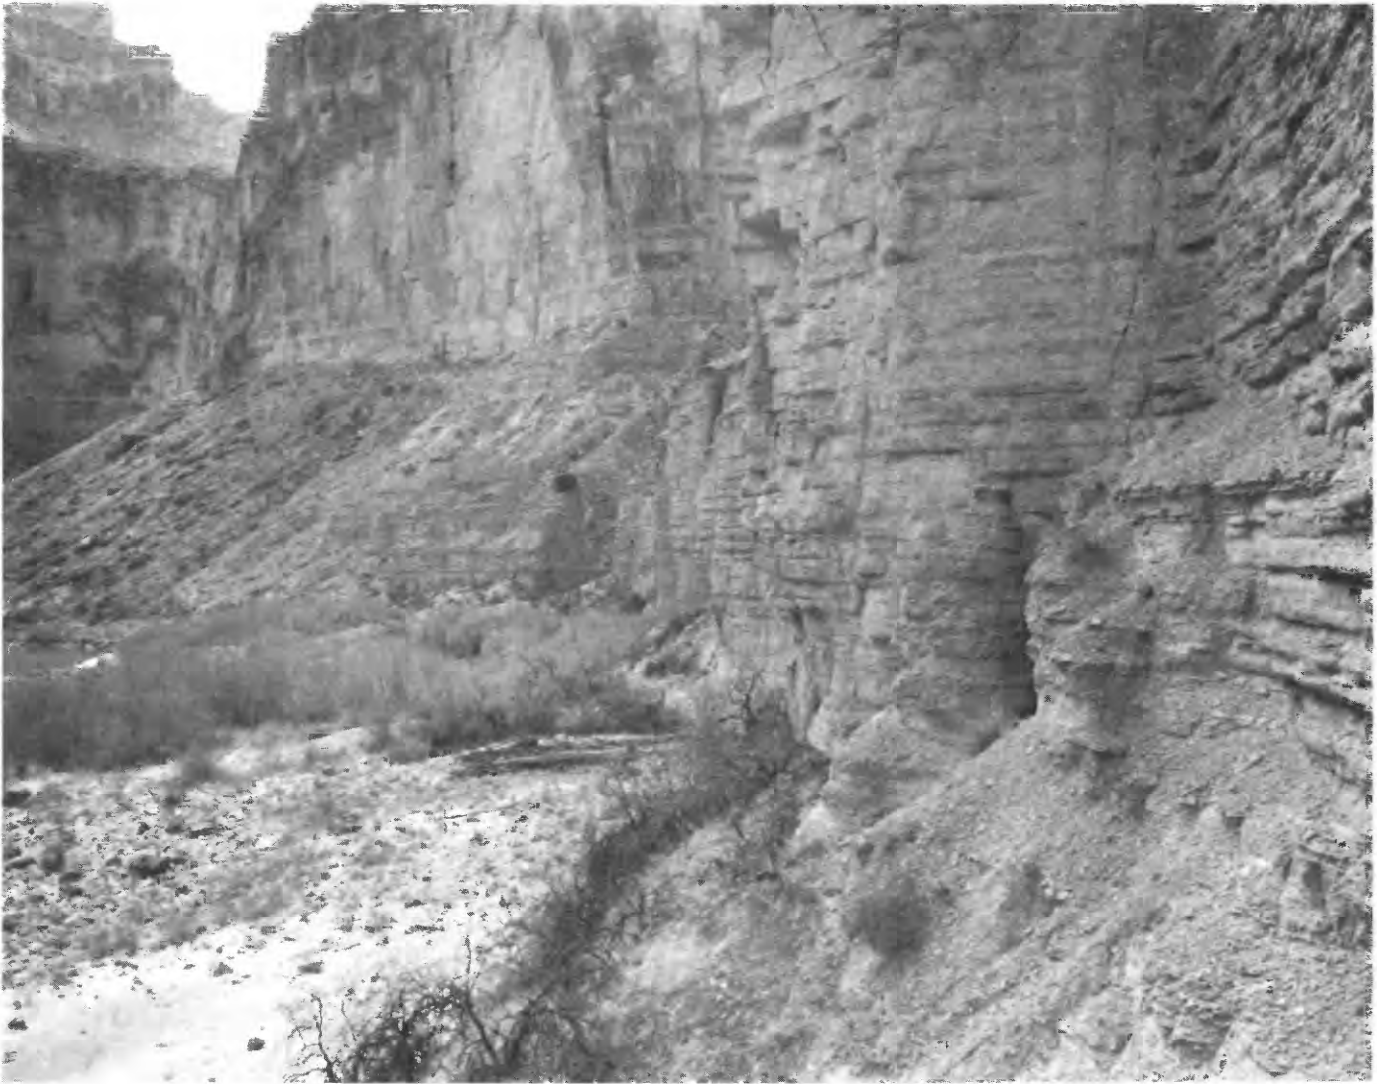
FIGURE 43B.—(1974). Driftwood is still visible in the same location as before, and many boulders are the same in both views. Much of the sand deposit is still relatively unstable and devoid of plants. In this March view the flood-line community, composed mainly of western honey mesquite in this section of Upper Marble Canyon, is leafless and cannot be easily compared with its counterpart in the August 1923 photograph. Western honey mesquite is first seen in the canyon only 11.5 kilometers upriver from here. Some of the plants (jointfir) on the talus slope at the right seem to be the same as those in the earlier view. The vegetation at the river's edge is predominantly saltcedar and willow, with sparse seep willow, arrowweed, and cattail. Other species found on the beach are peppergrass, desert plume, Russian thistle, red brome, globemallow, brittlebush, dyssodia, longleaf brickellia, and desert trumpet.

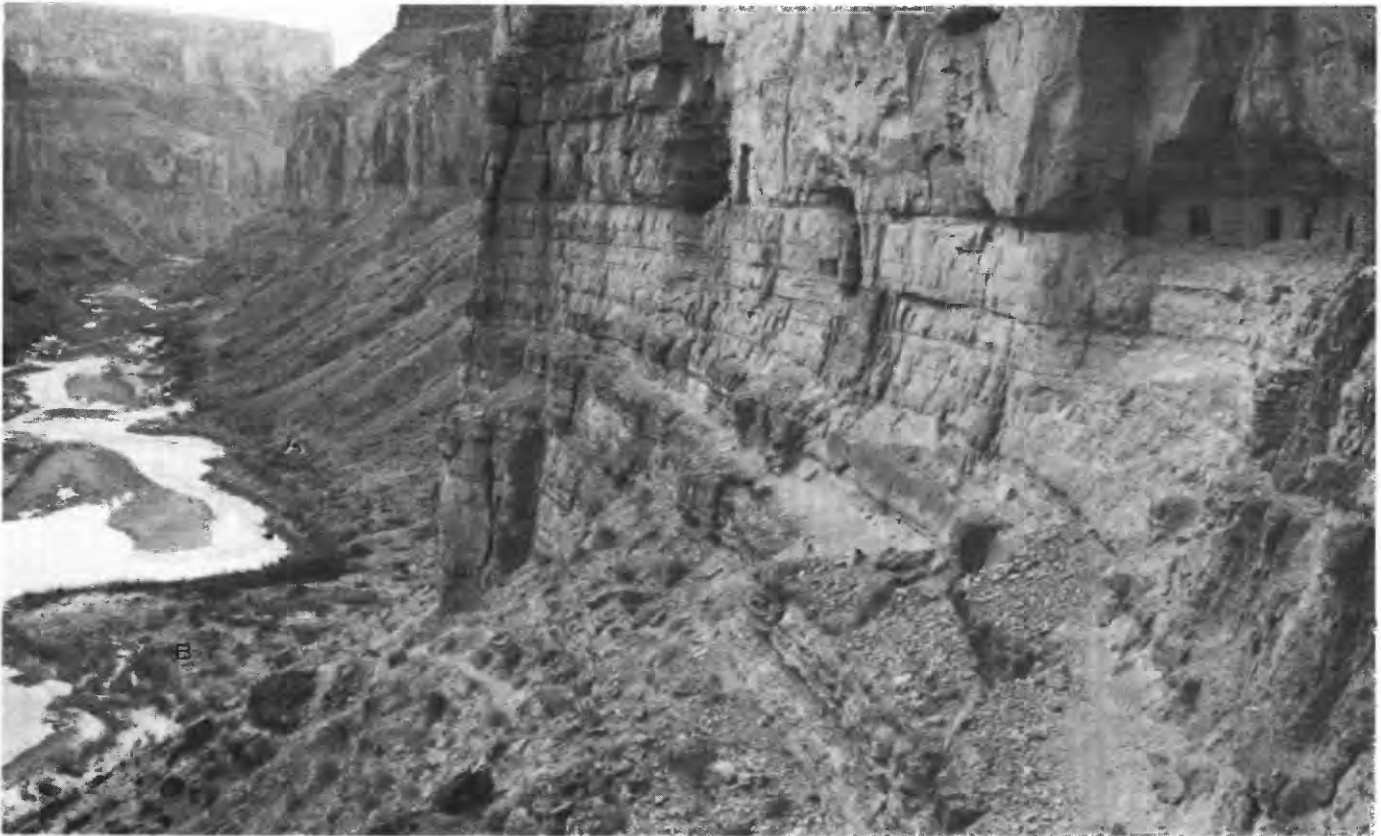
FIGURE 44B.—(1974). This matching photograph was taken in March before many of the shrubs and trees in the valley were in full leaf. The preceding photograph was taken in August when foliage was fully developed. Because the decrease in density of the plants at A might be the result of differences in seasonal development, additional photographs, taken by John Richardson, Southern Illinois University, in July 1978, were obtained. These photographs (not shown) were taken at a time of maximum leaf development and reveal the same decline in the predam flood-line community as in this March view. The dense thicket on the terrace above the boats (at B) was thinned by a wildfire that burned through the thicket in May 1970 (P. S. Martin, written commun., 1971). During the 51-year interval between the two photographs, there has been extensive development of the riparian belt near the margins of the river. Saltcedar, arrowweed, sandbar willow, and Emory seep willow are the dominant plants with occasional growths of cattail, smooth horsetail, and great bulrush. Trails have become prominent features of the slope leading to the Indian ruins.

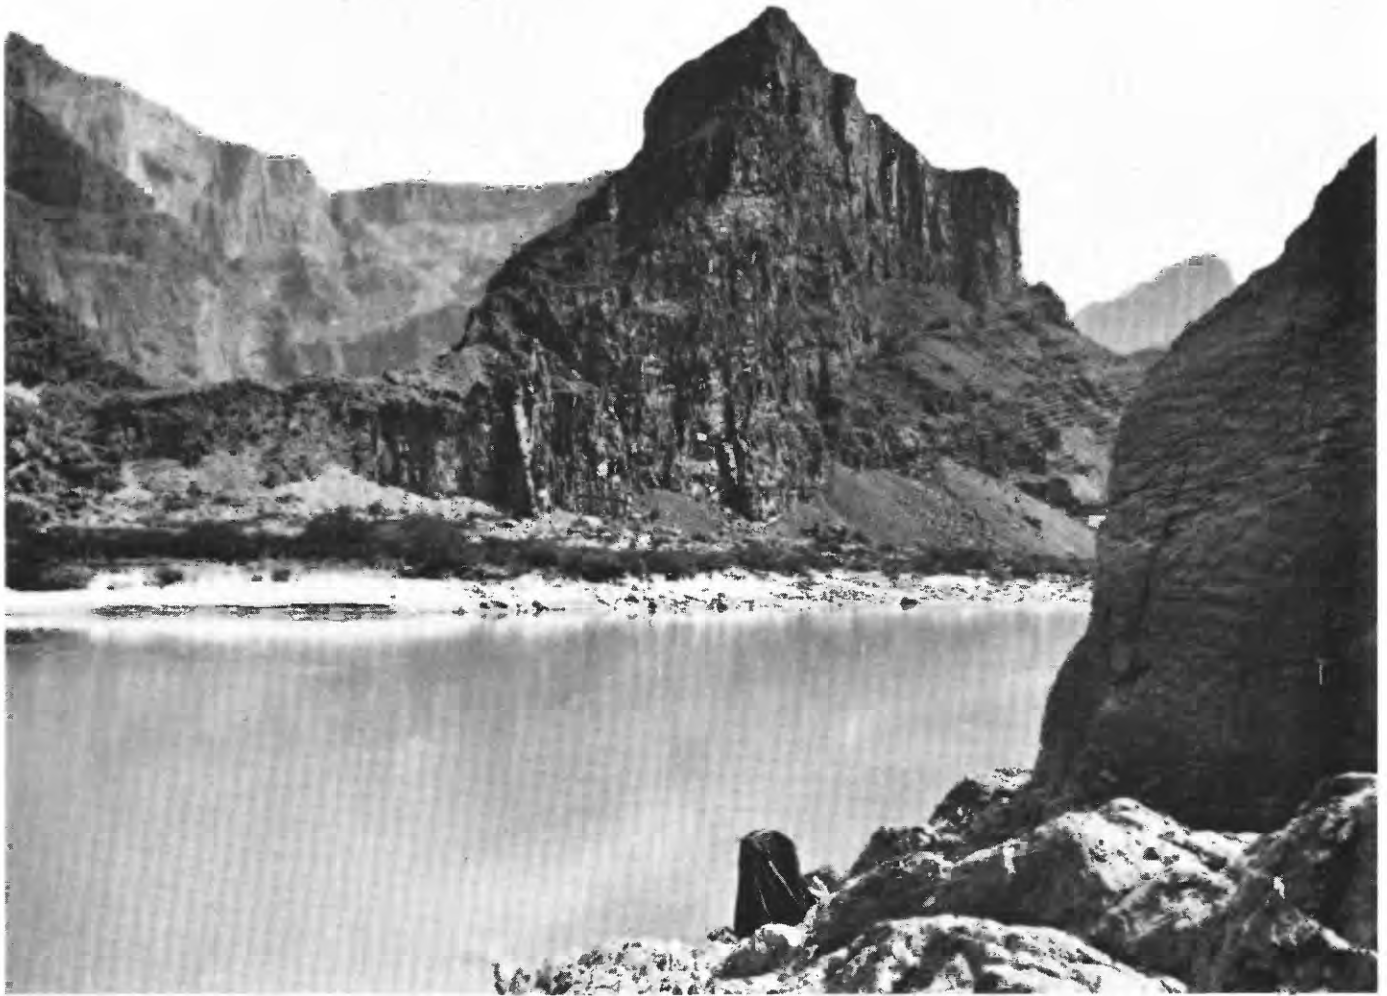
FIGURE 47A.—(1872). This photograph was taken by J. K. Hillers from near the mouth of Lava Canyon 105.4 kilometers below Lees Ferry. The vegetation on the opposite bank grows on a fan at the mouth of Palisades Creek. The dominant plants appear to be western honey mesquite and catclaw. Note the ripple marks on the block at the right. (Altitude 817 meters.)

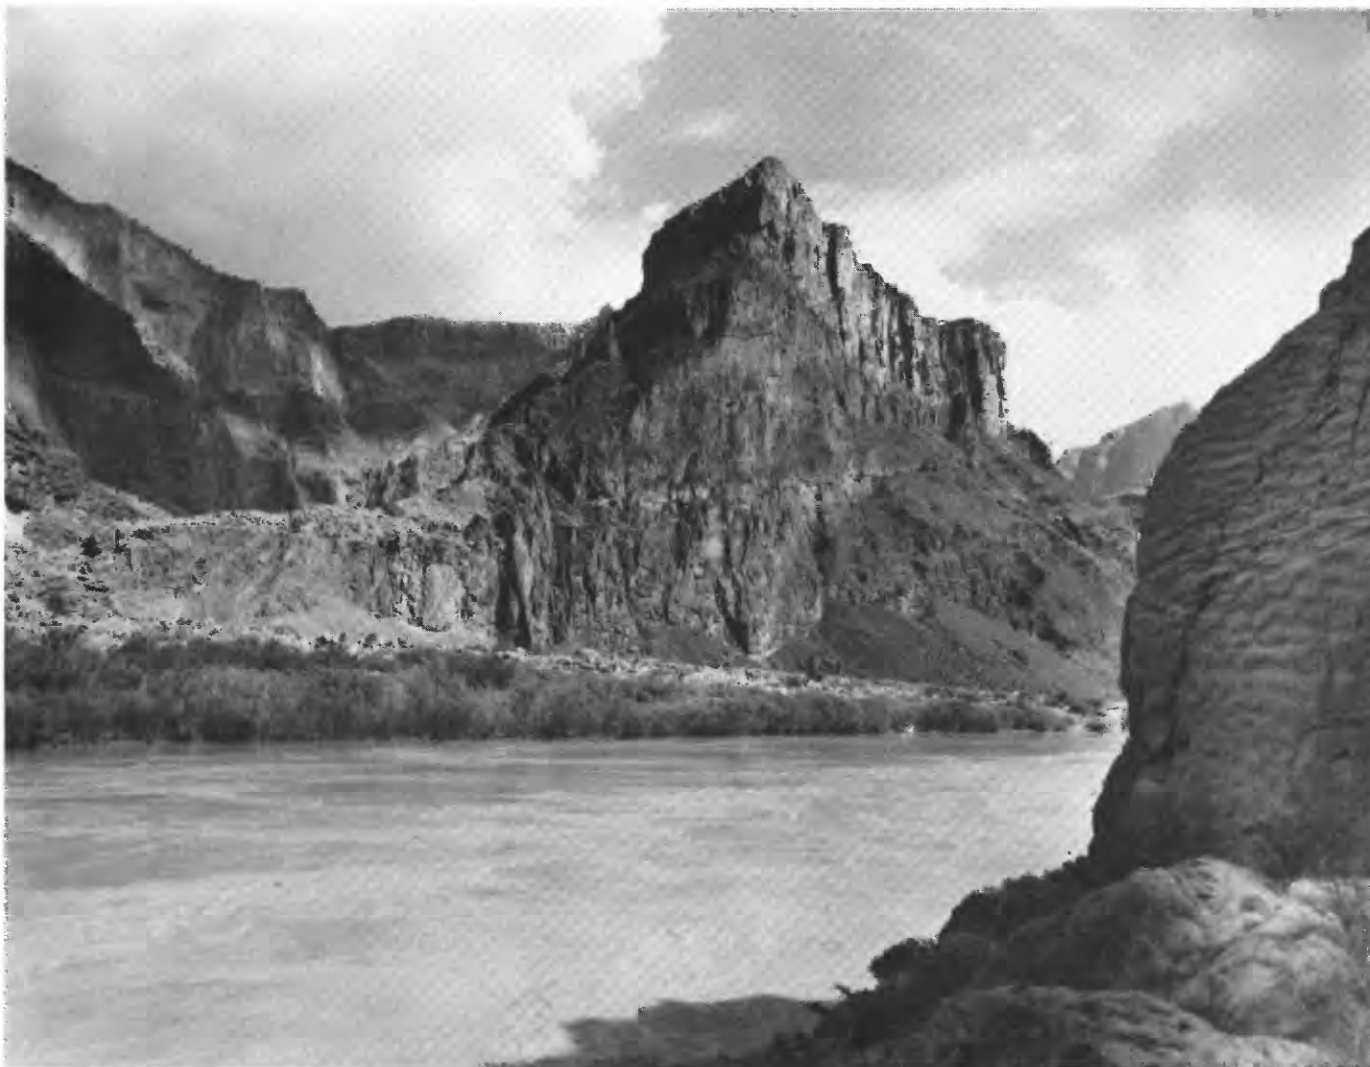
FIGURE 47B.—(1974). The foreground rocks show little change in the 102 years since the first photograph of this pair was taken. On the opposite shore, the bare sandy beach of the previous century is now covered by sandbar willow and saltcedar with minor inclusions of seep willow and arrowweed. The zone with western honey mesquite and catclaw is little changed and, although not discernible in this view, is separated from the riparian vegetation bordering the river by an open zone of mainly ephemeral plants.

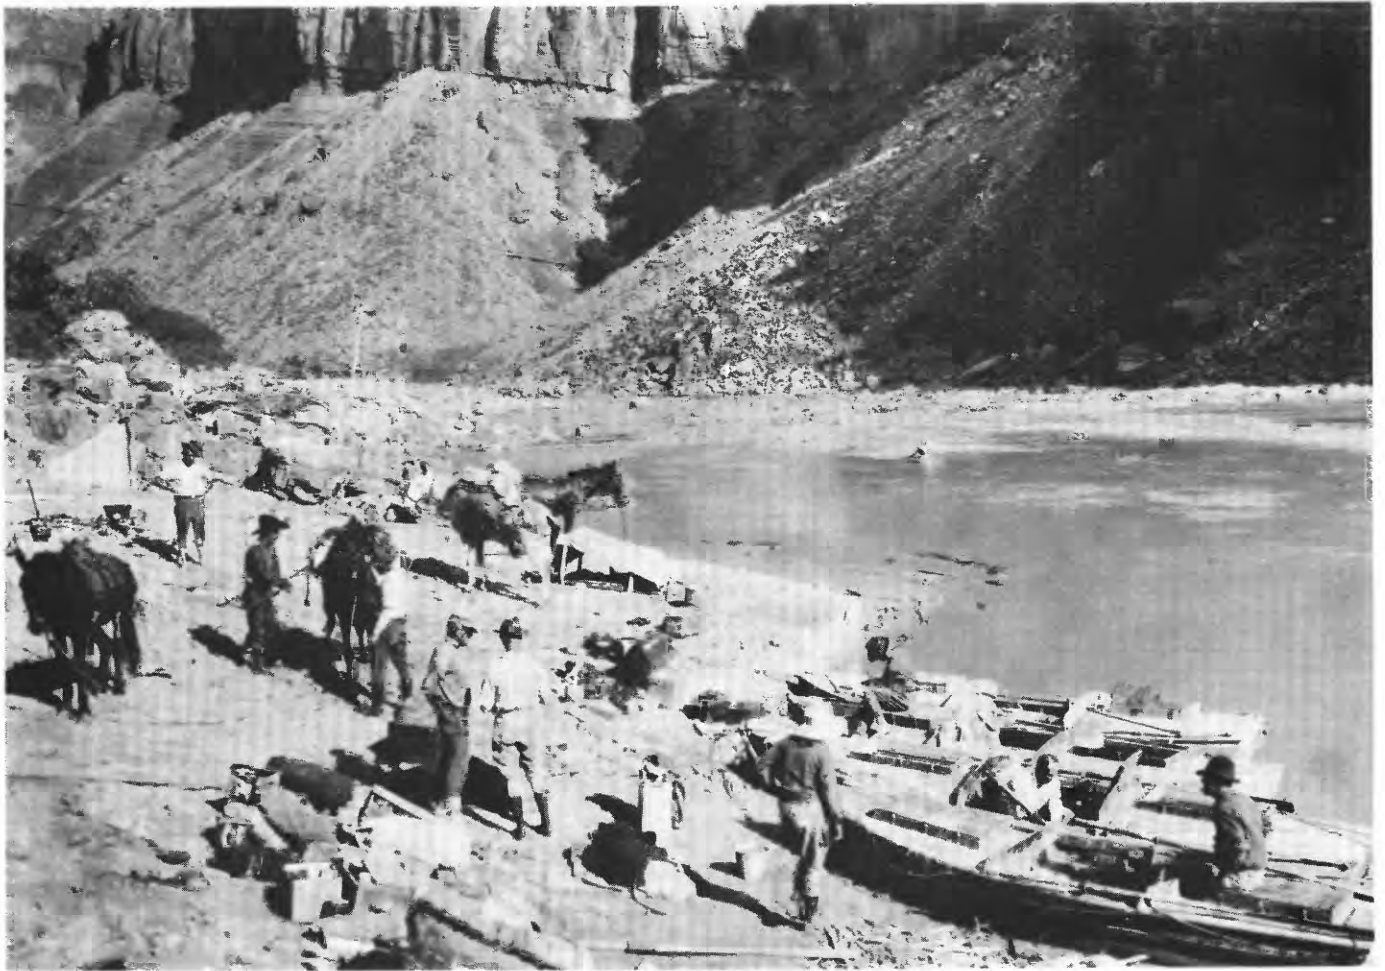
FIGURE 48A.—(1923). The U.S. Geological Survey team is shown packing up for portage at the head of Hance Rapids, 123.1 kilometers below Lees Ferry. The pack animals were able to reach the river from the South Rim by descending the Hance Trail. The base of the vertical exposure of Precambrian Shinumo Quartzite (upper left) is well defined by differential weathering of the underlying Hakatai Shale. A thicket of desert shrubs can be seen on the left above the zone scoured by floods. (Altitude 780 meters.)

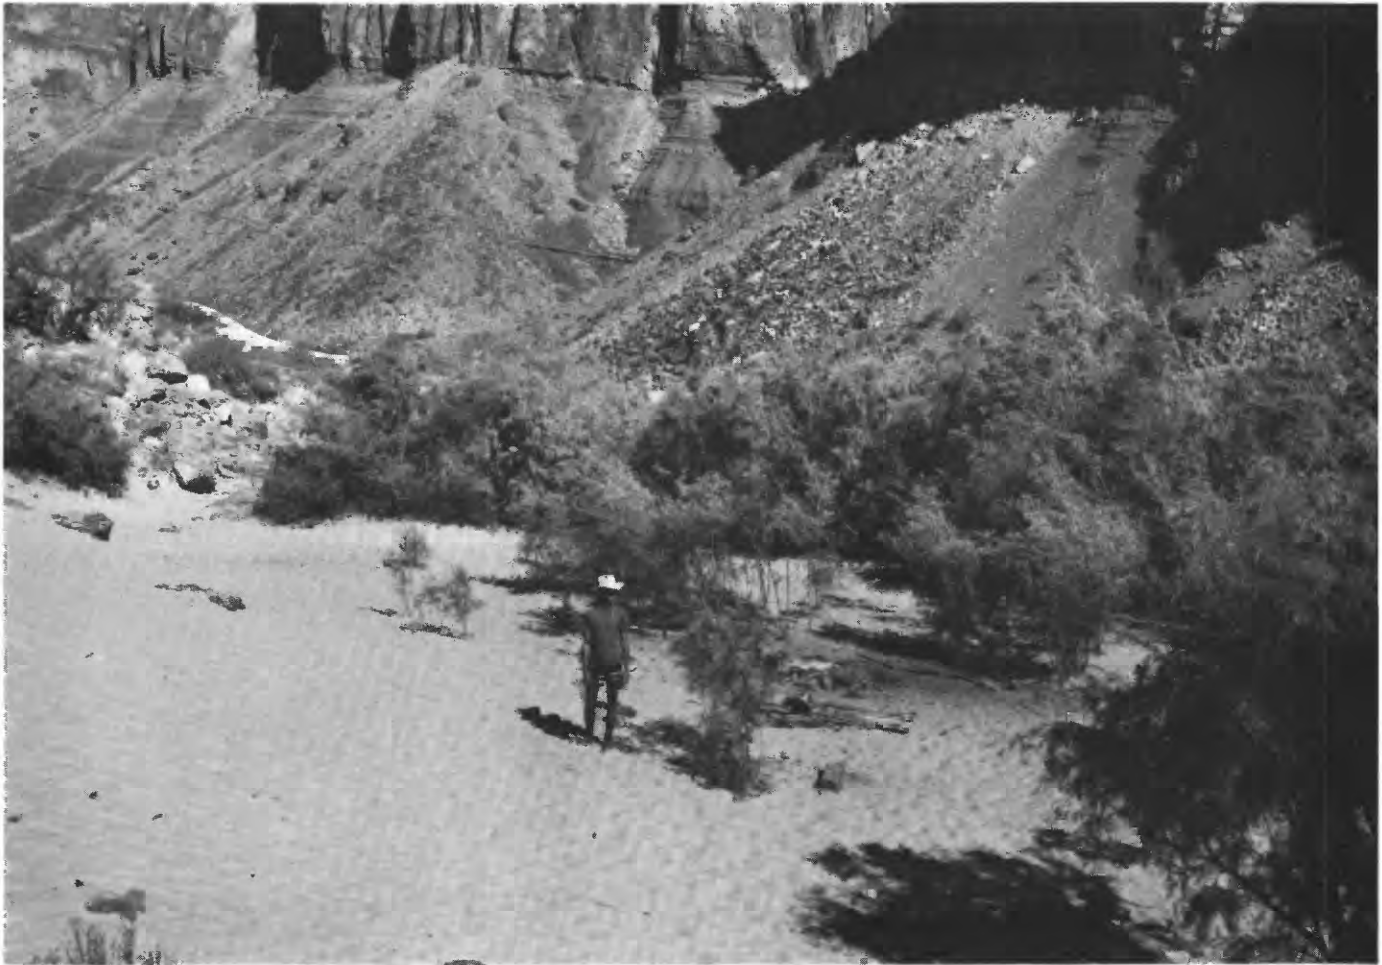
FIGURE 48B.—(1972). The depth of the sand deposit has increased and saltcedar grows densely along the edge of the river. The sand dune is new on the sloping area at left midground. The thicket of desert shrubs at left, comprising western honey mesquite, catclaw, and four-wing saltbush, is rearranged but may have changed little in biomass. The Hance Trail is no longer maintained and is not usable by pack animals. The remains of a campfire and the many human tracks attest to the heavy use the area receives as a campground by parties floating down the river. In 1974 this campsite was given a subjective human impact rating of 20.0 on a scale from 10.0 (no impact) to a maximum impact value of 22.6 (Aitchison, 1976). In spite of the heavy use, saltcedar has become established in abundance.

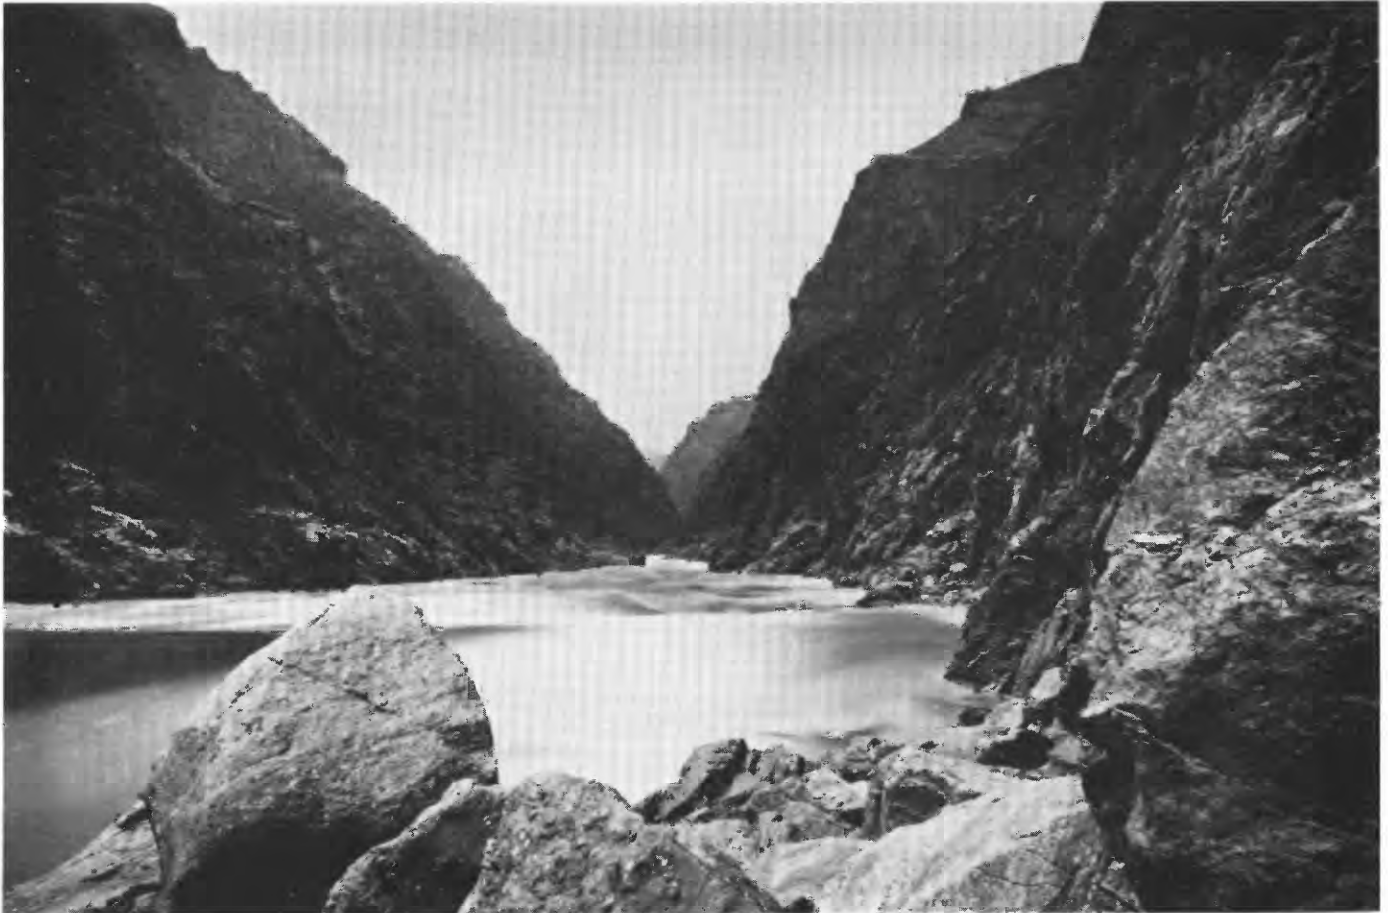
FIGURE 49A.—(1872). This downstream view, taken by J. K. Hillers on Powell's second expedition, shows the head of the rapids named Sockdolager by Powell in 1869. In boxing parlance this name means a heavy or finishing blow. The rapids are 126.3 kilometers below Lees Ferry and are the first in the Upper Granite Gorge, which begins about 2.4 kilometers upstream from here. Because the lower Precambrian rocks through the Upper Granite Gorge are resistant to erosion, steep walls and a narrow V-shaped canyon are produced. The great length of the rapids and the thunder produced by the sound of the waves reverberating from the walls as the water tumbles through the gorge, gives the rapids a frightening aspect. There is little substrate for terrestrial plants near the river or above on the cliff faces. (Altitude 770 meters.)

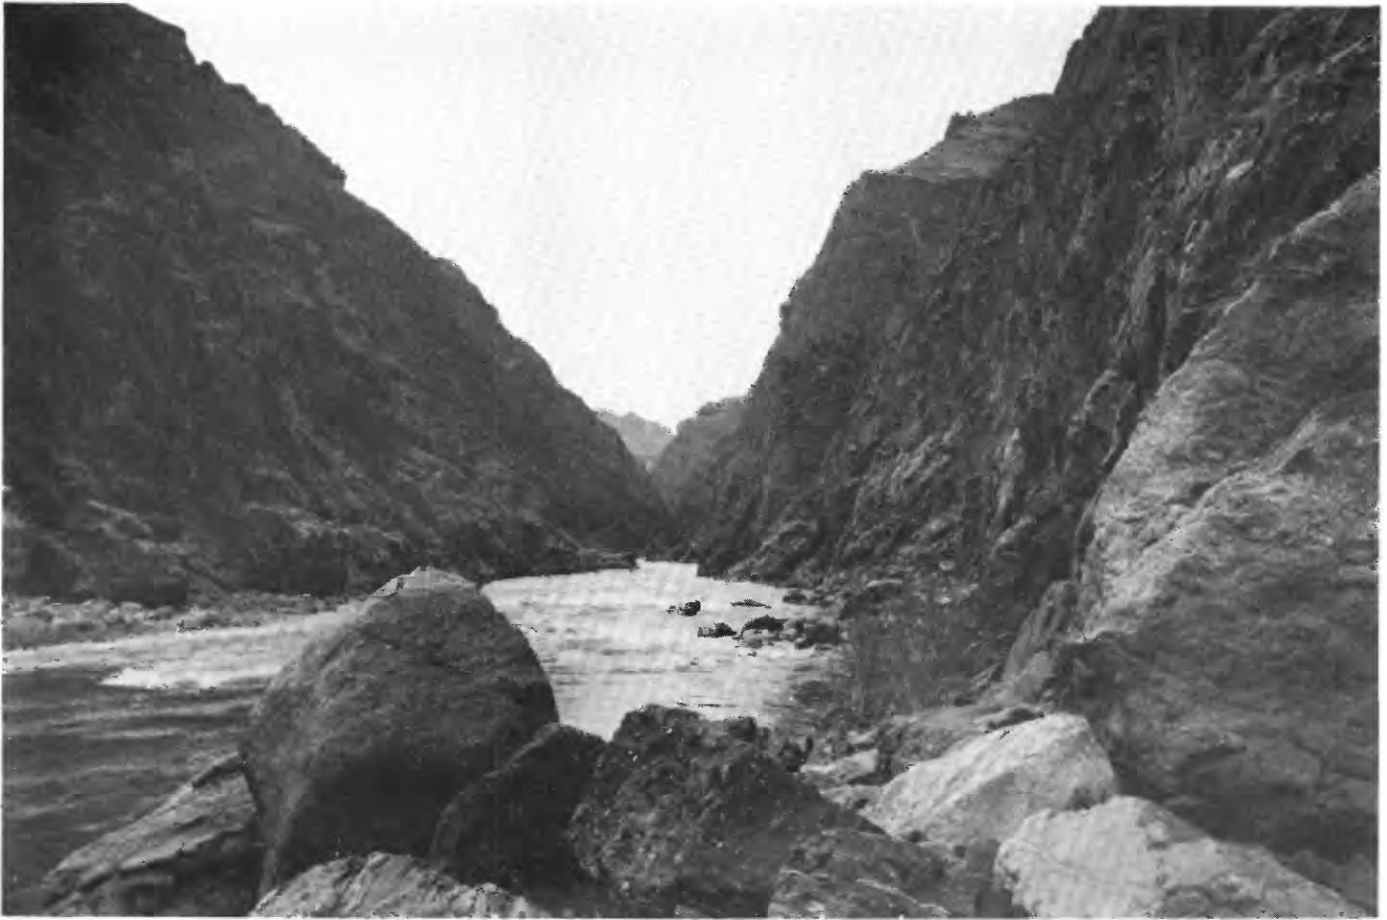
FIGURE 49B.—(1974). Except for one clump of saltcedar, leafless in the March view, little has changed in 102 years. Because of the narrow canyon and the near vertical walls, fluctuations in water level are exaggerated through this reach. The reaches of the river with the least vegetation change are the "Inner Gorges" represented by this view.

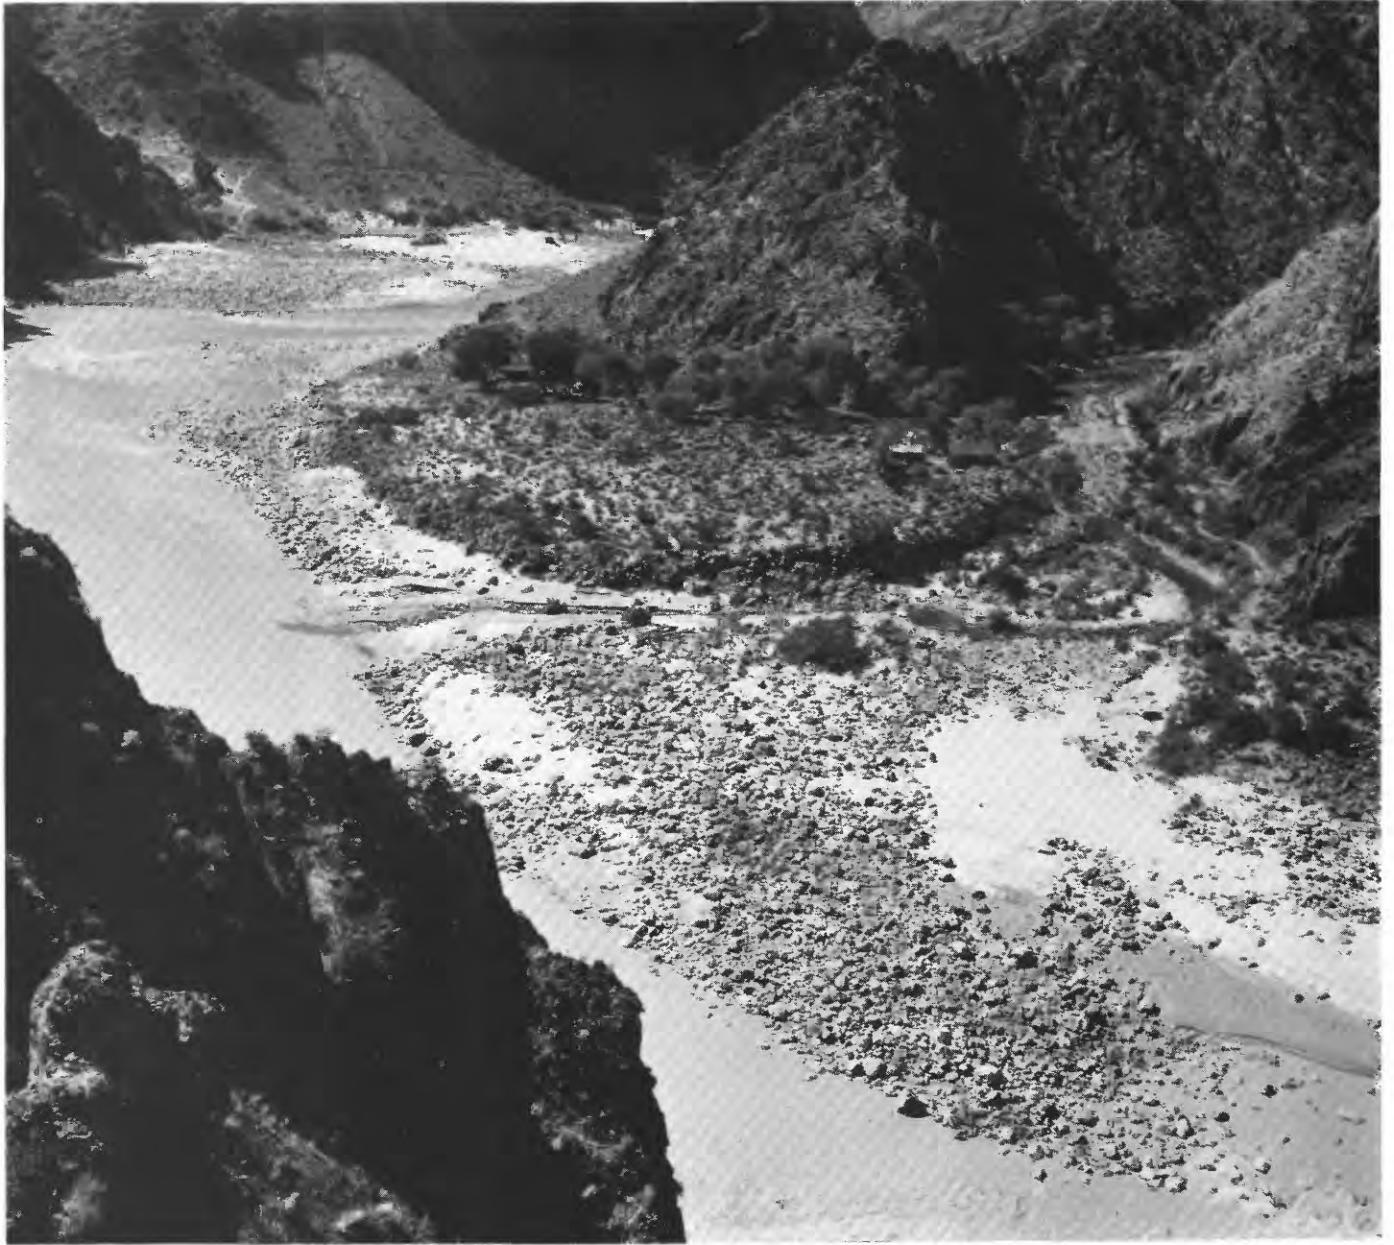
FIGURE 50A.—(1952). This photograph is the first in a set of three that spans 20 years. The photograph is taken from the Kaibab Trail just above the Kaibab Suspension Bridge, 140.6 kilometers below Lees Ferry, and shows the mouth of Bright Angel Creek. The debris fan at the mouth of Bright Angel Canyon is devoid of plants except on higher ground where western honey mesquite is the dominant large plant. The large trees around the base of the hill near midground are Fremont cottonwoods. Phantom Ranch is out of view upstream on Bright Angel Creek. The area near the mouth of Bright Angel Creek is the most heavily visited location in the bottom of the Grand Canyon and is served by two trails from the south rim and one from the north. (Altitude 741 meters.)
