# Recent Vegetation Changes Along the Colorado River Between Glen Canyon Dam and Lake Mead, Arizona

GEOLOGICAL SURVEY PROFESSIONAL PAPER 1132

By RAYMOND M. TURNER *and* MARTIN M. KARPISCAK

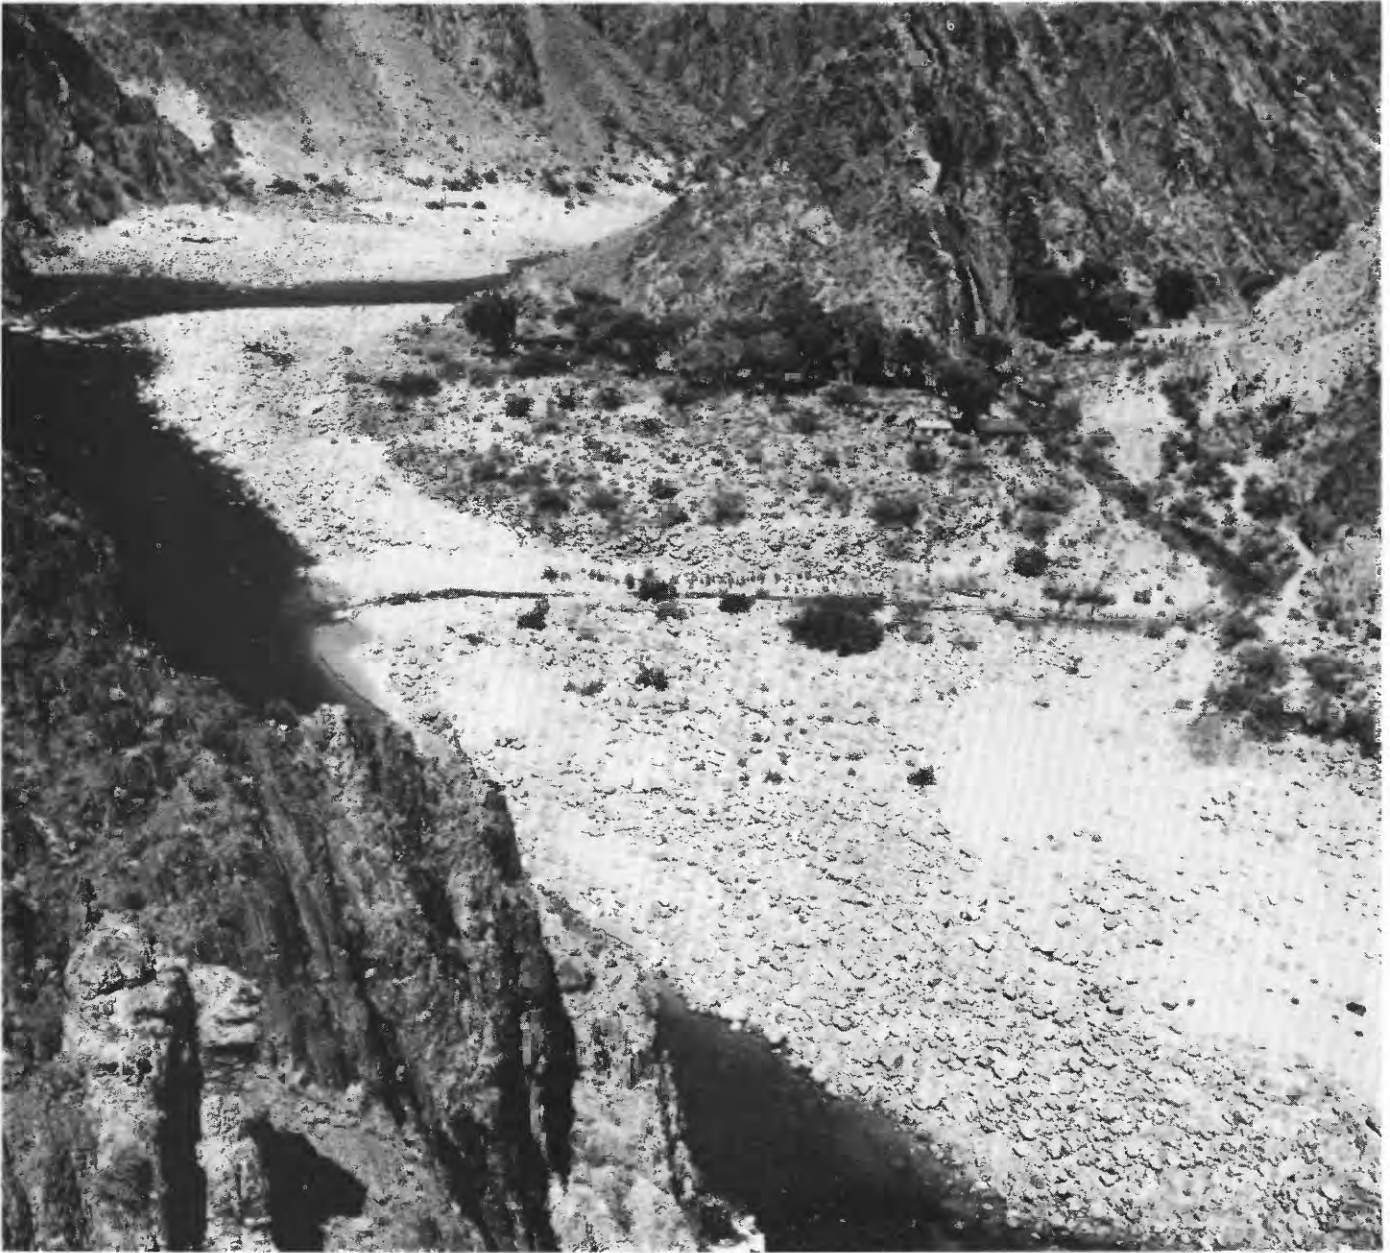
FIGURE 50B.—(1963). On the date of this photograph, Glen Canyon Dam had been completed and the water was being impounded in the reservoir area above it. No plants occur at the river's edge. Most of the boulders on the beach are the same in this and the earlier photograph.

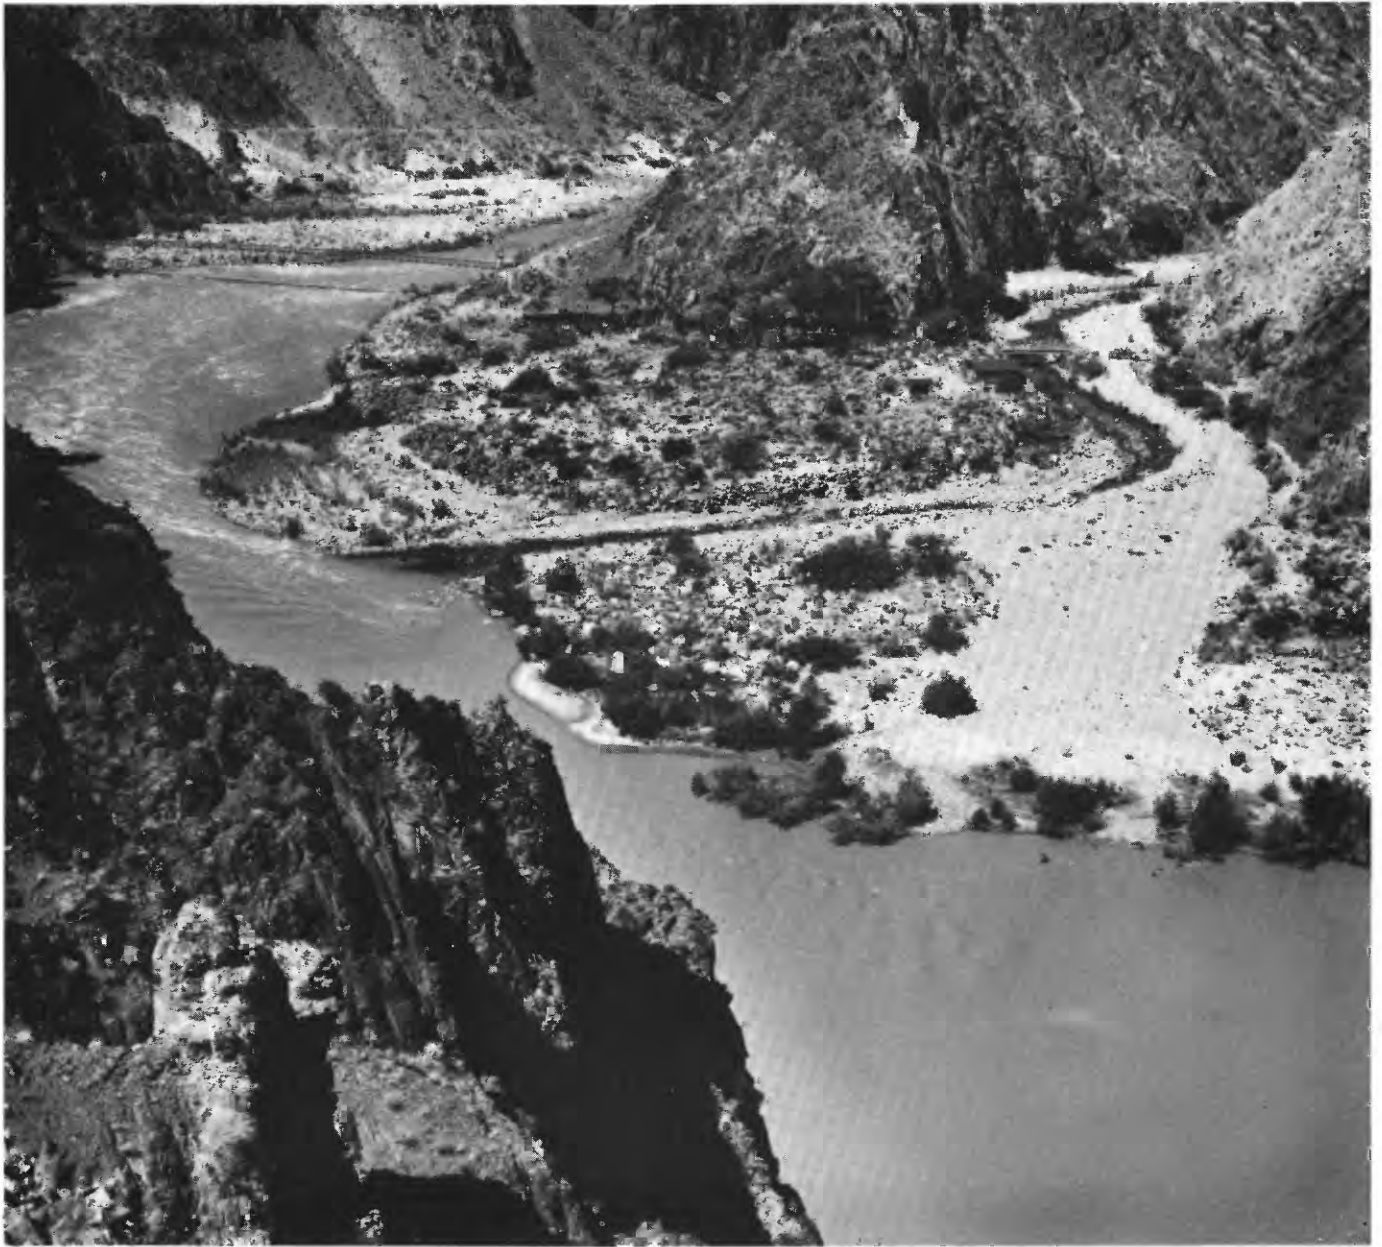
FIGURE 50C.—(1972). In the 9 years since the previous photograph was taken many new features are apparent. In December 1966, record flooding occurred in the Bright Angel watershed and the creek left the old channel, flowing across the debris fan toward the camera point. Boulders in the path of the flood were removed from the fan (or covered?) and finer material was deposited in their place. In the absence of subsequent flooding along the Colorado River, this area has remained free of boulders. The bridge across the Colorado River on the left was built in 1967 and is used as a foot bridge. The bridge also supports a pipeline carrying water from the upper reaches of Bright Angel Creek to the south rim. The cottonwoods at midview have declined as have the mesquites on the right (between the bare fan and the trail above). Plants now occupying the debris fan near the edge of the water include sandbar willow, saltcedar, and several Fremont cottonwood saplings. The fan was visited in May 1978. Beavers had cut the sapling cottonwoods, but the trees had produced multiple basal spouts.

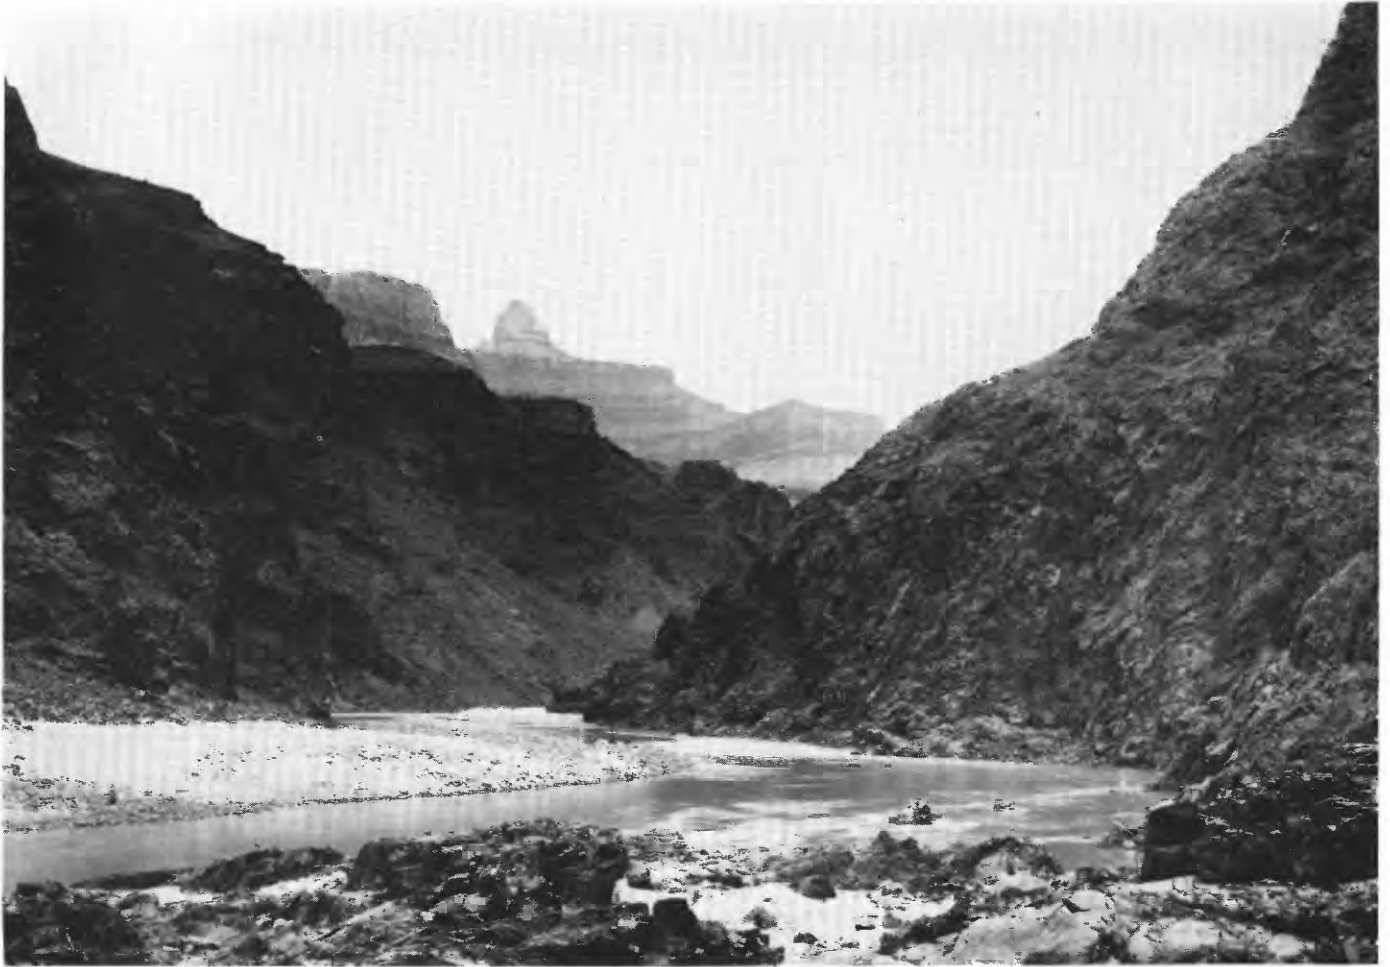
FIGURE 51A.—(1903). Bright Angel Trail reaches the Colorado River at the mouth of Pipe Creek (kilometer 143.1), the point from which this upstream view was taken. The floor of the canyon is devoid of plants. In the vicinity of the camera station, the only apparent features near the river are sand, cobbles, and consolidated rocks. (Altitude 732 meters.)

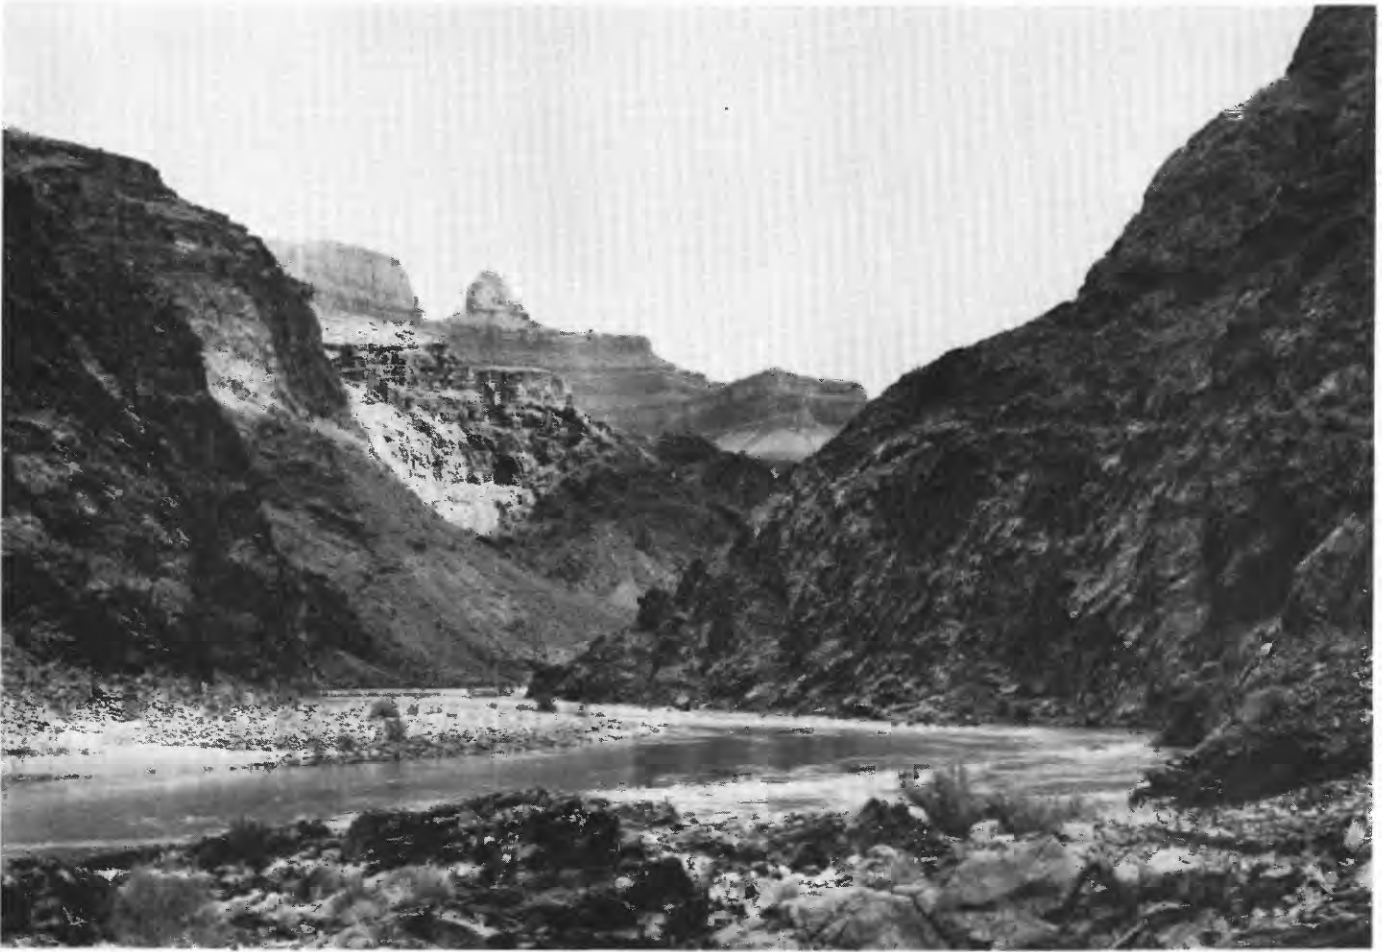
FIGURE 51B.—(1976). The sand deposits seen in the earlier view are largely gone and a few plants have become established along the river banks. The route of a trail cut through the Precambrian Vishnu Schist in 1936 (Hughes, 1967) can be seen above to the right. A large rock block, present in the earlier picture near the river at right, has fallen. It may have been displaced by falling rubble at the time of trail construction. Although not seen in this view, high water levels of predam time are expressed as sand and coarse gravel plastered against the canyon walls 12 to 18 meters above the river (Hamblin and Rigby, 1969).

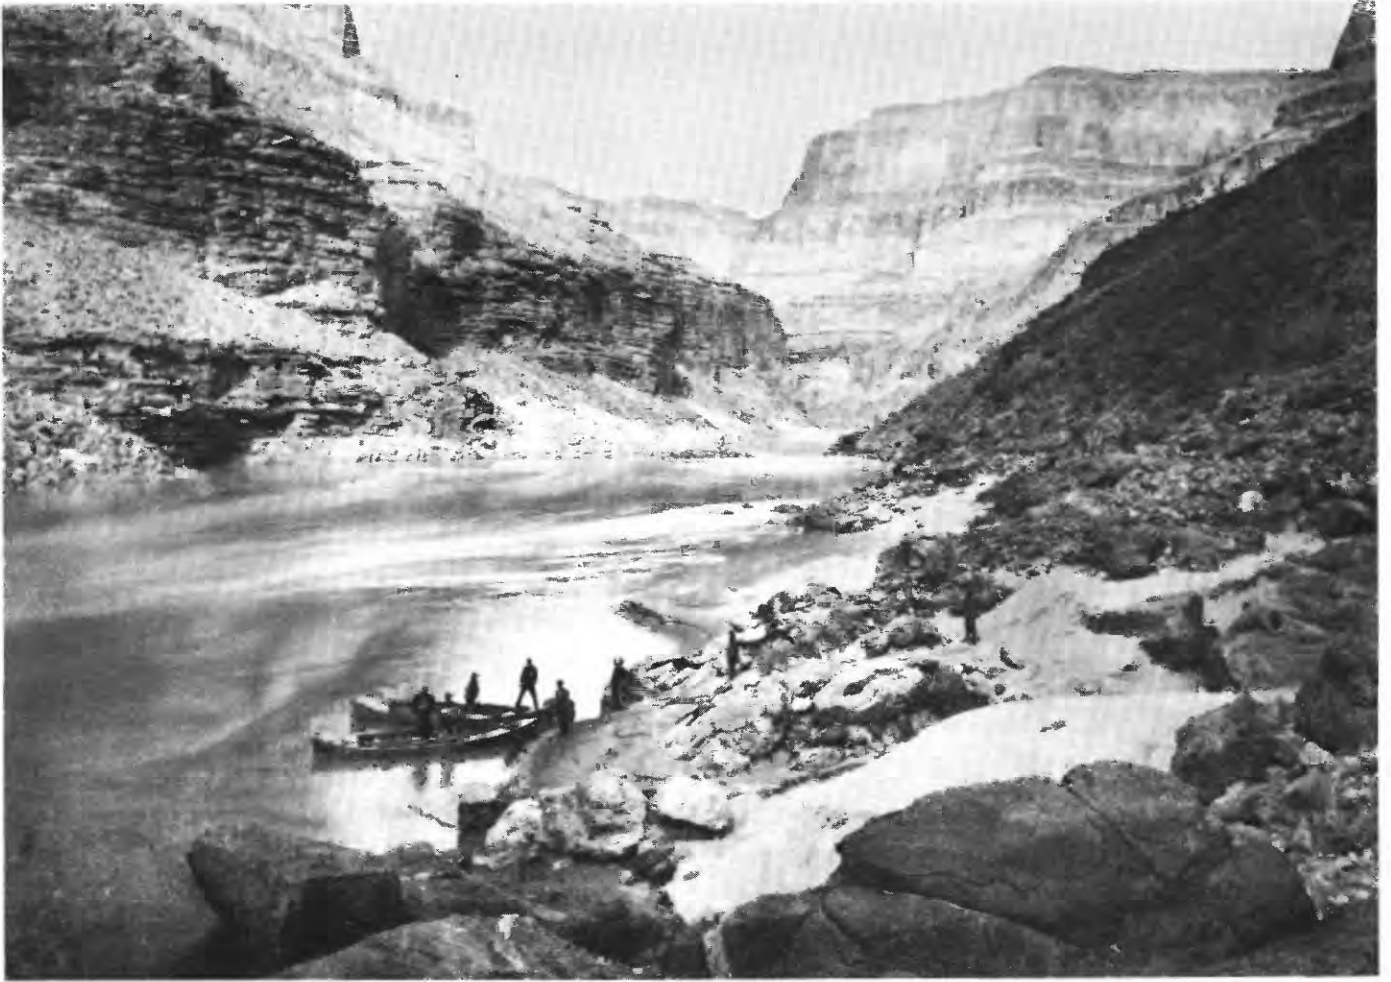
FIGURE 53A.—(1890). The three boats of the Stanton Survey party are tied up at a small sandy beach 185.8 kilometers below Lees Ferry. This upstream view shows the well-bedded Lower and Middle Cambrian Tapeats Sandstone at river level again, having been at varying elevations above the river since roughly the mouth of the Little Colorado River (fig. 45). Sand deposits near the camera station and upstream on the opposite bank have been left by high flows. No plants are established below the upper edge of these deposits. (Altitude 645 meters.)

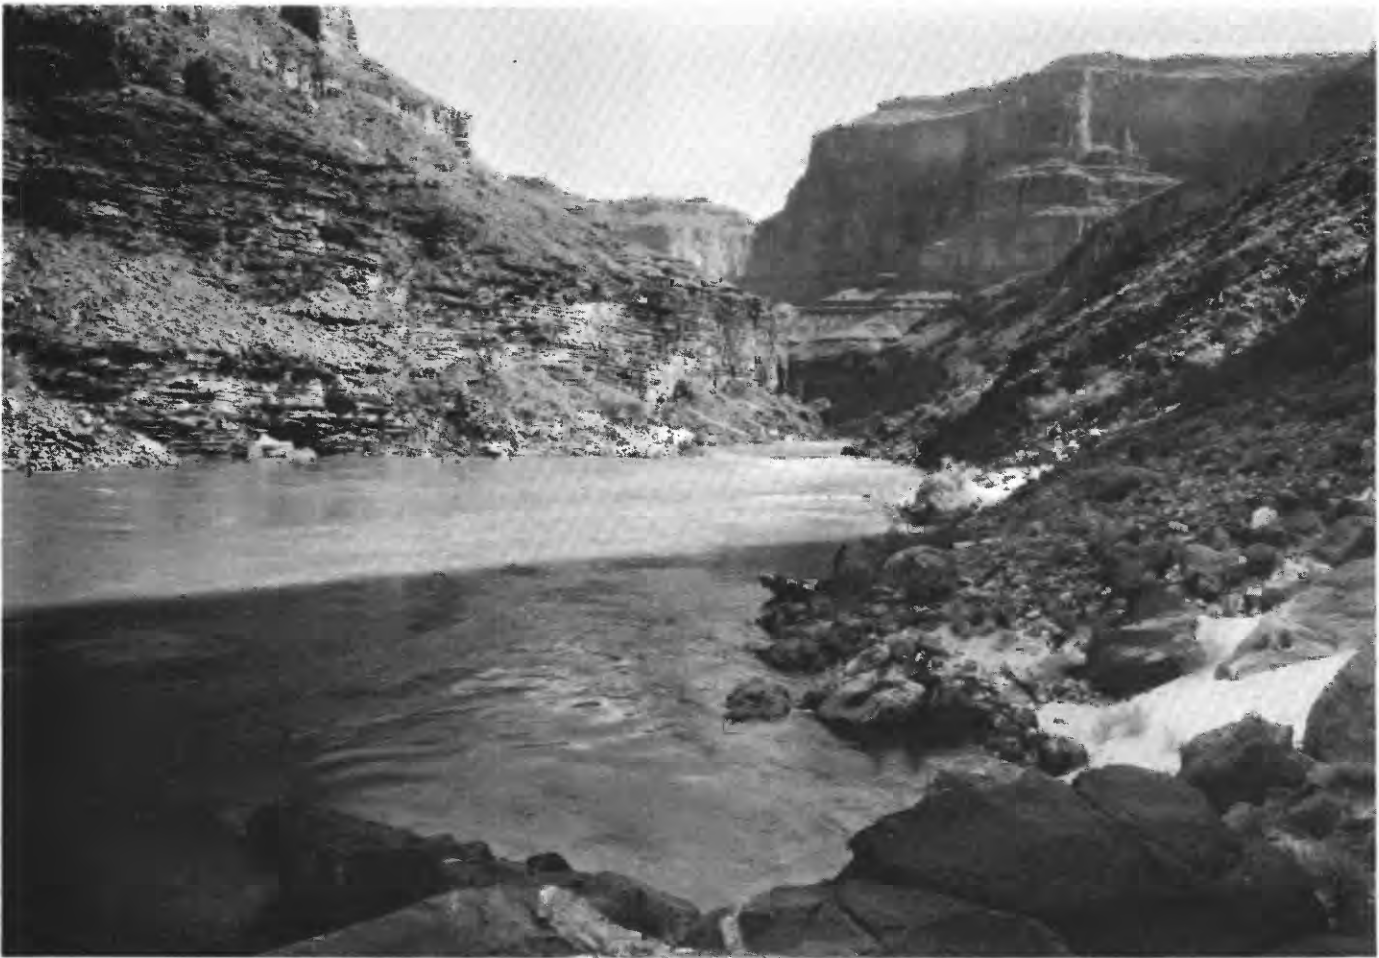
FIGURE 53B.—(1976). The river is at higher stage now than in the earlier view but loss of much of the higher sand deposits is evident. A few plants of *dicoria* occur on the sand. Saltcedar is perhaps 3-4 meters tall where it grows in scattered pockets near the edge of the river.

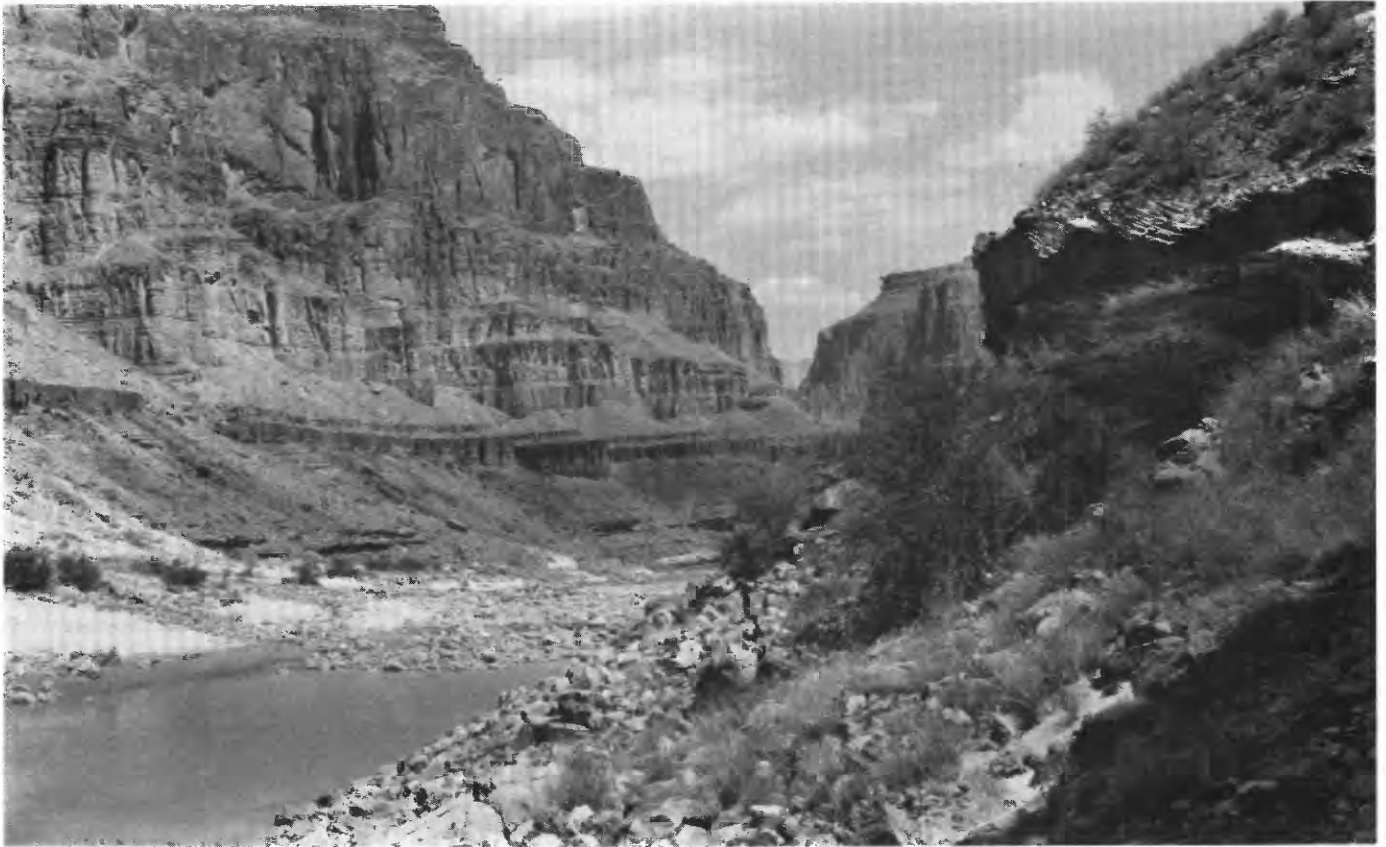
FIGURE 54A.—(1923). This downstream view shows the debris fan at the mouth of Fossil Canyon (out of view on left), 200.8 kilometers below Lees Ferry. The Middle Cambrian Bright Angel Shale is exposed near river level through this reach of the canyon, although it is mostly covered by slope wash. A line of scattered shrubs marks the high water line above the barren beach of rocks and patches of sand. (Altitude 623 meters.)

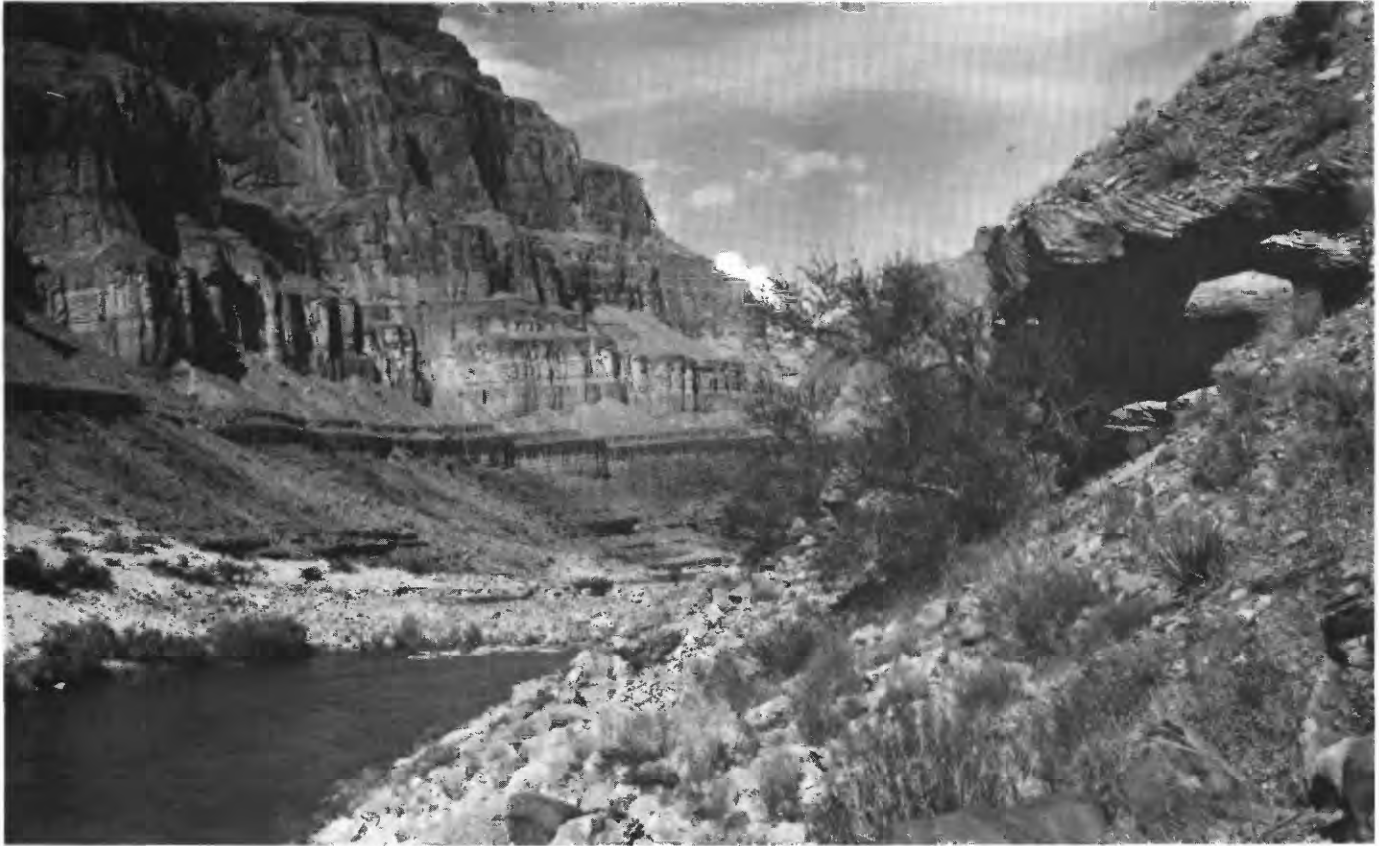
FIGURE 54B.—(1976). The line of shrubs seen in the previous view is composed of catclaw and appears to be little changed. Both views were taken in September, a month when the shrubs are in full leaf. The camera is too far back for an exact match. The catclaw right of center has grown in size. The herbaceous plants of the foreground slope are approximately as dense now as in 1923. This camera station is on a well-travelled burro trail. Saltcedar grows densely along sandy stretches on the opposite bank and long-leaf brickellia grows in an open stand on the rocky areas. The sand deposits on the opposite bank are less thick than in 1923.

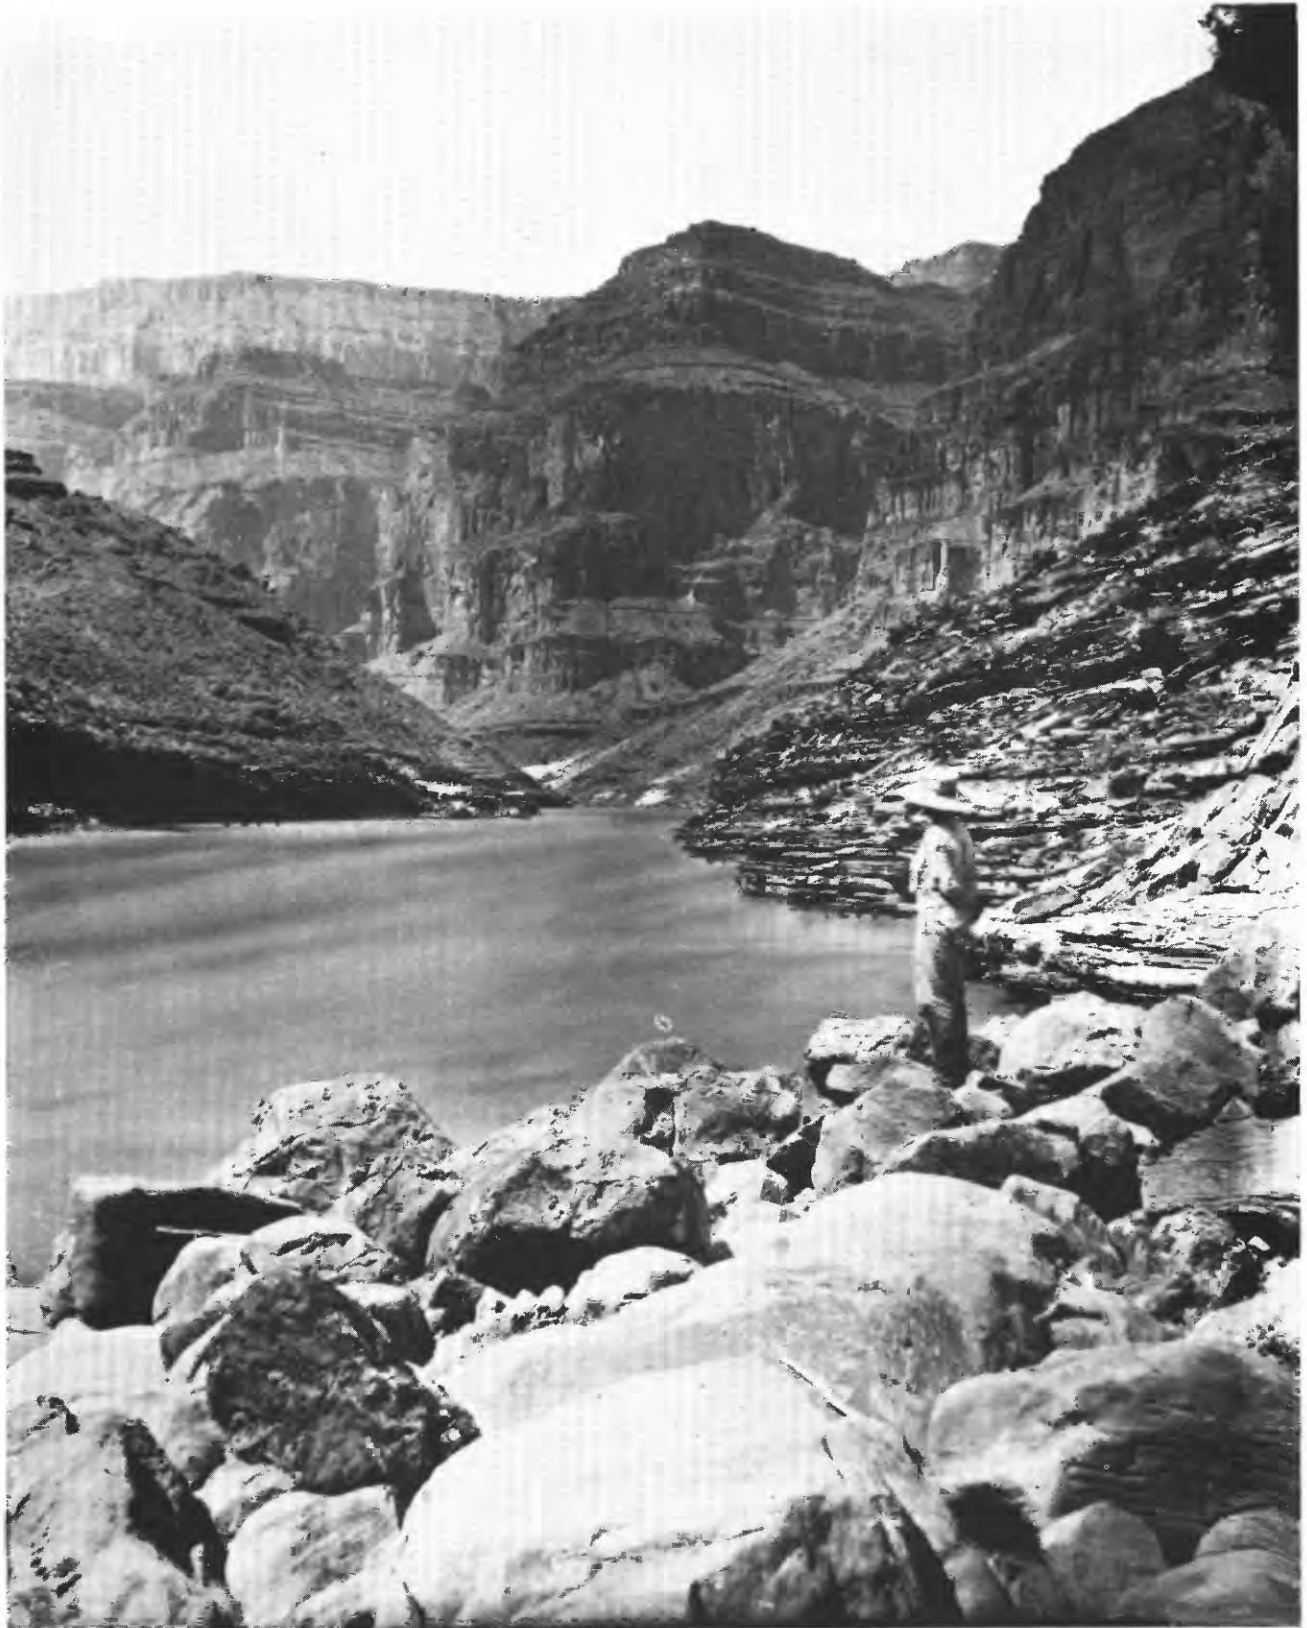
FIGURE 55A.—(1872). A. H. Thompson, who was in charge of topographical work on Powell's second expedition (Dellenbaugh, 1908; Bartlett, 1962), was photographed looking upstream from the left bank a short distance below Fossil Canyon at the head of the Middle Granite Gorge, 202.7 kilometers below Lees Ferry. The Lower and Middle Cambrian Tapeats Sandstone forms a shallow inner gorge here. There is no observable vegetation on the pile of boulders in the foreground. (Altitude 619 meters.)

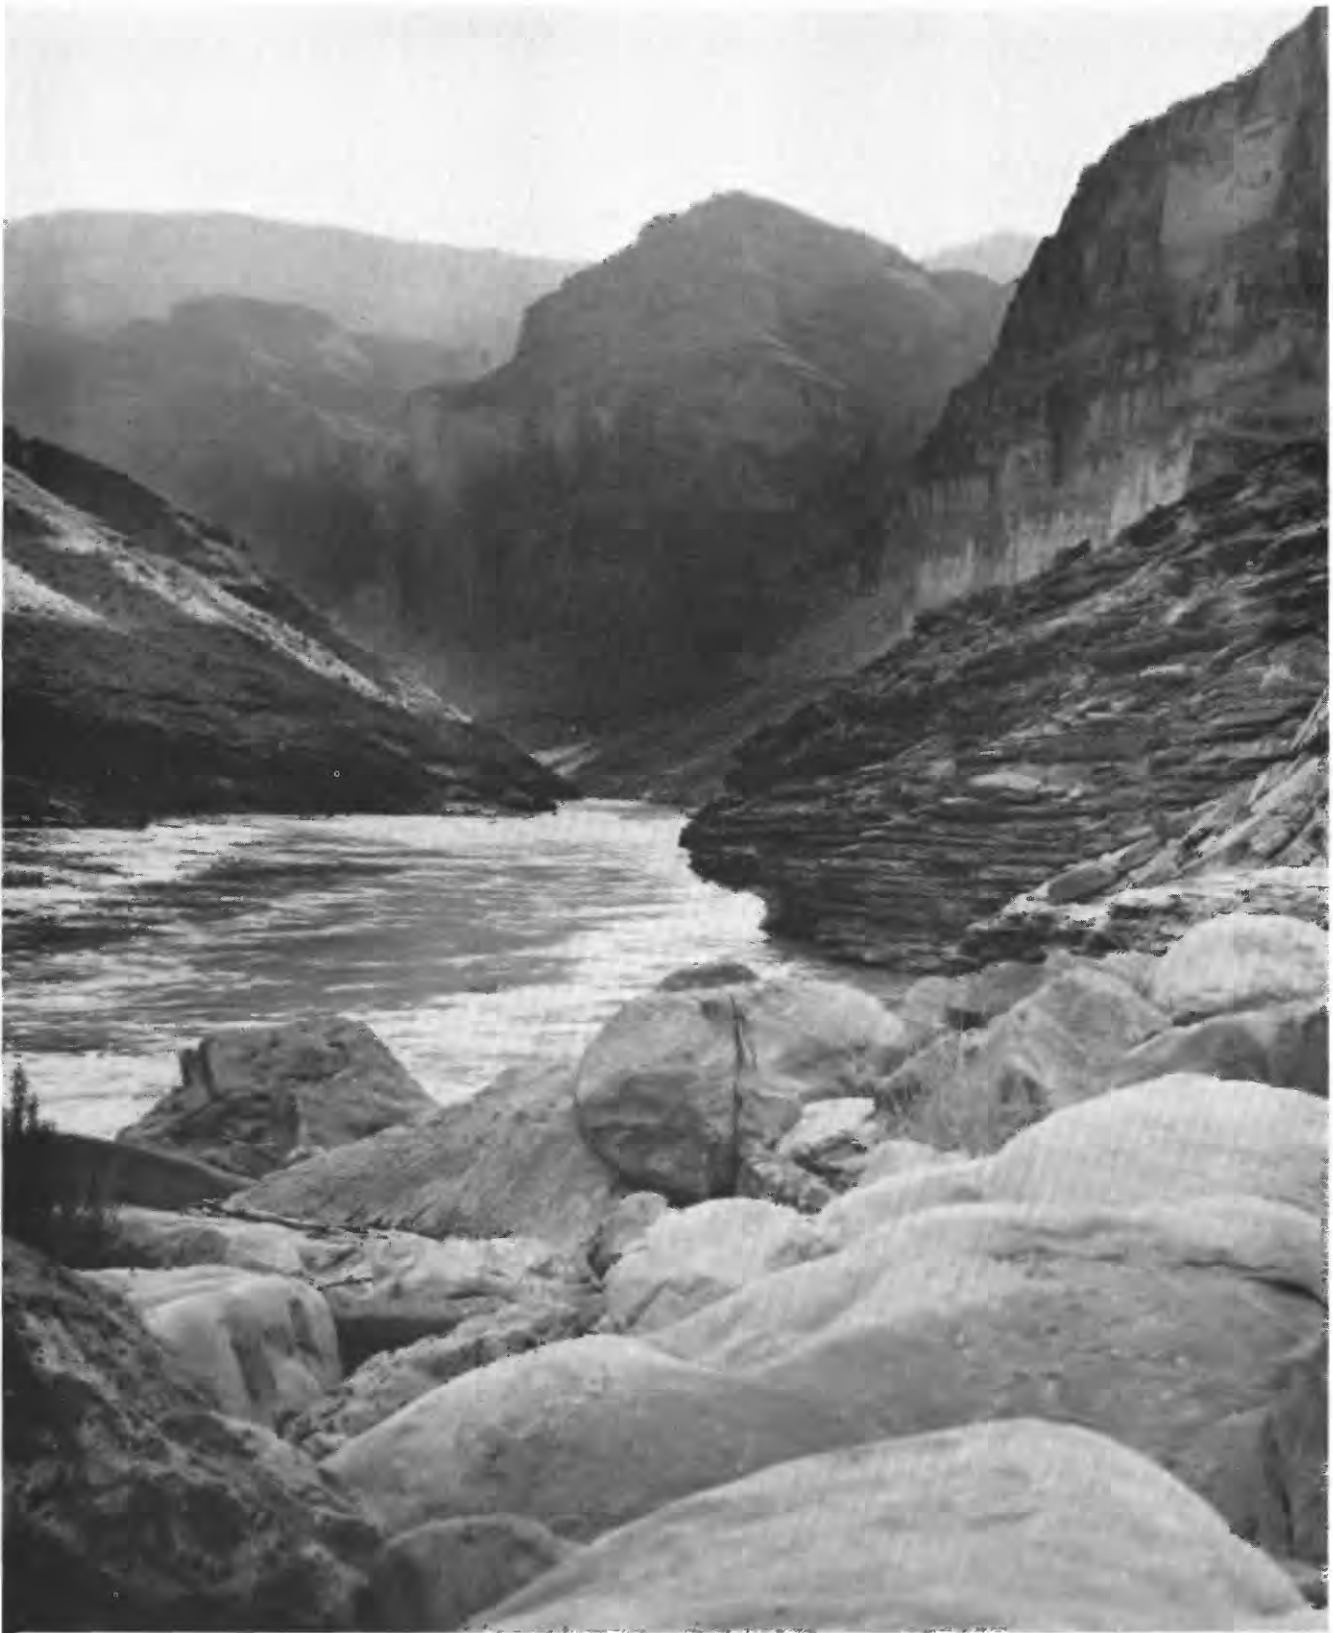
FIGURE 55B.—(1974). Although the photograph is not an exact match, one can easily see that the configuration of the pile of boulders has changed little, if at all. After 102 years, such plants as dropseed, seep willow, and saltcedar have become established among the large rocks. The light colored sand deposits appear smaller now than before.

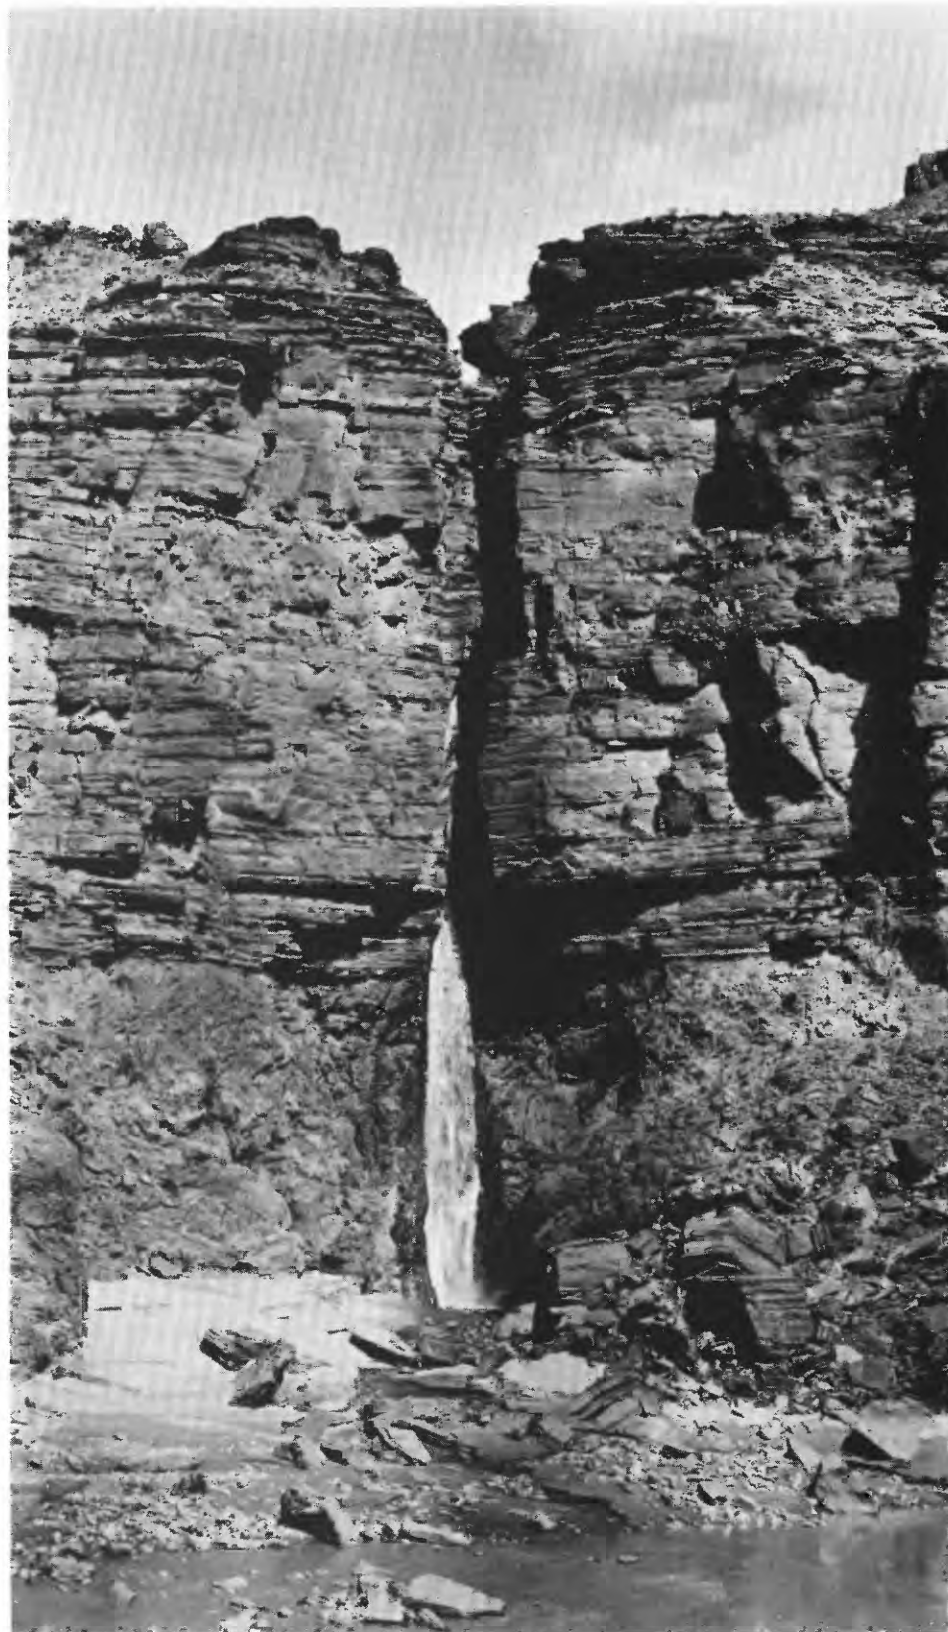
FIGURE 56A.—(1923). The water in Deer Creek plunges more than 30 meters through a slot cut in the Lower and Middle Cambrian Tapeats Sandstone just before entering the Colorado River, 219.1 kilometers below Lees Ferry. Angular blocks from the cliff face above lie on the banks of the river. The Colorado River flows from right to left in this picture. (Altitude 588 meters.)

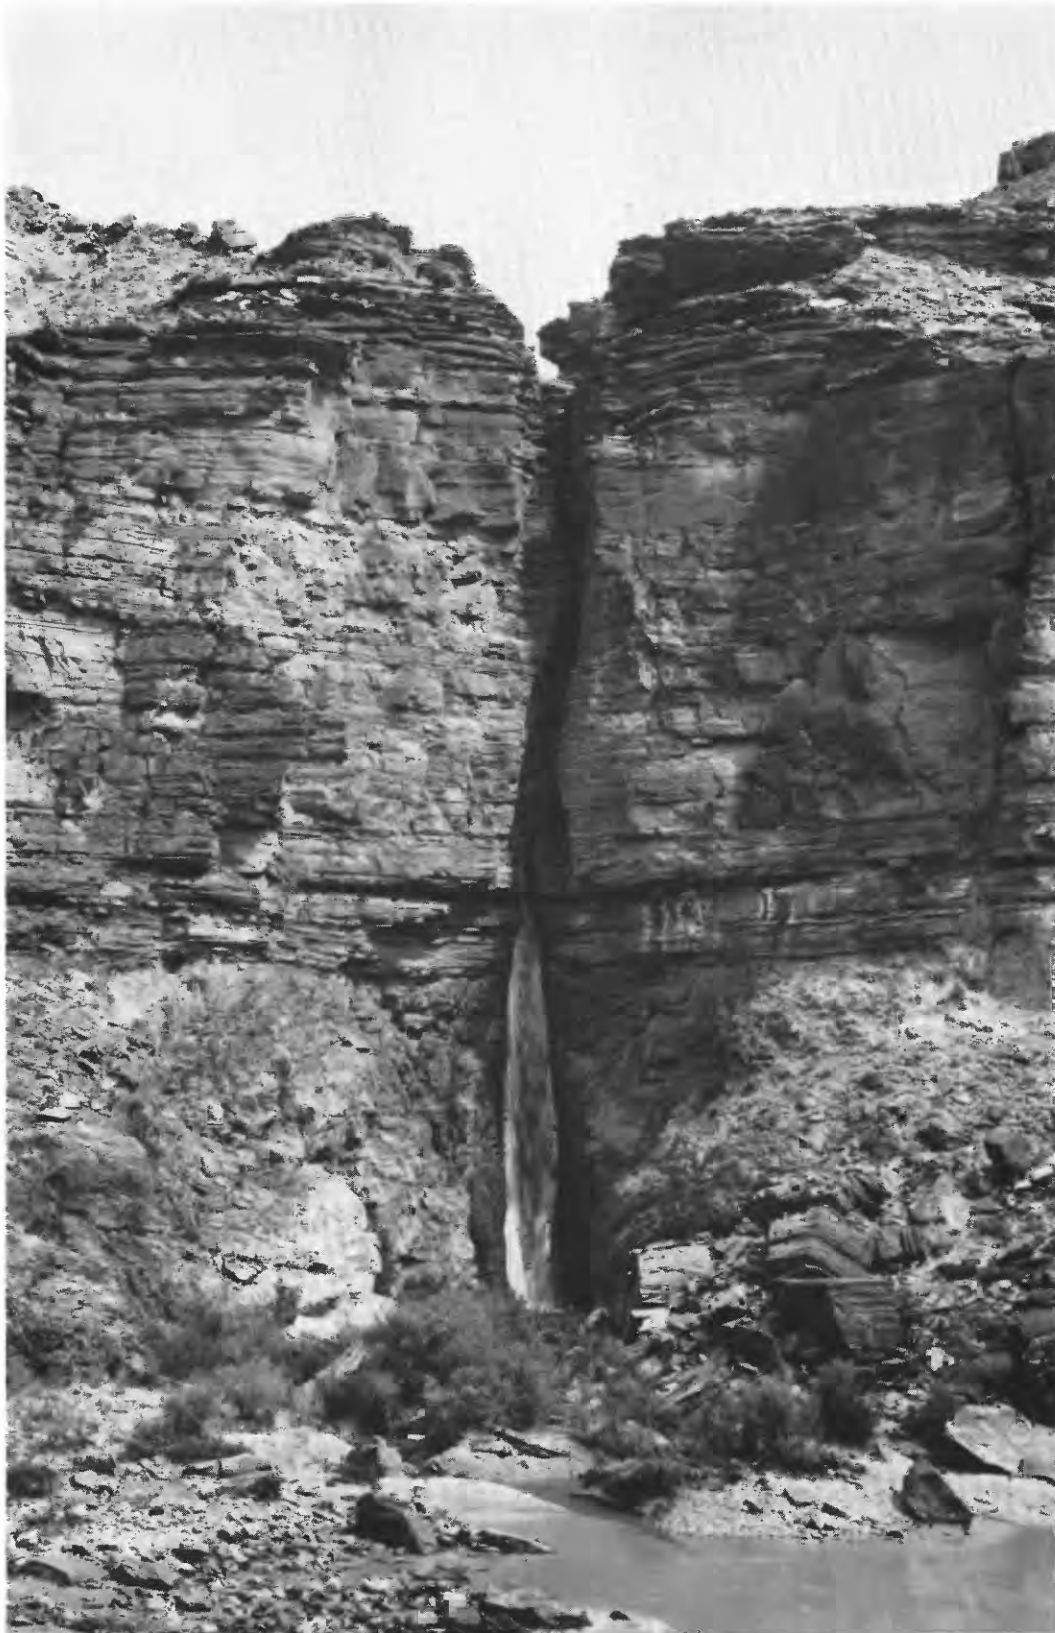
FIGURE 56B.—(1972). Few raft parties pass here without stopping: between 1963, when Glen Canyon Dam was completed, and August 1972, when this photograph was taken, an estimated 50,000 people had visited this site. Saltcedar, sandbar willow, and seep willow grow densely at the mouth of Deer Creek in spite of the heavy human impact. The large blocks and boulders have not changed noticeably but changes involving some of the smaller rocks along the beach are evident. The large sand deposit on the left in the old photograph is gone.

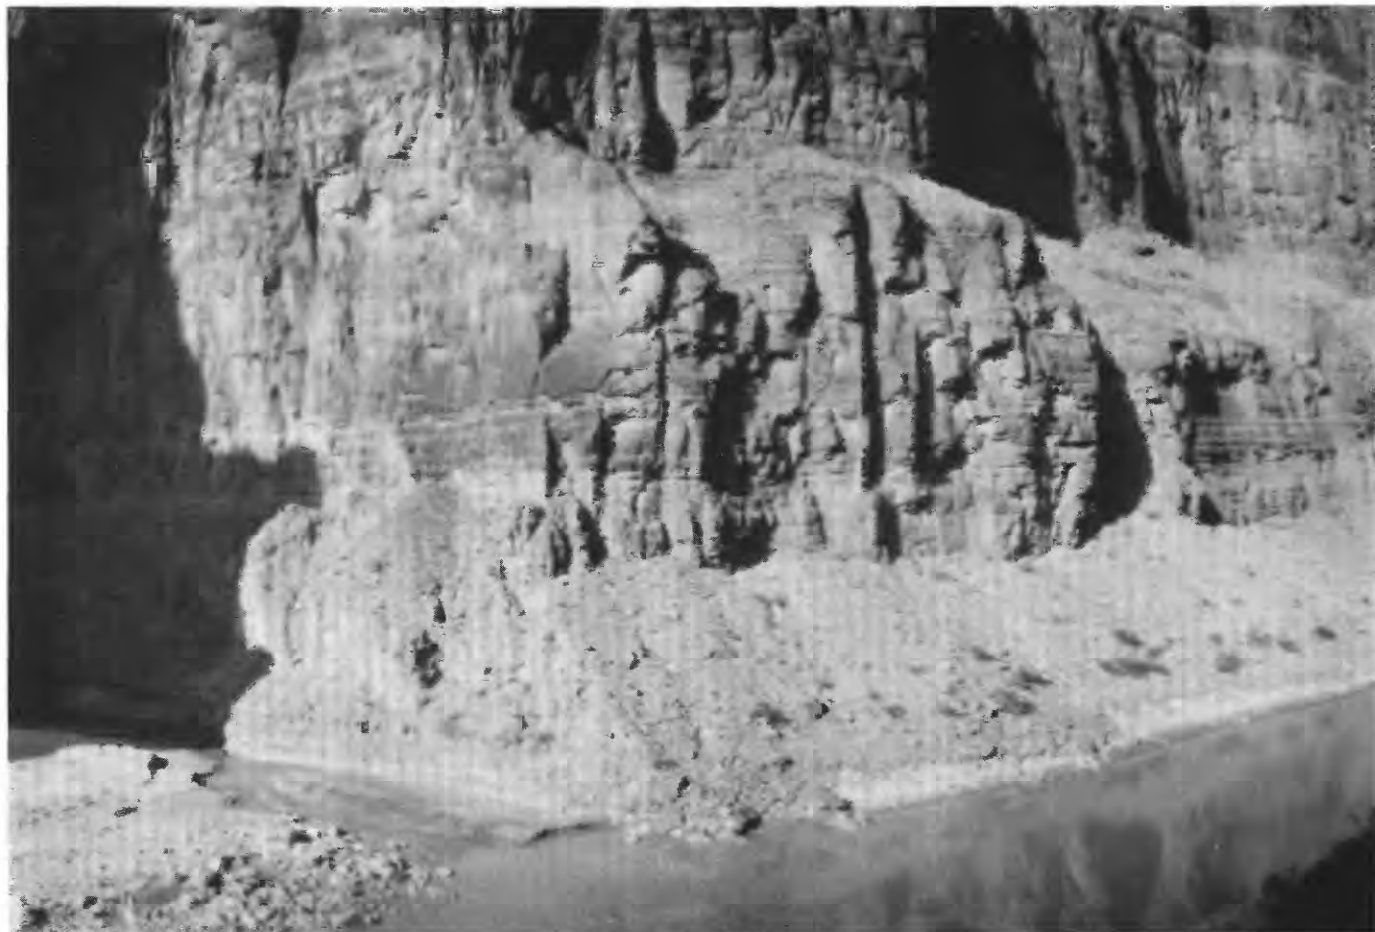
FIGURE 57A.—(1923). Kanab Creek (left foreground) enters the Colorado River 231.2 kilometers below Lees Ferry and is seen here from a camera station approximately 100 meters above the river. Powell ended his second trip here in 1872, leaving the Grand Canyon via Kanab Canyon. The Middle Cambrian Muav Limestone is exposed at the entrance to Kanab Canyon, with Mississippian Redwall Limestone and Devonian Temple Butte Limestone forming the vertical walls above. The development of a well-defined row of shrubs above the position of maximum flood stage is the most conspicuous feature of the vegetation in this view. (Altitude 572 meters.)

On talus slopes clearly above the influence of predam flooding, the vegetation is remarkably stable. The photographs in this series do not support earlier conclusions (Clover and Jotter, 1944) that landslides made the talus slopes so unstable that a climax vegetation did not develop. From field observations and from the photographs, we judge that most talus is stable as is the vegetation it supports. Unstable talus is seen in figure 48 and a recent rock fall in figure 57B. In the many other views of talus, unstable surfaces are not evident.
