# Recent Vegetation Changes Along the Colorado River Between Glen Canyon Dam and Lake Mead, Arizona

GEOLOGICAL SURVEY PROFESSIONAL PAPER 1132

By RAYMOND M. TURNER *and* MARTIN M. KARPISCAK

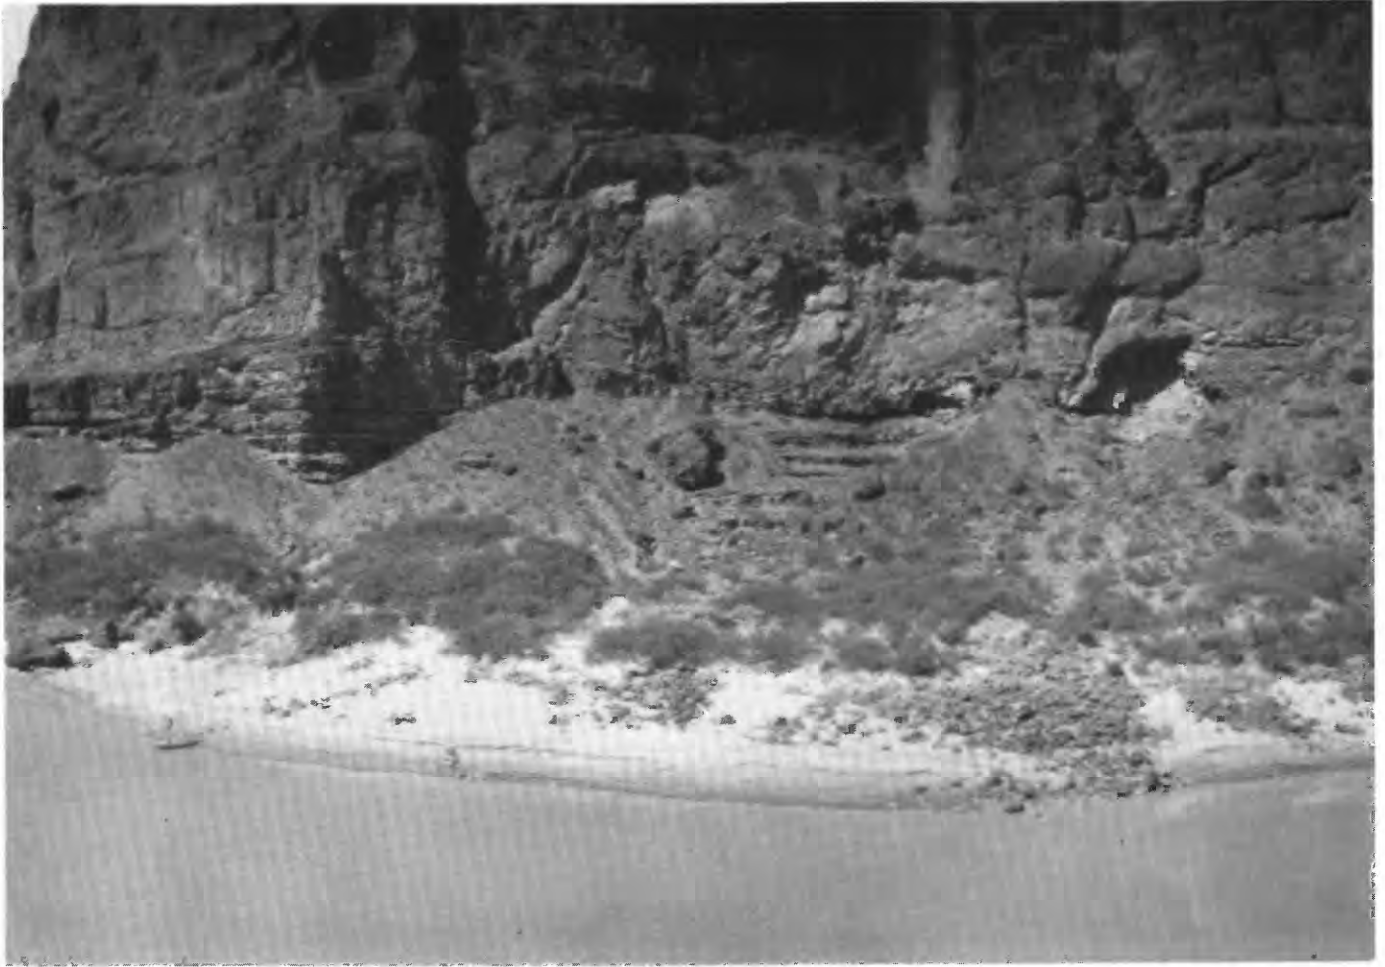
FIGURE 58A.—(1923). A bare skirt, several times wider than the length of the U. S. Geological Survey boat at left, is seen in this view of the right bank a short distance above Lava Falls, 287.4 kilometers below Lees Ferry. A dense shrub community occurs above the reach of flood water. (Altitude 511 meters.)

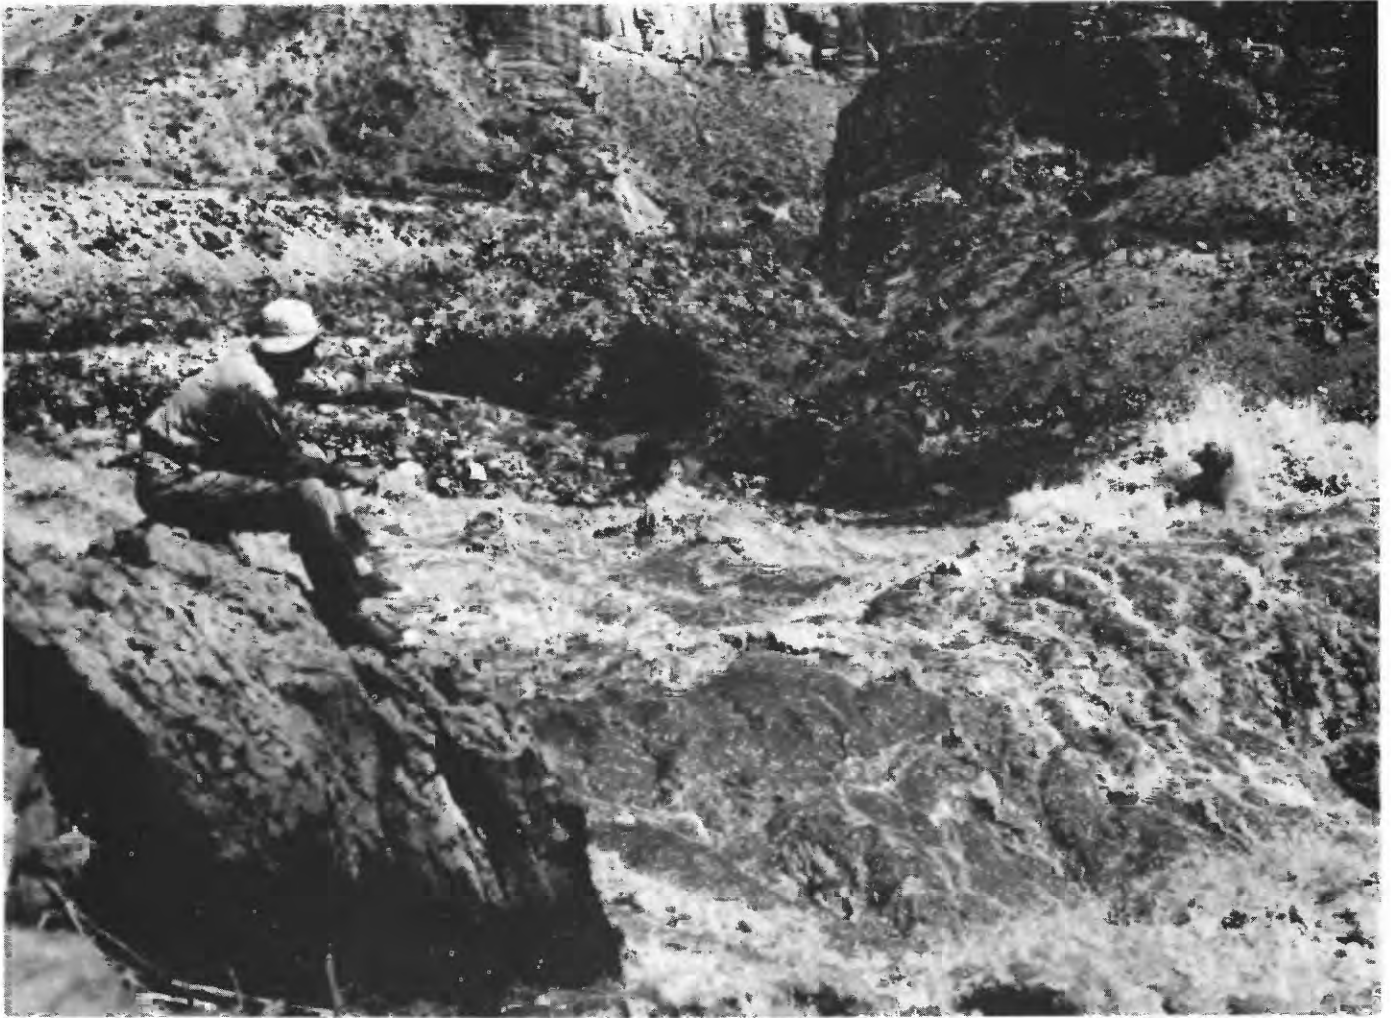
FIGURE 59A.—(1950). Most boatmen agree that Lava Falls Rapids, which lies 288.5 kilometers below Lees Ferry, represent the greatest hazard to navigation on the Colorado River. This remarkable photograph was taken of the rapids from the right bank looking toward the mouth of Prospect Canyon. Flow in the river was approximately  $1,473 \text{ m}^3/\text{s}$ . The great turbulence created when the water encounters erosional debris from Prospect Canyon is clearly seen in this photograph. The large dark shrubs in this view were still present in 1976 (fig. 59B) and are catclaw. Some of the shrubs on the opposite bank are desert broom. (Altitude 511 meters.)

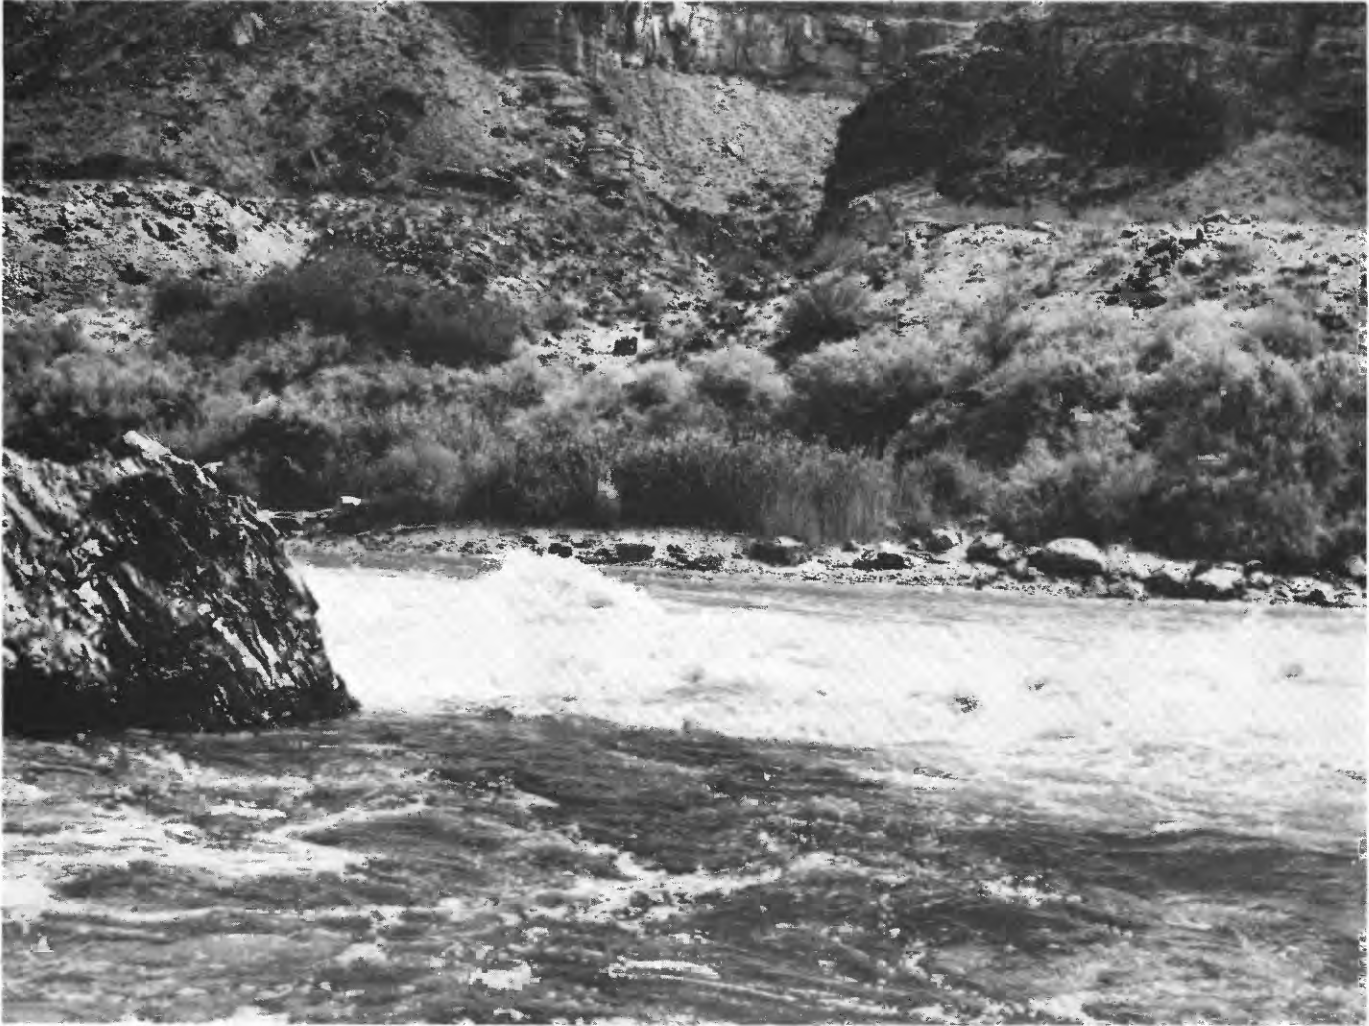
FIGURE 59B.—(1976). This photograph was taken from a slightly different position and at a time when the Colorado River was carrying only  $102 \text{ m}^3/\text{s}$ . There has been a notable biomass increase in the riparian community during the 26 years since the original photograph was taken. The erect, coarse grass at the mouth of Prospect Creek is carrizo. Other plants growing near the river include arrowweed, desert broom, cattail, saltcedar, and horseweed. On the dissected fan at the mouth of the canyon is creosote bush, catclaw, ocotillo, and barrel cactus. The last seems to have declined in number since 1950.

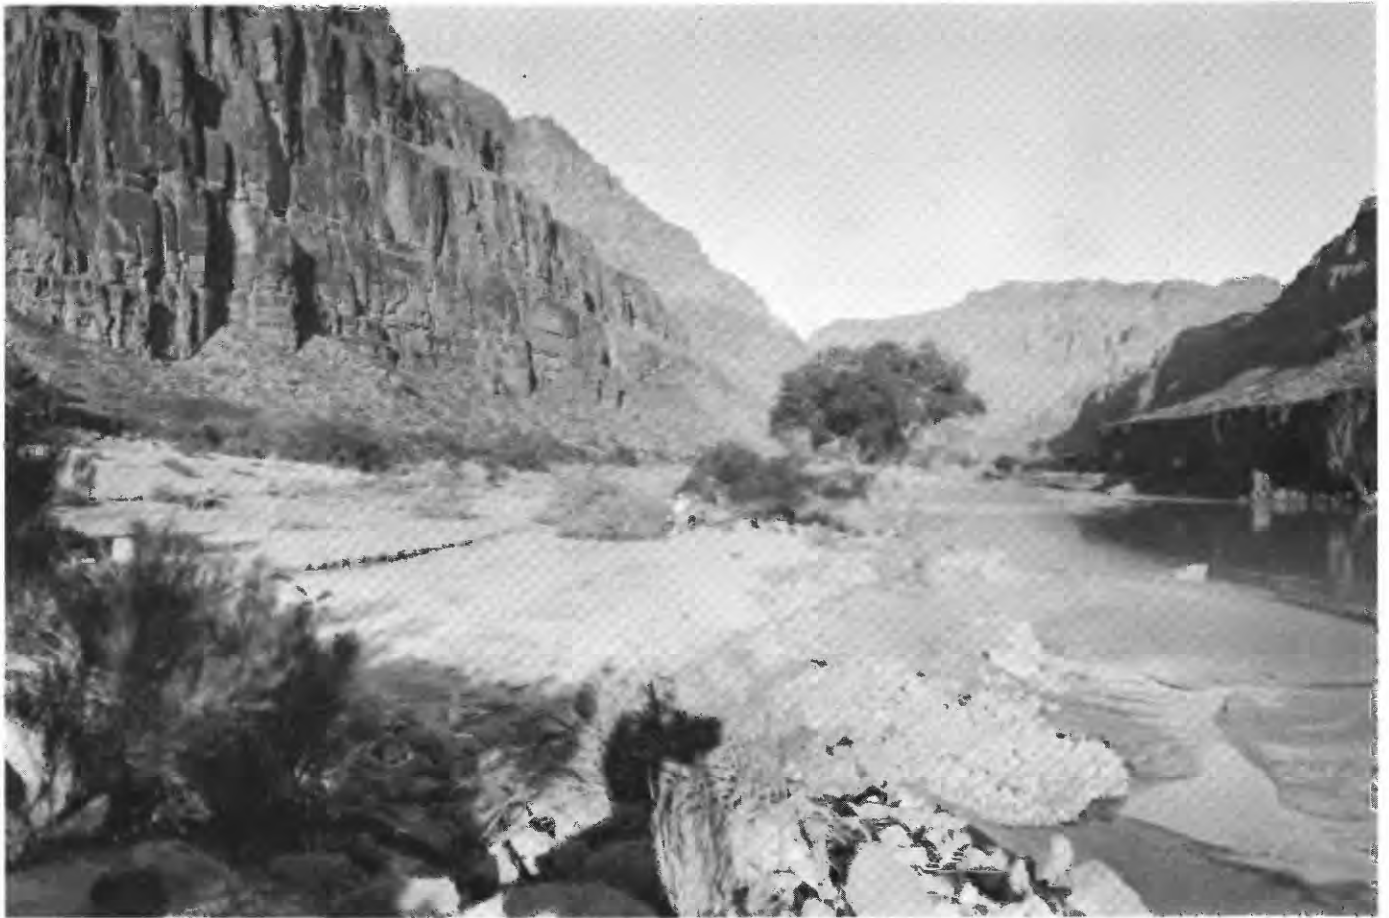
FIGURE 604.—(1923). This photograph was taken from the left bank 313.6 kilometers below Lees Ferry. A Quaternary basalt flow is seen at river level on the right. The canyon of the Colorado River is broad enough here so that the scouring action of flood waters is dampened and some perennial plants became established in the alluvium near the river. A flood, 6 days earlier, overtook the U.S. Geological Survey crew at Lava Falls, 25.1 kilometers upstream from here and the river stage increased by 6.7 meters (Freeman, 1930). The signs of recent wave action high on the beach in this photograph probably stem from the same flood. Several plants such as the tree (Fremont cottonwood or willow) at right midground, desert broom (left foreground), and what is probably saltbush (near the men), withstood these floodwaters. (Altitude 471 meters.)

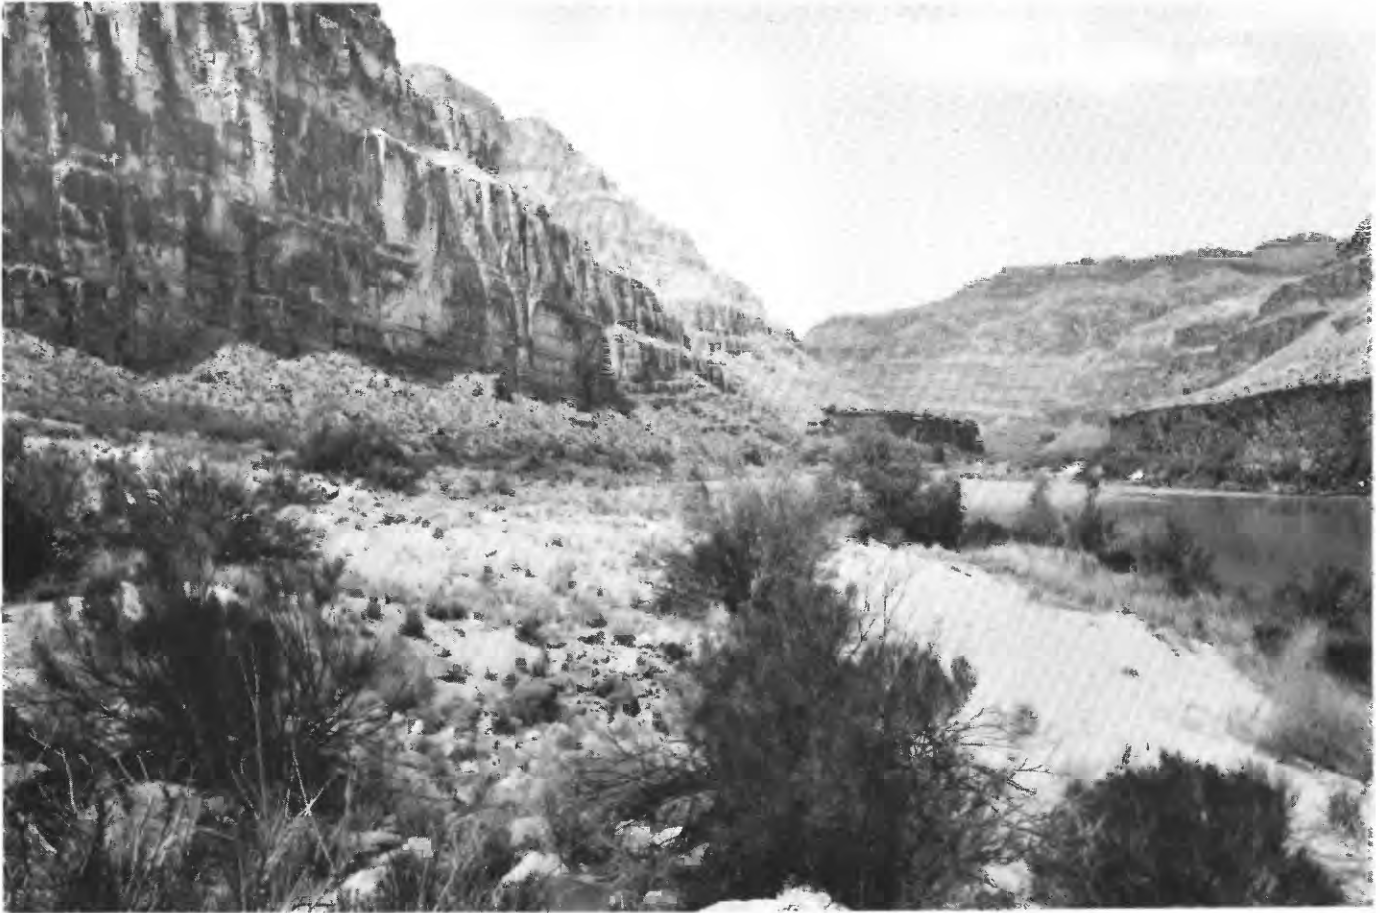
FIGURE 60B.—(1972). At the time of this photograph a Goodding willow was growing at the same location as the tree in the previous view. The present tree is smaller than the one in the earlier photograph. Either the original tree was broken and then resprouted or there is now a different tree growing in the same location. Desert broom is the dominant woody plant of the foreground beach. The grasses, which have increased notably over the beach area, will serve to stabilize the sandy soil of the beach. The new camera location closely matches the old, although the lack of stable foreground features precludes exactly matching the two views. An increase in sand deposition on the beach is obvious. The giant grass, carrizo, grows at the edge of the river with saltcedar.

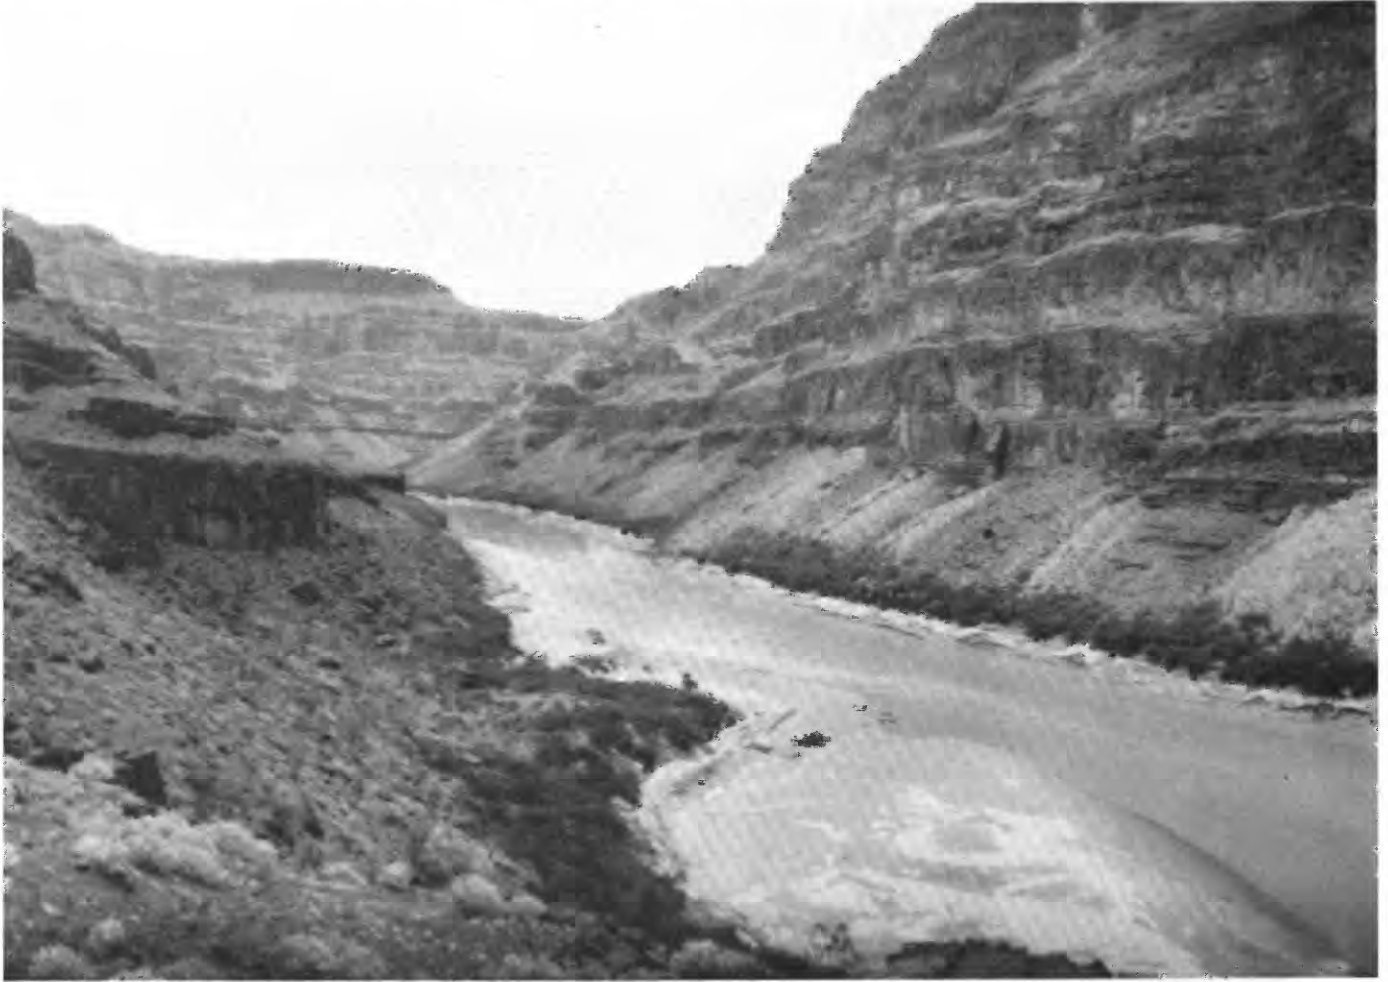
FIGURE 61A.—(1923). This upstream view was taken from a point just above Spring Canyon, 328.9 kilometers below Lees Ferry. The Middle Cambrian Bright Angel Shale, mostly covered by slope wash, is at river level. A well-developed community occurs above the flood line on both sides of the river. At the present river stage, a large bar, unoccupied by plants, is exposed. (Altitude 454 meters.)

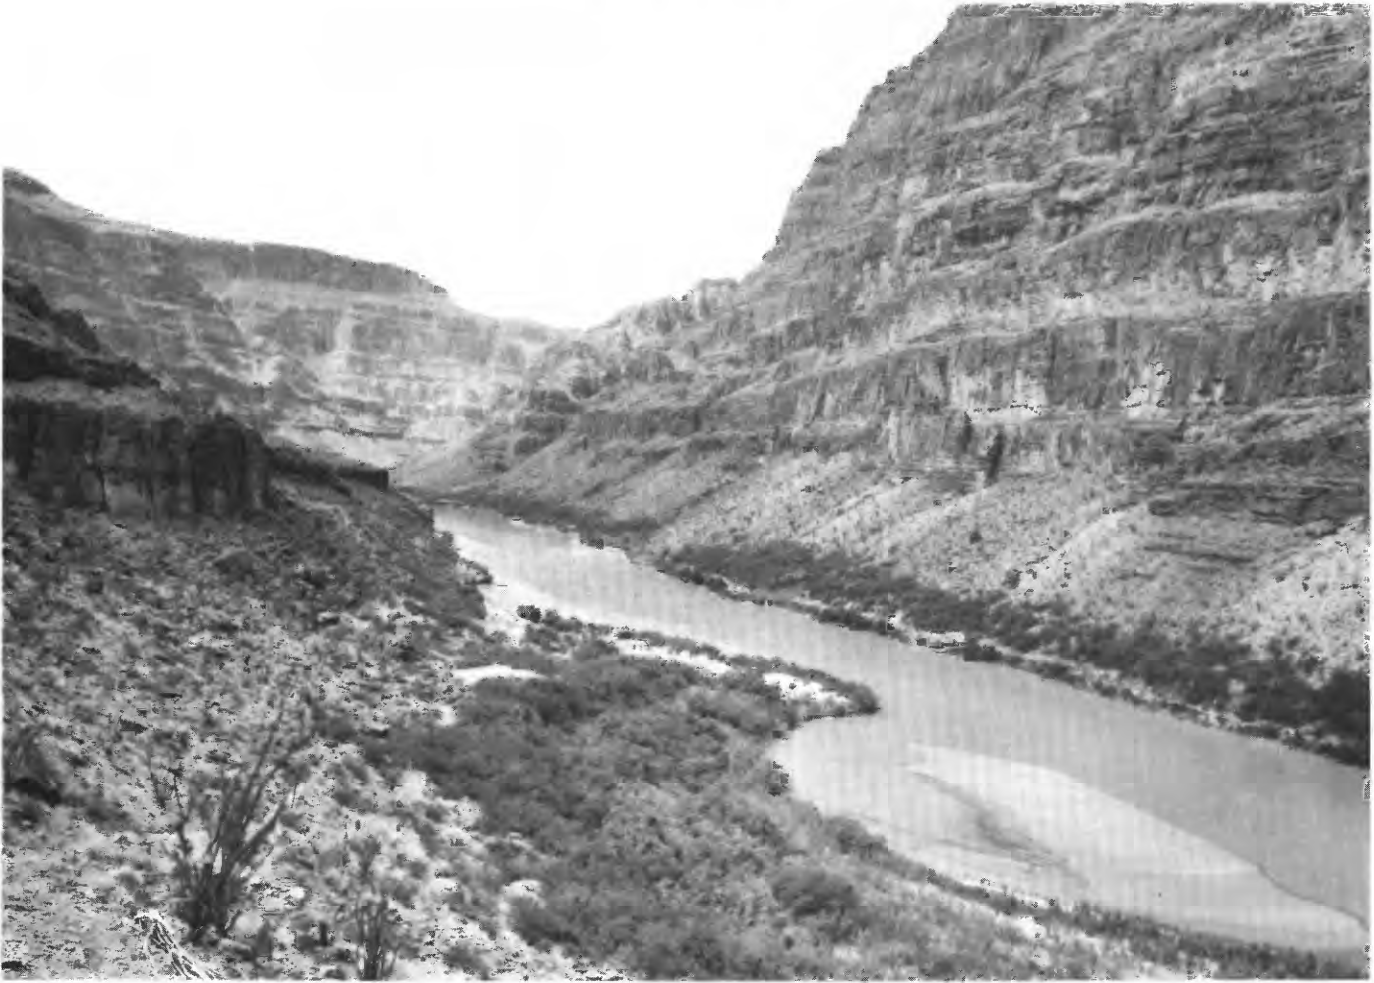
FIGURE 61B.—(1974). The camera station is too far forward and too far to the right for an exact match. The plants that now densely occupy the higher ground of the old bar include saltcedar, seep willow, desert broom, catclaw, arrowweed, and some large western honey mesquites. The present exposed bar is probably low enough to be inundated by the regular daily high flows. Because of the slightly darker tones of western honey mesquite and catclaw foliage compared to the color of the riparian plants, the contact between the old highwater community and the new riparian community is apparent. Across the river where the talus slopes have a northerly aspect, the highwater community is mostly western honey mesquite and catclaw. This elongate community appears slightly more open in 1974 (August) than in 1923 (September). The same highwater community below the camera station has a southerly aspect, and four species share dominance: western honey mesquite, wolfberry, creosote bush, and catclaw. On the slope in the foreground is Mohave Desertscrub vegetation comprising ocotillo, brittlebush, creosote bush, Mormon tea, and barrel cactus.

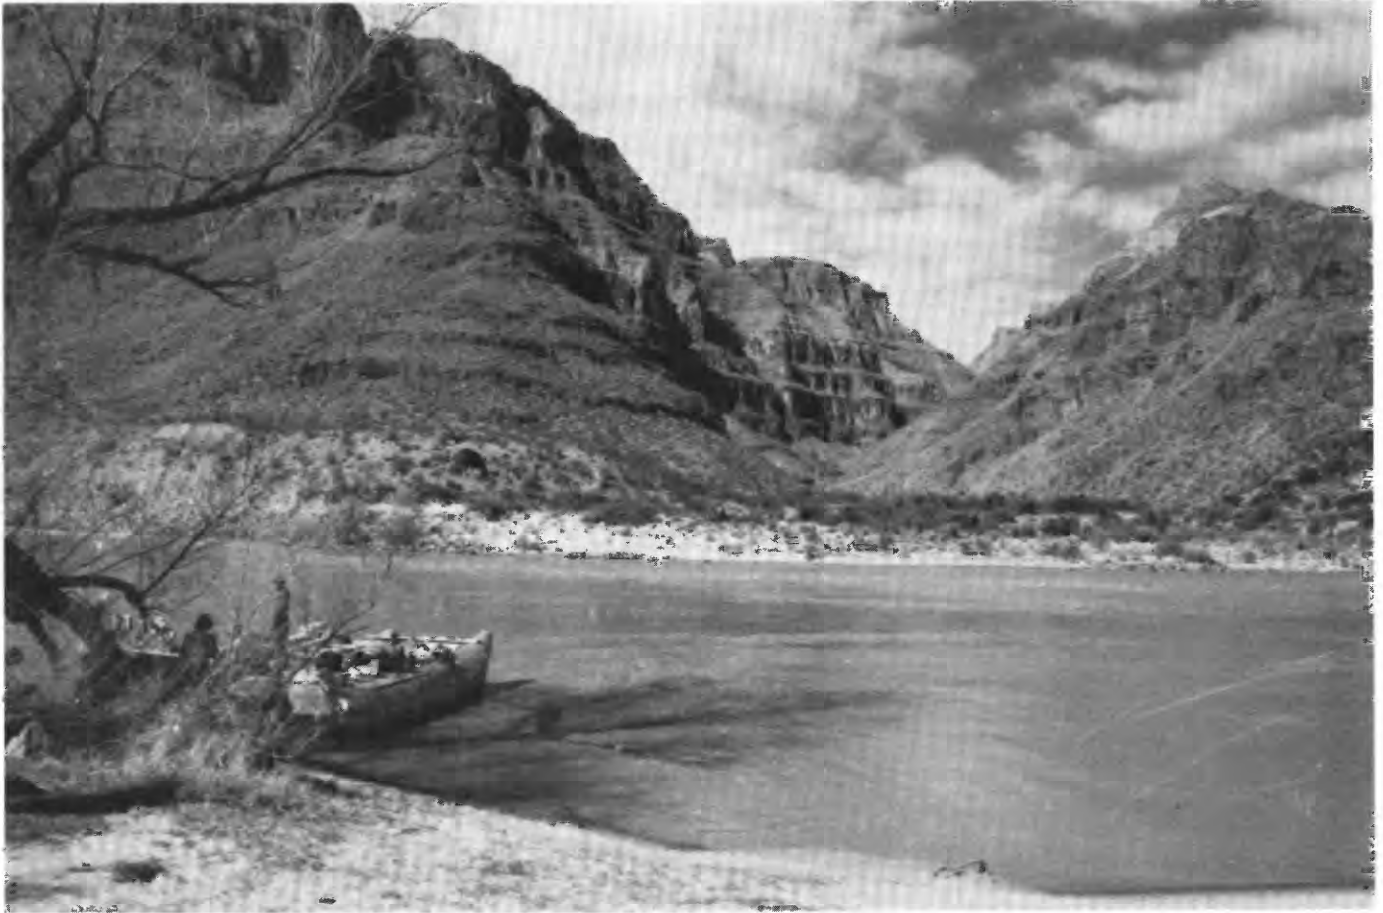
FIGURE 62A. —(1923). The mouth of Two Hundred and Ninemile Canyon is seen across the river from this camera station in a small cove at Granite Park, 336 kilometers below Lees Ferry. The first cliffs above the river to the right of the canyon mouth are remnants of a basalt flow and are preserved here, as elsewhere along this reach of the Grand Canyon on the inside of a meander bend. The willow at left is one of those seen from a distant hill in figure 644. Once these plants have developed a large enough root system, they withstand considerable buffeting by floods in the broad valley at Granite Park. A well-developed flood-line community can be seen across the river at the mouth of Two Hundred and Ninemile Canyon. (Altitude 442 meters.)

The only large willow growing along the Colorado River below Glen Canyon Dam is Goodding willow (pl. 3, fig. 25). Clover and Jotter (1944, p. 602) observed that willows in the lower part of the Grand Canyon "became so well established in some locations as to attain a height of thirty or forty feet." The few places that tree willows appear in predam photographs are from the lower part of the Grand Canyon (figs. 62A, 63A, and 66A).

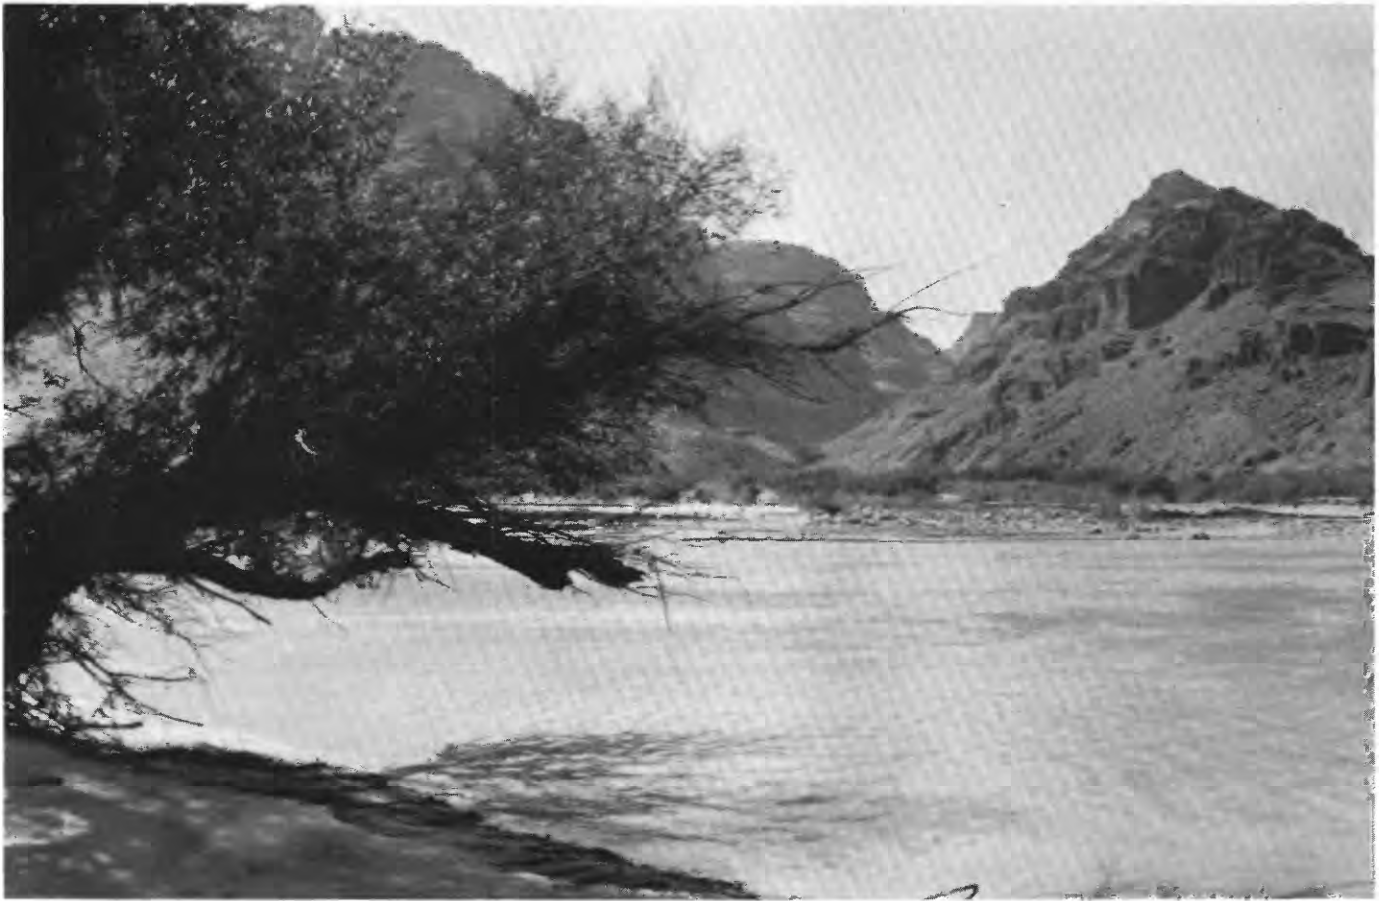
FIGURE 62B.—(1974). Because the old camera station is now overgrown by saltcedar and desert broom, this photograph was taken from a slightly different location than in 1923. The tree at left is Goodding willow and is the same plant as in the earlier view. Bermuda grass now grows on the beach near the tree. The flood-line community at the mouth of Two Hundred and Ninemile Canyon comprises western honey mesquite and catclaw. Although not evident in the photograph, close field inspection revealed that both species, trimmed through grazing by burros, are infested by mistletoe.

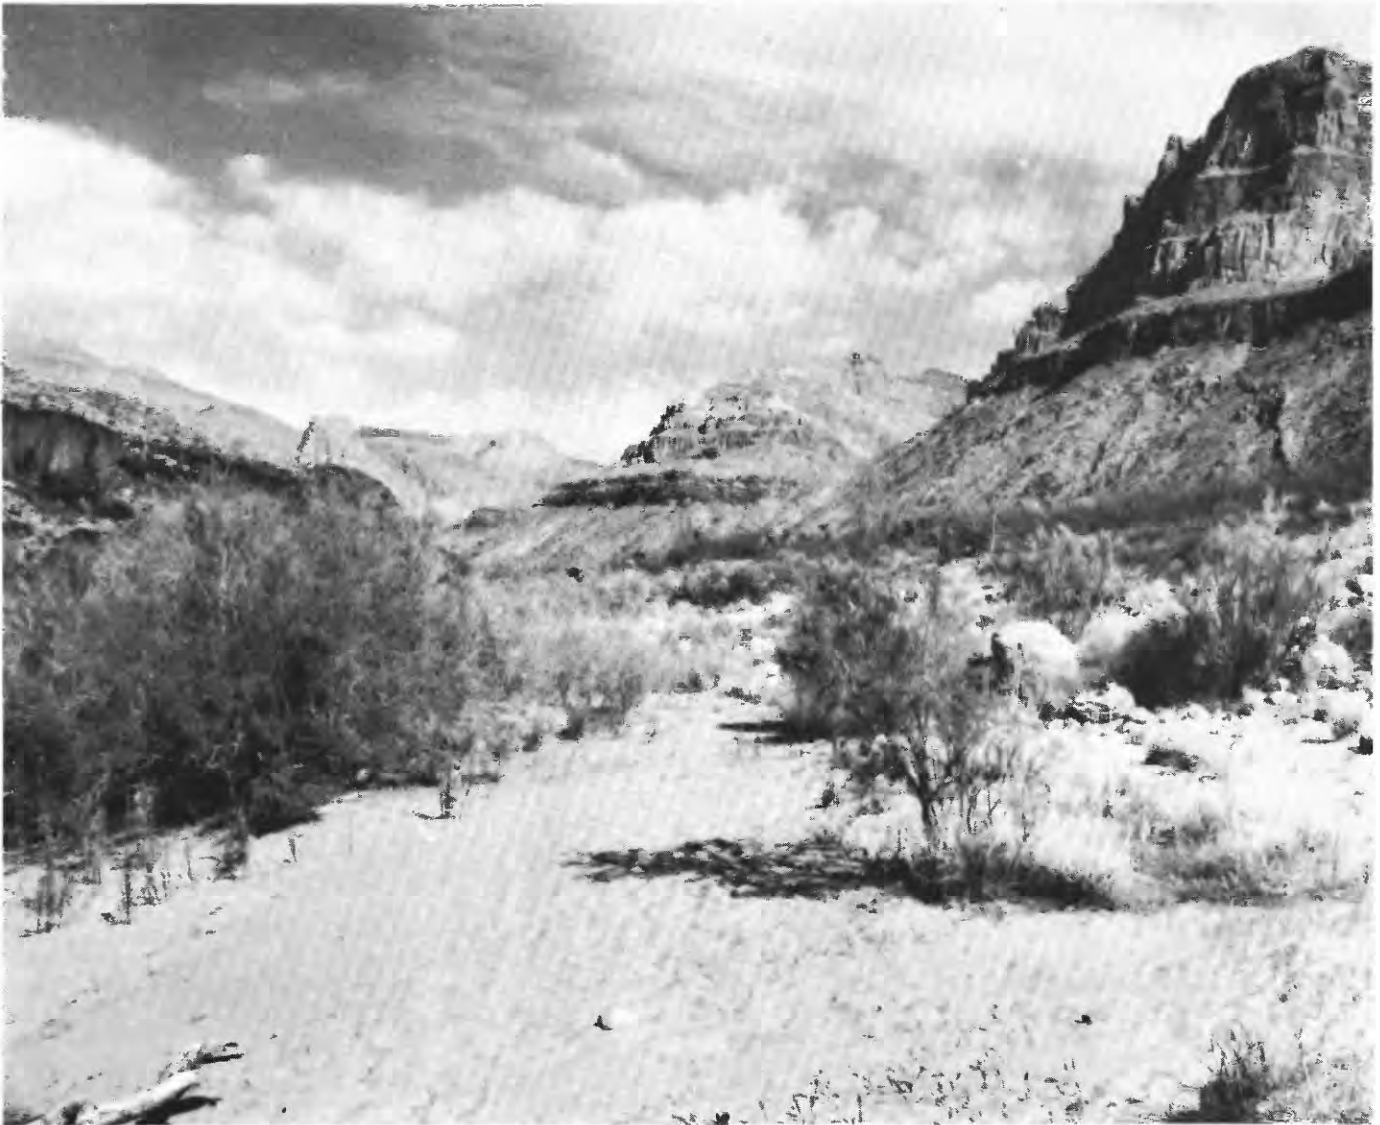
FIGURE 63B.—(1974). The clump of large shrubs seen near the boats in the previous view are gone and have been replaced by a few small Goodding willows which are obscured by the more abundant saltcedar. The band of arrowweed has expanded and now occupies, with desert broom, the sandy beach between the saltcedar fringe along the river and the scarp below the first terrace. On the terrace, the dark shrubs of the old flood-line community are mainly western honey mesquite with some catclaw.

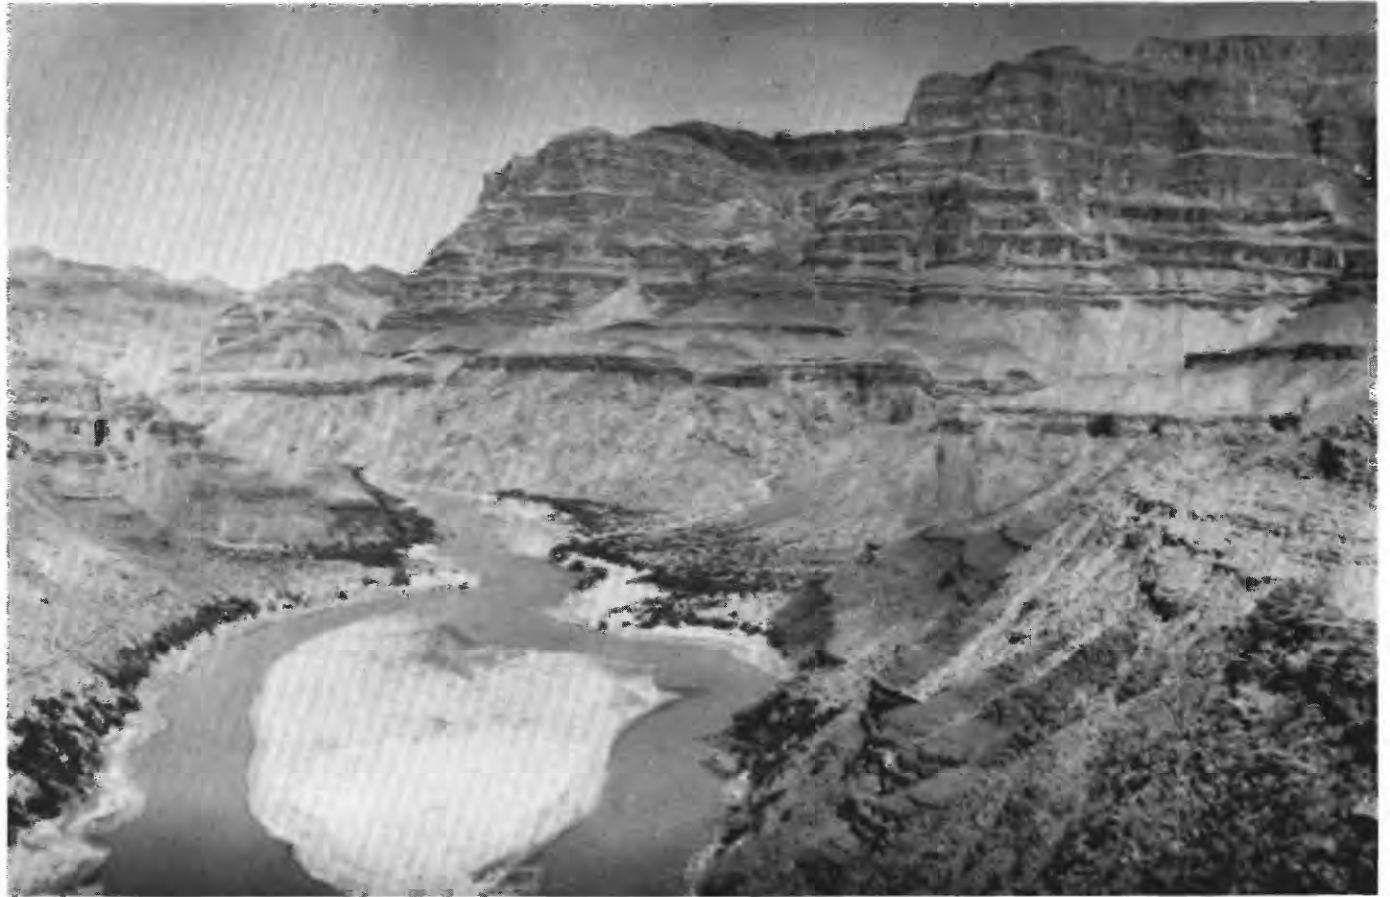
FIGURE 64A.—(1923). This upstream view was taken from a point 168 meters above the Colorado River and shows Granite Park, 336 kilometers below Lees Ferry. A flood-line community is strongly developed along this section of the canyon. Some trees have become established at the edge of the river, a habitat that is here more stable than usual because of the great width of the valley floor. (Altitude 442 meters.)

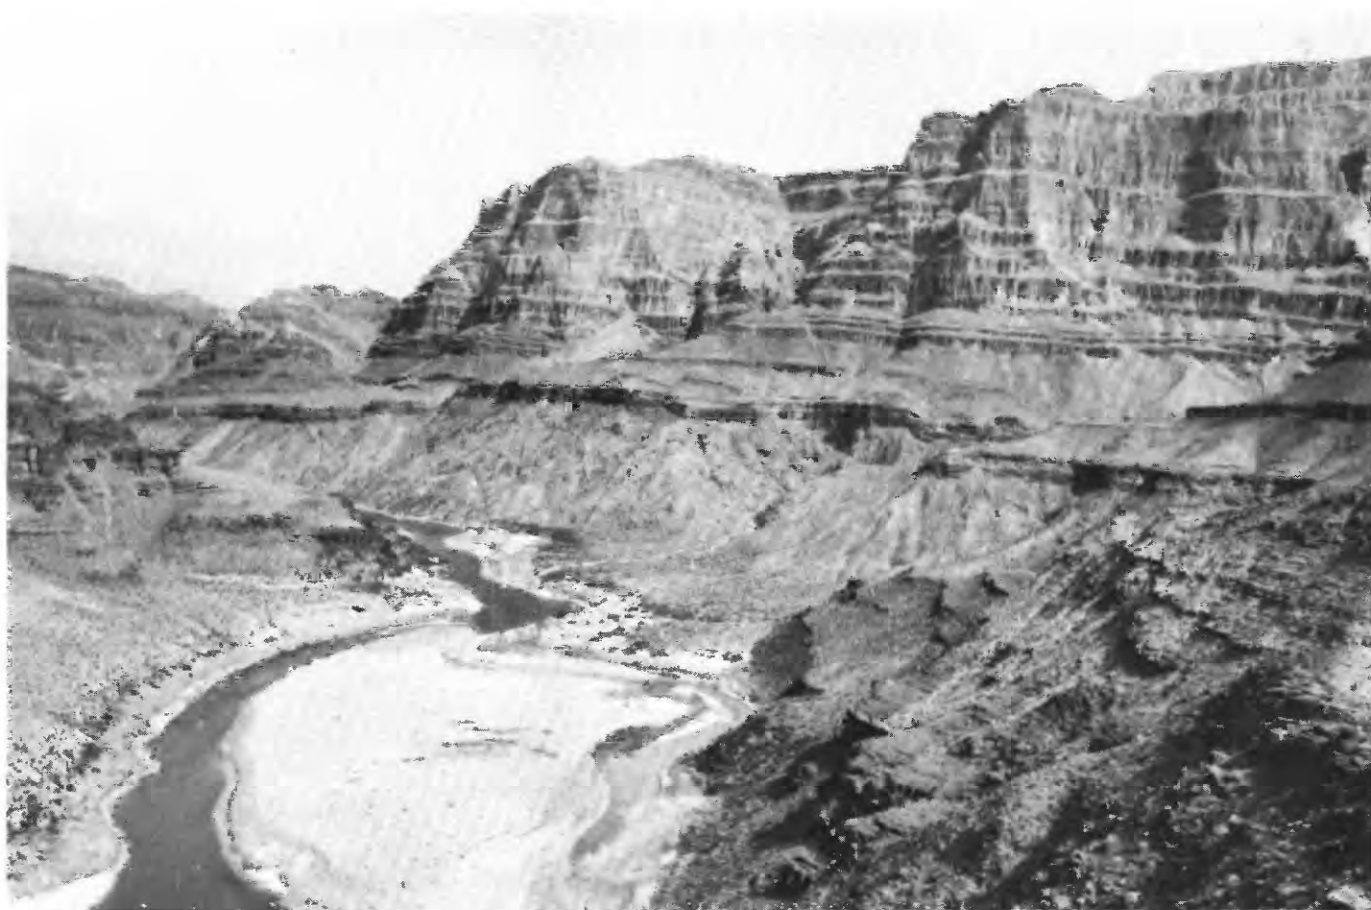
FIGURE 64B.—(1974). This view, taken in March, shows a greatly diminished flood-line community, but this reduction in plant biomass is more apparent than real—the shrubs comprising the community are leafless at this season, whereas in the 1923 photograph, taken in September, the plants were in full leaf. The streamside plants that were present in 1923 and which persist to the present are willows. Unlike the condition in 1923, the beach at Granite Park now supports a dense growth of plants. The dominant species on the beach are willow, arrowweed, saltcedar, camelthorn, red brome, and Bermuda grass. All but the first two species have been introduced to this continent from other parts of the world. Feral burros, another introduced species, are found only on the right side of the river. On areas of poorly stabilized sand, grow sand verbena, evening primrose, and dropseed. The vegetation of the bajada is typical Mohave Desertscrub with creosote bush, white bursage, brittlebush, ocotillo, range ratany, and various cacti.

Sand deposits on the large formerly barren island are becoming stabilized by such plants as dropseed, sand verbena, evening primrose, hebbia, globemallow, longleaf brickellia, and slender poreleaf. The arm of the river to the right of the island in the photograph now carries little flow and may be an incipient marsh. Along its margin grow such marsh species as cattail, carrizo, and horsetail in addition to saltcedar, seep willow, willow, and arrowweed.

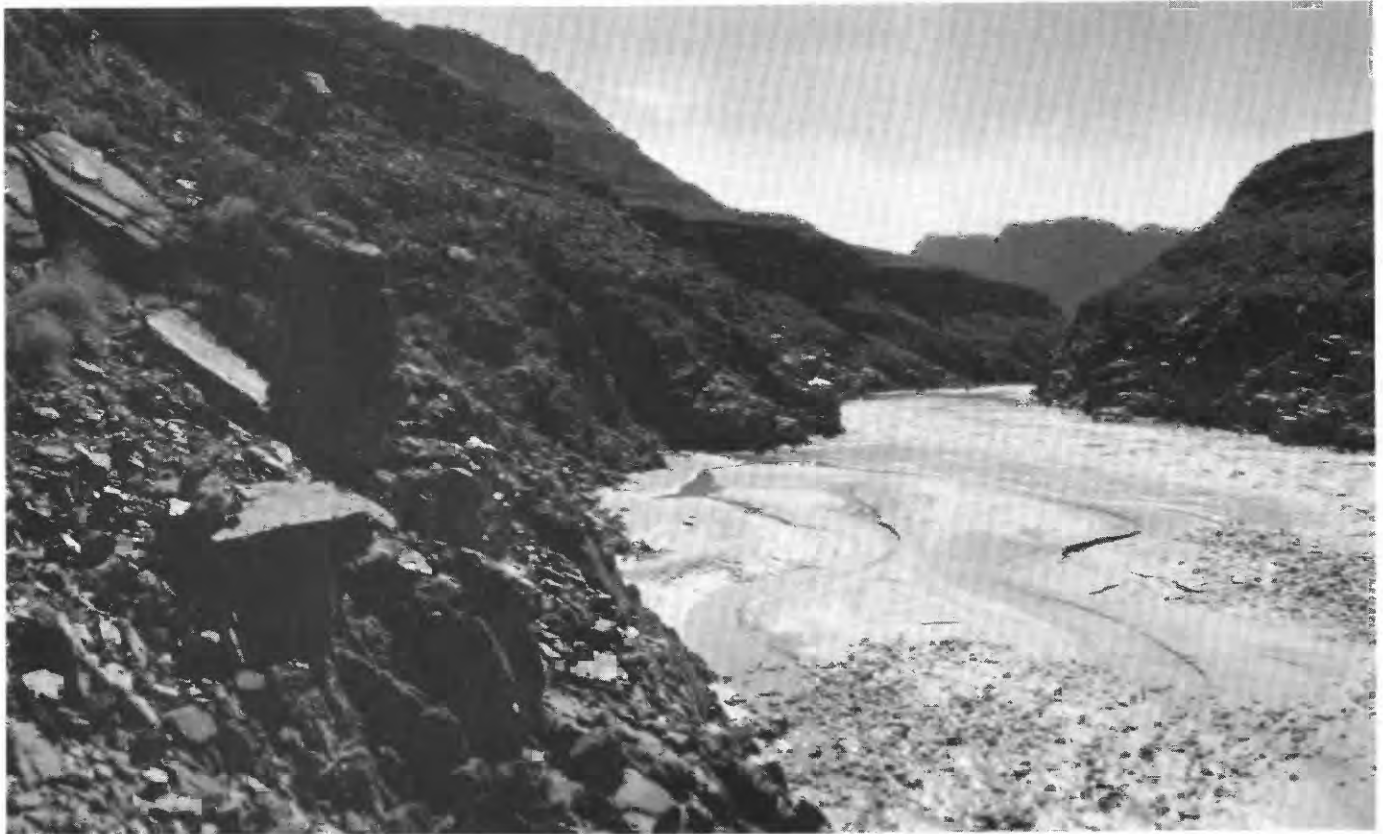
FIGURE 65A.—(1923). This downstream view was taken at kilometer 350.3 from a station just below the mouth of Two Hundred and Seventeenmile Canyon and only a short distance into the Lower Granite Gorge. Except where sediment has entered the canyon from tributaries, there are few sand or gravel shores within the Lower Granite Gorge, so steeply have the Precambrian rocks eroded to river level. Even where substrate exists for riparian communities, as on the foreground debris fan, the narrowly defined valley tends to increase the depth of flood waters making these habitats too unstable for plant establishment. The flood-line community is also missing on the steep slopes above the river. (Altitude 424 meters.)

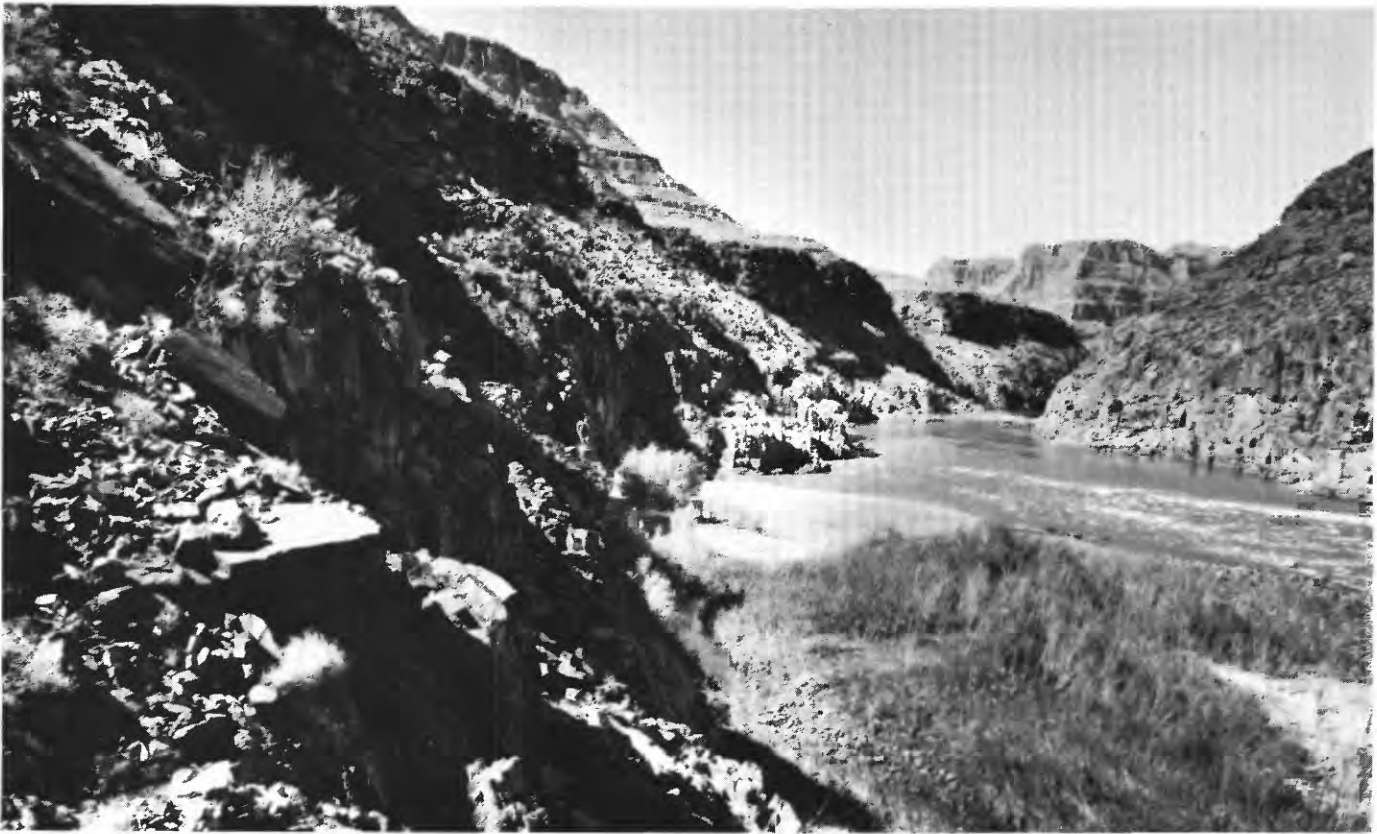
FIGURE 65B.—(1972). Seasonal flow maxima are greatly reduced under the present flow regime and formerly inhospitable debris fans now support a varied plant life. Among the species on the foreground alluvium are arrowweed, cattail, carrizo, desert broom, sandbar willow, and saltcedar. The conspicuous shrub below the sloping flat boulder at upper left is catclaw; the plant has changed little in nearly half a century.

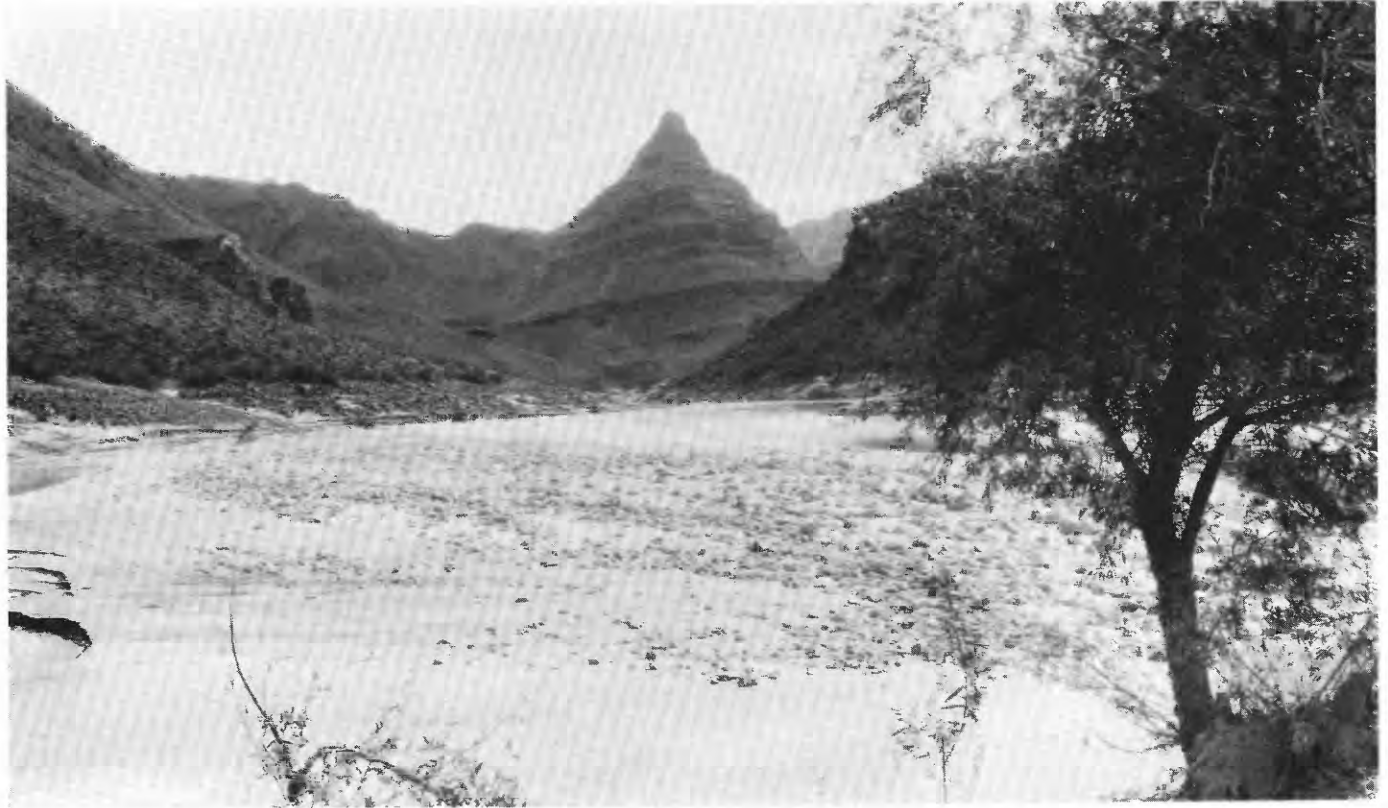
FIGURE 66A.—(1923). Members of Powell's second river expedition found quartz crystals on an ant hill near the pyramid-shaped peak at center and the peak became known as Diamond Peak (Dellenbaugh, 1908). The valley is broad through this section of the Lower Granite Gorge, and alluvial deposits are common. There is a single plant at the left on the far side of the gravel bar in this downstream view taken 358.1 kilometers below Lees Ferry. The plant's identity is uncertain, but it appears bent over, perhaps from the same flood of a few days earlier that overtook the U.S. Geological Survey team at Lava Falls. The flood-line community is conspicuous in this photograph taken in early October. In the foreground, a large willow can be seen. (Altitude 413 meters.)
