# Recent Vegetation Changes Along the Colorado River Between Glen Canyon Dam and Lake Mead, Arizona

GEOLOGICAL SURVEY PROFESSIONAL PAPER 1132

By RAYMOND M. TURNER *and* MARTIN M. KARPISCAK

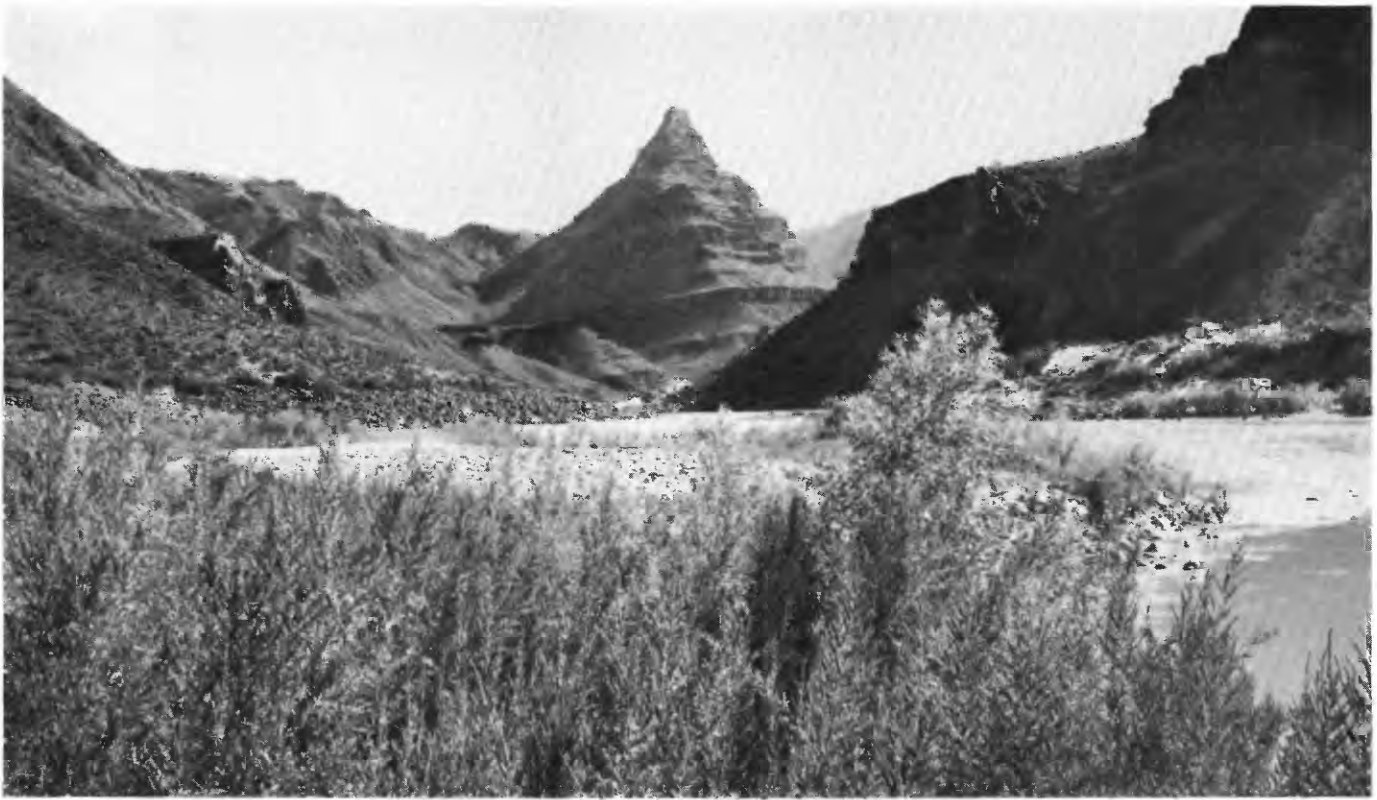
FIGURE 66B.—(1972). The camera station is now in a dense stand of arrowweed. Many saltcedar plants grow around the edge of the gravel bar where a half century earlier only one plant was visible. In addition, two western honey mesquites, desert broom, Goodding willow, and desert isocoma grow near the shore. The flood-line community, mainly of catclaw with few western honey mesquites, is still present but seems diminished in this August view. Close inspection of this community shows that there are numerous burro trails and the basal portions of flood-line community shrubs are stripped of foilage where in reach of the animals.

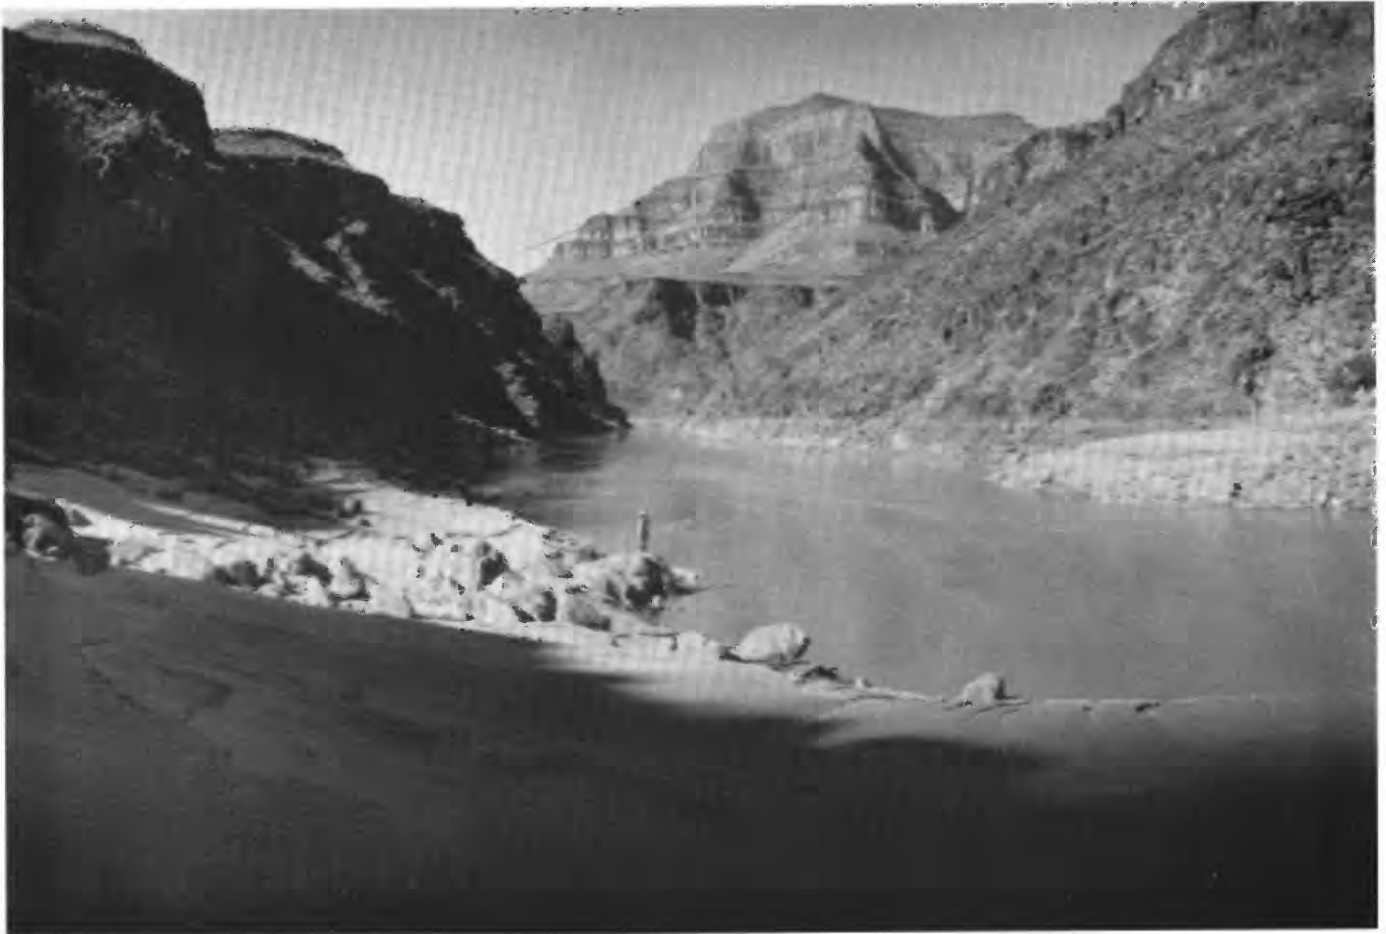
FIGURE 67A.—(1923). View down the V-shaped canyon cut through Precambrian metamorphic rocks. The stratified formation capping the Precambrian rocks is the Lower and Middle Cambrian Tapeats Sandstone. The far skyline is defined by a formation of the Pennsylvanian and Permian Supai Group. The sand deposit in the foreground and the one across the river are both at the mouths of minor tributary canyons 360.7 kilometers below Lees Ferry. A flood line is apparent from stains on the rocks of the opposite shore and no plants are visible below that level. (Altitude 408 meters.)

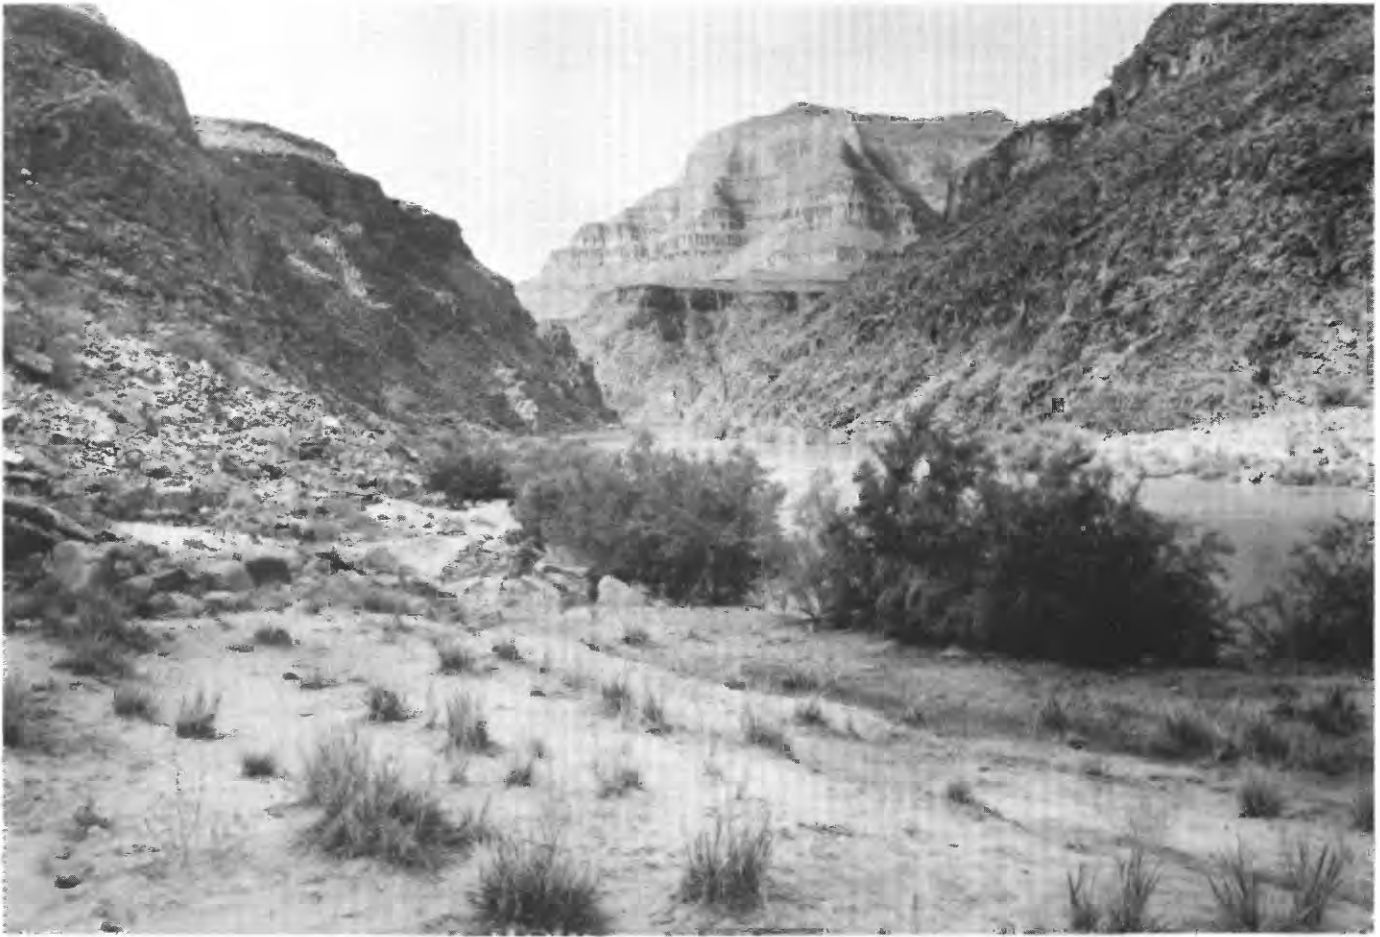
FIGURE 67B.—(1976). The boulder with the man standing on it in the previous photograph is now hidden by saltcedars, which form a discontinuous strip along both shores. The depth of sand around the base of the boulders is less now than before. The sand deposit is now partially stabilized by dropseed (the coarse grass), red brome, and Russian thistle. Signs of burros are abundant.

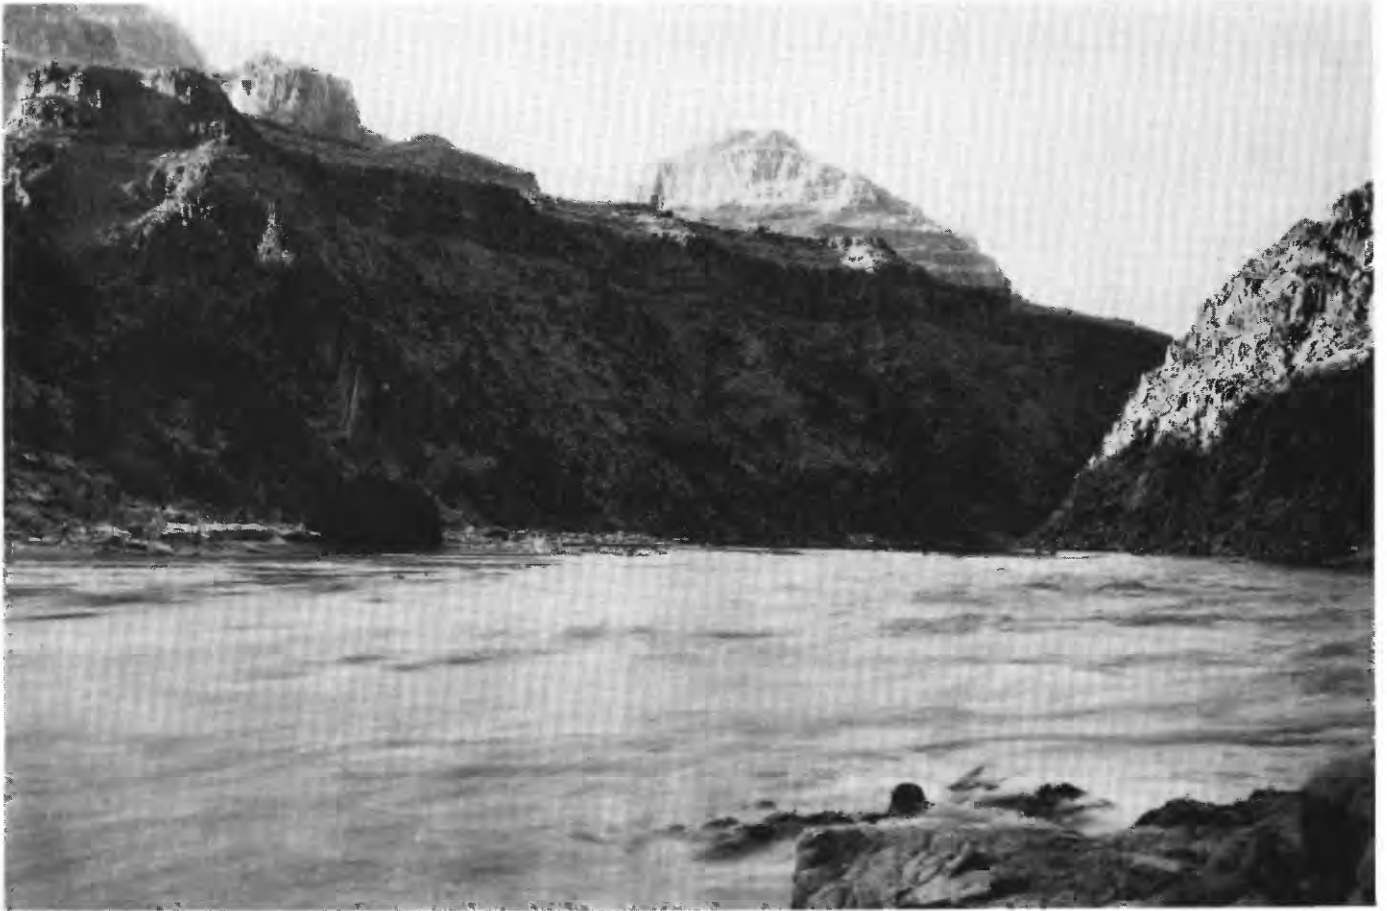
FIGURE 68A.—(1902). This photograph was taken from the small promontory of rocks seen beyond the fan in the previous pair of pictures and shows in close view the same large tree near the river as seen in the previous views. For the tree to have reached this size would probably require 10 or more years of growth. Thus, the tree became established in about 1892 or earlier and persisted until at least 1923 (fig. 69A). (Altitude 408 meters.)

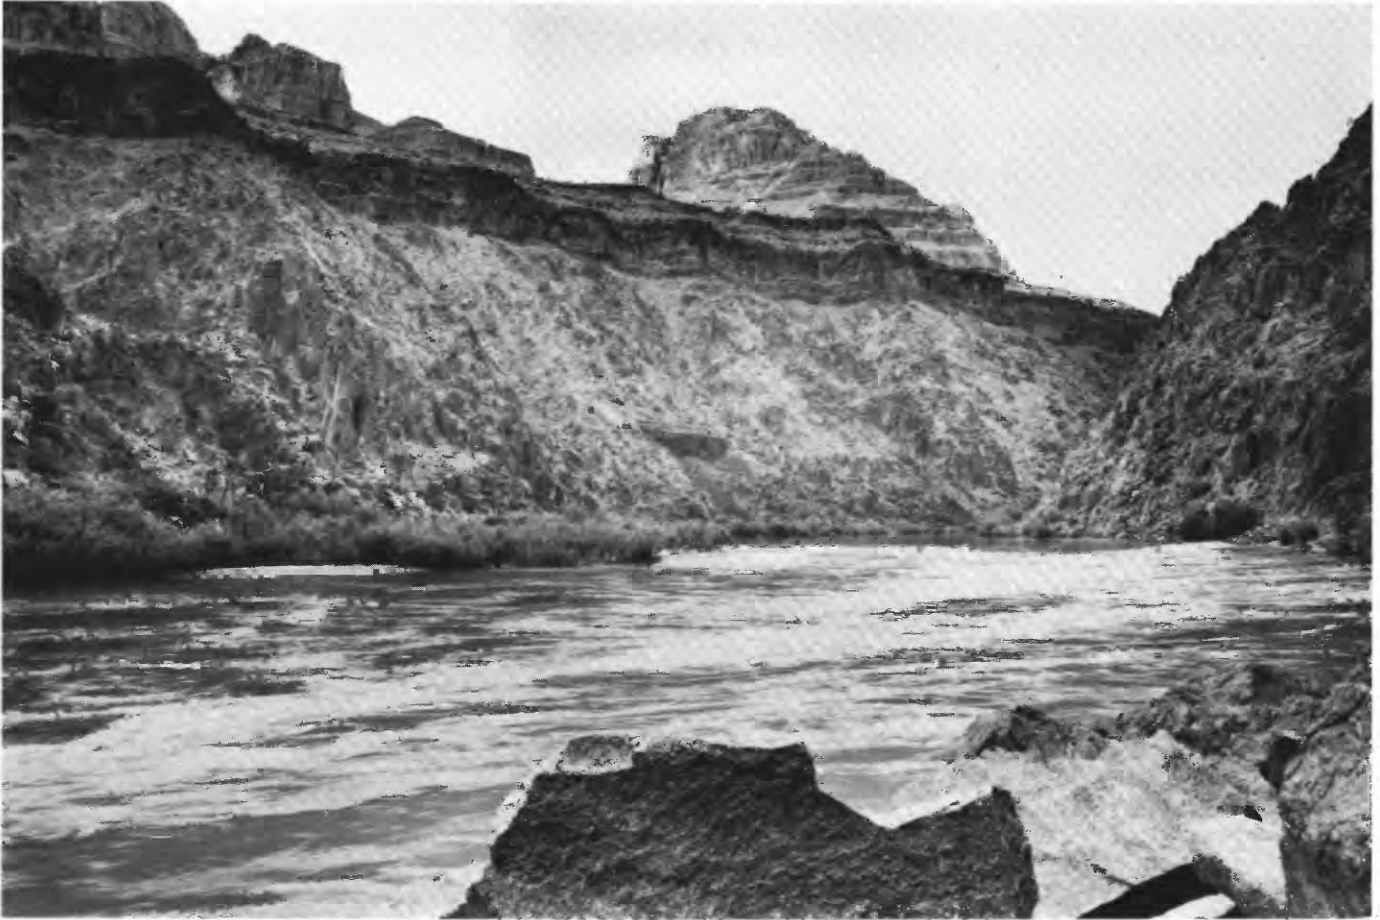
FIGURE 68B.—(1972). Saltcedar, arrowweed, and seep willow grow thickly at the site occupied earlier by the single tree. Slightly to the right of that position can be seen a clump of cattails.

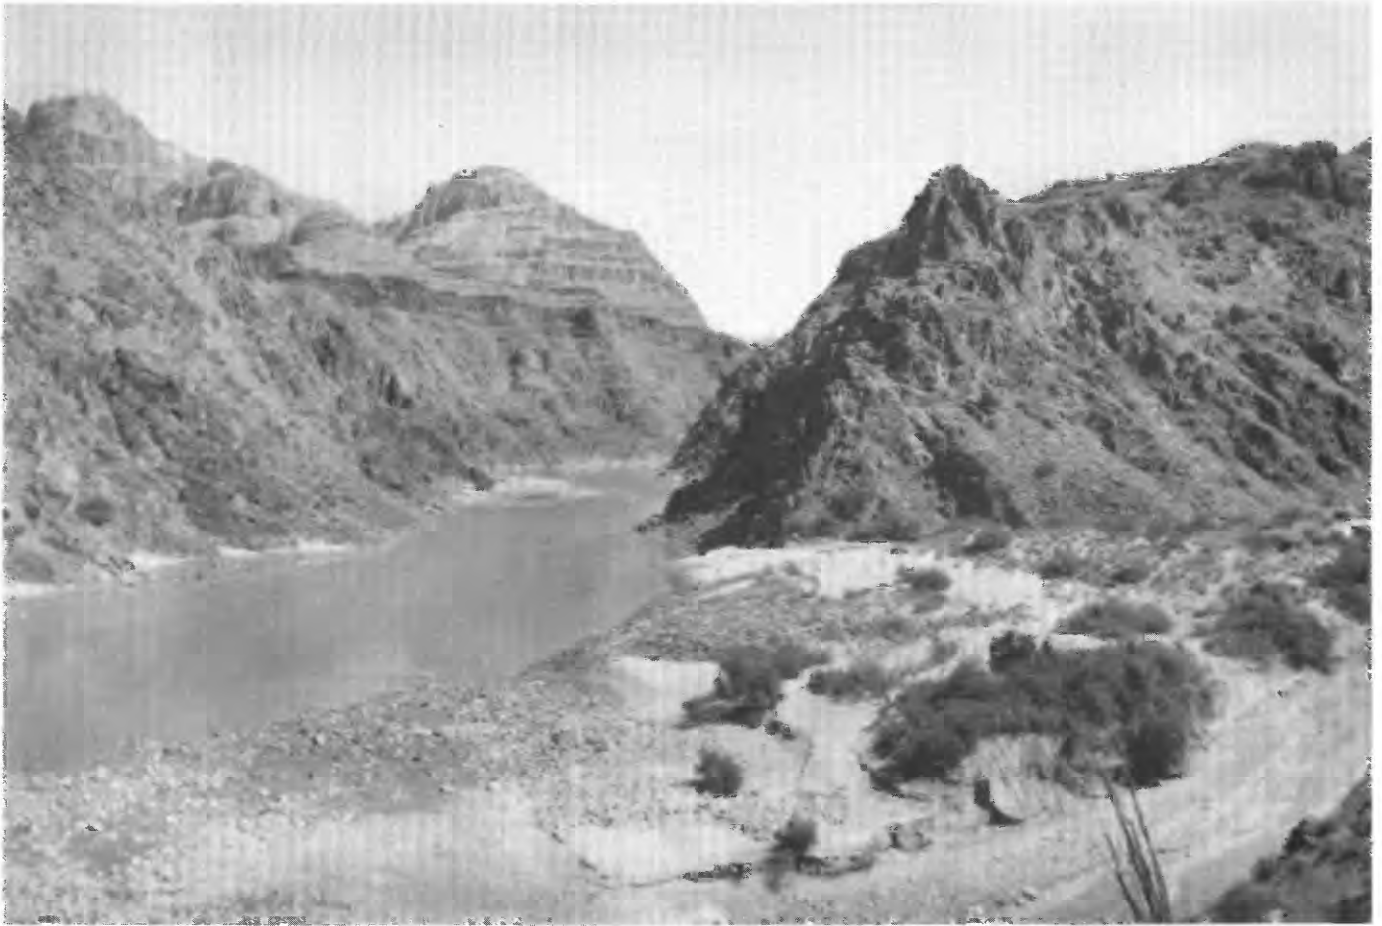
FIGURE 69A.—(1923). Diamond Creek enters the Colorado River 363.2 kilometers below Lees Ferry and is the first place in that distance where vehicles can reach the river. The mouth of Diamond Creek was visited by Ives and his party in 1858 (Ives, 1861) and was the terminus of the Wheeler Expedition in 1871 (Wheeler, 1872). The Diamond Creek Hotel was in operation here for sightseers from 1884 to 1889 before scenic areas farther east were developed (Barnes, 1960; Simons and Gaskill, 1969). In this upstream view, the only plant at the river's edge is a large tree visible on the opposite bank in a protected area below a bar. (See also figure 68A.) Large plants on the fan at the mouth of Diamond Creek (right midground) are probably mesquites. On the uppermost sandy terrace of the fan a dense growth of small shrubs is evident. (Altitude 407 meters.)

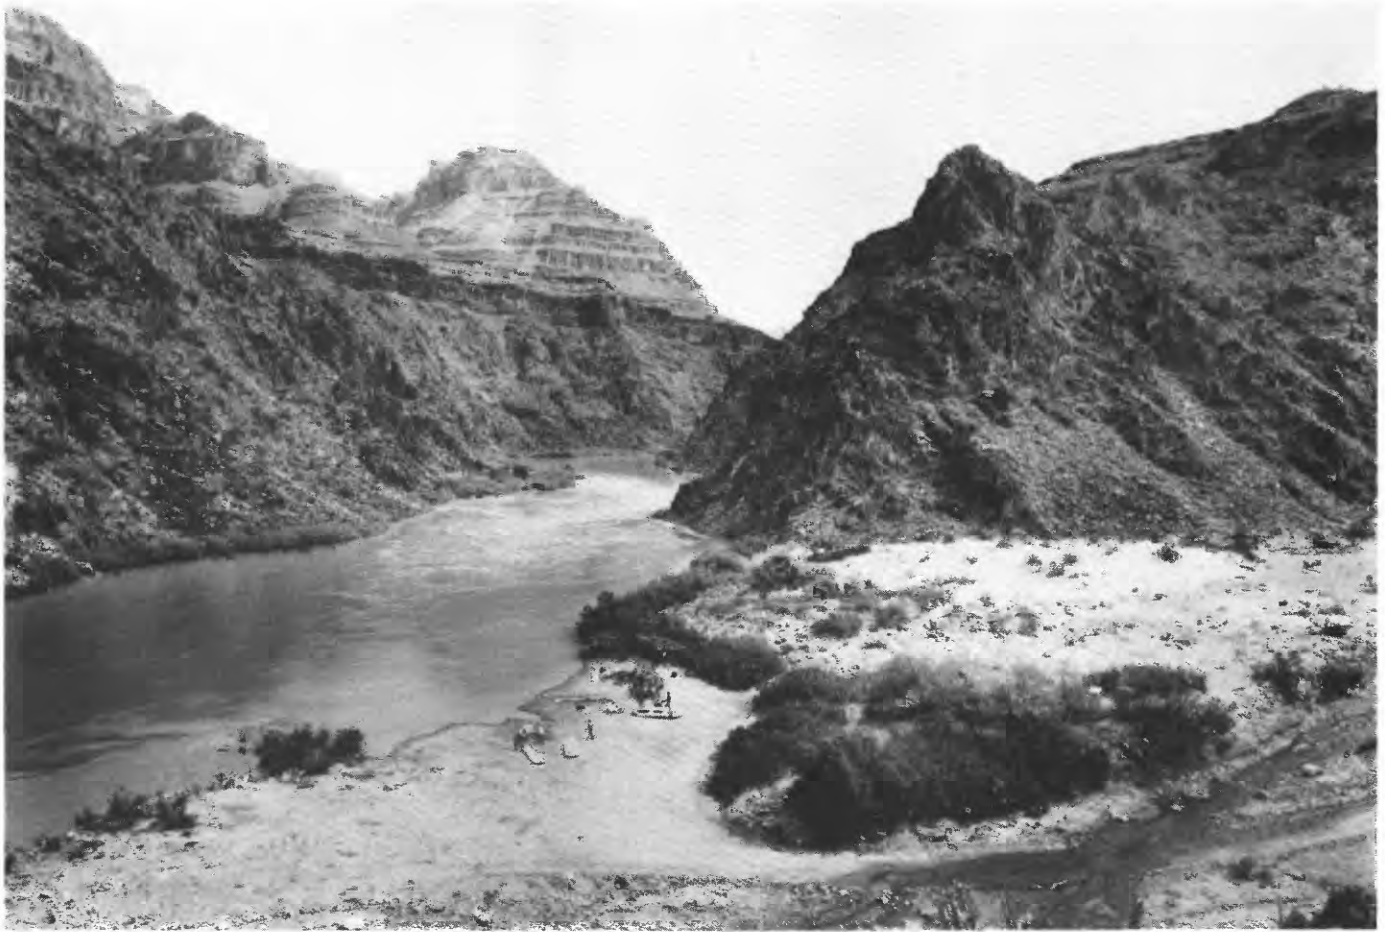
FIGURE 69B.—(1976). A dense community of saltcedar, arrowweed, and seep willow has become established along the shore on both sides of the river. The fan at right is more heavily overgrown by plants than before, except for the formerly stabilized high terrace which now seems to be covered by a sand deposit. The large tree on the opposite bank has not persisted to the present. The Colorado River no longer floods the large bare area with boats and people on it; as a result, fine material, deposited by flooding on Diamond Creek, now covers the gravels that were present earlier. Bermuda grass grows in moist soil near the shelters. The lower reach of Diamond Creek (foreground) is lined by a riparian community dominated by saltcedar.

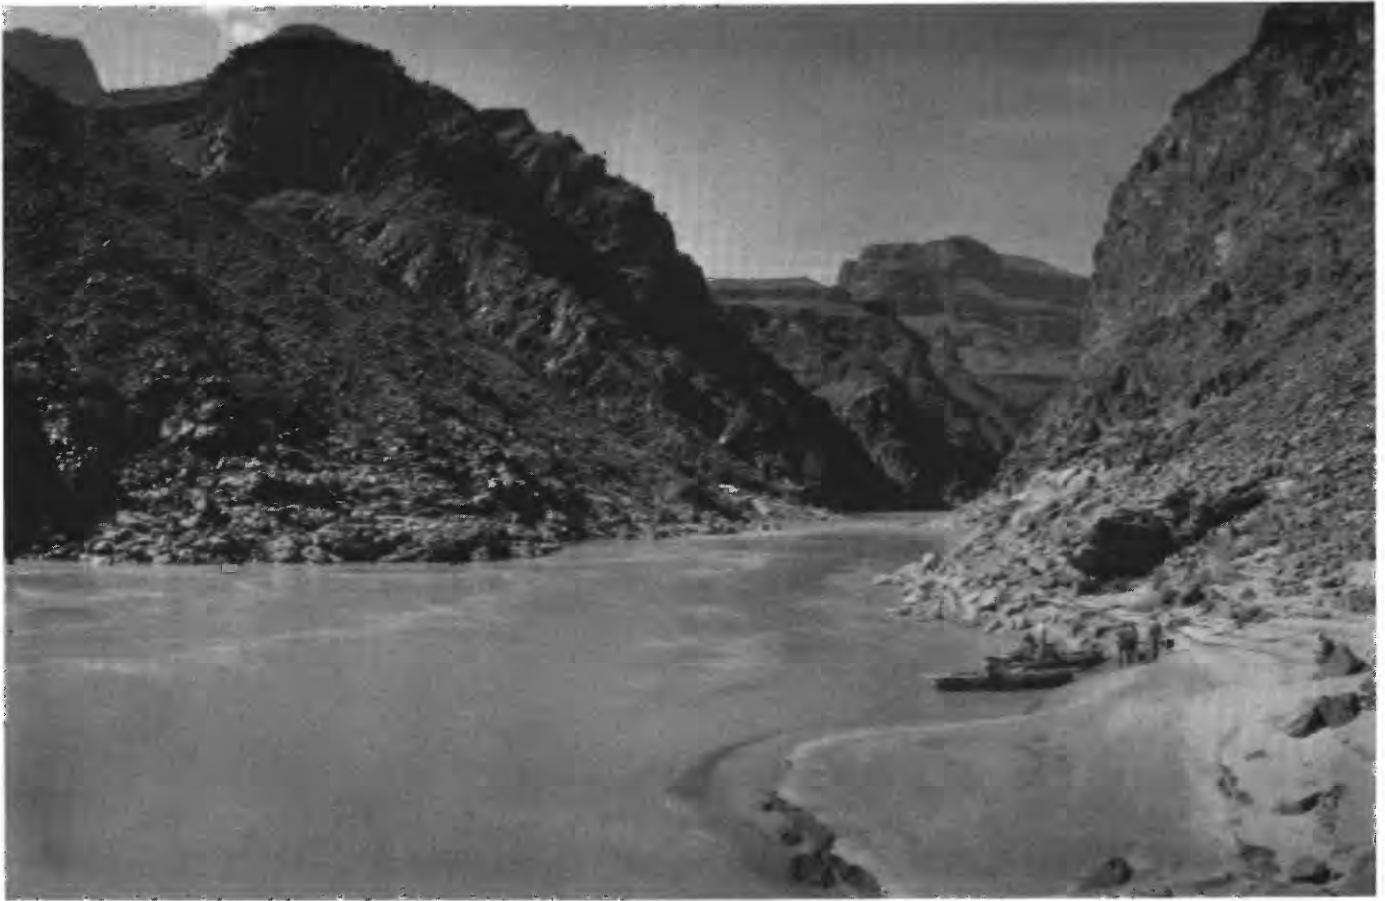
FIGURE 70A.—(1923). The U.S. Geological Survey team has moored its boats near a large rock at a sand bar on the right bank, 368.0 kilometers below Lees Ferry. Although no flood-line community is found on the steep walls of the Lower Granite Gorge, the flood line is visible because of stains on the rocks of the talus slope. No plants are found below that line, and above it are seen widely scattered desert shrubs. (Altitude 395 meters.)

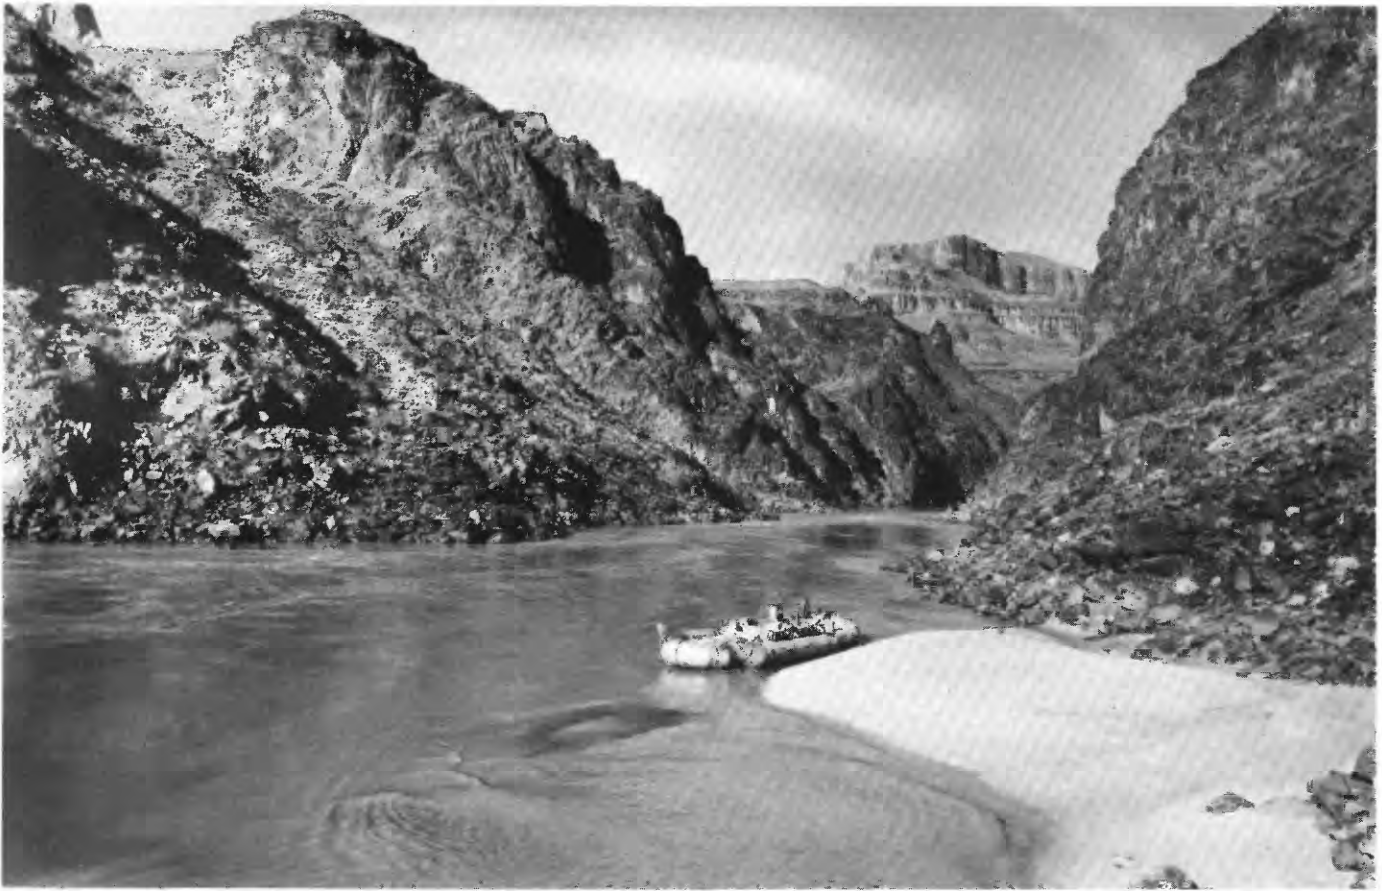
FIGURE 70B.—(1972). The new flood line now lies below the large rock and several plants of brittlebush grow on the slope between the new and the old flood lines. The bar in the foreground is unusual in that no plants have become established there. The Inner Gorge is narrow here and during times of high flow the bar is flooded, making for an unstable surface for plant establishment.

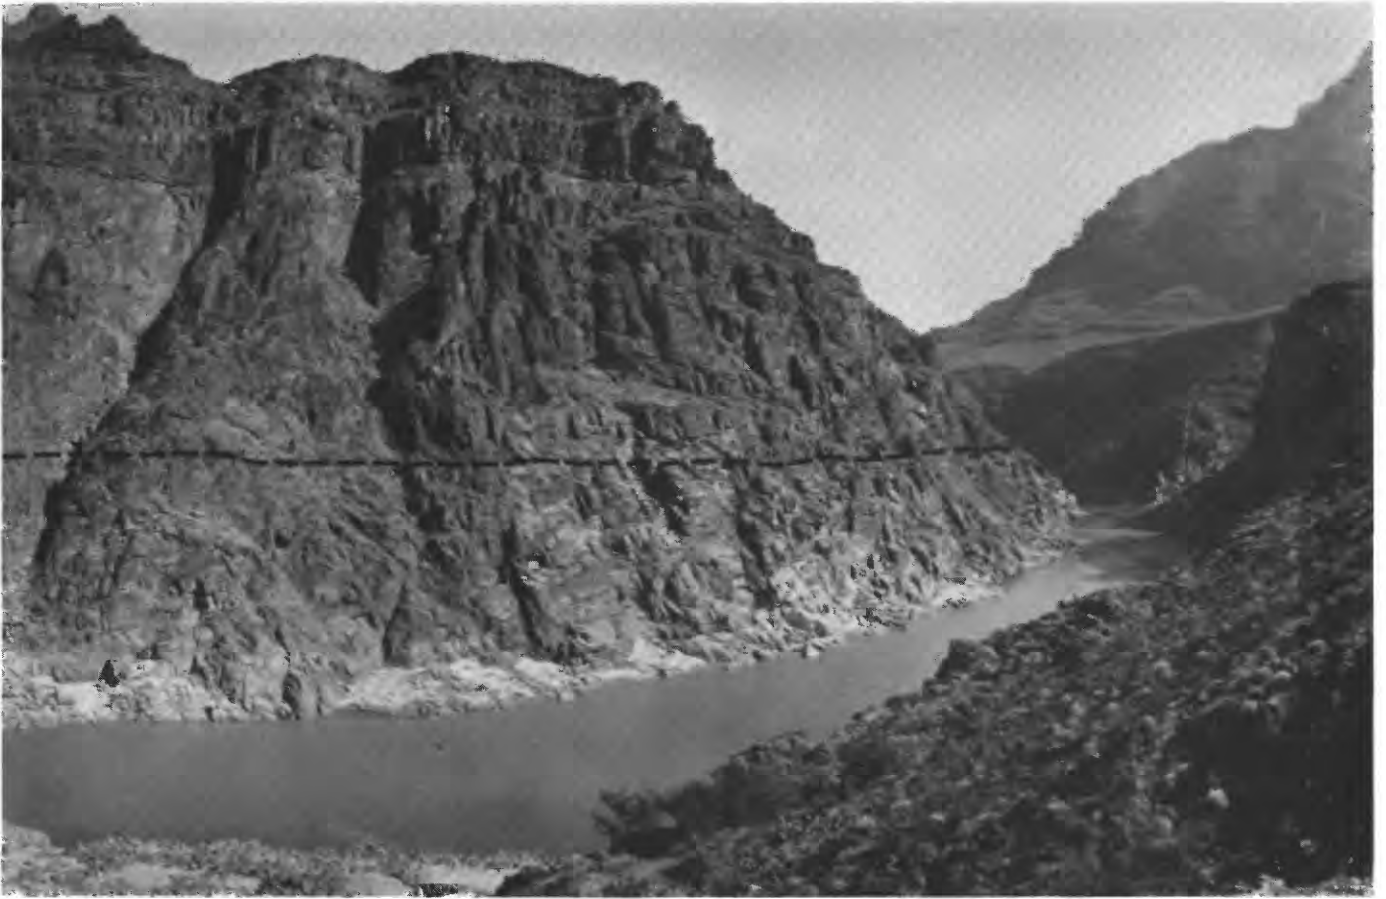
FIGURE 71A.—(1923.) This upstream view of the Colorado River was taken from a hill above the mouth of Maxson or Reference Point Canyon, 406.0 kilometers below Lees Ferry. At the time of the photograph, barren silt accumulations deposited during floods could be seen high on the steep walls of the Inner Gorge. For explanation of the dashed line, see the next figure. (Altitude 322 meters.)

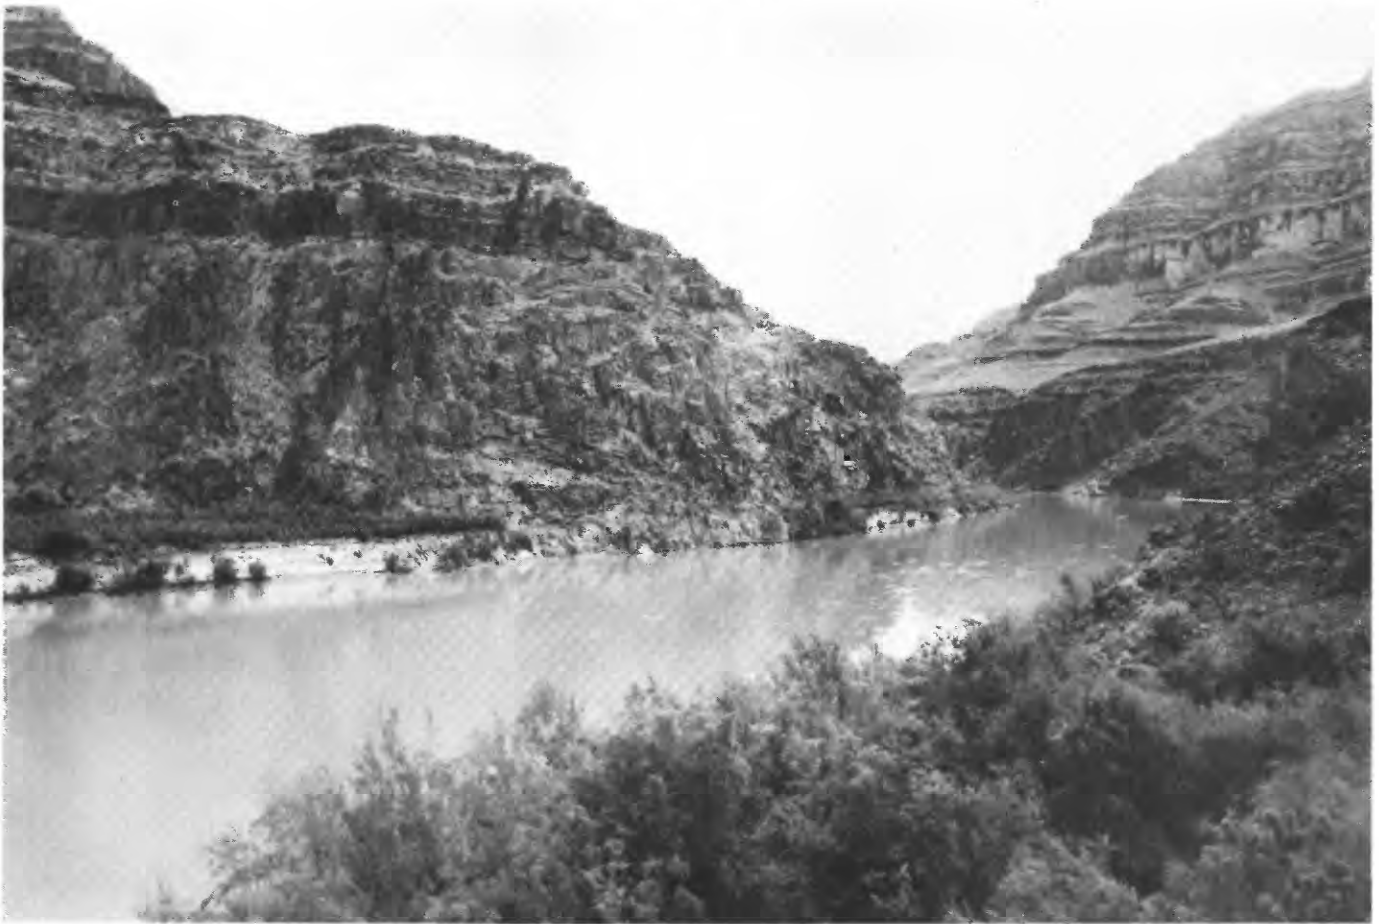
**FIGURE 71B.**—(1972). Silt had accumulated to a depth of over 50 meters in this reach of the Lower Granite Gorge by 1948, approximately 13 years after the completion of Hoover Dam (Pampel, 1960). The old camera station is now within the reservoir area of Hoover Dam and is buried beneath Lake Mead silt. The new station has been moved upslope. Saltcedar is the dominant plant of the foreground. The dashed line in the previous figure marks the approximate location of the surface of the silt deposit seen in this view. The vertical silt bank extends approximately 5.5 meters above the present water surface and has developed since 1963 when the water level in Lake Mead was lowered sharply at the time impoundment of water in Lake Powell began. A secondary riparian community has developed at the base of the bank. At the time of the photograph, the lake level was approximately 352.5 meters above mean sea level (U.S. Geological Survey, issued annually). By the following May, the lake level reached 361.8 meters above mean sea level (U.S. Geological Survey, issued annually), at which time the silt bank was probably inundated resulting in the death of many of the saltcedars.

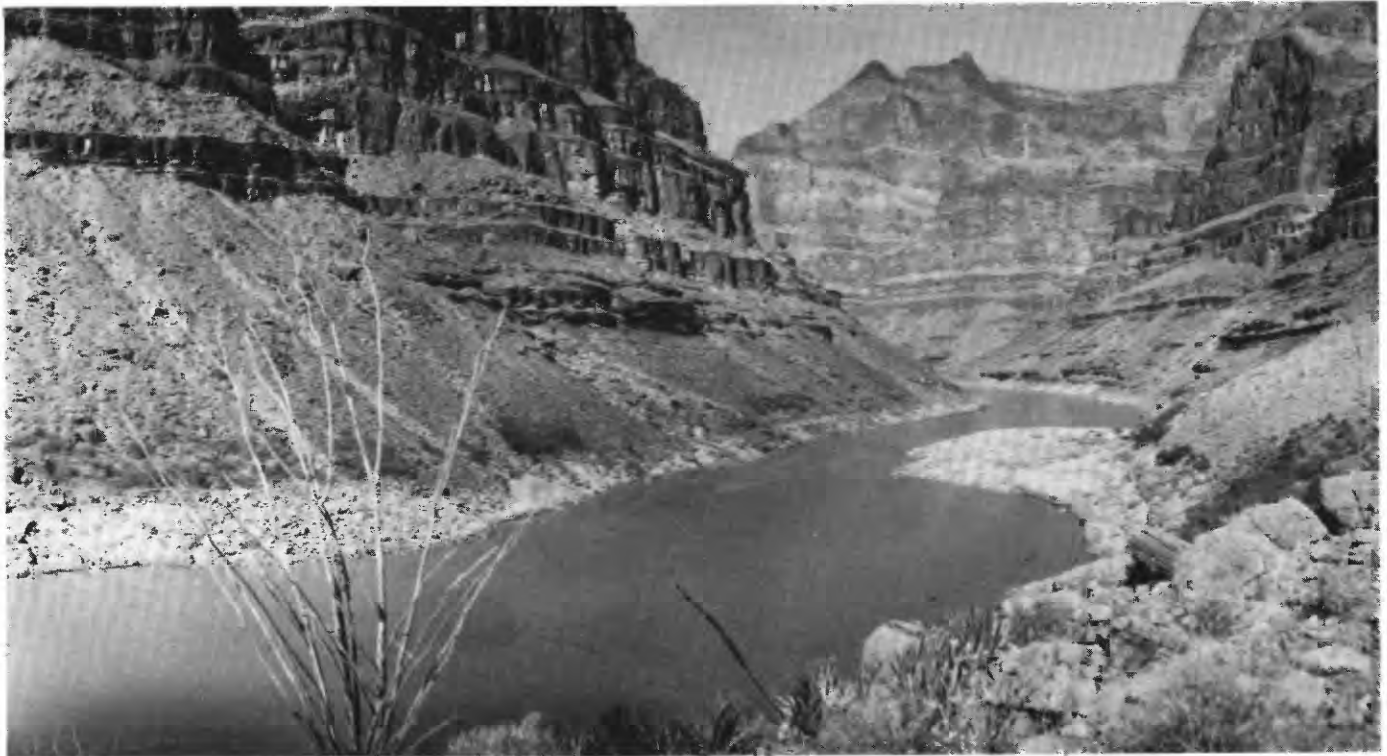
FIGURE 72A.—(1923). The Lower Marble Canyon ends at about kilometer 414.3 and the steep walls of the Inner Gorge give way to less steep talus slopes. In this view, looking down the canyon of the Colorado River 437.6 kilometers below Lees Ferry, the flood-line community is well developed above the conspicuous highwater line. The Middle Cambrian Bright Angel Shale is at river level. Typical Mohave Desertscrub species of the foreground include ocotillo, white bursage, and agave. The floodline community probably includes western honey mesquite and catclaw. (Altitude 282 meters.)

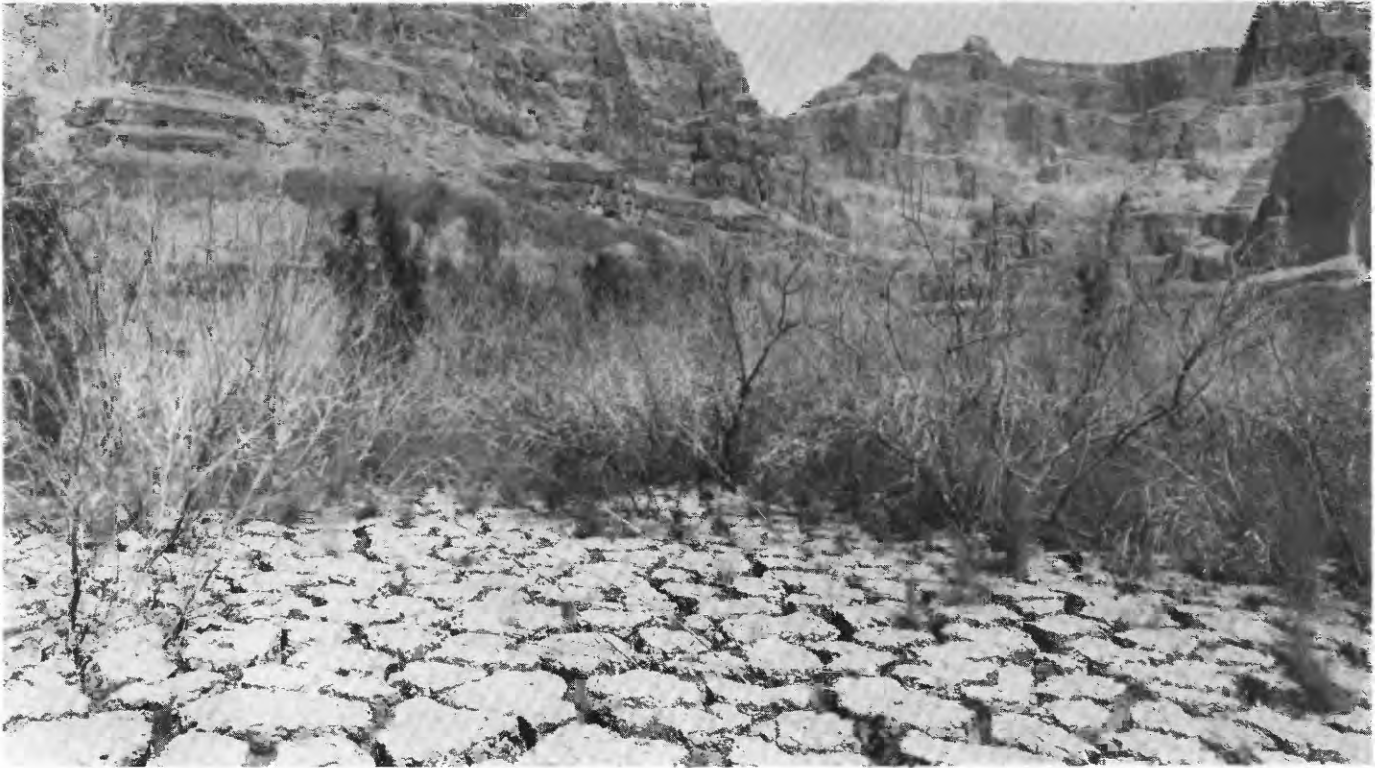
FIGURE 72B.—(1974). The old camera station lies beneath Lake Mead silt several meters below and to the right of the new position. Before Hoover Dam was built the thalweg altitude was roughly 275 meters; now the thalweg altitude exceeds 350.5 meters, representing an accumulation of 76.2 meters of sediment (Pampel, 1960). Saltcedar is the only plant seen on the deeply cracked silt deposit. Many of the plants are dead in this August view, presumably from submergence during earlier months when this site was covered by water to a depth of 2.7 to 3.7 meters. Some taller plants survived. Seedlings growing from the deep cracks in the foreground became established after the water receded. This scene illustrates the dynamic nature of the saltcedar community on Lake Mead silt.

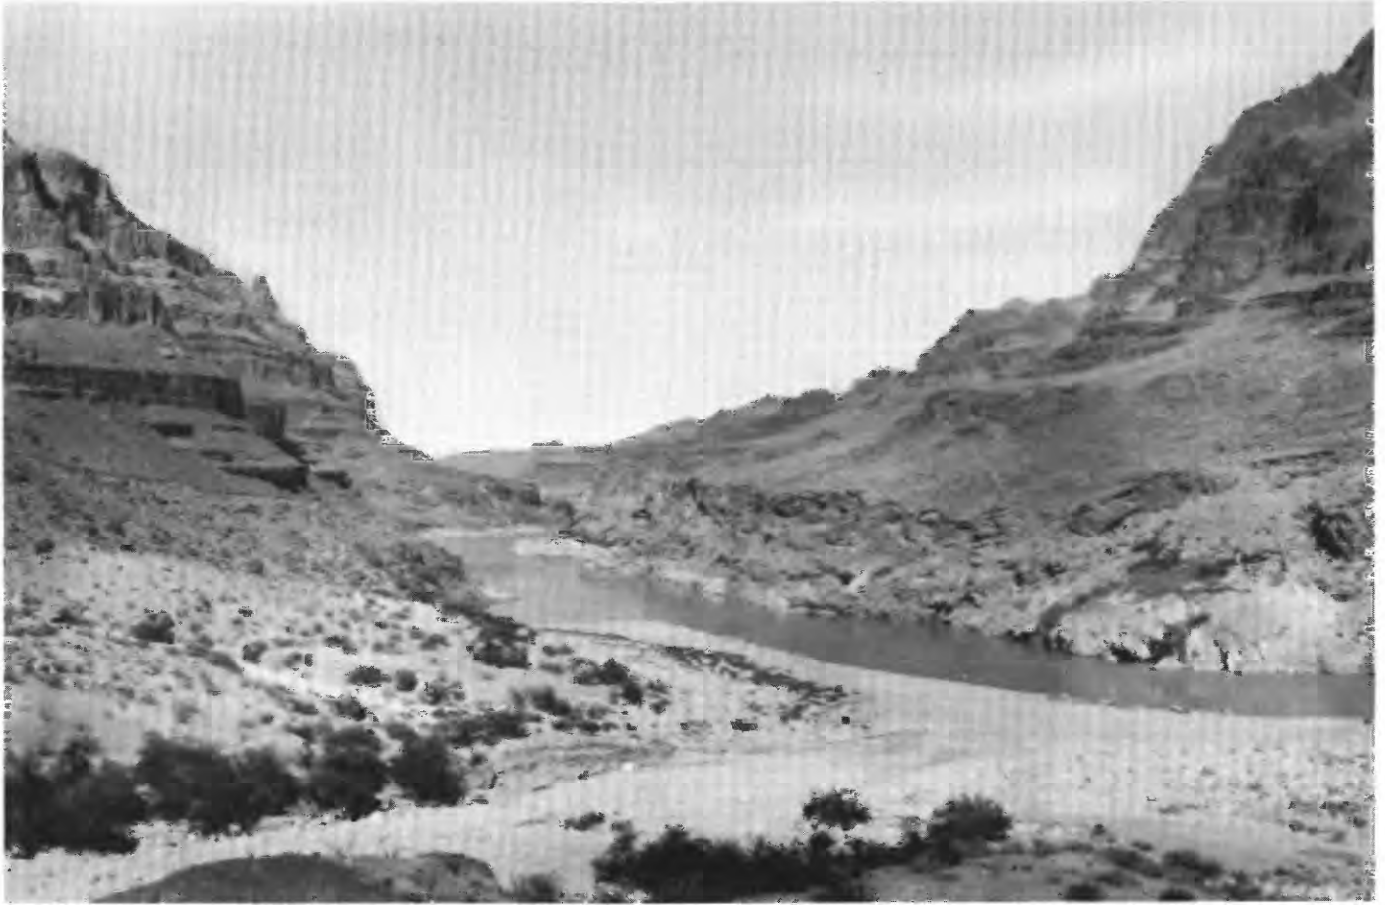
FIGURE 73A.—(1923). What appear to be catclaw and western honey mesquite form a dense community lining the channel of Cave Canyon which enters the Grand Canyon from the left bank 441.3 kilometers below Lees Ferry. This community merges with the flood-line community of the Colorado River valley. There is apparently a moist area in a travertine deposit on the bank opposite the mouth of Cave Canyon which supports a low growth of plants that extends to the edge of the river. The slopes near the camera station are dominated by creosote bush and white bursage. (Altitude 280 meters. Estimated from Pampel, 1960; Belknap, 1969.)

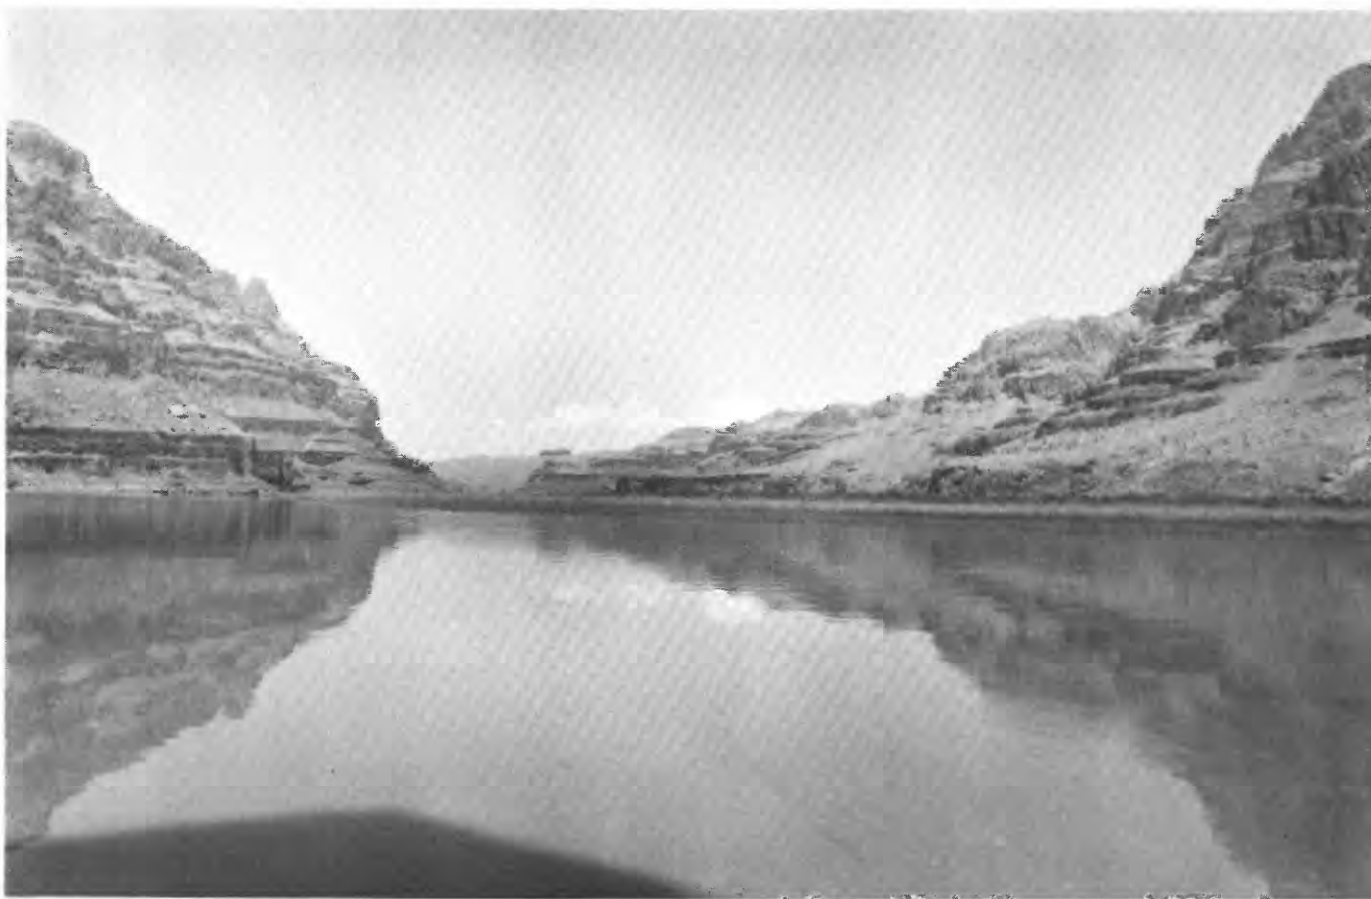
FIGURE 73B.—(1974). The original camera station is now covered by water and silt and cannot be reoccupied. By 1948-49, silt had filled the valley at this location to depths as great as 73.2 meters (Pampel, 1960). The upper surface of the silt deposit is exposed near the opposite bank and is densely overgrown with saltcedar. Plants of the saltcedar thicket are leafless and dead at the time of this August photograph; death was probably from inundation during 1973. That year the lake reached the highest levels since 1963 when diversion began for filling Glen Canyon Dam.
