Failure and Degradation Modes of PV modules in a Hot Dry Climate:

Results after 4 and 12 years of field exposure

A Thesis Presented in Partial Fulfillment
of the Requirements for the Degree
Master of Science in Technology

ARIZONA STATE UNIVERSITY

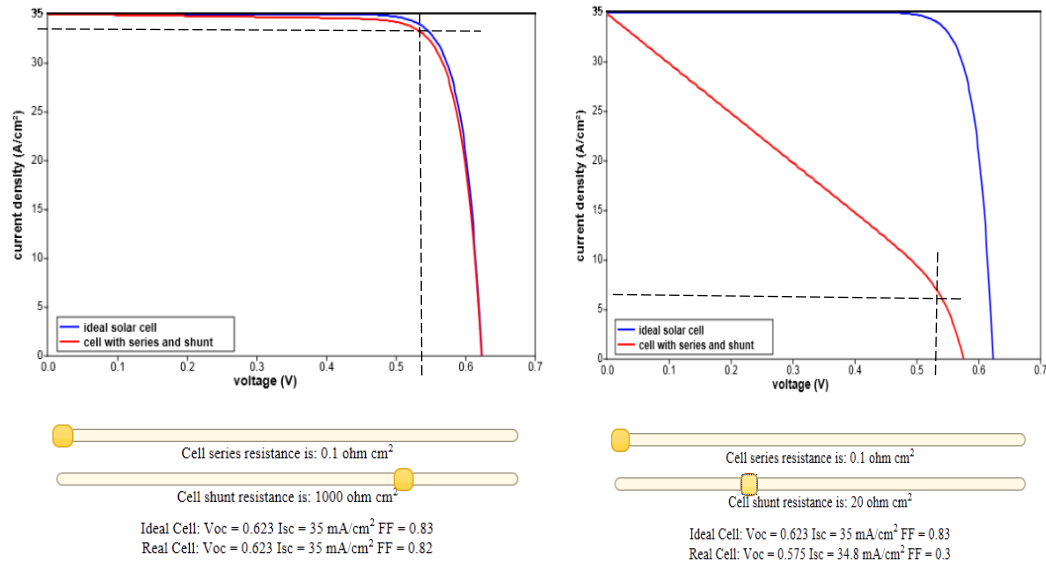
Shunt resistance drop is caused typically by manufacturing defects, potential induced degradation and severe hot spots. The drop in shunt resistance could decrease the voltage and have a severe impact on current at low light levels.

Figure 9 Cell shunt resistance [14]

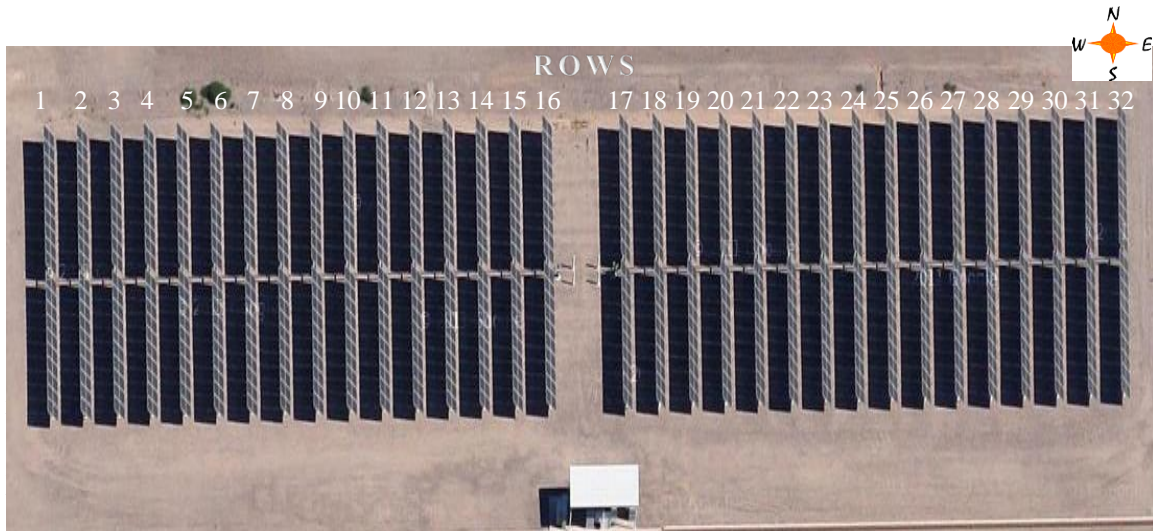
Figure 11 Site 4c site layout

As shown in Figure 11 below, Site 4c system consists of 32 rows/arrays, each with 5 strings of 8 modules connected in series.

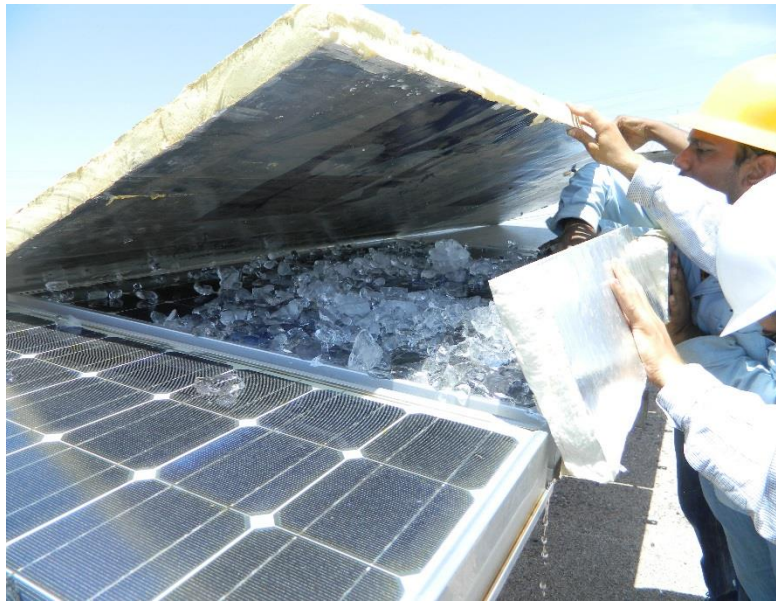
The measured I-V curves are required to be translated to Standard Test Conditions (STC). Temperature coefficients for voltage (β), current (α), and power are required for the translation. The modules to be tested at the power plant were cooled uniformly using ice

cubes and covering the top of the module with Styrofoam. The module's backsheet temperature was monitored and once the temperature fell between 12°C to 18°C, the ice cubes were removed and the module surface was dried using dry towels. Ten I-V curves were taken between 18°C to 45°C and with the irradiance approximately 1000 W/m².

Figure 18 Module cooled using ice and styrofoam.

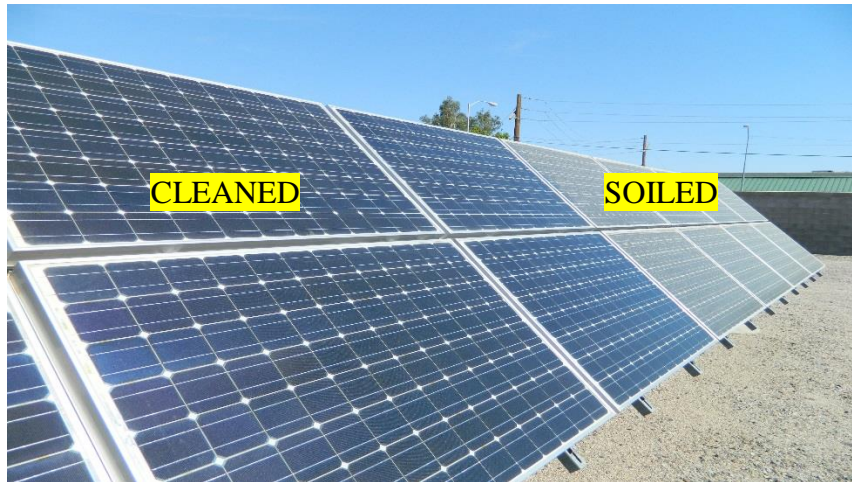
Soiling on the modules causes transmittance issues, which reduces the I_{sc} of the modules. The strings which were selected for individual module level analysis were cleaned with water. The strings were then allowed to dry for a few minutes. After drying, cleaned string level I-V curves and module level I-V curves were taken.

Figure 23 Cleaned and Soiled string comparison in Site 4c

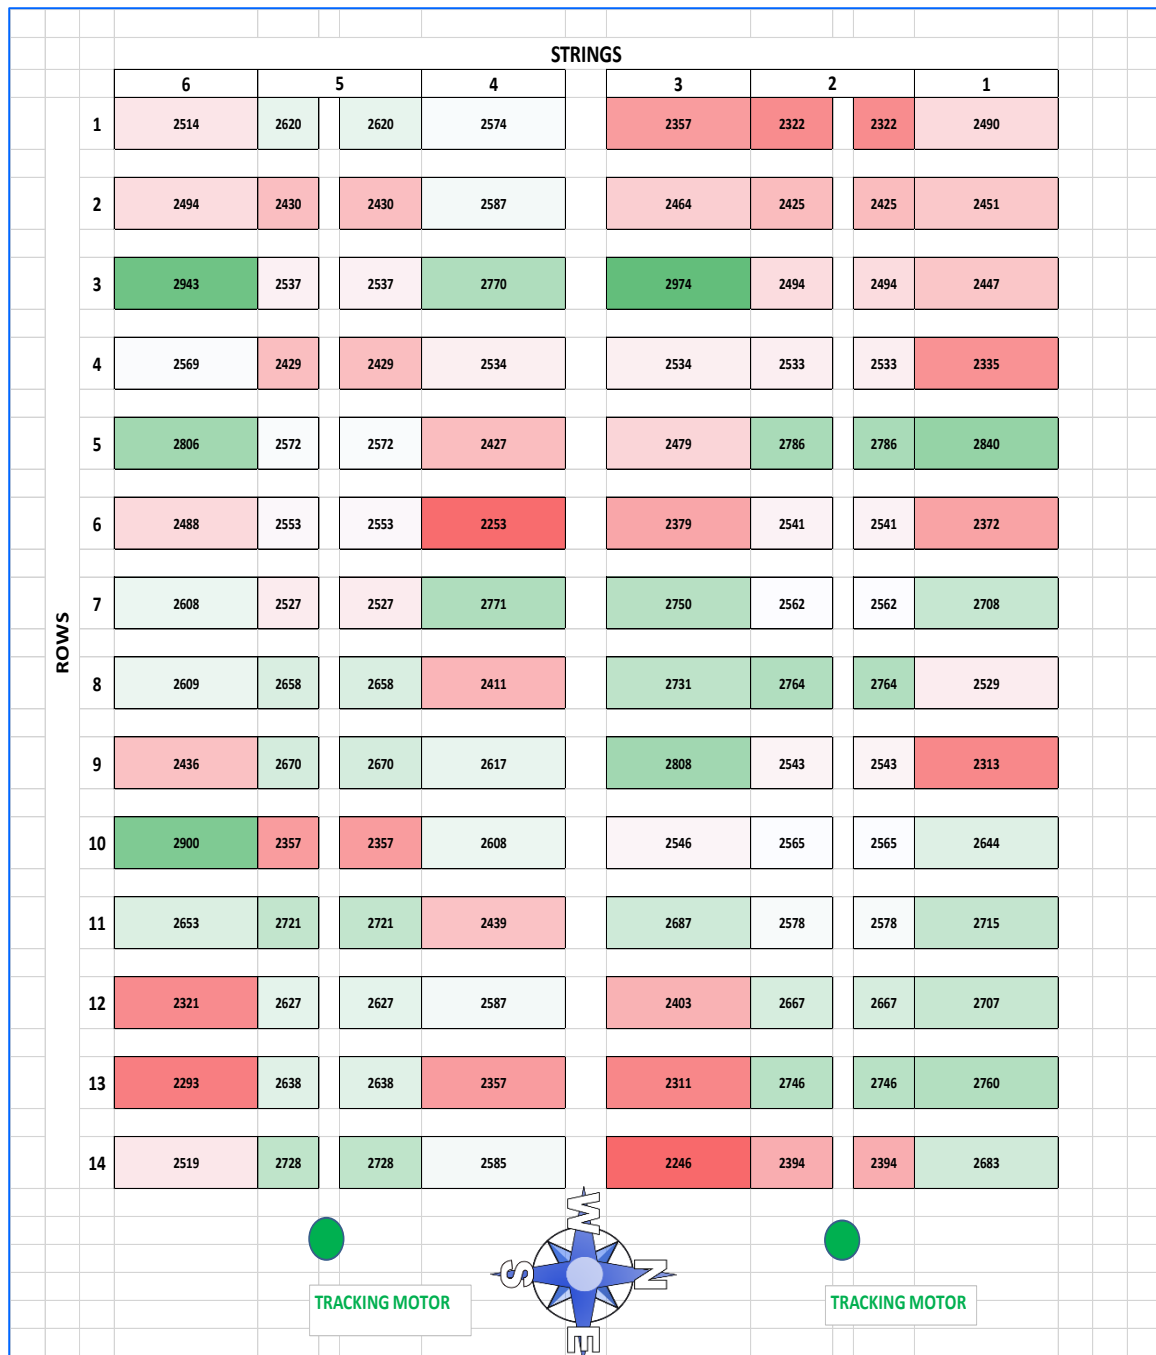
Figure 64 Site 3 string power distribution to see if there is any systematic wind direction effect on degradation rates of strings

The modules performance is dictated by the temperature under which they are operating. Wind flow will help cool the modules. The wind direction in and around Phoenix Arizona is typically from the south –west. If there is a wind direction effect due to nearby wind obstructing objects, the south-west strings are expected to degrade at a lower rate than the north-east array. In Site 3 the surroundings are open with a farm land on the north and scrap yard (30 ft.) on the west and two big tanks far away (175 ft.) on the east and south sides . This can be seen in Figure 62. Due to an absence of barriers which obstruct the wind flow, no systematic wind direction effect on the module performance was observed. Figure 64 shows the string power distribution in Site 3. Site 4c has a wall on the south side, a building on the east side and Site4a, 4b situated about 5 feet from ground level of Site 4c on the north. No systematic wind effect on module performance was observed due to a lack of wind barriers. Figure 65 indicating the absence of wind direction effect on the degradation rate of the PV modules in these power plants.
