Damming Ephemeral Streams: Understanding Biogeomorphic Shifts and Implications to
Traversed Streams due to the Central Arizona Project (CAP) Canal, Arizona

A Dissertation Presented in Partial Fulfillment
of the Requirements for the Degree
Doctor of Philosophy

ARIZONA STATE UNIVERSITY

May 2014

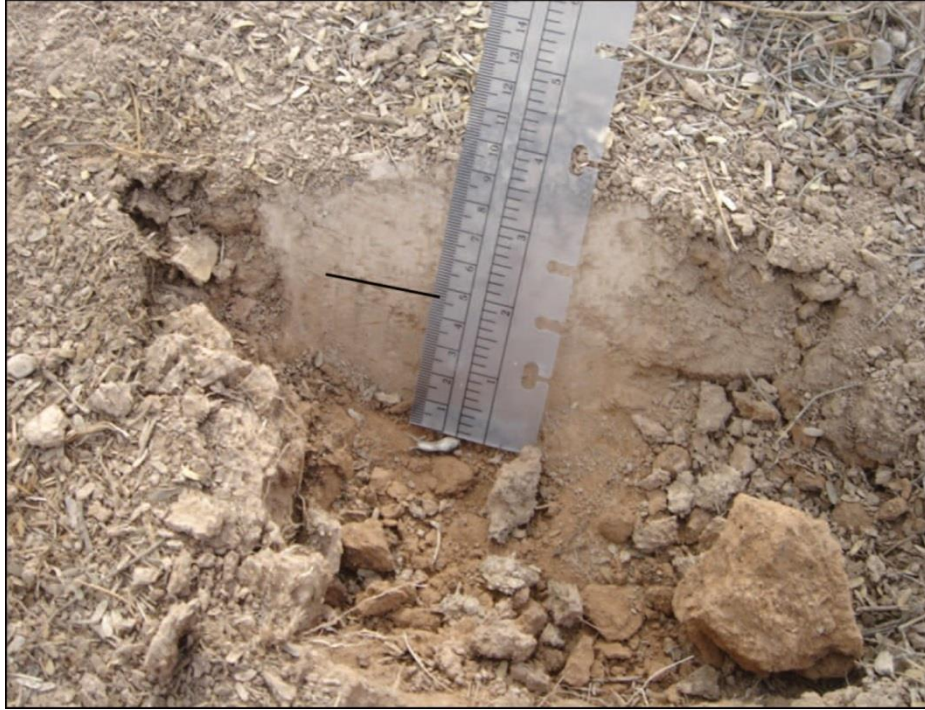
Figure 3. Layers of sediment in the study area. The uppermost (whitish-grey clay) layer is distinguishable by a subtle color change; its boundary with the reddish sandy layer below is marked by the black line adjacent to the ruler.

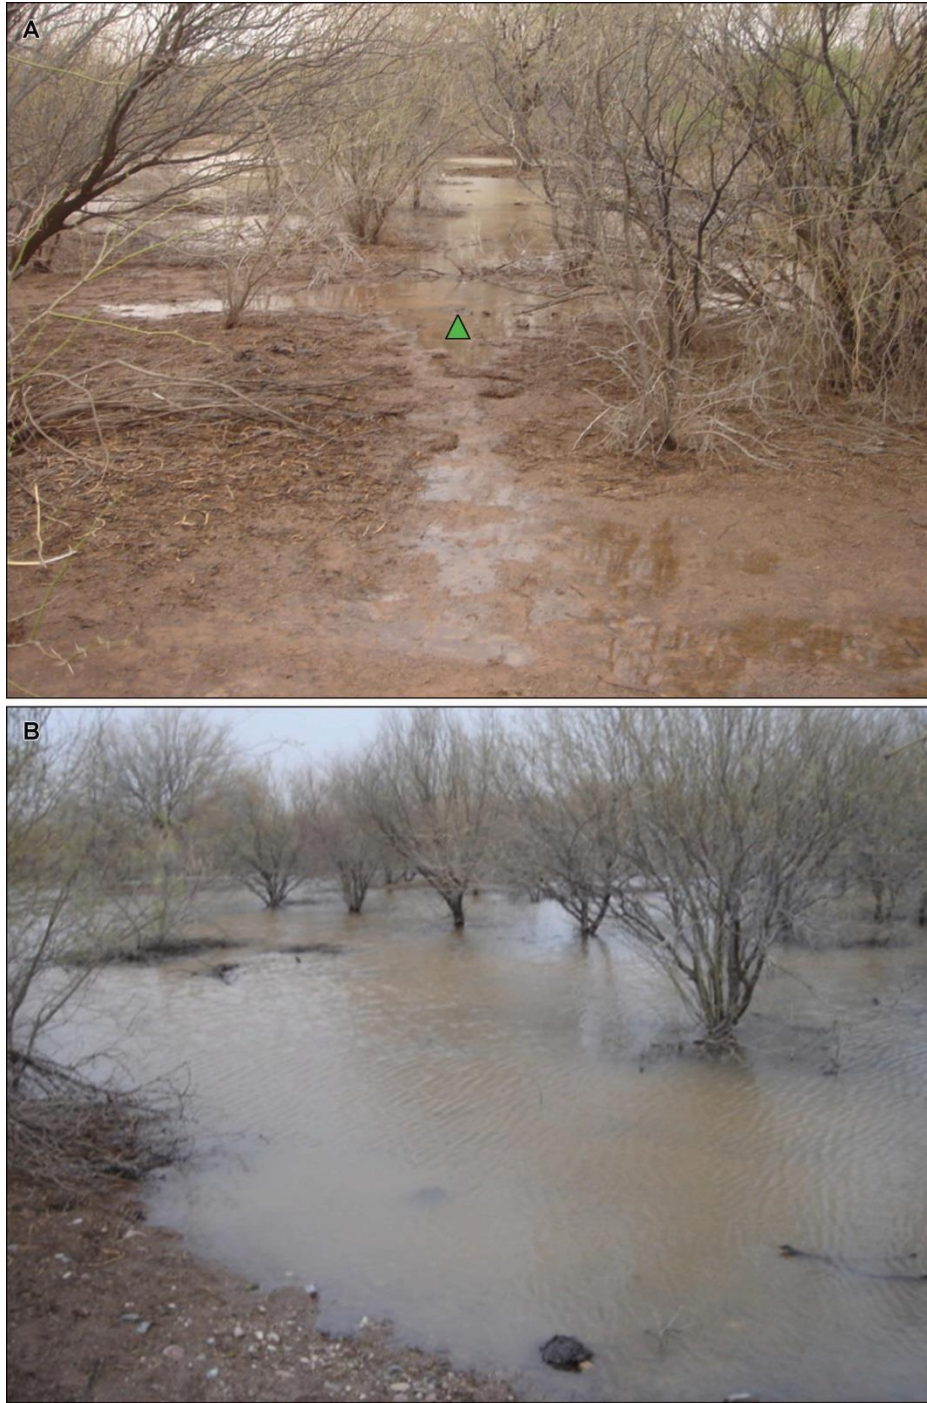
Figure 9. A. View facing southwest of storm water flows into the anthropogenic playa on January 23, 2010. The green triangle marks the end of the channel. B. Closer view, facing north, of water impounded by the canal.

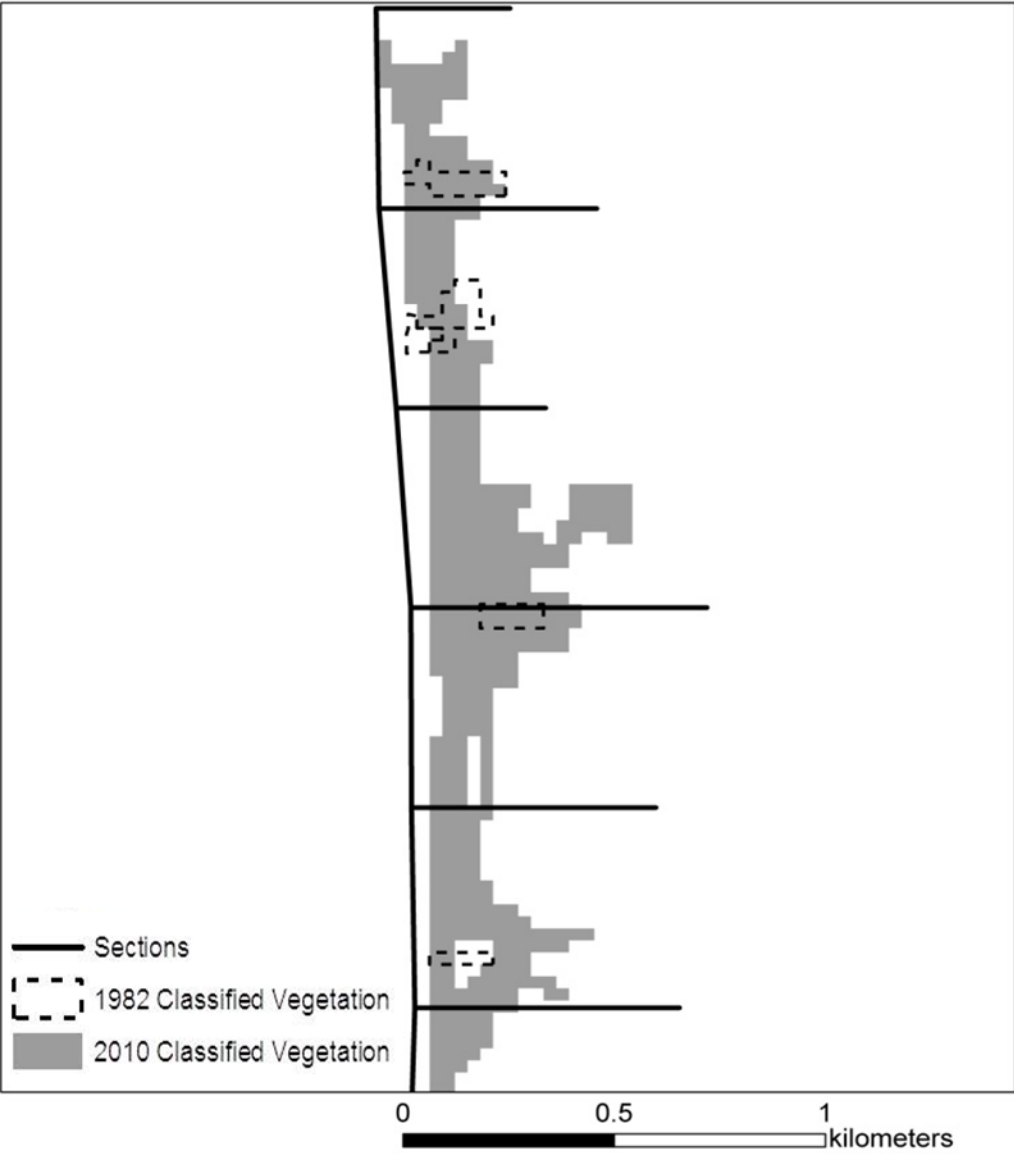
Figure 13. Vegetation change: the change was analyzed in 0.5 km sections along the canal.

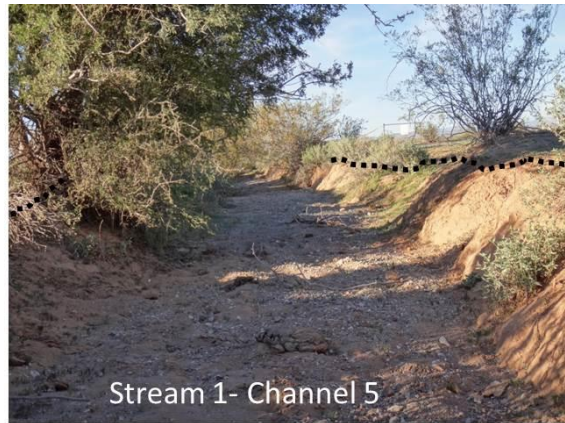
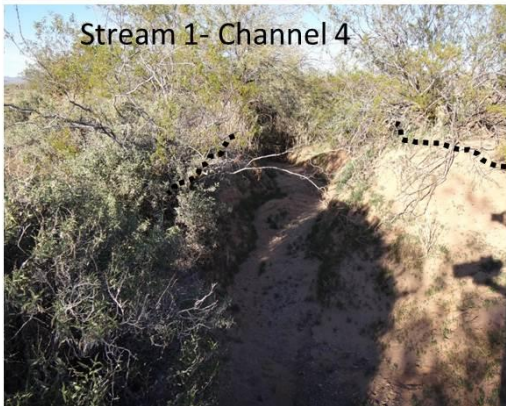
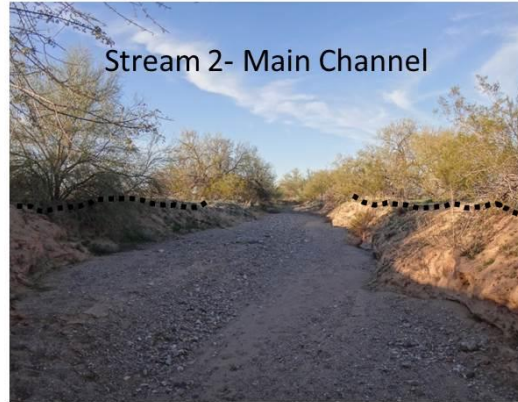
Figure 19. The above aerial photograph displays the channels that were surveyed in the field to calculate bankfull discharge rates. Stream 1 had eight channels (numbered in the aerial photo above) and Stream 2 had one channel. The photographs are examples of channel characteristics of the two sites where the dotted black line denotes the bank.

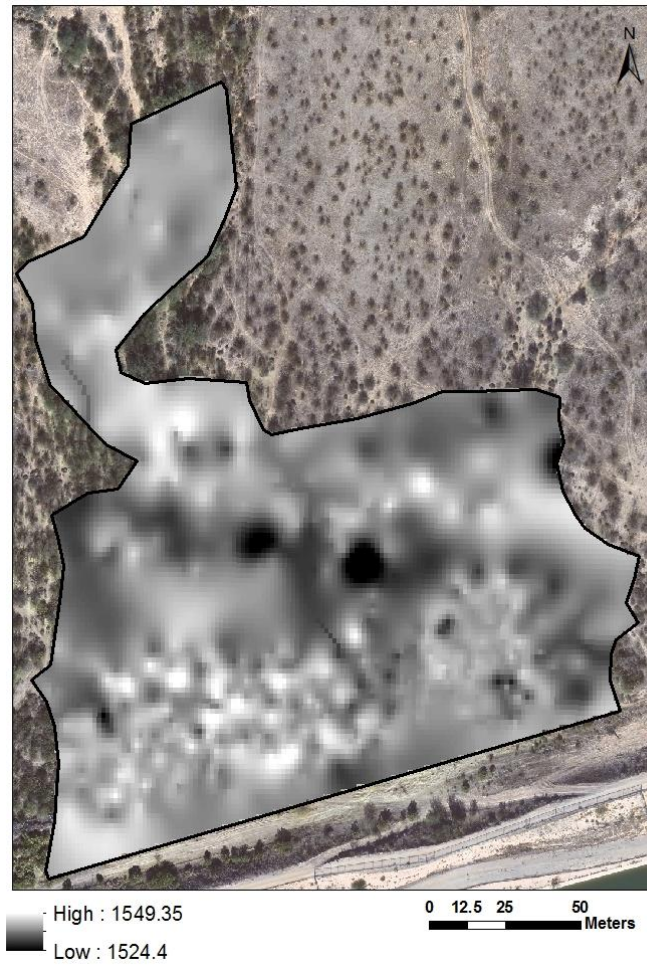
Figure 20. The topography of the green-up zone illustrates the numerous sources and sinks.

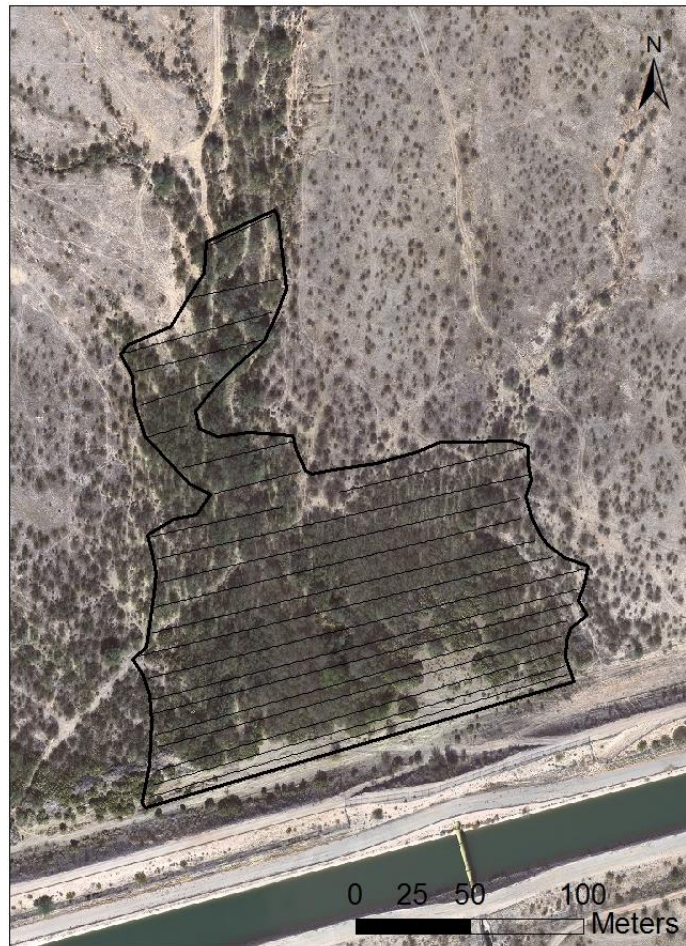
Figure 21. The figure displays the 20 transects used to calculate the total average volume contained in the green-up zone when flooded. The black boundary signifies the green-up zone boundary.

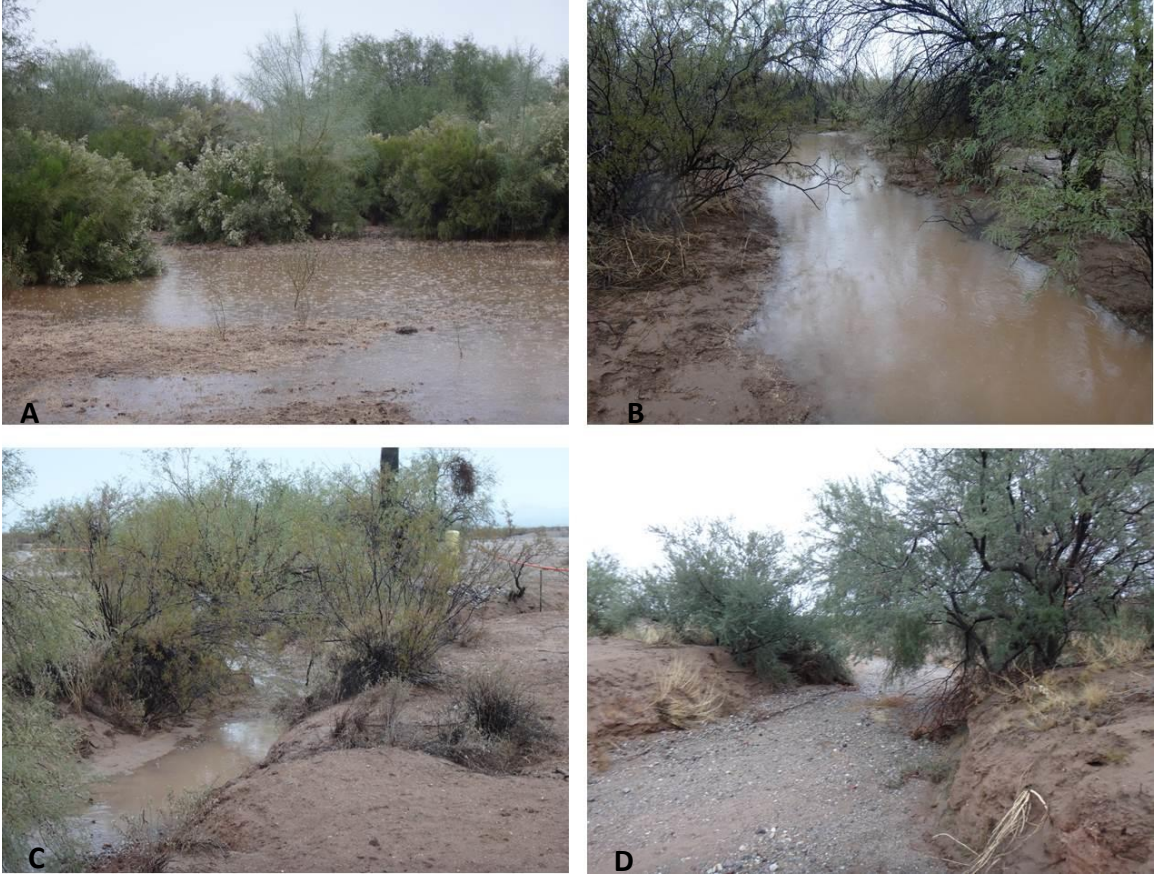
Figure 24. The images are all captured facing upstream (northward). Images A, B and C are in order from the canal's boundary (upstream) to approximately 350 meters upstream. No flow was present in the Stream 2 shown in image D. Precipitation data downloaded from the FCDMC shows this area received approximately 0.04 inches of rain about every half hour totaling to about 1 inch of rain during the time the pictures were taken in the field.

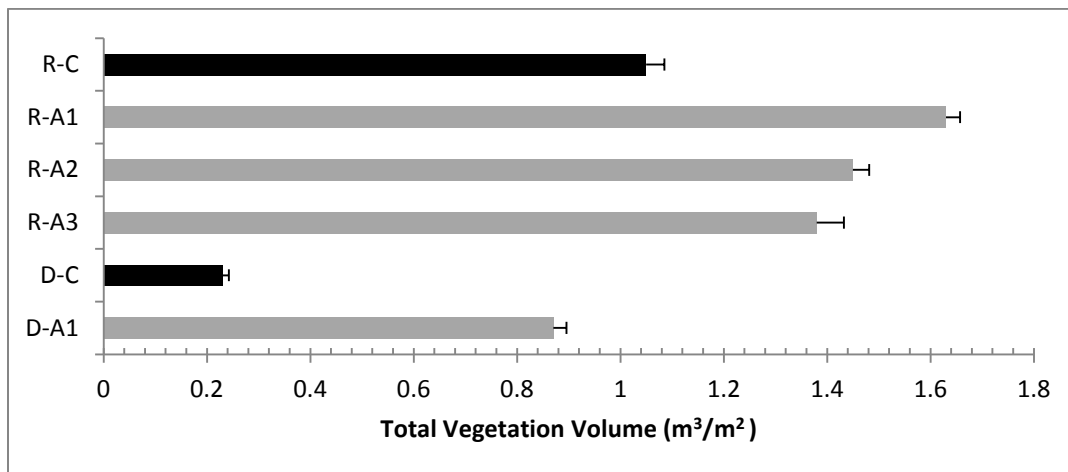
Figure 29. Total vegetation volumes for each zone.

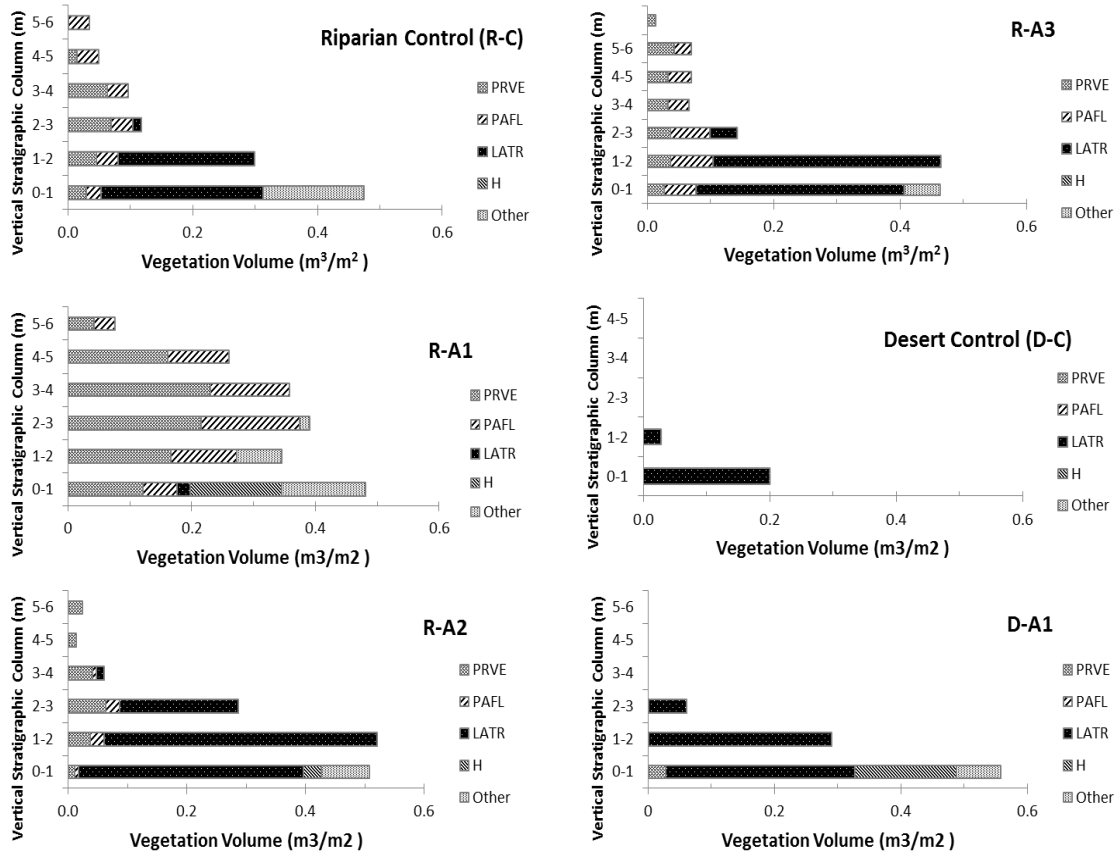
Figure 30. Vegetation volume of species within each sampled zone.

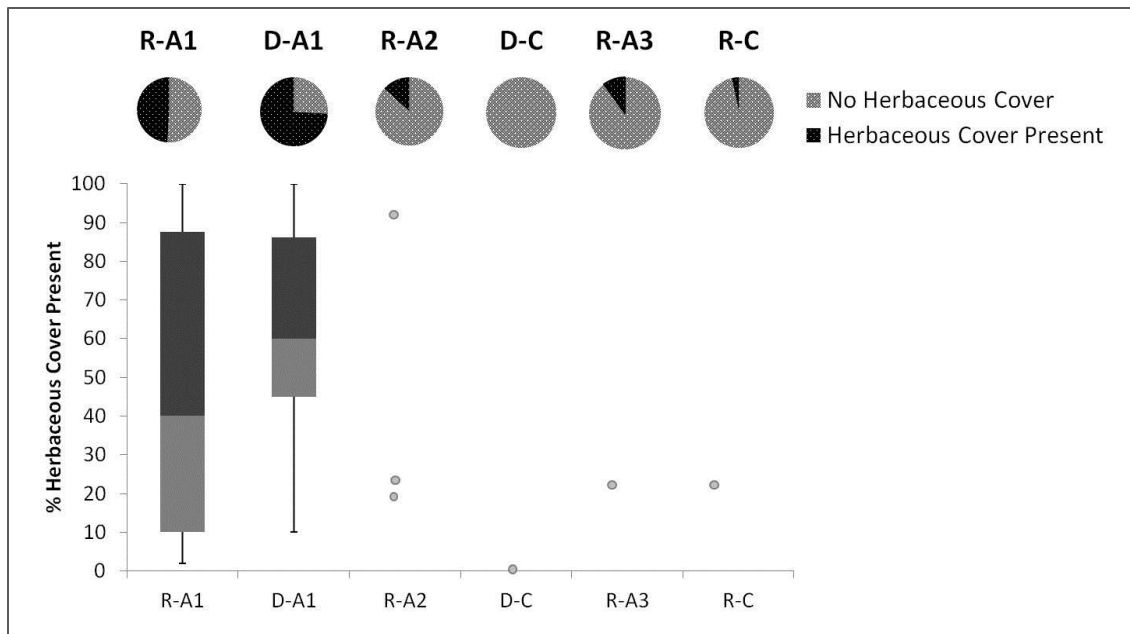
Figure 33. Percent herbaceous cover for each zone.

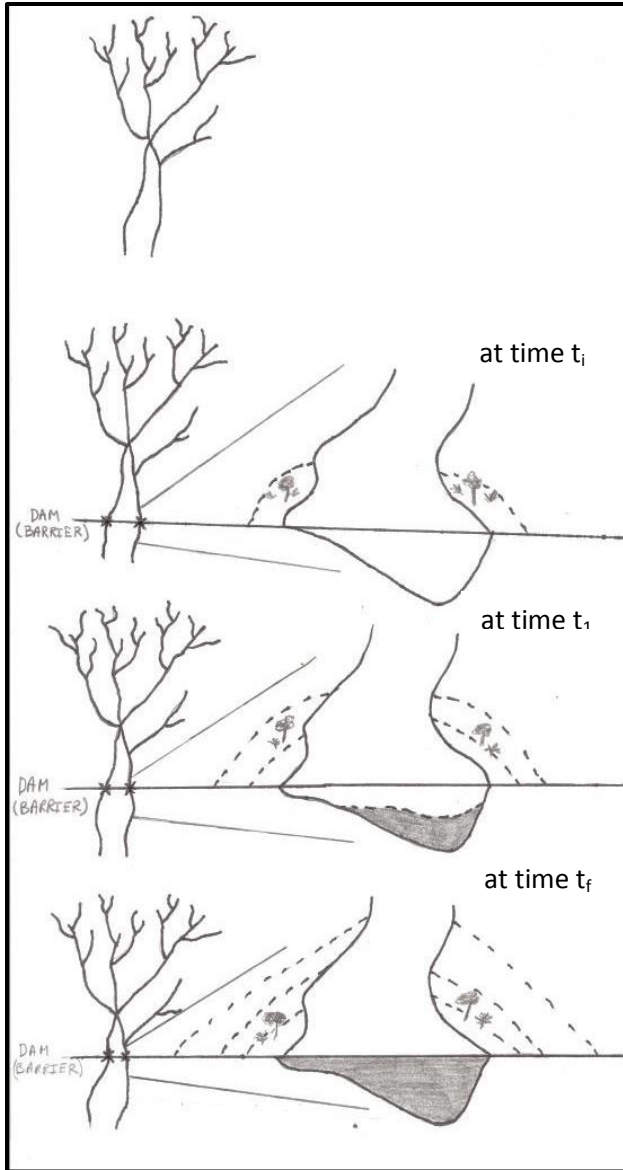
Ephemeral stream network
before canal construction

Green-up initiation along the
banks of the channel. The
initial boundary of green-up
depends on the maximum
runoff volume dammed, V_R .
