Characterization and Analysis of Long Term Field Aged Photovoltaic Modules and
Encapsulant Materials

A Thesis Presented in Partial Fulfillment
of the Requirements for the Degree
Master of Science

ARIZONA STATE UNIVERSITY

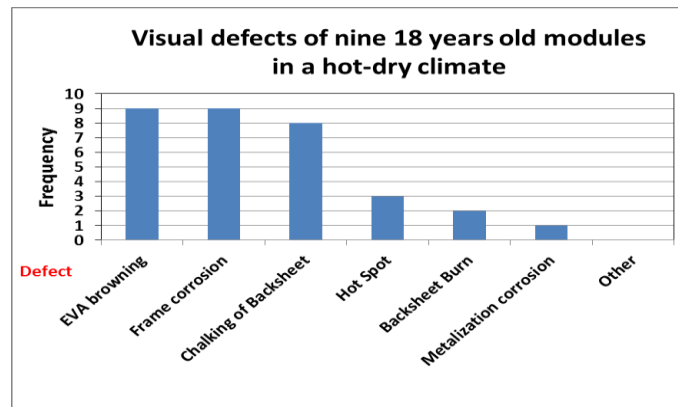
Visual inspection was done on one fresh module (stored indoor) and nine field aged modules of Siemens M55 Model with nameplate rating of 53 W. A Pareto chart displaying all the visual defects observed on the field exposed modules (18 years) is shown in Figure 1. However, it should be noted that not every visual defect seen on a module will have an effect on the power output of the module. Three defects were seen in every field aged module: EVA browning, frame corrosion and chalking of the backsheet. No delamination or cell damage was observed for these nine field aged modules.

Figure 1: Pareto Chart Showing Visual Defects Observed in Nine, 18 Years Old Modules Using NREL Checklist. “Other” Refers to Anything Else in the Checklist that was or was not Observed.

One of the modules, 514183, had the following defects: backsheet burns, EVA browning, frame corrosion (very minor), hot spots, and backsheet chalking. Not all of these defects

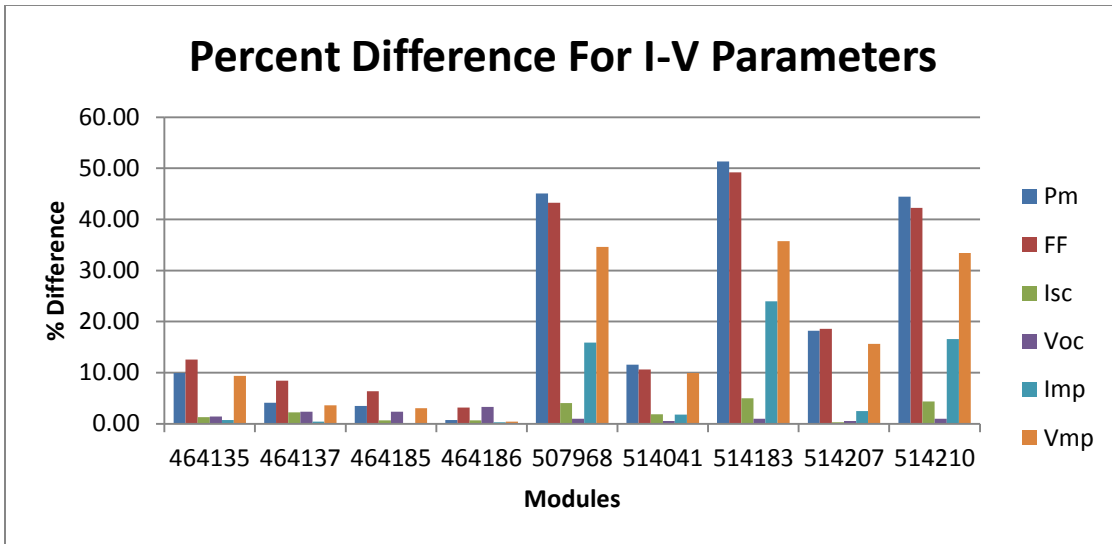
Figure 4: Degradation of I-V parameters for 9 Fielded Modules as Compared to the Control Module Over 18 Years Hot Dry Climate of Arizona

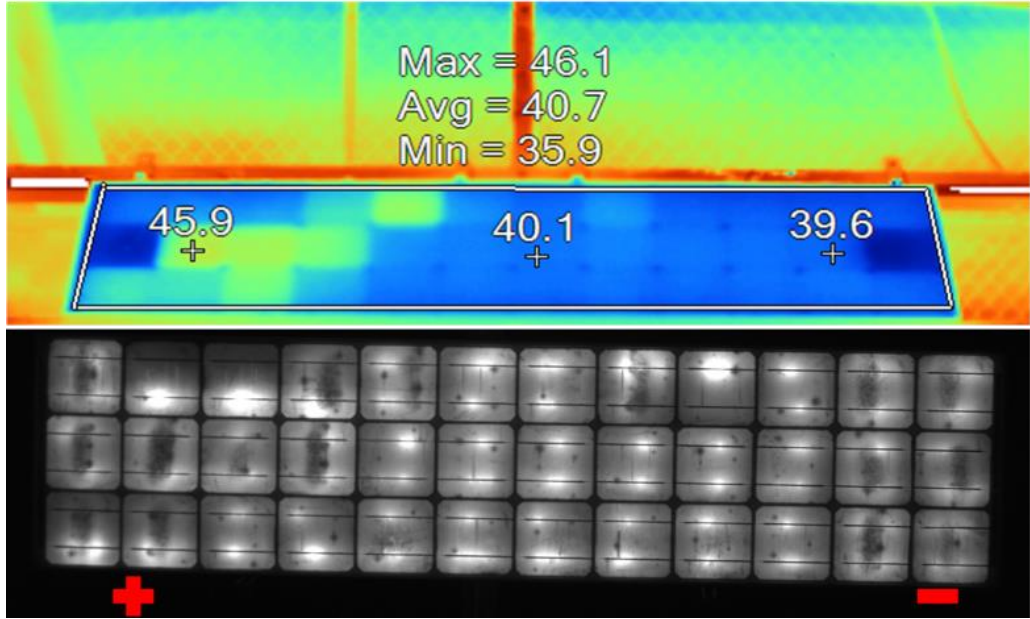
All Arizona modules were investigated with the aid of Infrared (IR), and electroluminescence (EL) imaging equipment and software. In Figure 7-9, the results of module 514183 one of the worst modules, 464186 one of the best modules, and 514207 one of the median modules are shown for the Arizona modules. The multiple hotspots depicted in Figure 7-9 correspond to the bright white spots in the EL image indicating areas where excessive current is being forced to travel through due to the other local solder bonds breaking, or degrading. The dark regions in Figure 7-9 depict both shunted cells, metallization finger detached regions and broken solder bond. Other patterns in this evaluation of all nine modules as shown by IR imaging have indications of hot cells, generally only located over junction boxes.

Figure 7: Arizona Module EL (bottom) and IR (top) of Module 464186(best)

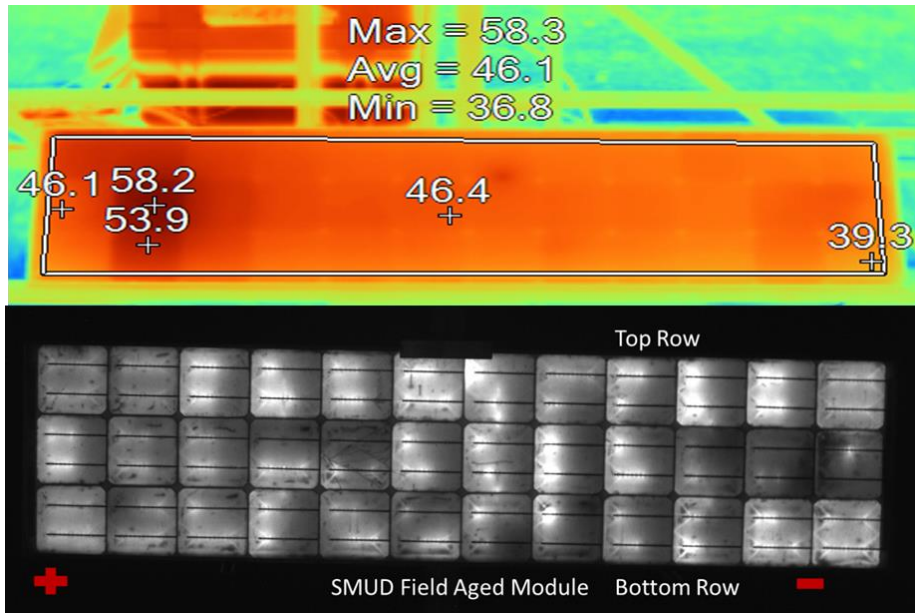
The IR and EL images of the control and field aged SMUD modules is shown in Figure 10 and Figure 11. The positive junction box in these images is on the left side along with the metal plate warning label. These areas combined with the extra heat from the junction box are significantly hotter than the rest of the module due to restricted direct air access to the backsheet. Slightly higher operating temperature of the aged module, in the non-junction box regions, may be attributed to the I^2R heating due to metallization degradation as evidenced in the R_s increase and the temperature coefficient increase.

Figure 10: California SMUD aged module IR (Top) and EL(bottom)

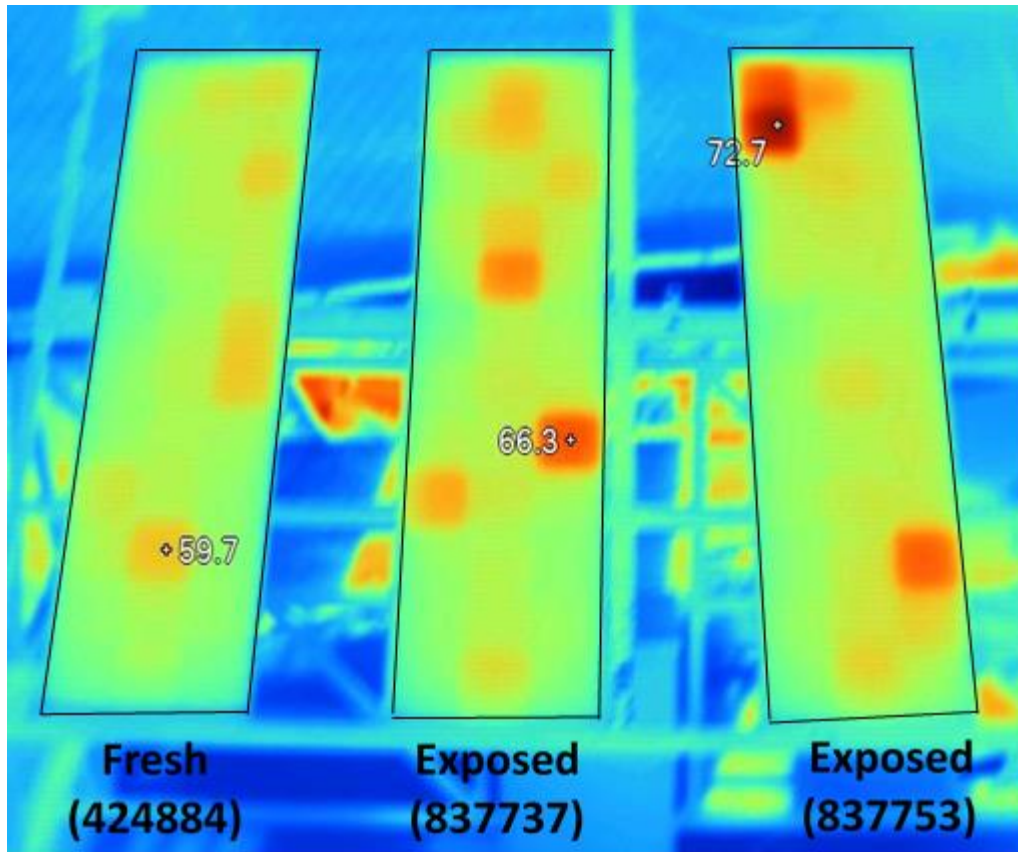
The IR and EL images of the control and field aged Denver modules is shown in Figure 12 and Figure 13. The EL images clearly indicate that the control module has somehow experienced localized metallization related damages during the storage or it might have been briefly accelerated stress tested leading to metallization damages without causing any browning. These damages may not be severe enough to affect the performance or I_{sc} of the cell as there is no browning issue but they are expected to affect localized QE curves obtained in spots of each cell as discussed later.

Figure 12: IR of Denver Modules

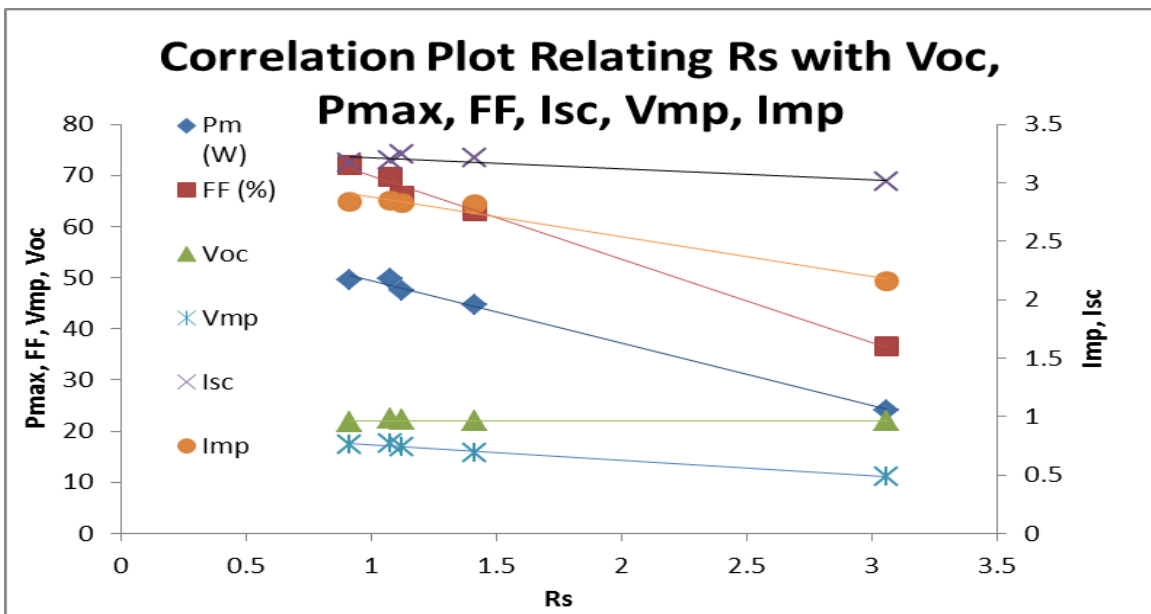
all the I-V parameters versus R_s . Fill factor was the most affected parameter and is the primary cause for P_{max} drop due to increase in series resistance, and then encapsulant browning. The degradation of cell interconnects including solder bonds and/or cell metallization was suspected to be the cause for the series resistance increase. Because this trend is based on the physical properties of a module operation this trend is expected in all environments to varying degrees based off of their series resistance.

Figure 14: Series Resistance Effect on the Various I-V Parameters.

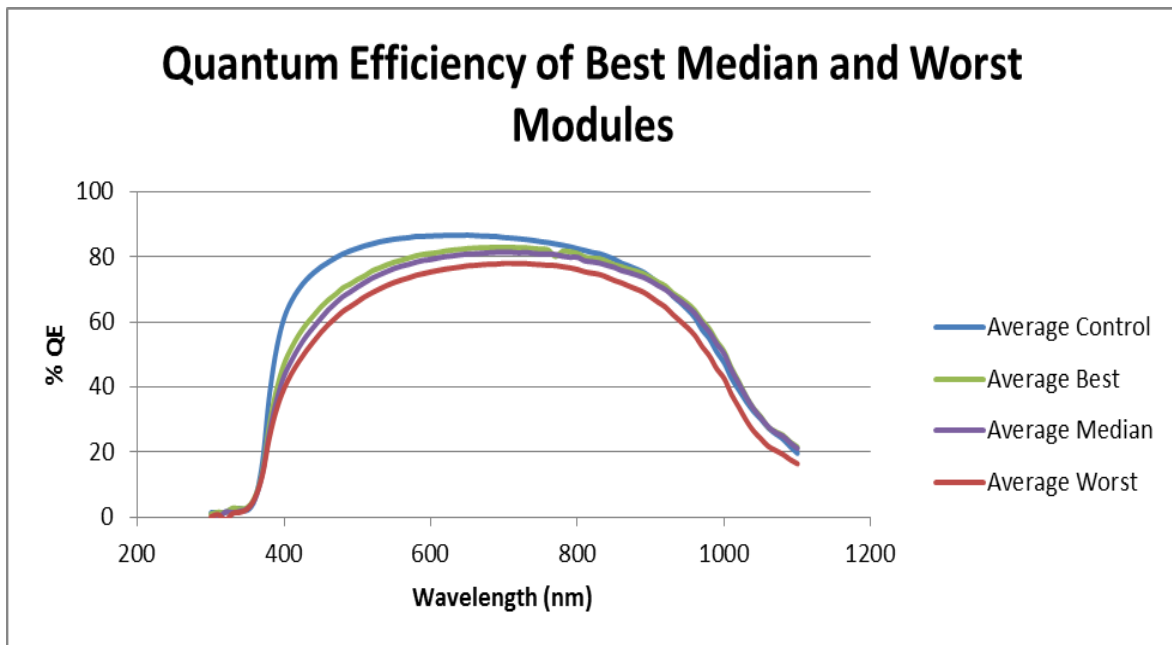
Figure 18: QE of Each Category, Best, Median, and Worst Modules of Arizona

Figure 18 shows the trend series resistance has on the spectral response of a module. The two parts of energy generation in solar modules are first being able to absorb the sunlight and generate electrons, and then being able to collect those electrons. With an increase in series resistance a modules ability to capture all the light generated electrons is hindered resulting in a reduction in QE. As shown in Figure 18 the area referred to as the “series resistance effected region” (650-1100nm) suffers further loss in QE as the series resistance increases from the best to worst category of modules for the Arizona climate. Due to the small number of modules received from the other two environment’s this graph could only be produced for the Arizona climate.

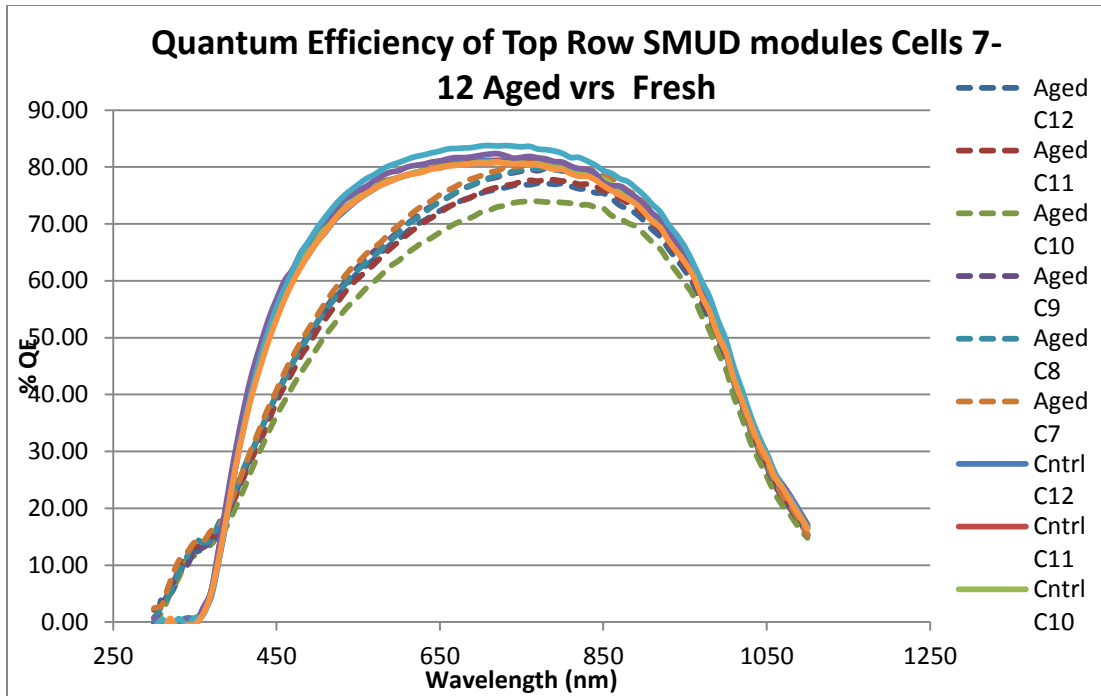
Quantum efficiency measurements were taken for every cell of the SMUD aged and control module as well. The QE curves for the control and field aged modules are shown in Figure 22. Much like the Arizona modules browning was suspected to play a major role in the observed drop of power based on the I-V measurements. It is interesting to note that the QE of field aged modules below 390nm is higher than the control module and this may possibly be attributed to the exhausted UV absorber additives in EVA leading to higher QE for the aged module at lower wavelengths.

Figure 22 SMUD Aged and Control Module QE Graph

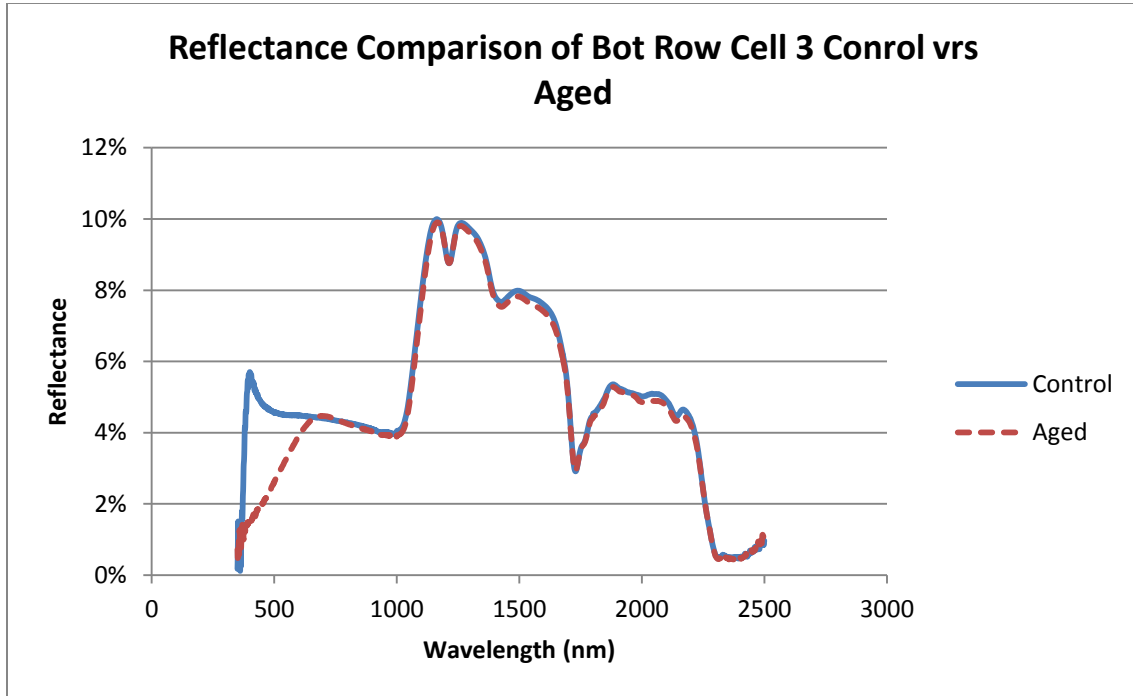
The reflectance spectra obtained for the fresh/control and exposed modules are shown in Figures 23 and 24. The peak seen around 400 nm on the control module, which is caused by the anti-reflective coating, is not there for the aged module which lead to an average reflection loss of 2% from 350-1110nm. The average reflectance from 350 to 700nm for the control module was 5%. The average reflectance of the field aged module from 350-700nm was 2%. The reason for the loss in reflectance in this area is due to the browned encapsulant increased absorption in this region. Due to the encapsulant degradation the anti-reflective coating has either been affected chemically or is not being utilized because the browned EVA is not absorbing the light that would be reflected. Further attention will be given to this point during future research.

Figure 23: Reflectance Comparison Between Control and Aged SMUD Modules

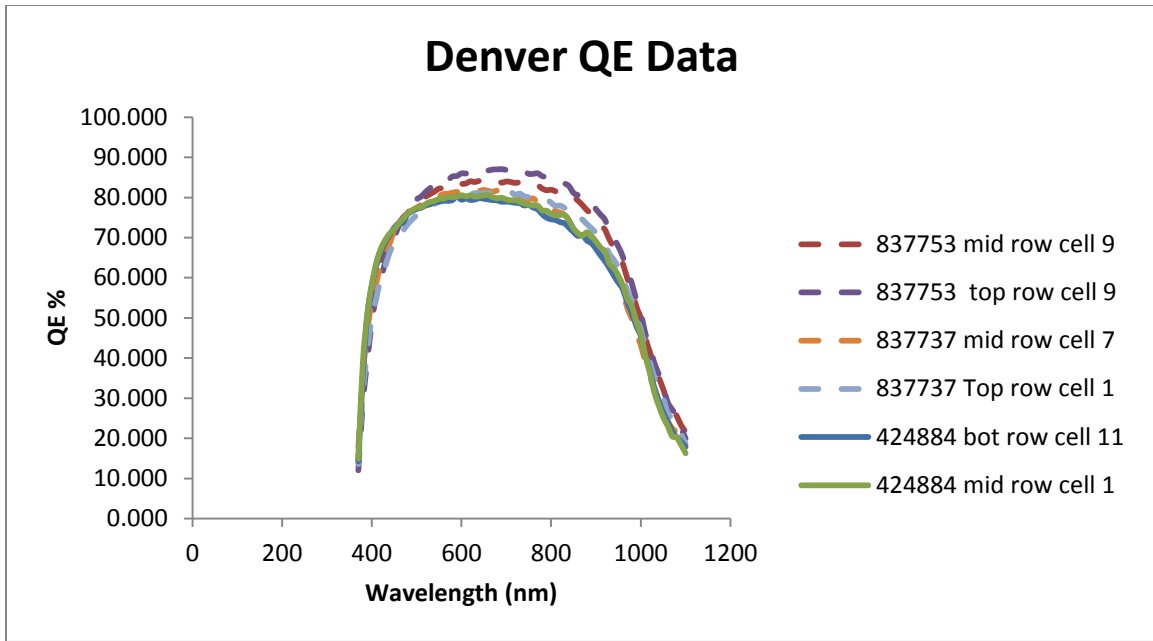
Figure 25: Aged (dashed line) and Control (solid lines) Module Graph of Denver Modules

Figure 25 shows the QE graph of the aged and control modules from Denver. As stated previously it was believed after analysis that the Denver control module may have cell metallization damages as evidenced in the EL images presented earlier and hence it was not considered as an ideal control module for spot-specific QE and this measurements is why the control module 424884 shows a lower QE than the other two aged modules. Figures 26 and 27 show the Denver location module reflectance data. As expected the control module experiences higher reflectance values at both center of cell and edge of cell locations. The main cause of this difference as compared to the other two sites (Arizona and California) was suspected to be very mild extent of browned encapsulant in both of the aged Colorado modules. An interesting difference between the Denver modules and the other two locations was that the reflectance for the Denver modules was different throughout the whole spectrum and not just in the 300-500nm

range..This difference could possibly attributed to the absence of browning and to presence of mild optical decoupling at the cell/encapsulant or glass/encapsualt interface due cold temperature induced delamination. Figure 28 provides an overlaid QE and reflectance plots for one of the aged modules. As evidenced from the absence of QE and reflectance responses below 400nm, Figure 28 clearly indicates that the UV absorber is not lost in the encapsulant of these Colorado aged modules.

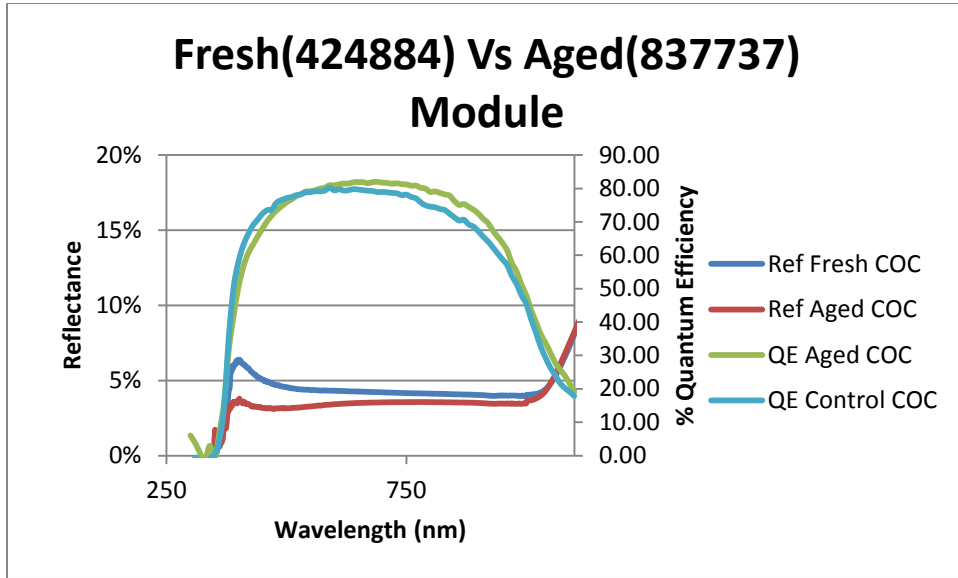
Figure 28: QE and Reflectance Overlay Graph for Aged and Control Colorado Module

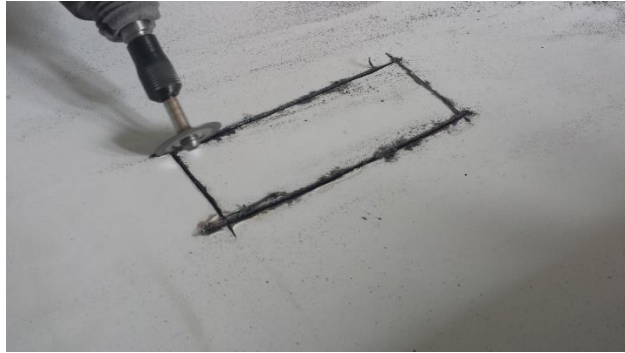
Figure 30: Diamond Dremel Tool Cutting Out the Center Part of a Cell

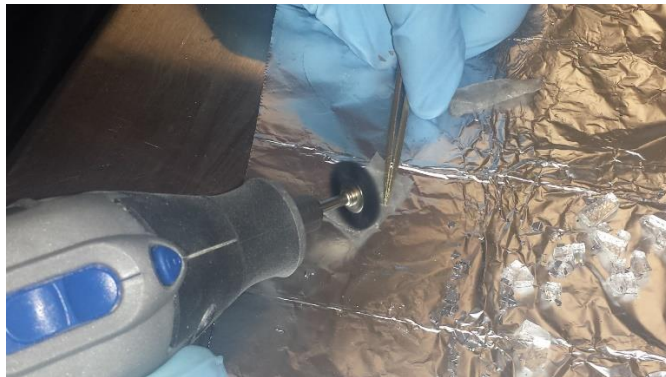
Figure 31: Dremel Tool Plastic Brush Cleaning the Extracted EVA layer

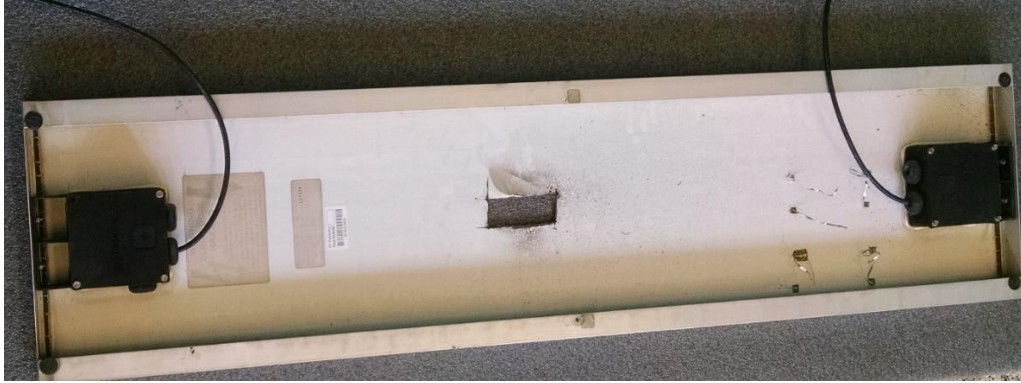
Figure 32: Photograph of a Module With Center Part of a Cell Removed from the Laminate

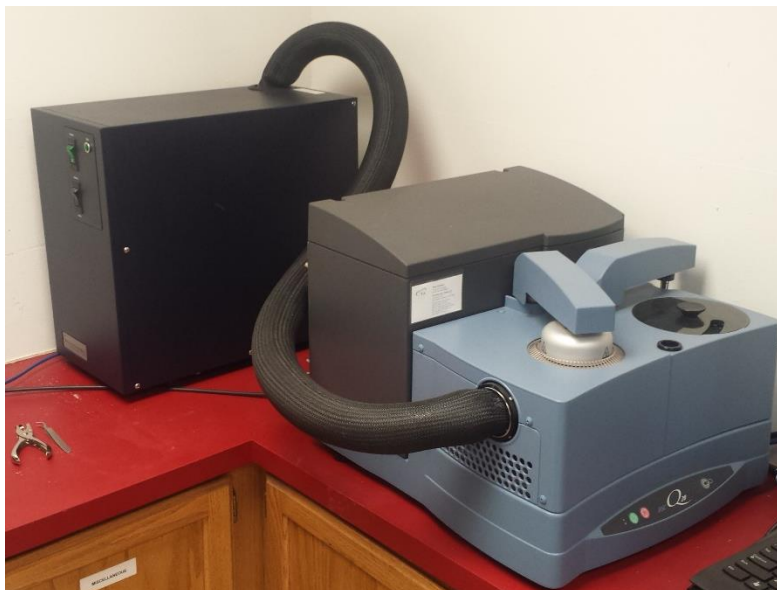
The DSC Q20 from TA instruments, shown below, was used to perform all DSC measurements. Small hole punch samples were placed into sample holders for each run performed. The sample holders shown in figure, were placed into an air tight chamber and a run sequence was chosen based off of the desired analysis of the experiment. Various run sequences were performed based off of current standards and conditions required to test for a variety of physical states such as melting transition, crystallization temperature, glass transition state, and degree of curing calculations.

Figure 34: DSC and Cooling Tower Attachment Used for DSC Analysis

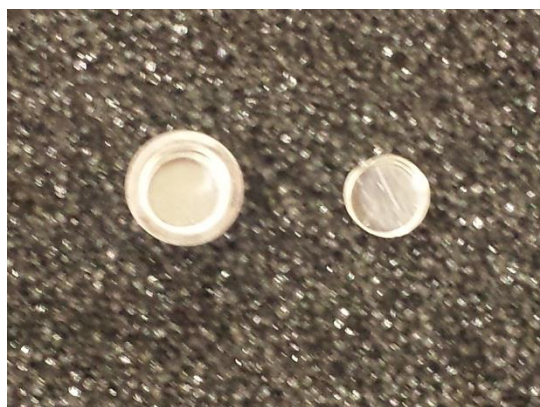
Figure 35: Hermetically Sealed pan (left) with its Lid (right)

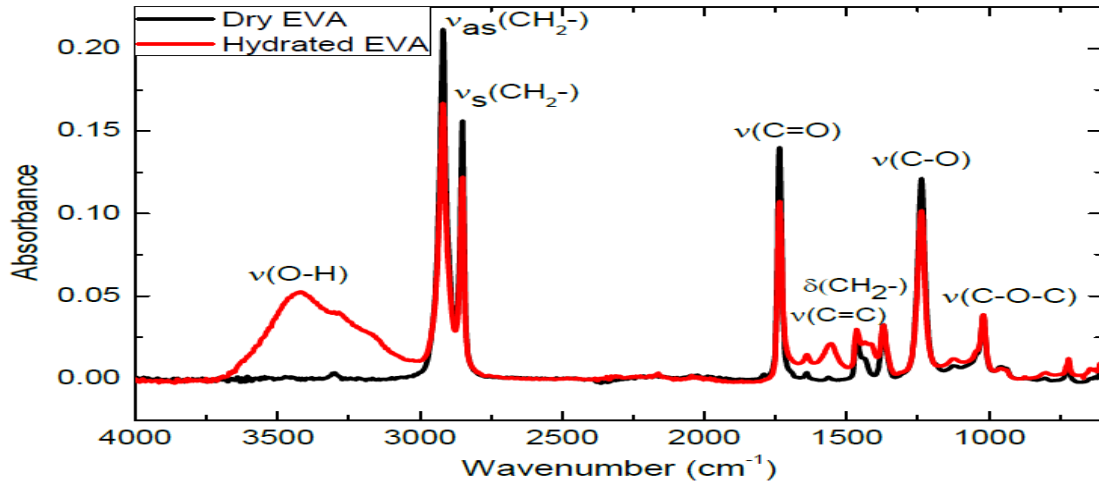
Figure 36 and Table 3 show the typical FTIR spectra of dry and hydrated EVA [9]. The potential degradation pathway of EVA due to heat and UV is shown in Figure 29 . FTIR spectra shown in Figures 37-39 and Table 4 for the EVA of aged SMUD module indicate the absence of hydrolysis (broad peak at $3200-3600\text{ cm}^{-1}$) but presence / formation of polyenic chromophores (1641 cm^{-1} , 1545 cm^{-1}). Based on the small (may be considered not significant) broad peak around 1600 cm^{-1} , UV-Vis-NIR reflectance spectra between 400 and 650 nm and the spectral/QE response between 400 and 650 nm, it may be possible to indicate that the polyenic chromophores have been formed only for the front-EVA of the aged sample due to heat and UV, but not for the control samples (no UV or heat) and the back-EVA of the aged sample (no UV). To confirm this argument, this study needs to be extended with additional number of samples from this and other modules which have browned EVA. The acetic acid formation due to deacetylation (Norrish II reaction pathway) may lead to corrosion of metallization, busbars, solder bonds, cell interconnects and string inter connects. Corrosion of these components is expected to increase the series resistance of the cell leading to fill factor drop (see Table and Table1 and 2). Figures 40 and 41 are the FTIR graphs of the Arizona aged modules. These modules show simliar results as the SMUD modules.

Figure 36: Typical FTIR Spectra of Dry and Hydrated EVA [9]

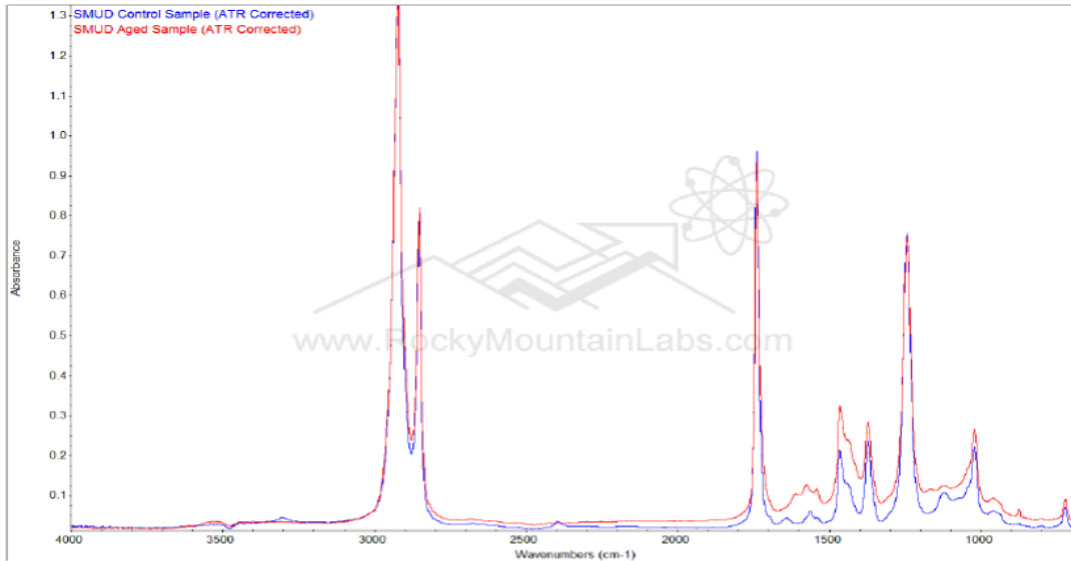
Figure 37: FTIR of Extracted EVA for SMUD Modules Control and Aged

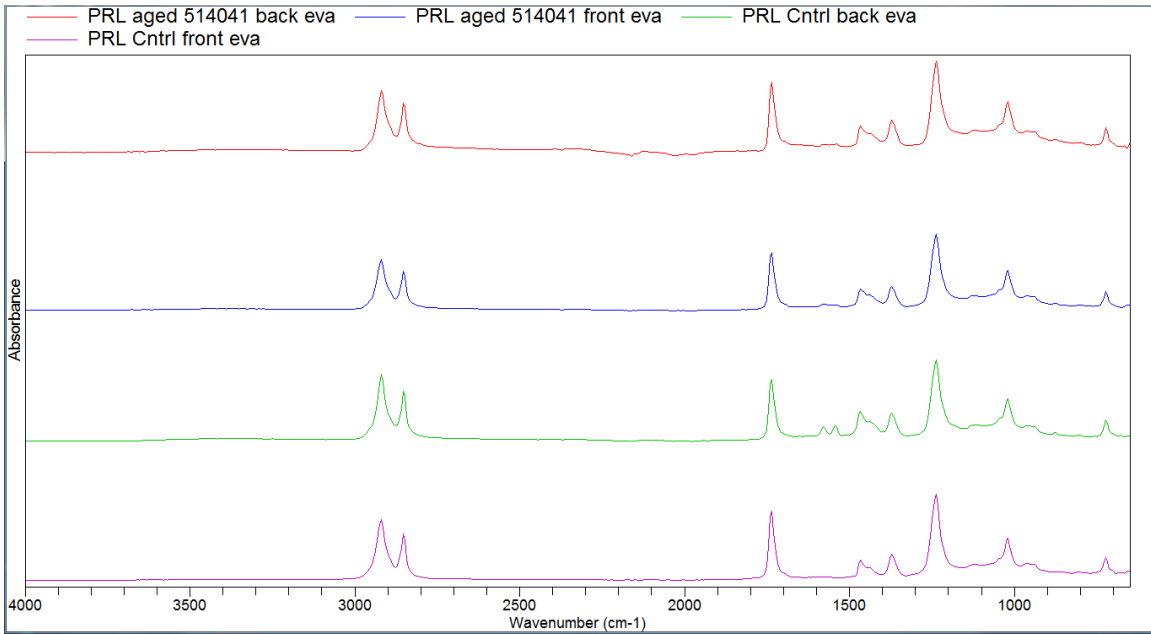
Figure 40: PRL Aged and Control Module FTIR Stacked Display

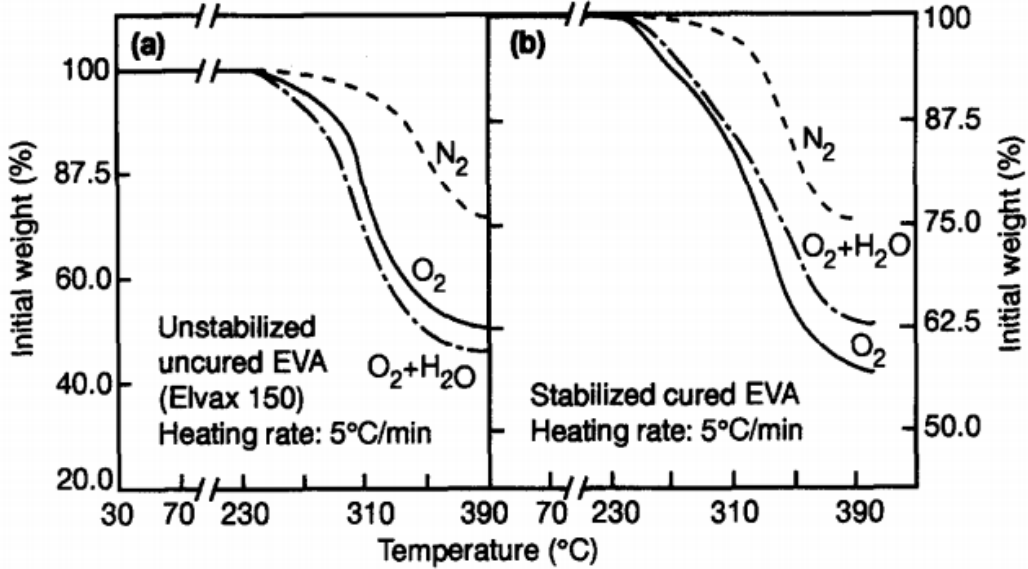
Figure 46 and 47 provides the TGA thermograms obtained in dry N₂ atmosphere for front-EVA and back-EVA of both control and aged modules. Figure 48 provides the TGA thermograms for the stabilized and cured EVA in dry N₂, O₂, and O₂ saturated with water vapor. Comparison of these thermograms in these two figures indicates that the EVA material in the aged module has not been affected by the reactions caused by oxygen or moisture. Based on the QE, reflectance, FTIR and TGA studies, it may be possible to conclude that the observed EVA discoloration is apparently caused by heat and UV without significant influence from atmospheric oxygen and humidity.

Figure 48: TGA Thermograms of Encapsulant in Various Conditions [8]
