Characterization of Landslide Geometry and Movement

Near Black Canyon City, Arizona

A Thesis Presented in Partial Fulfillment  
of the Requirements for the Degree  
Master of Science

ARIZONA STATE UNIVERSITY

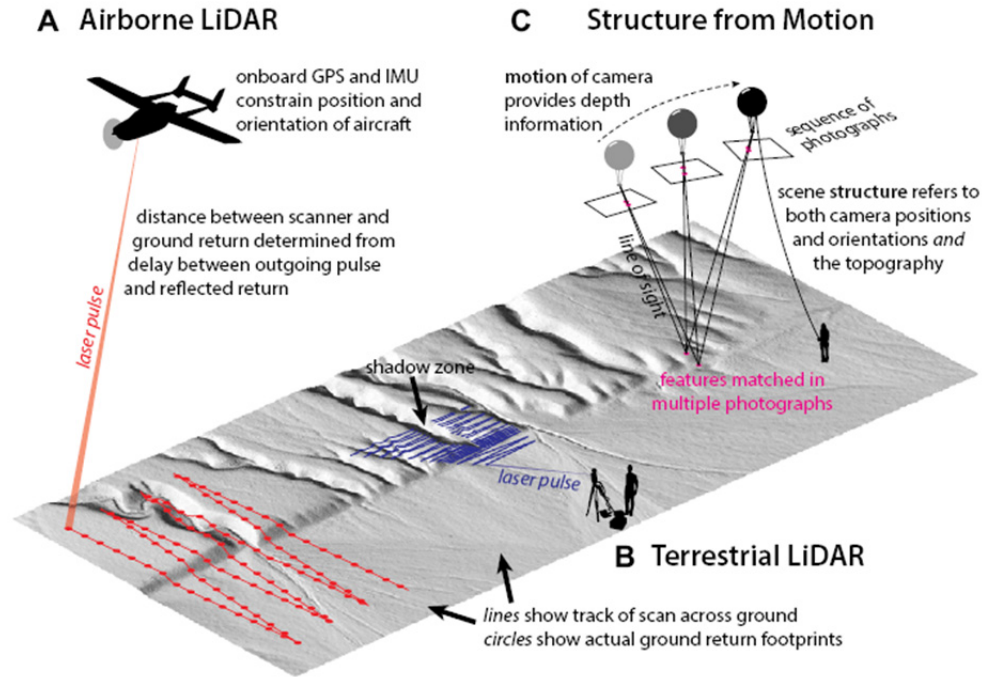
Figure 1. Illustration of three different methods of image data acquisition: airborne LiDAR Scanning (ALS), Terrestrial LiDAR Scanning (TLS) and Balloon Photography (adapted from Johnson et al., 2014)

this method are also useful for land-use planning and development, as shown by Lucieer et al. (2014). Comparison between the LiDAR and SfM data acquisition is shown in Figure 1. We implement the SfM method using imagery obtained from balloon and UAV to generate a high-resolution topography data to map the BCC landslide, in detail.

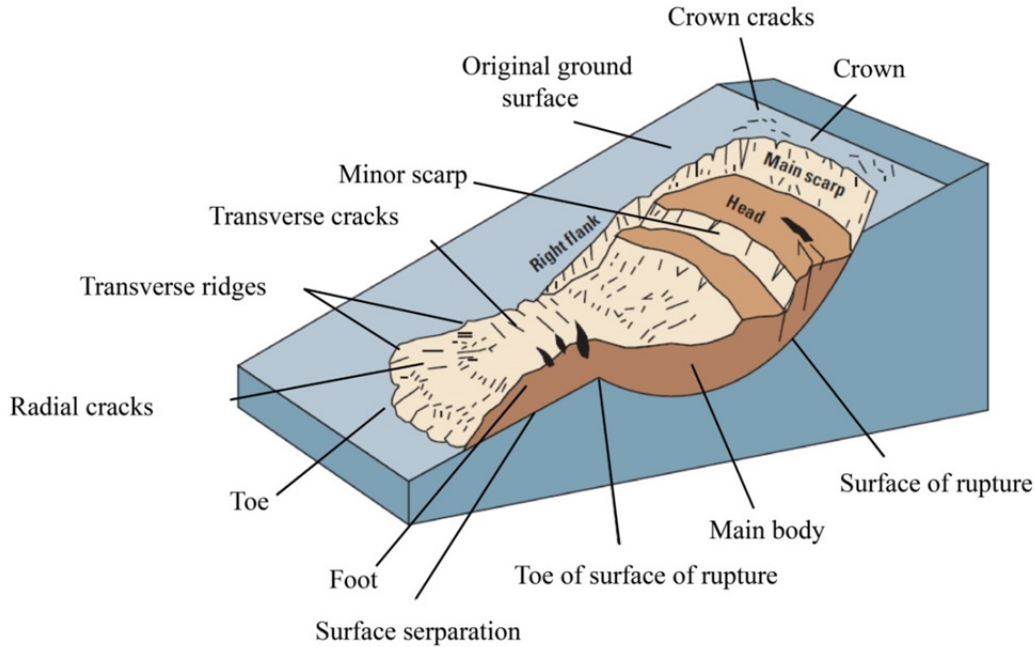
Figure 2. Diagram showing the primary features of a rotational landslide (from Highland and Bobrowsky, 2008)

A rotational landslide is a slope movement, observable at the surface through series of surface ruptures that are commonly characterized by curved, concave-up basal detachment surface (Varnes, 1978)(Figure 2). The rotational events may occur along one or more sliding surfaces that can be activated in single, multiple, or successive slide events. The single rotational slide is characterized by a concavely upward-curving failure surface where the axis is parallel to contour line (Varnes, 1978). Based on the principal failure or detachment surface position, the geometry of the single rotational slide is divided into slope, toe and basal failures (from Hutchinson, 1988 in Dikau, 1996). The surface manifestation of the multiple rotational slide surfaces is similar to the single, except that the slope failure is developed into at least two or more blocks where each of the shear surfaces is tangential to the main basal slip surface (from Hutchinson, 1988 in Dikau, 1996). Where a single, shallow rotational slide occurs progressively downward along the slope the slide caused by this successive movement is called successive slides (Haefeli, 1948; Skempton and Hutchinson, 1969). In the contour map, a rotational slide is indicated by irregular, wavy contour lines (as an indication of scarp), stepped pattern, and closely or regularly spaced discontinuous lineaments (Rib and Liang, 1978).

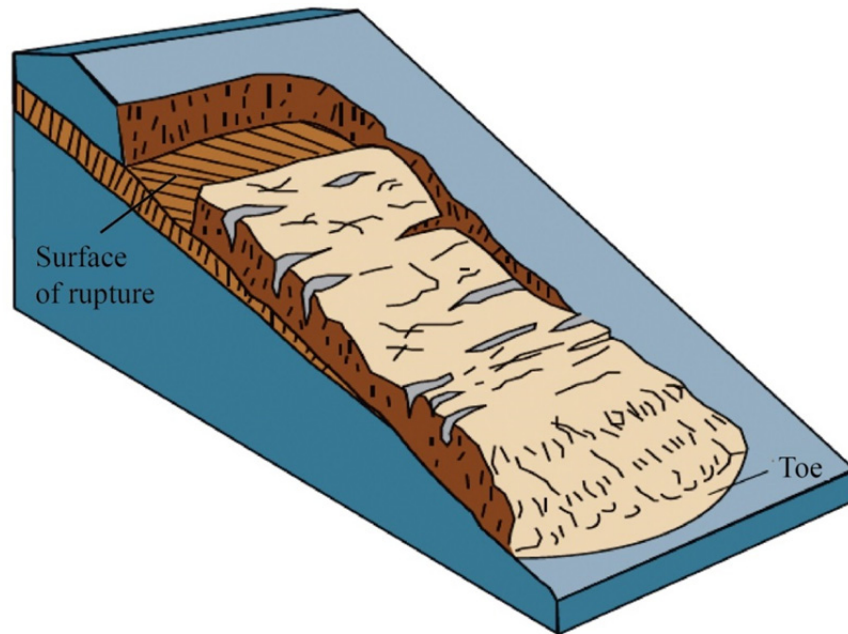
Figure 3. Diagram of characteristic features of translational landslide (from Highland and Bobrowsky, 2008)

A translational landslide is a mass movement that involves translation of a slide mass along a relatively planar surface, occasionally followed by small rotational movement or backward tilting at the base (Dikau, 1996) (Figure 3). This slope failure is normally localized by a pre-existing weak interface along which the motion occurs. The surface failures commonly occur along geologic discontinuities, such as the intersection of jointing surface, fault, inclination or sub-horizontal bedding surfaces and along contact between rocks and soil. The material involved in translational landslide ranges from unconsolidated soil, loose and un-stratified sediment to large scale slabs of rock, or both determined by the slope failure and the sliding speed.

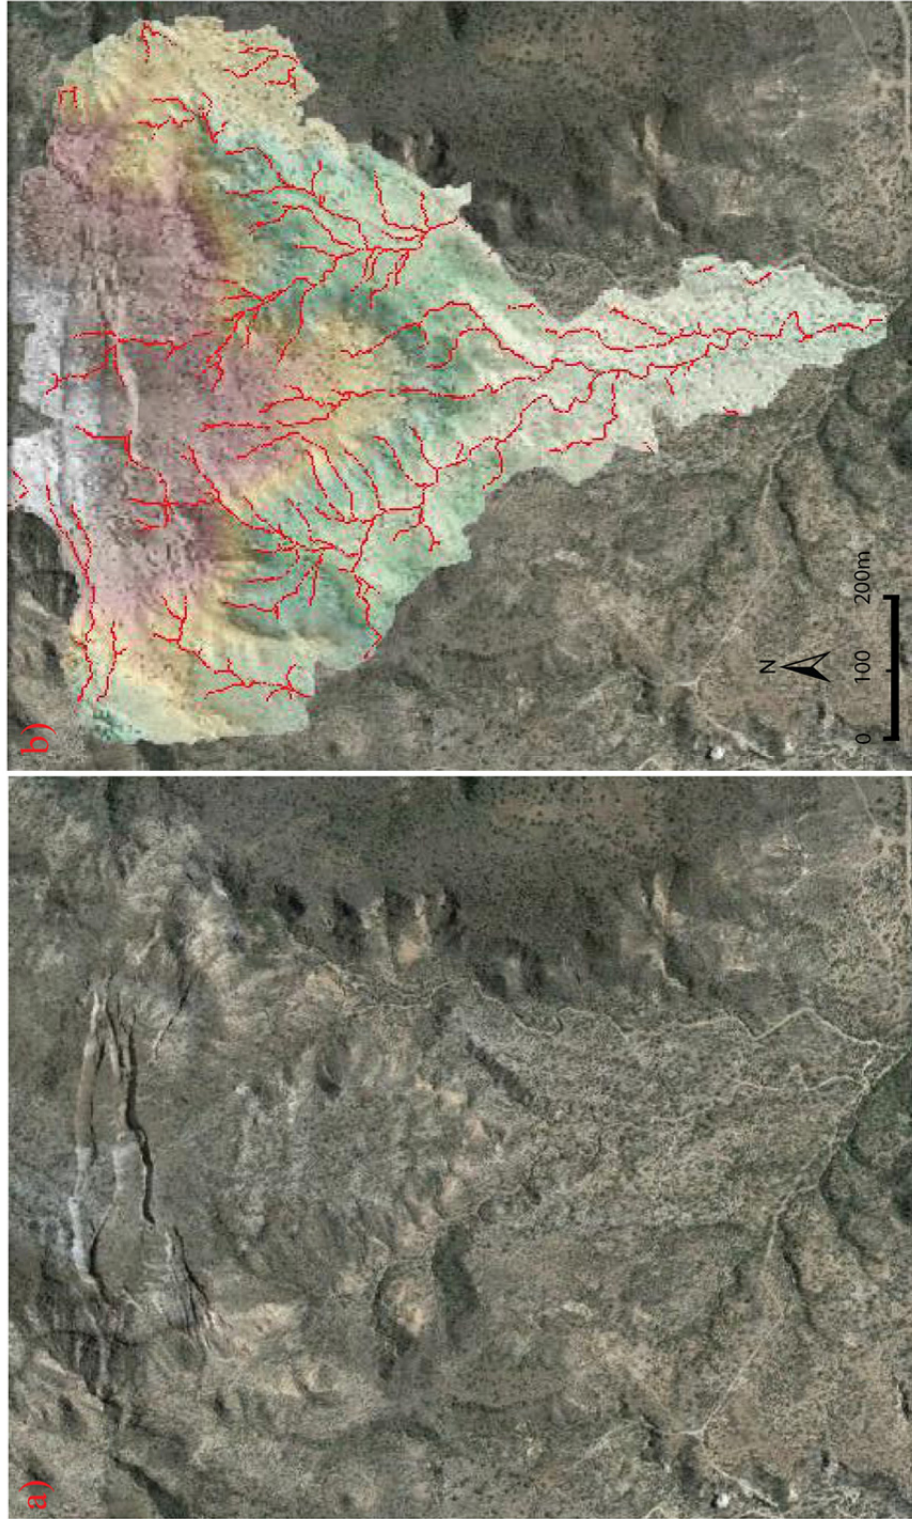
Figure 8. Hillshade map+DEM of the study area overlain on top of Google earth imagery showing that the feature and topography of the model fit well with the topography and features identified in Google earth.

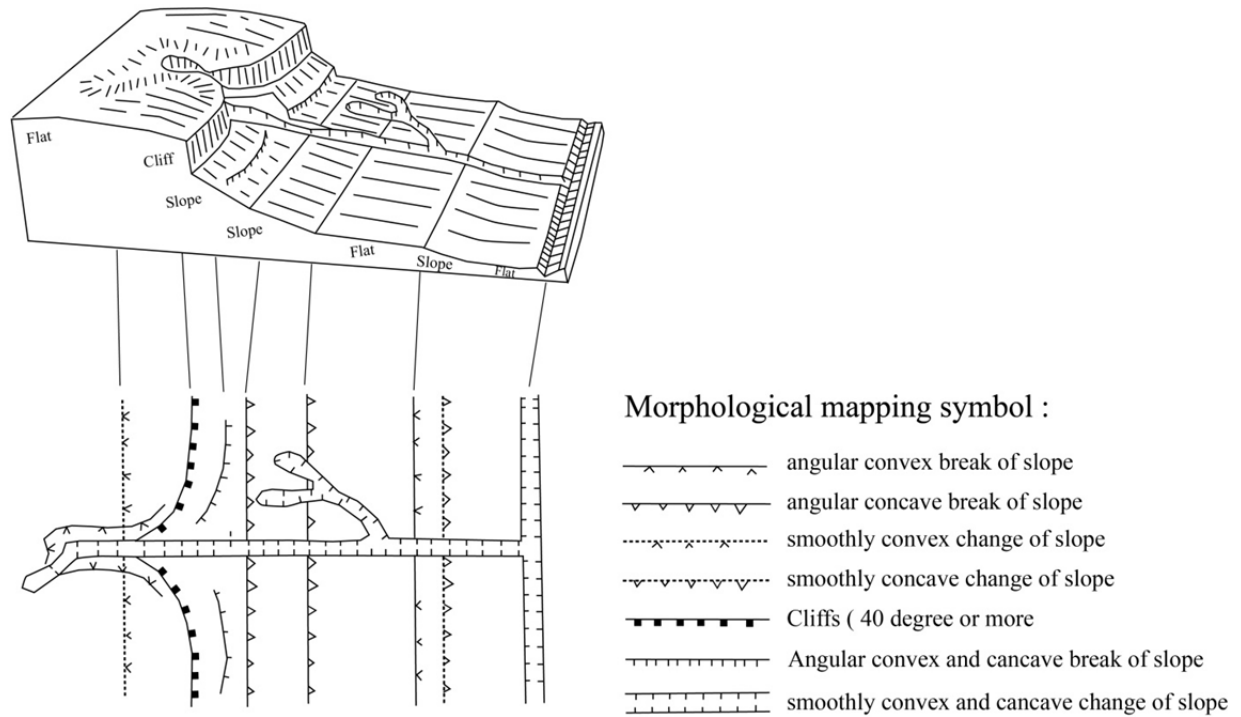
Figure 9. Morphological mapping aspects and their symbol for detailed morphology mapping (modified from Savigear, 1965).

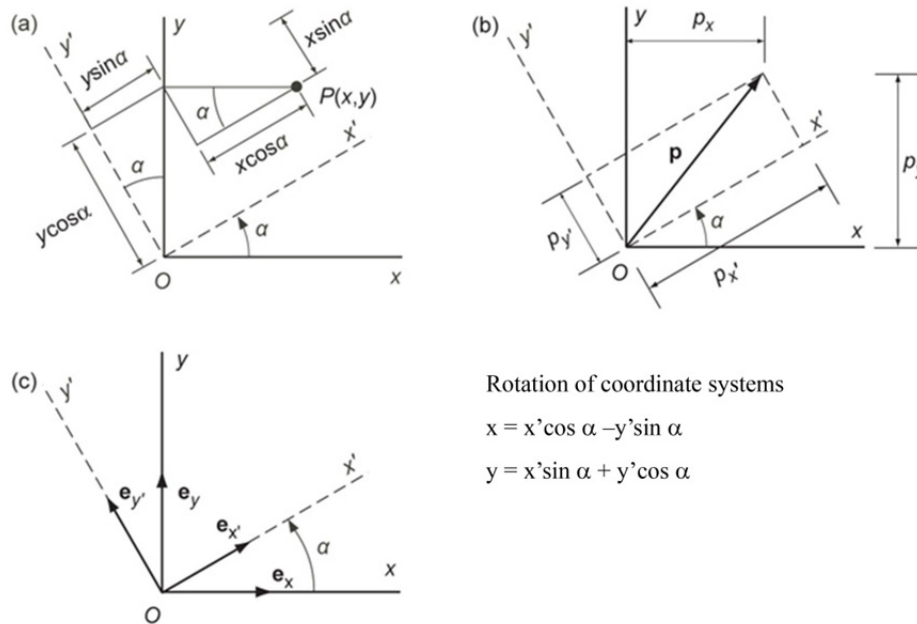
Figure 10. Rotation of coordinate systems (—From Pollard and Fletcher, 2005, Figure 2.8).

where  $x$  and  $y$  is the new coordinates,  $x'$  and  $y'$  is the old coordinates, and  $\alpha$  is the degree of rotation (obtained from comparing the old and new data) (Figure 10). We calculate the difference of the position (east, north and height component) relative to instrument station and BM1, which is located in a stable part of the landslide.

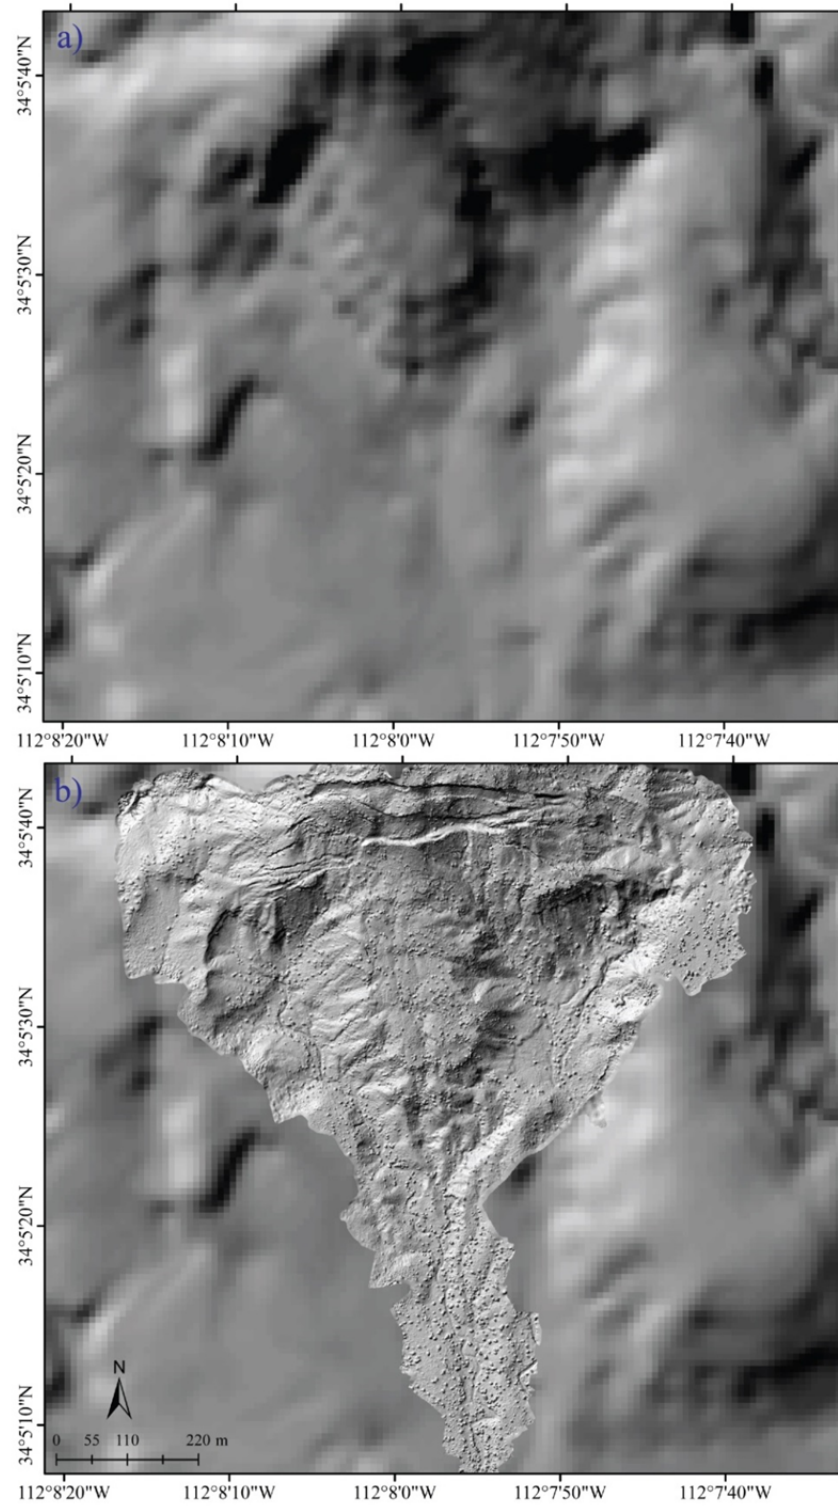
Figure 11. Comparison of the hillshade generated from the DEM from the older 10-m resolution USGS DEM (a) and the 20-cm resolution DEM resulted from this study (b).

Topographic features of varying scales were clearly visible in the dataset. We were able to comparably distinguish the features that we identified in the imagery in the field with high confidence. When viewed in the GIS software as hillshade (colored by elevation) overlaid by DEM, the modeled area successfully demonstrated the fine (meter) scale surface features of the landslide and surrounding landscape (Figure 8b). Vegetation was also clearly defined. Some of the vegetation also appears in the DEM as clumps, covering the topography, but because they are not obscuring the observation, the vegetation removal process was not necessary. Comparison between the DEM generated from the SfM and the 10-m DEM USGS is shown in Figure 11 and highlights the improvement of the quality and resolution of the topography data.

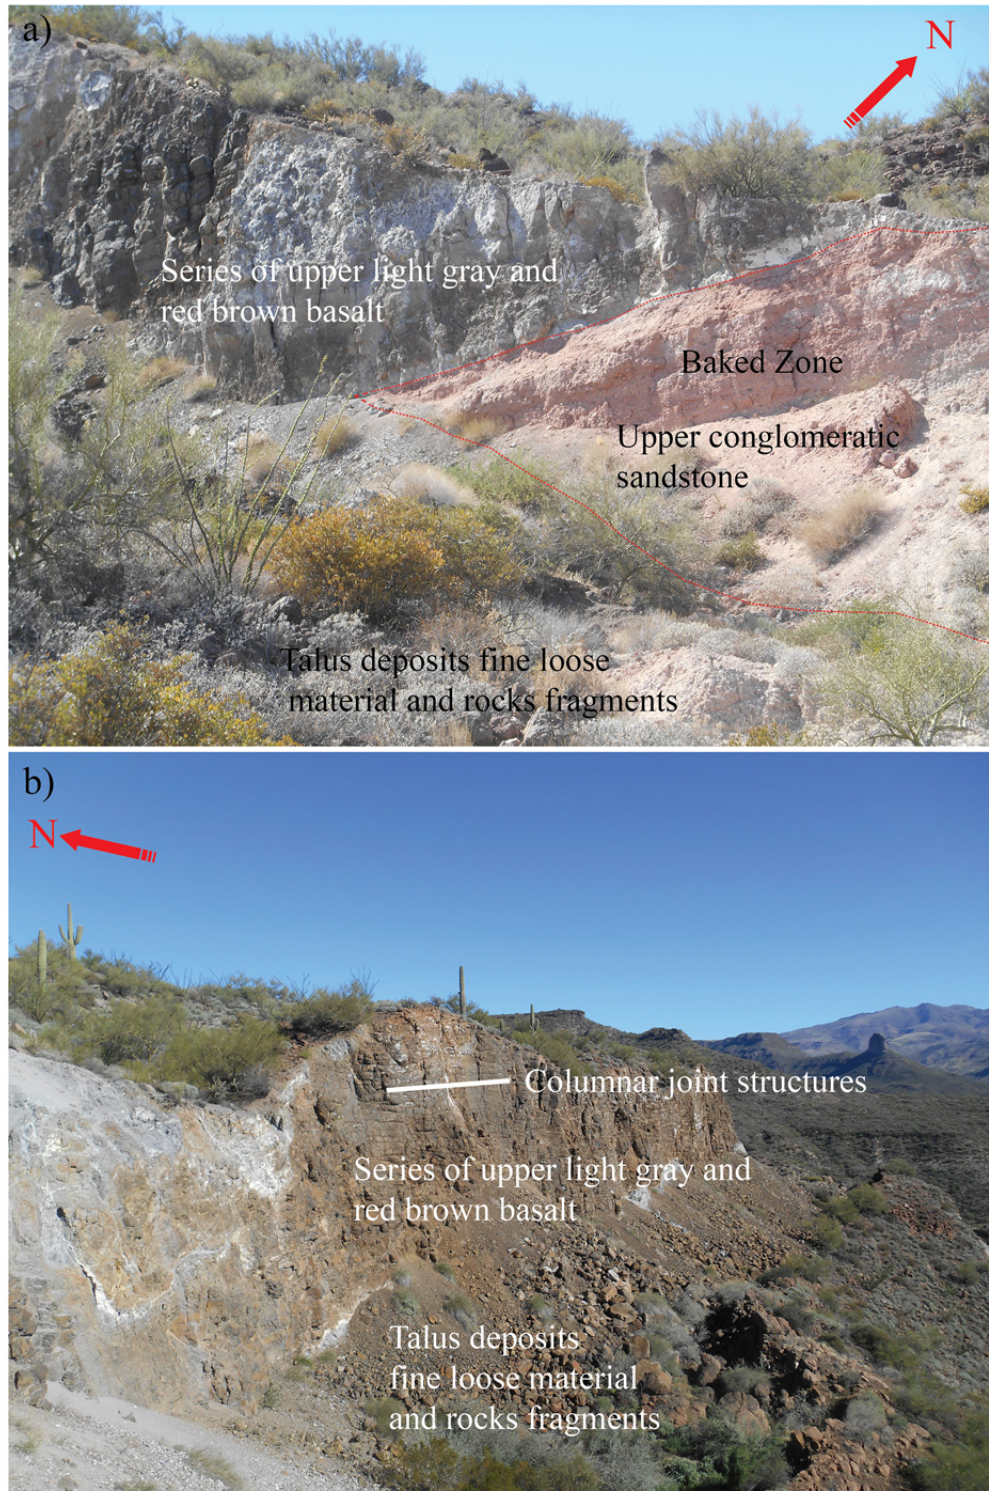
Figure 17. Field photographs of the Hickey Formation exposed along the main head scarp and head of BCC landslide. a) Series of upper light gray and red brown basalt overlying the upper conglomeratic sandstone. Reddish band at upper part of the conglomeratic sandstone unit represents a baked zone contact between this sedimentary rock unit and

The area within the head and in the crown is rough with sparse to moderate vegetation. The most prominent surface features observed within the head area are scarps that are associated with extensional structure such as normal faults and tension crack (Figure 16). Two E-W trending main scarps were observed along with few SW-NE trending minor scarps. The E-W trending scarps are approximately ~470 m in length with maximum local relief of ~14 m (Figure 16). The highest point of the scarps is at 777 m above sea level. The SW-NE minor scarps are ~469 m long, have a maximum relief of ~7 m with a maximum elevation of 758 m. Both the main and minor scarps are represented in the morphology as a steep-almost vertical cliffs formed by normal faulting as the block mass moved and stretched horizontally downslope (Figure 14). The downhill movement of the hillslope along these faults created a local graben- and horst-like morphology, bounded by the faults (Figure 12). The grabens are represented by a pair of concave curvatures in the morphology map and are filled by talus sediments (Figure 17a,

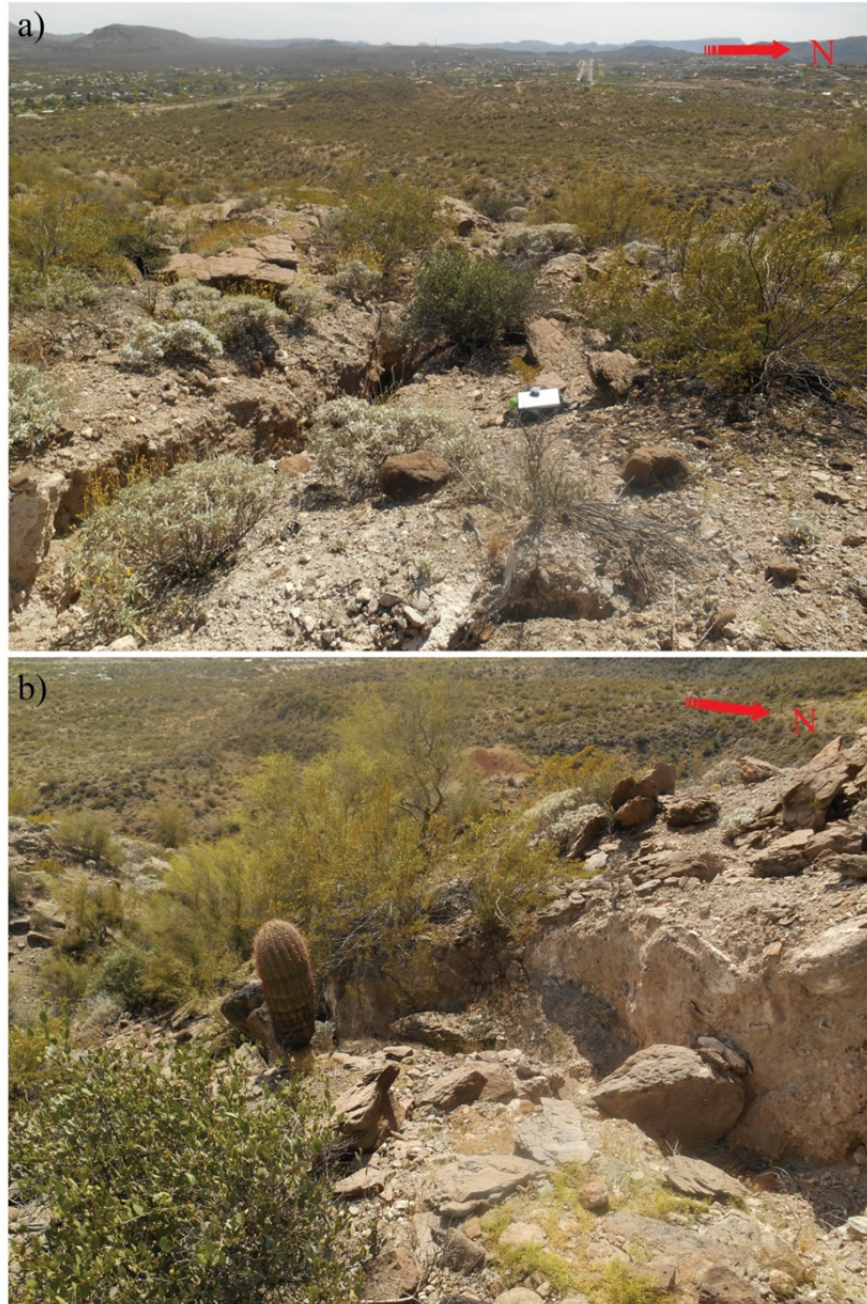
Figure 19. Photographs of open fractures and cracks found along the main lobe. a) Longitudinal crack at the lower conglomeratic sandstone show a 0.3 m opening and 0.05m vertical displacement, b) Longitudinal cracks at lower conglomeratic sandstone with 0.5 m vertical and 0.3 m horizontal displacements. Refer to Figure 15 for location.

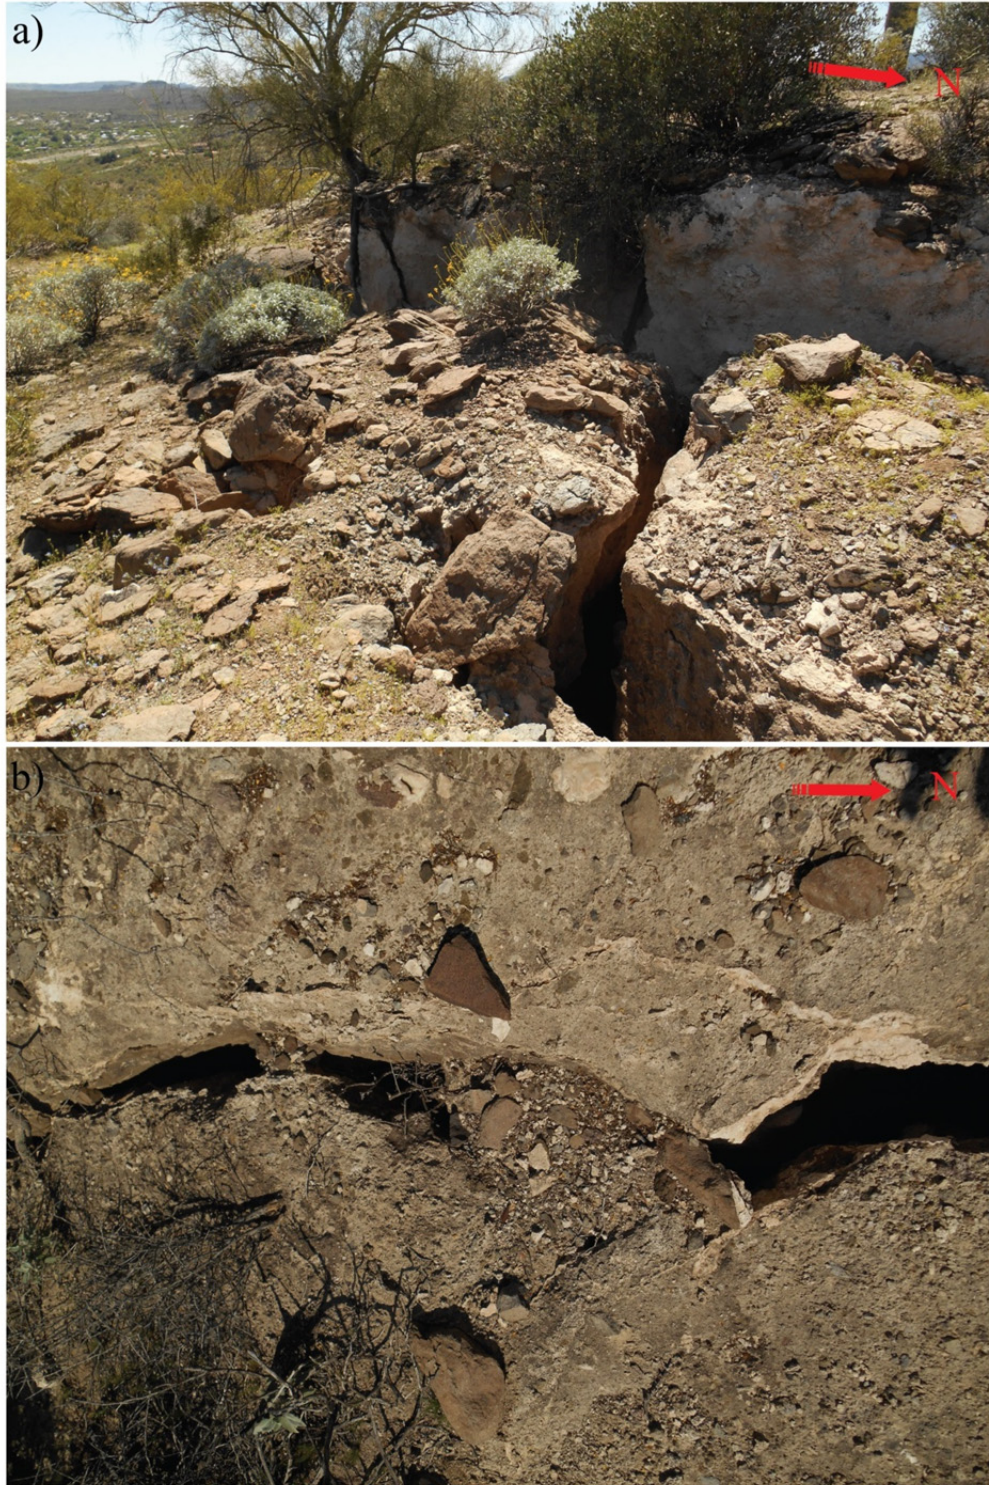
Figure 20. Photographs of open fractures and cracks found along the main lobe. a) Longitudinal cracks at lower conglomeratic sandstone with 0.6 m vertical and 0.7 m horizontal displacements; the surface of the lower conglomeratic sandstone is covered by caliche. b) Small longitudinal cracks across the main body with 0.05 m vertical and 0.1 m horizontal displacements. Refer to Figure 15 for location.

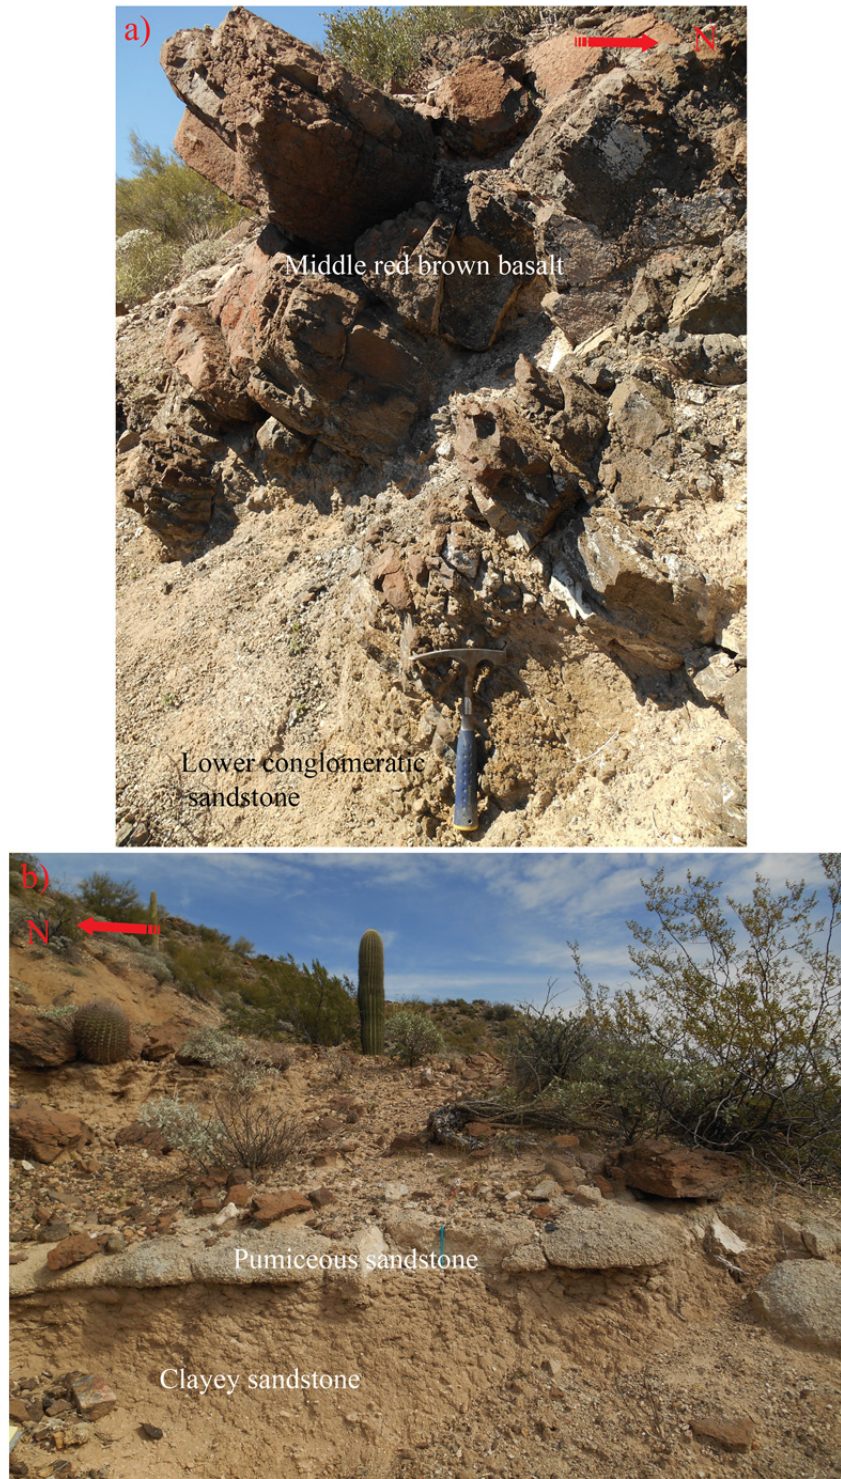
Figure 22. Field photo of outcrops observed across the main lobe body, a) The middle red brown basalt detach to the lower conglomeratic sandstone, b) outcrop of an interbedded pumiceous sandstone at base of west side of the landslide within the clayey sandstone unit. Refer to Figure 15 for location.

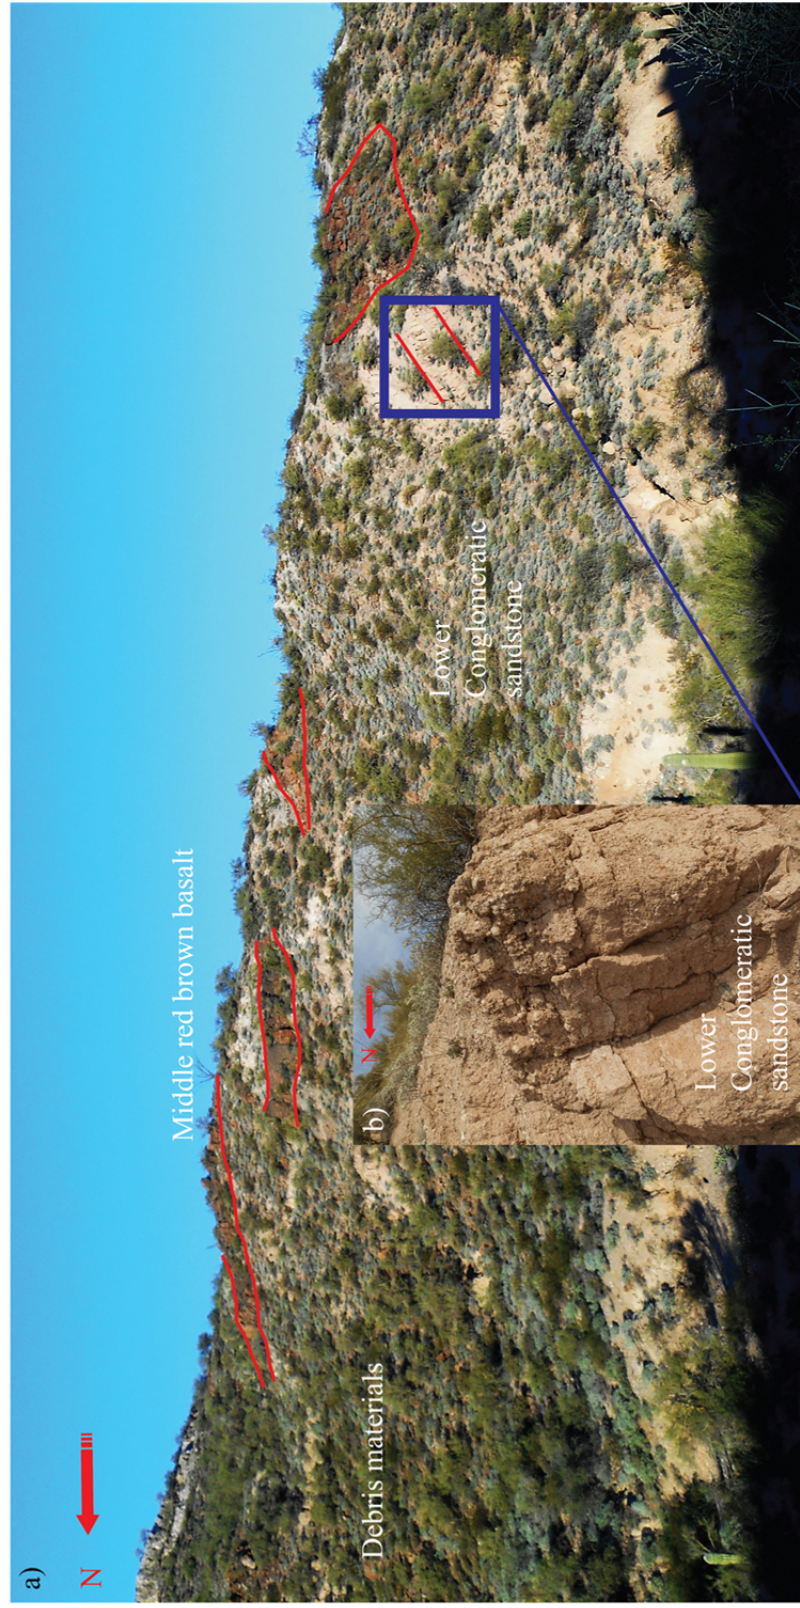
Figure 23. (a) photo show the general overview of the hillslope within the main lobe body, showing the alignments of middle red brown basalt units (red lines). (b) detailed photo of the material forming the hillslope which mostly consist of thick lower conglomeratic sandstone. Camera facing to the east. Refer to Figure 15 for location.

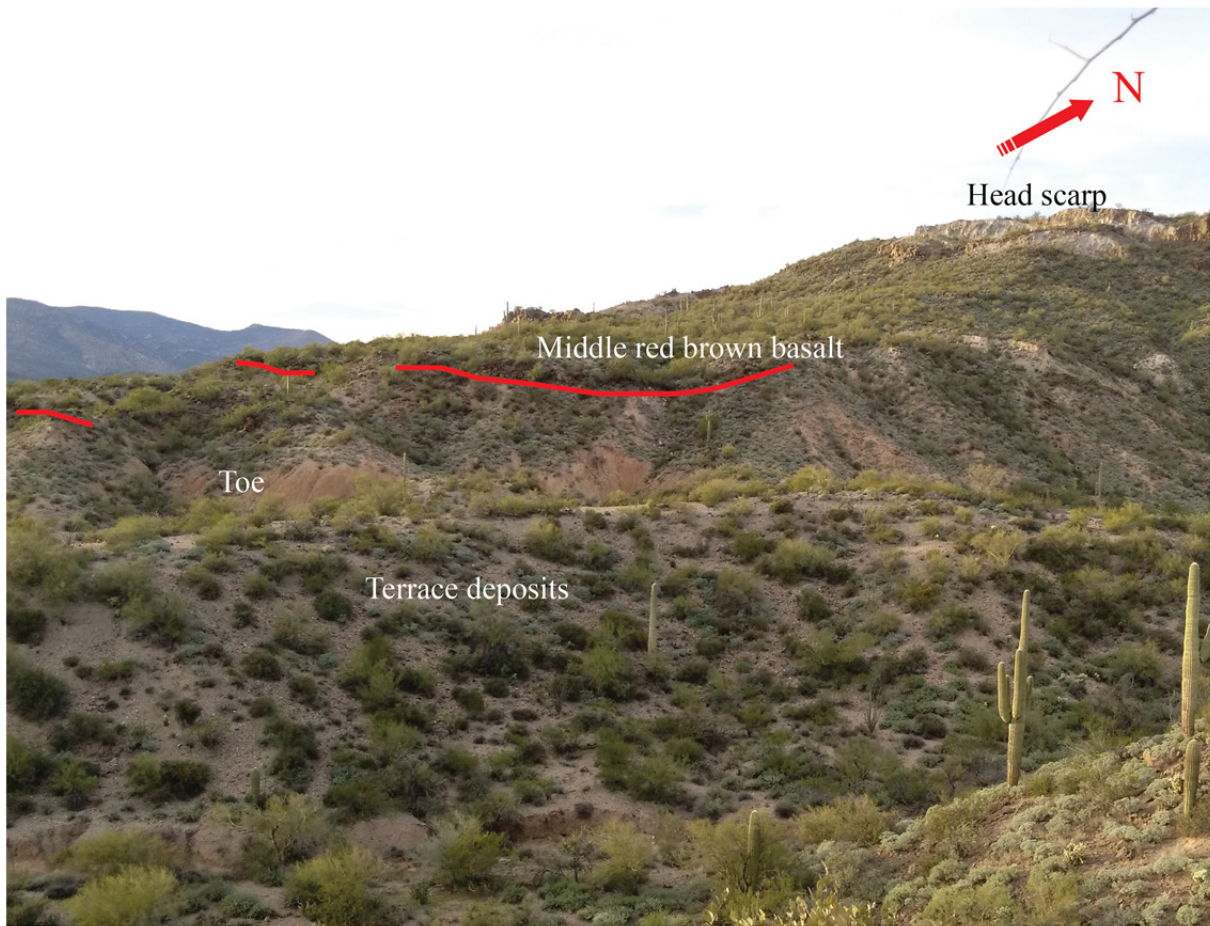
Figure 24. Field photo of a layer of middle red brown basalt covered the hillslope of main lobe, which is indicated by a red line. Outcrops forming hillslope consist of thick lower conglomeratic sandstone; this conglomeratic sandstone dips north, N290E/32NE (e). Refer to Figure 15 for location.

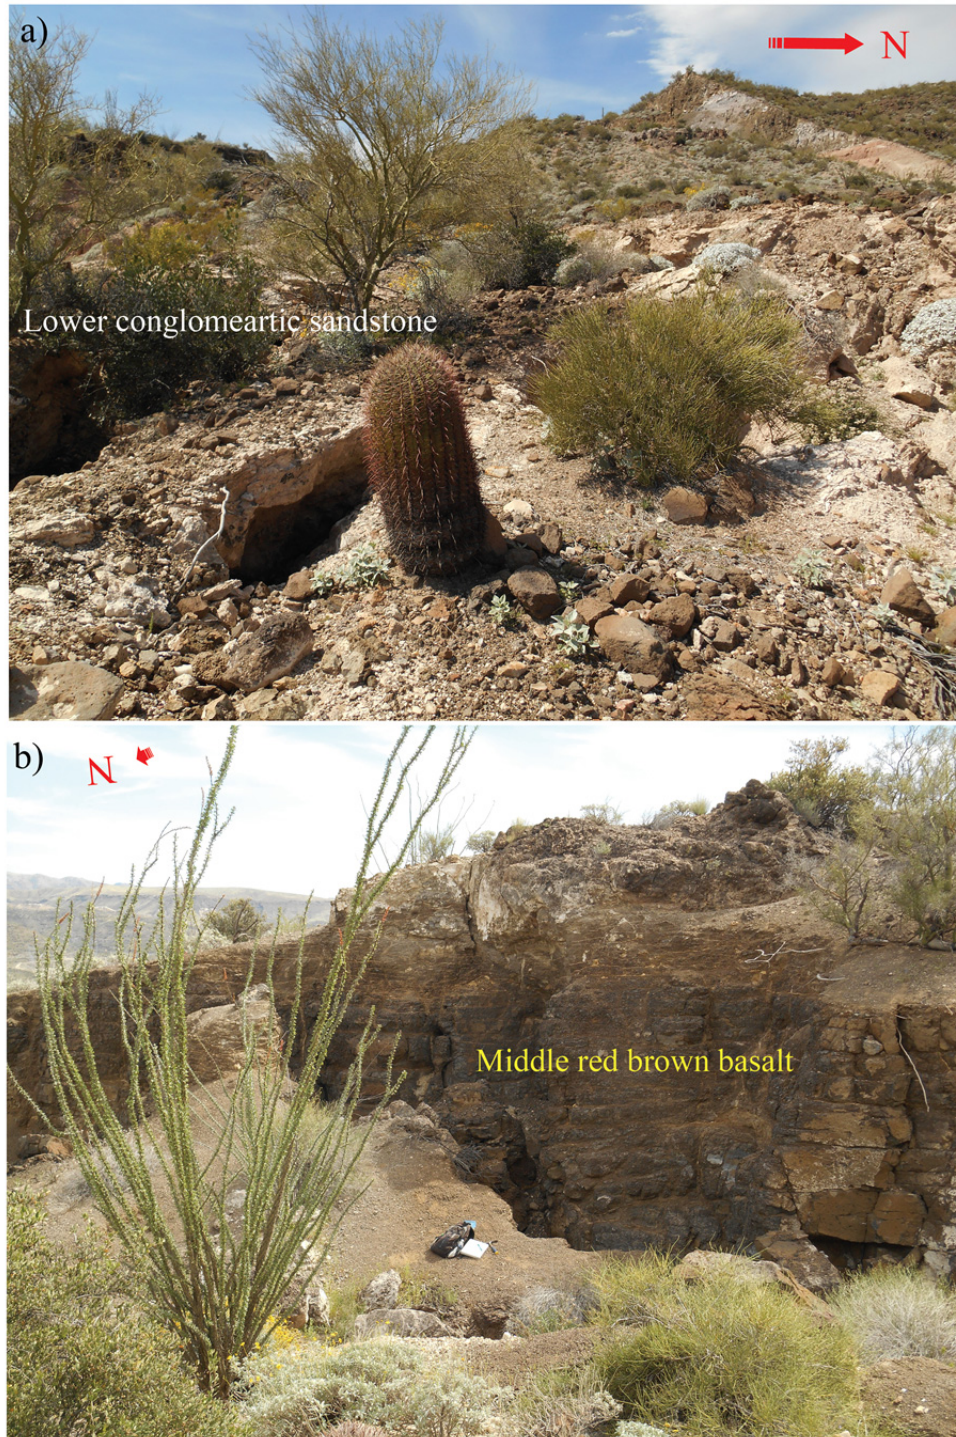
Figure 26. Photographs of features observed along the SE lobe body. a) Damage zone at surface of the lower conglomeratic sandstone unit at the eastern edge of the slide of the SE lobe body. This unit has been displaced 0.25 m vertically and 0.6 m horizontally. b) Minor scarp with 1.5 m vertical displacement at red brown basaltic-andesite unit with intensive platy jointed structure. Refer to Figure 15 for location.

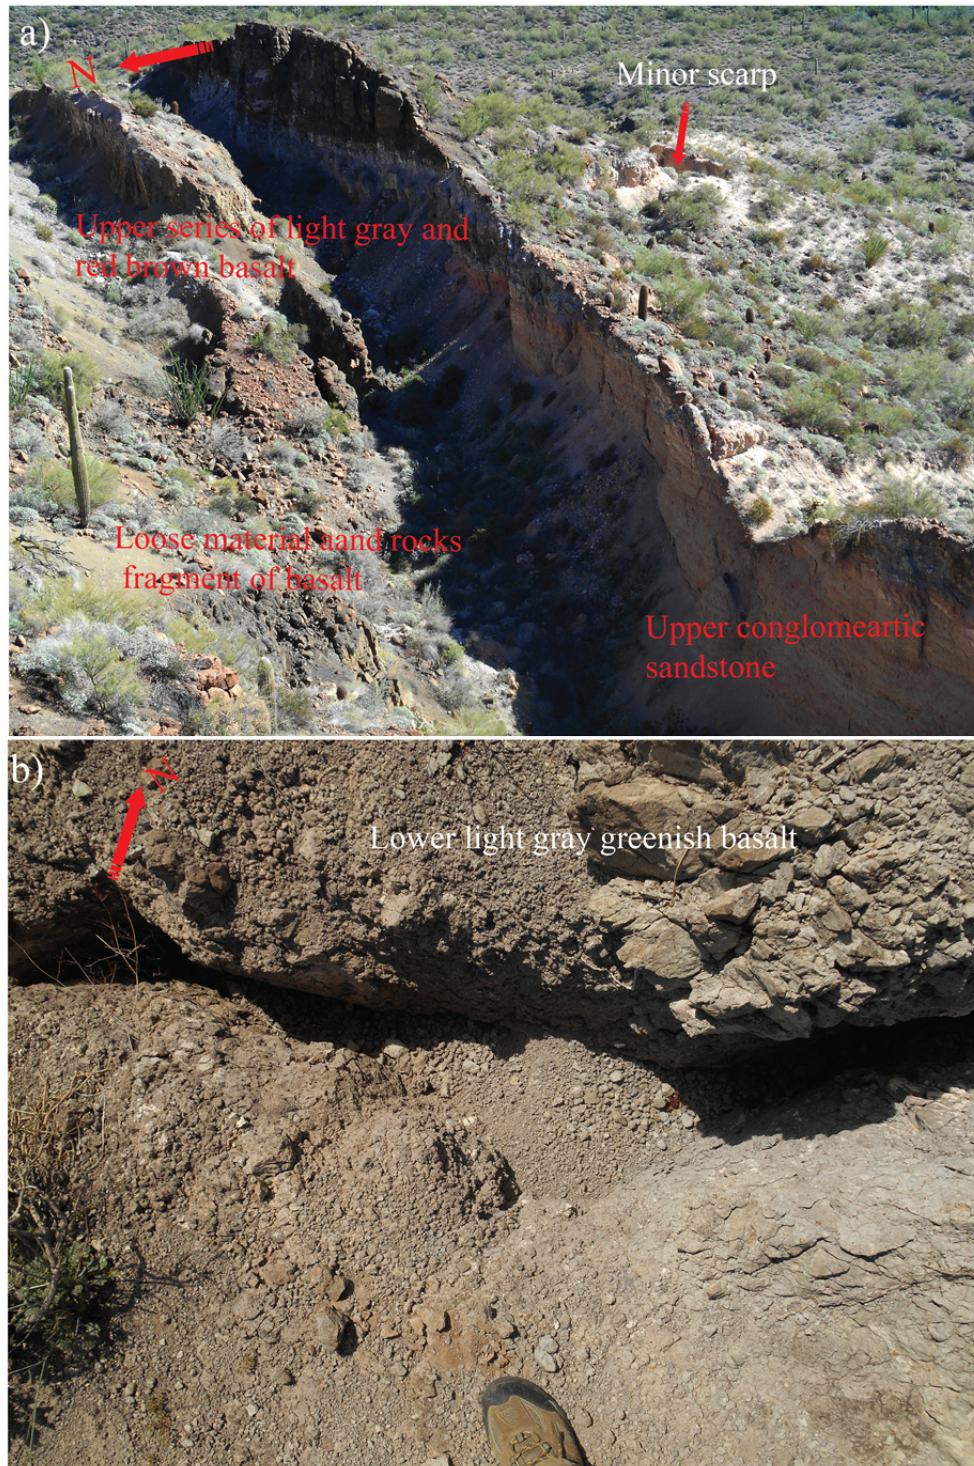
Figure 27. Photographs of features observed along the SE lobe body. a) Contact between the upper conglomeratic sandstone and series of upper light gray and red brown basalt with reddish color at the contact (baked zone). b) Small transverse cracks at the lower

light gray greenish basalt with 0.04m vertical and 0.07m horizontal displacements. Refer to Figure 15 for location.

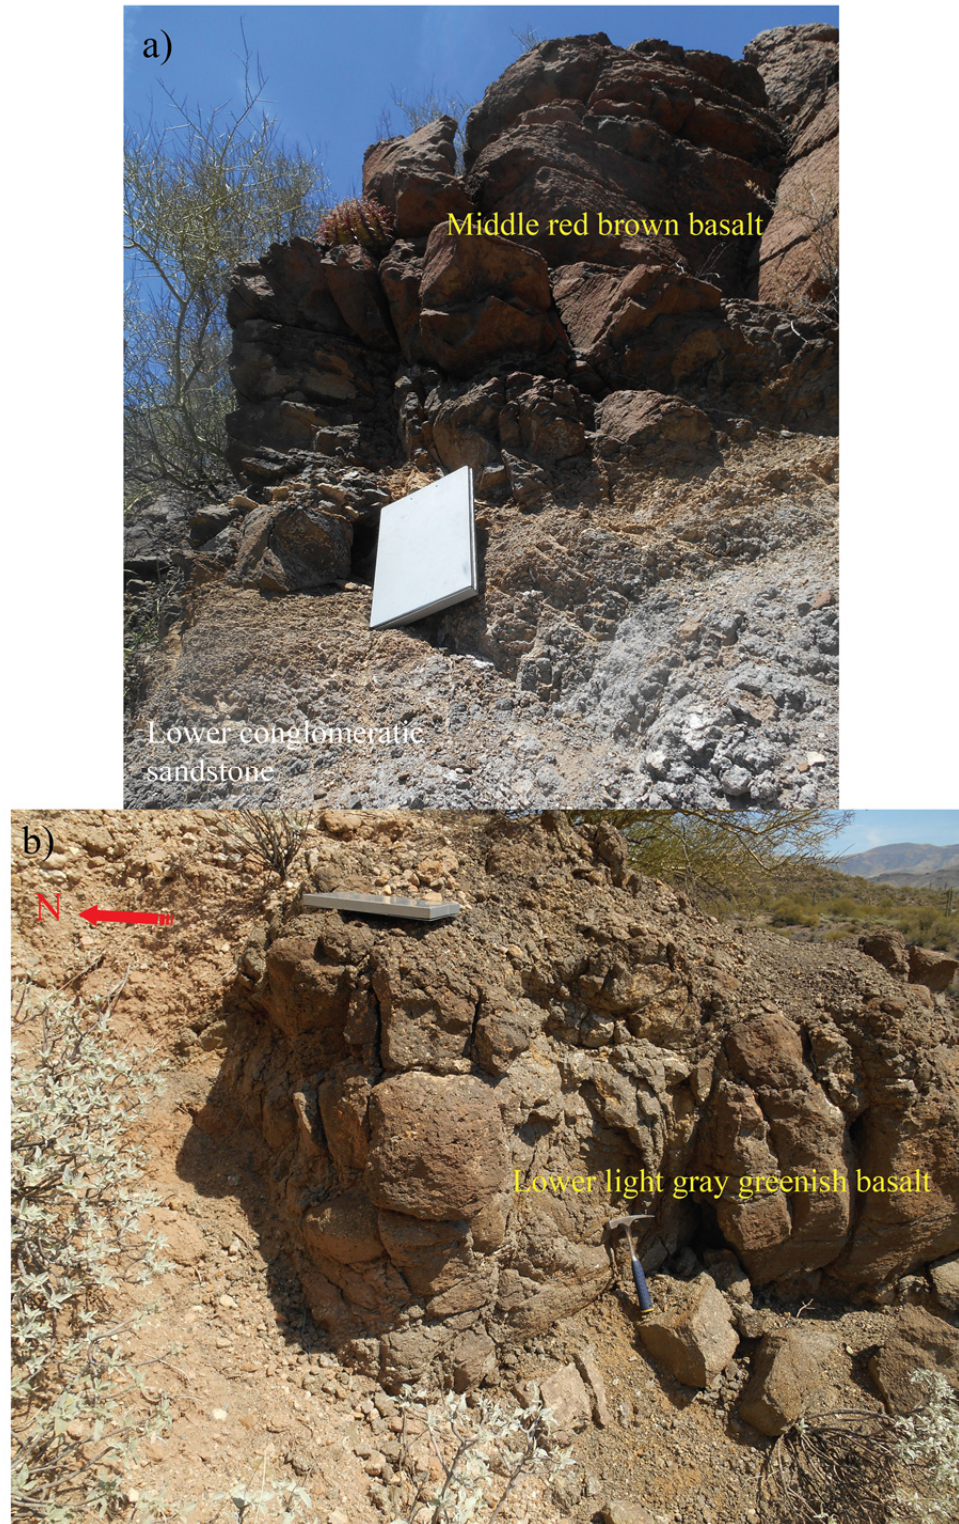
Figure 28. Photographs showing some of the units exposed across the SE lobe. (a) show the middle red brown basalt contact with the lower conglomeratic sandstone unit, and (b)

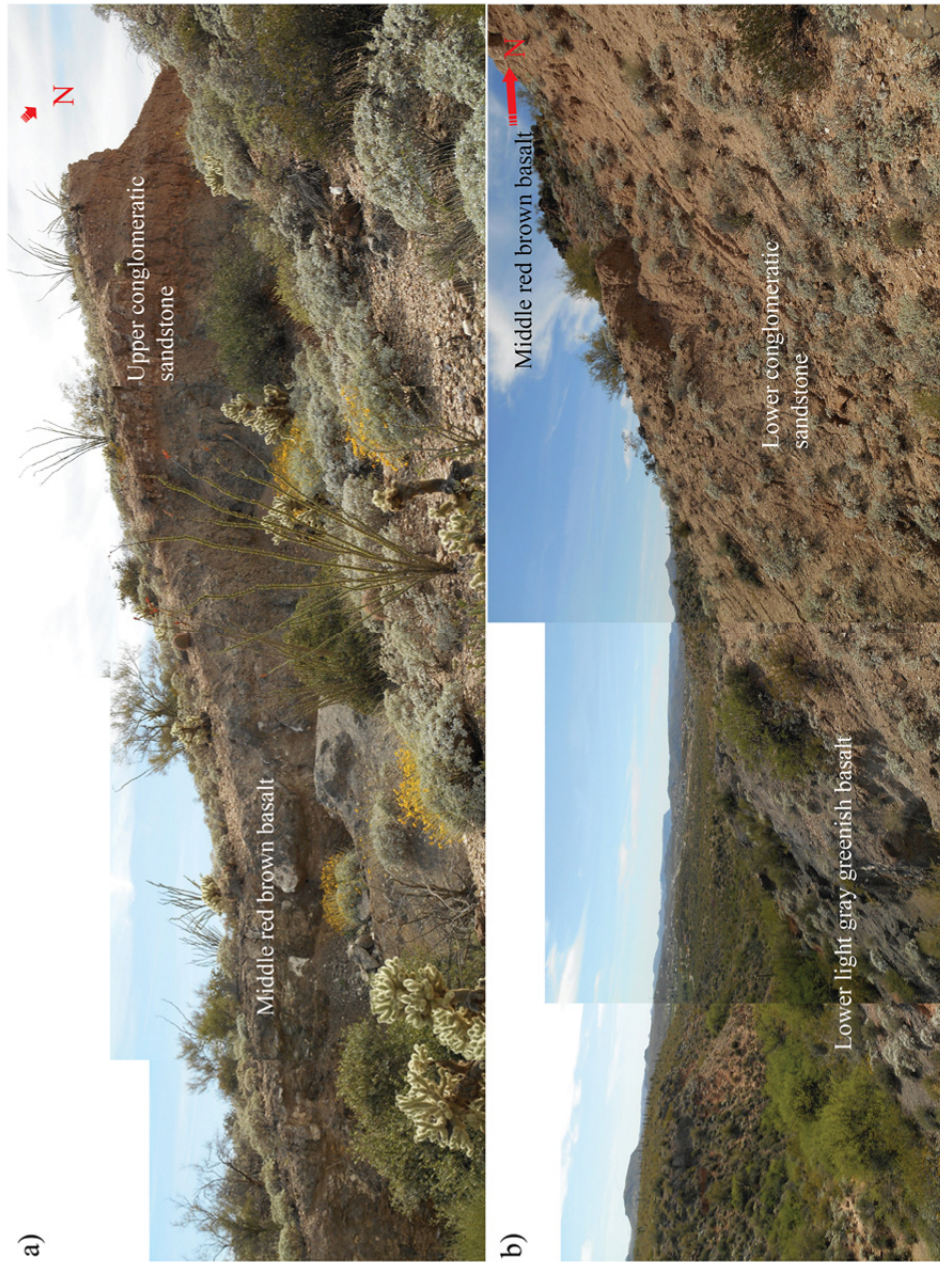
Figure 29. Photographs showing view of upper conglomeratic sandstone contact with the middle red brown basalt (a), and the lower light gray greenish basalt contact with lower conglomeratic sandstone. The distribution of the basalt unit are discontinue to the landslide. Refer to Figure 15 for location.
