Characterization of Landslide Geometry and Movement

Near Black Canyon City, Arizona

A Thesis Presented in Partial Fulfillment  
of the Requirements for the Degree  
Master of Science

ARIZONA STATE UNIVERSITY

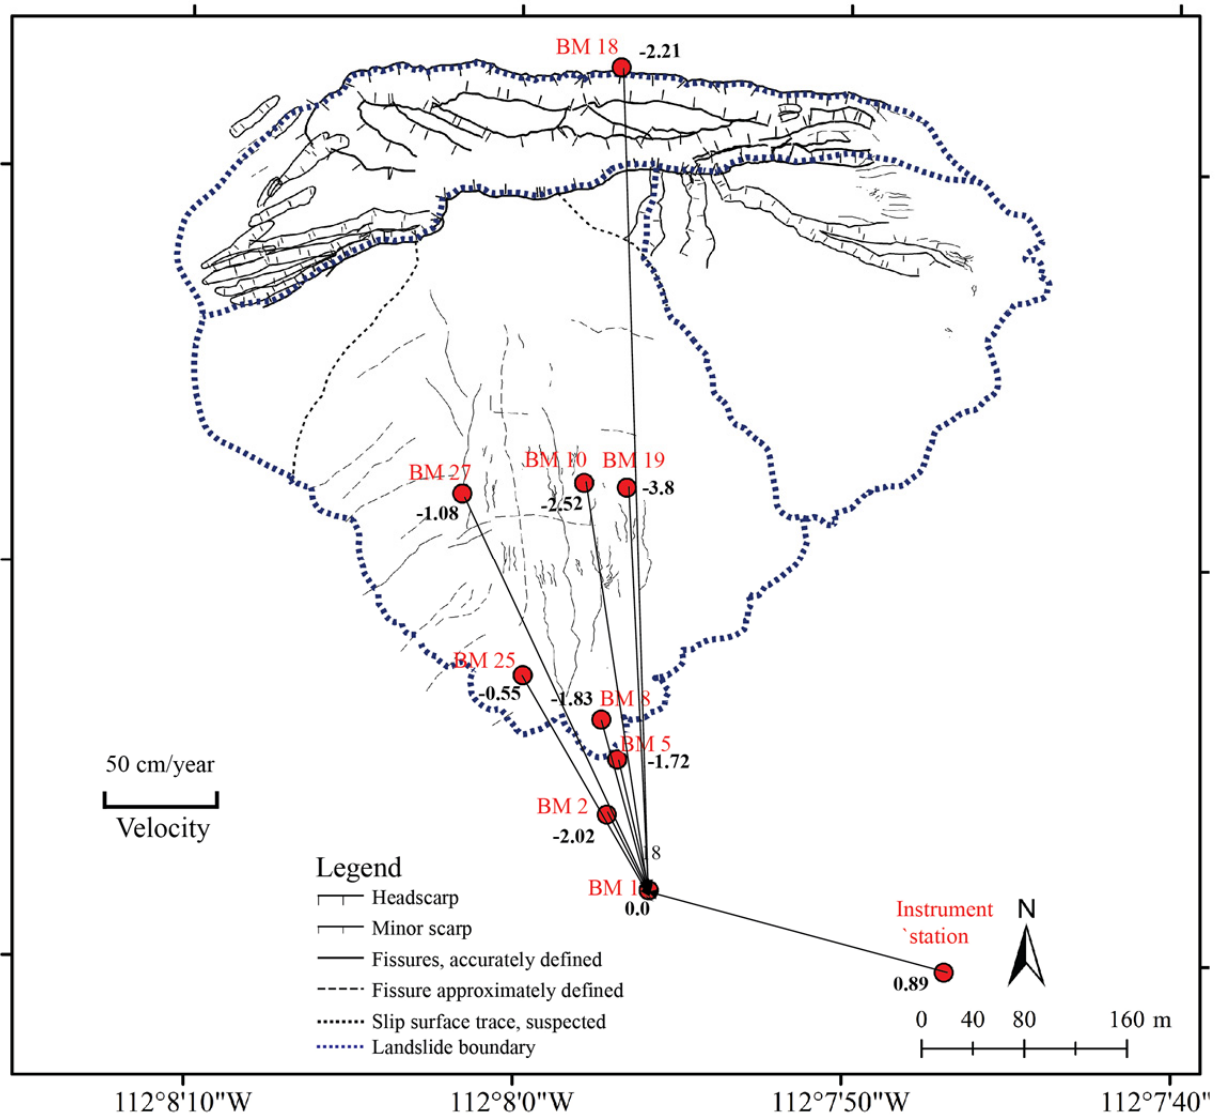
Figure 31. Map showing average changes in distance of the benchmarks relative to station 1 (BM1), where the average is calculated from 1998, 2000, 2002, and 2006 survey data relative to 2016 measurement. Black arrow indicates the magnitude of the changes relative to station 1. Negative distance change means that the stations moved closer together. Changes shown here are 1998-2016. See also table 10.

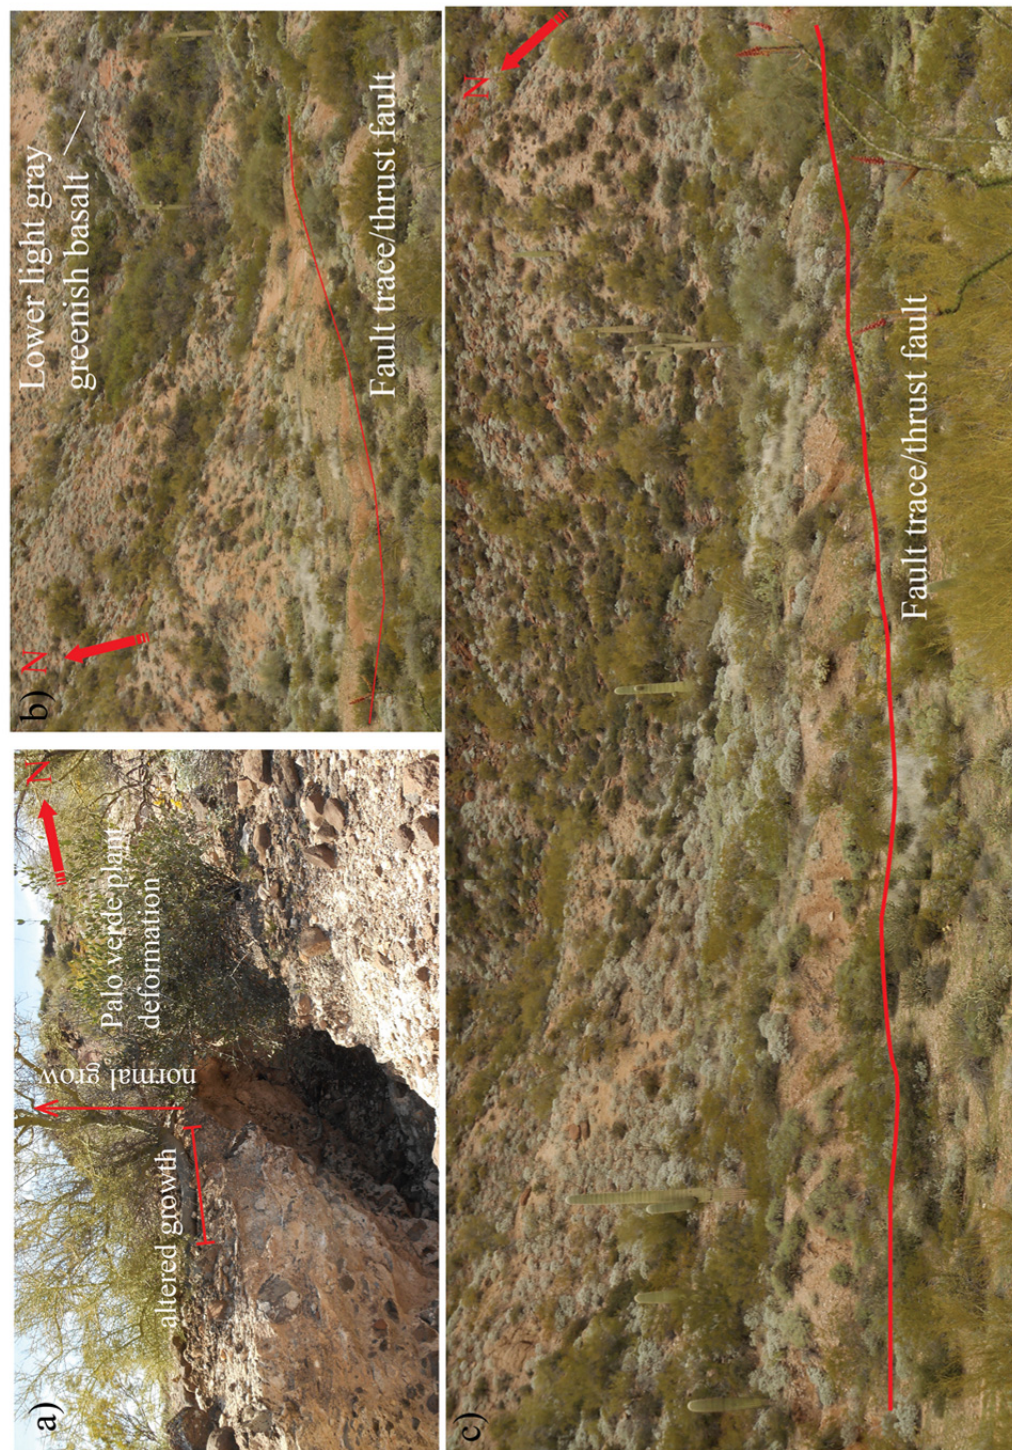
Figure 32. (a) Photographs of altered growth observed in a Palo Verde tree disturbed by the landslide. (b) Photograph of compressional feature (thrusts) observed at the main lobe body near the toe. See Figure 15 for location.

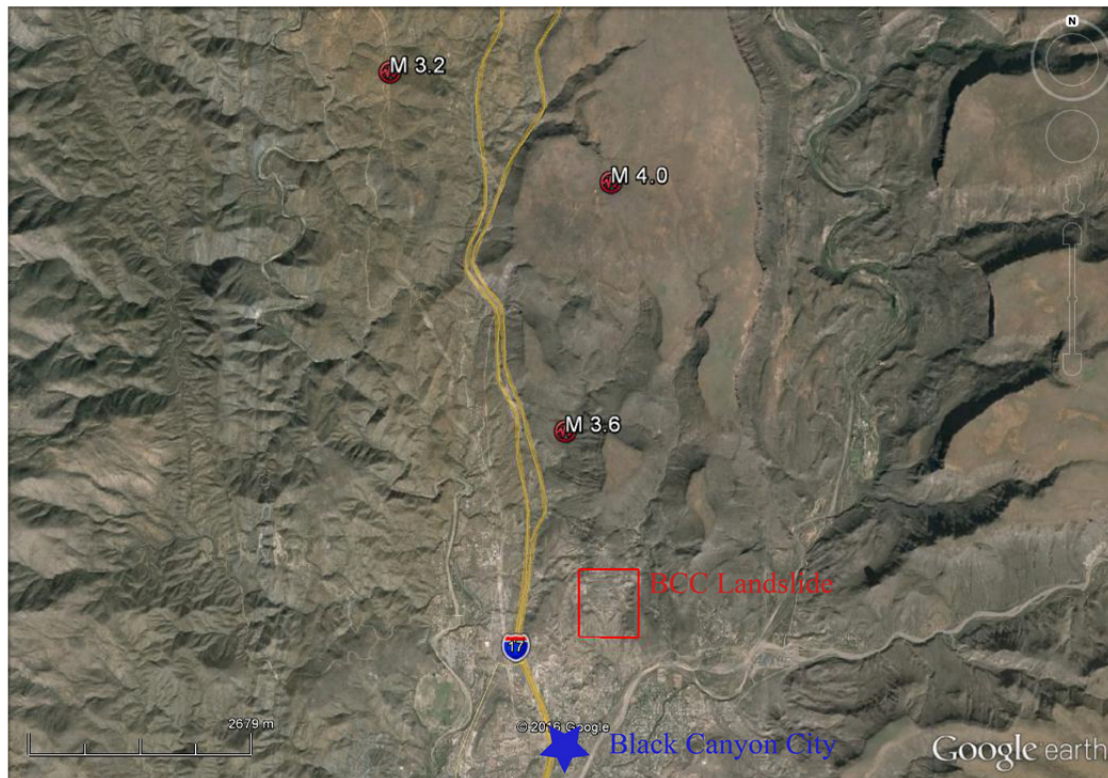
Figure 34. Map show the location of earthquakes epicenters of earthquakes occurred during November 2<sup>nd</sup>, 2015, near Black Canyon City, Arizona. The basemap is from the Google Earth imagery.

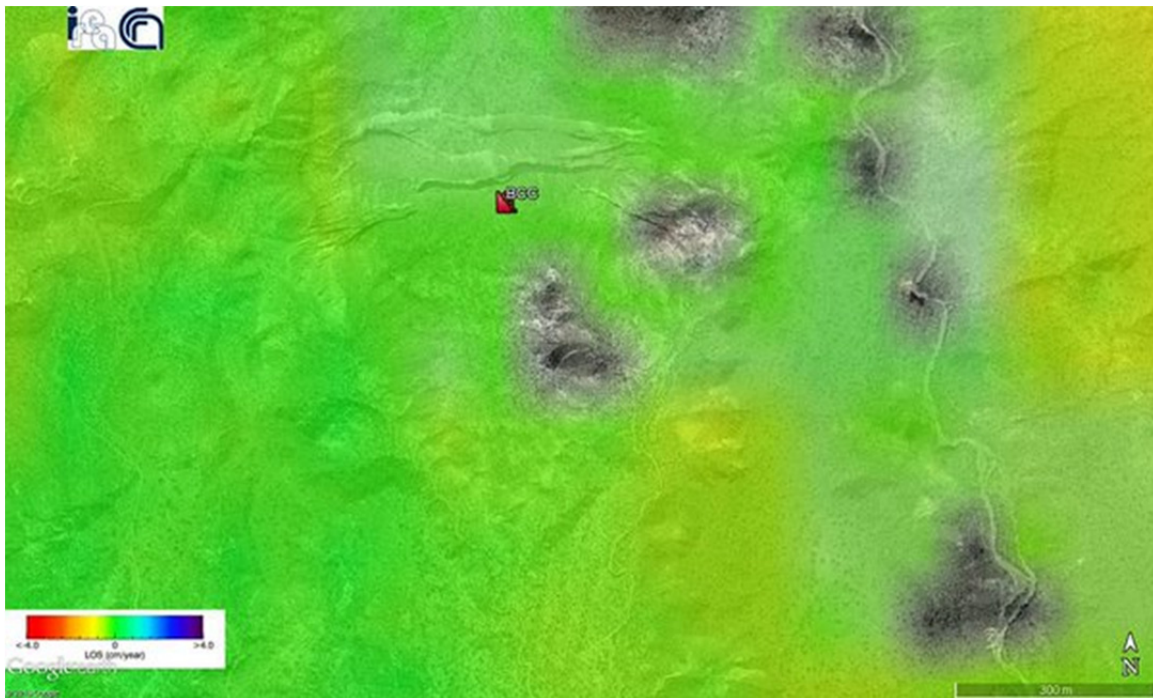
Figure 37. InSAR displacement analysis of the Black Canyon City landslide, green color represent zero displacement.
