Effect of Series Resistance Increase on Fill Factor of PV Cells Extracted from
Field Aged Modules of Different Climates

A Thesis Presented in Partial Fulfillment
of the Requirements for the Degree
Master of Science

ARIZONA STATE UNIVERSITY

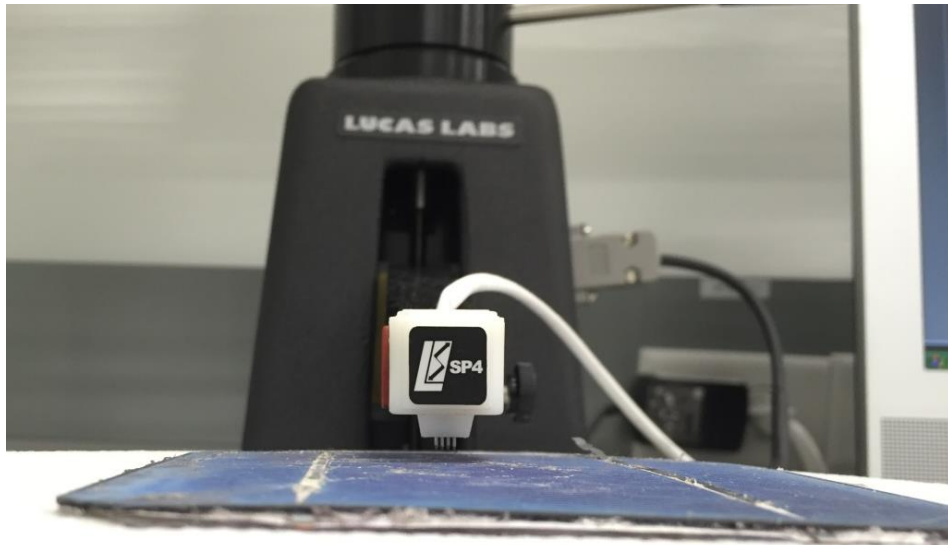
Figure 19: Four Probes Touching the Metallization of the Cell

Electrical resistivity is a basic material property that quantifies a material's opposition to current flow; it is the reciprocal of conductivity. One of the most common ways of measuring the resistivity of some thin, flat materials, such as semiconductors or conductive coatings, uses a four-point collinear probe. The four-point probe technique involves bringing four equally spaced probes in contact with a material of unknown resistance. A DC current was forced between the outer two probes, and a voltmeter measures the voltage difference between the inner two probes. The resistivity was calculated from geometric factors, the source current, and the voltage measurement. The instrumentation used for this test includes a DC current source, a sensitive voltmeter, and a four-point collinear probe. The figure for the setup of multimeter is shown in figure 18. The four-point probe resistance measurements are done using the SMU 2450 source measurement unit, SP4 - four-point probe head and S-302 test stand. The model set up for the placement of probes over the cell is shown in figure 19.

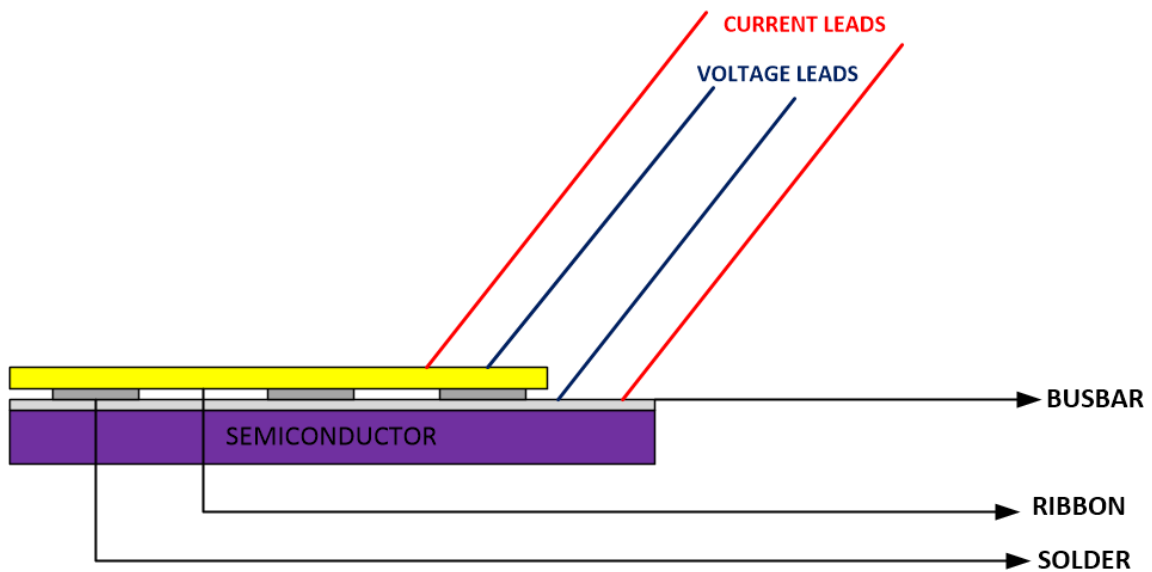
Figure 21: Four-Point Probe Lead Positioning

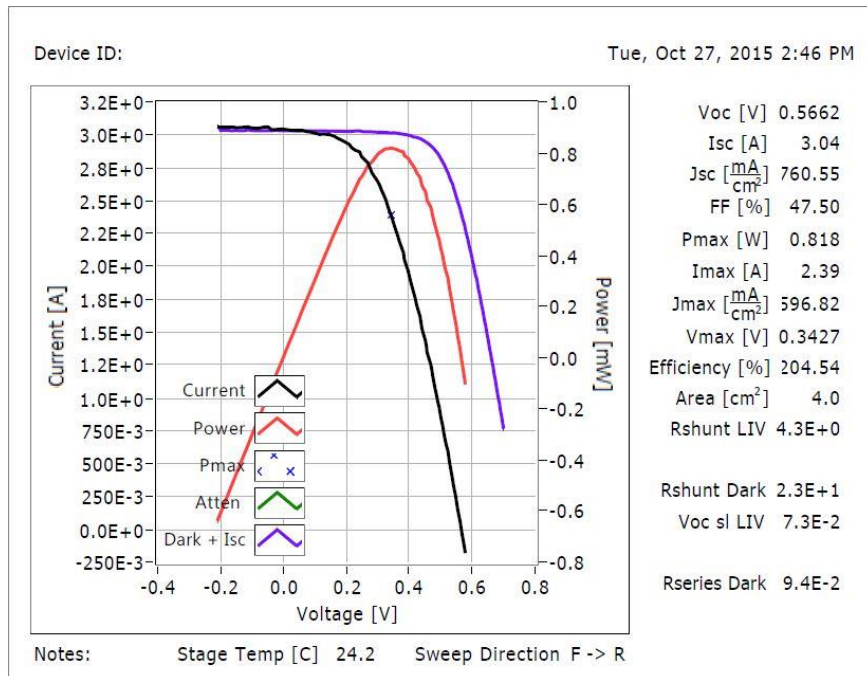
Figure 22: Sample Report Generated for I-V Curve from Indoor Solar Simulator

In this sections, all the tests performed before the destruction of the modules are discussed. All the modules were cut on the back side of each cell and were soldered using the soldering gun and ribbon as described in the methodology. These soldered modules are connected to the solar simulator machine one after the other in order to perform cell level dark I-V curve tests. A sample report from the dark I-V curve is shown in the following figure.

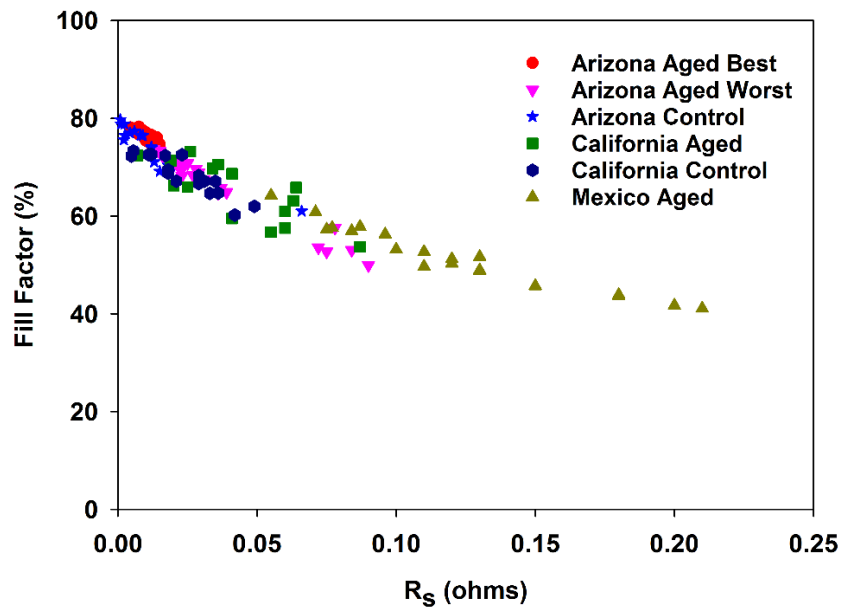
The following graph shows the relationship between the series resistance and fill factor for all the modules at cell level. From the graph we can observe that the fill factor of the cell decreases with the increase in series resistance. The highest drop in the fill factor is observed for the cells from Mexico module (P29005) due to their high series resistance. The high series resistance is observed due to their high field exposure (23 years) and also due to the climate in which they were exposed (warm and humid). Due to the humid conditions, the moisture ingresses through the backsheet of the modules and creeps into the solder joints causing corrosion which depletes the ribbon contact with the busbar. When this happens, the electrons generated in the cell have to find an alternate but a narrow and long route in order to get transferred from cell to ribbon thus increasing the series resistance. After Mexico module, the worst series resistance is shown by the Arizona field exposed module (514210) which is exposed for 18 years in hot and dry

climate. The other exposed module from Arizona (464185) shows series resistance values very close to that of the control module which indicates that the solder bonds in the modules are practically intact and show very less degradation. The California aged module shows higher series resistance when compared to the California control module as expected. California module are expected to have lower series resistance than Arizona modules due to their temperate climate and also due to lesser cloud cycles.

Figure 23: R_s Vs FF for Modules from Different Climates at Cell Level

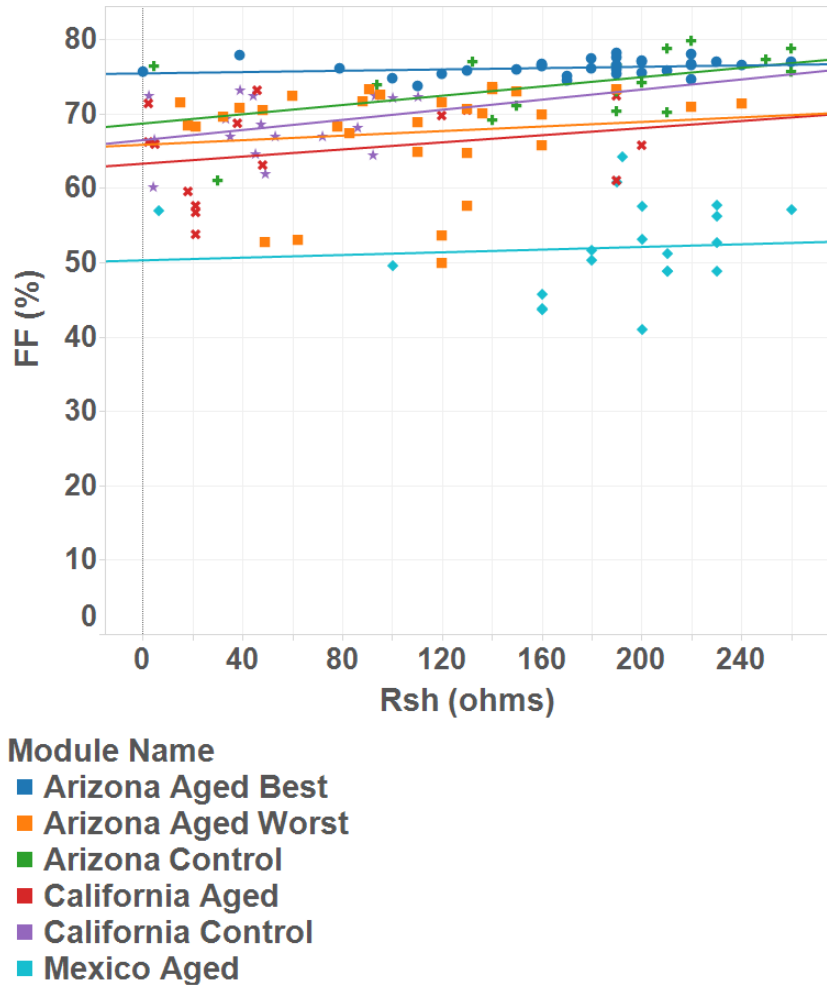
The relationship between the shunt resistance (R_{SH}) and Fill Factor is shown in figure 24. The values for R_{SH} were also obtained from the cell level dark I-V curves. It can be observed that the fill factor of the cell increases with increase in shunt resistance which is expected. High shunt resistance implies lower defects in the cell which indicates a better performance. When the trends in the previous figure are combined with this figure, it can be seen that R_s plays the primary role and R_{sh} plays an insignificant role in FF reduction.

Figure 24: R_{SH} Vs FF for Modules from Different Climates at Cell Level

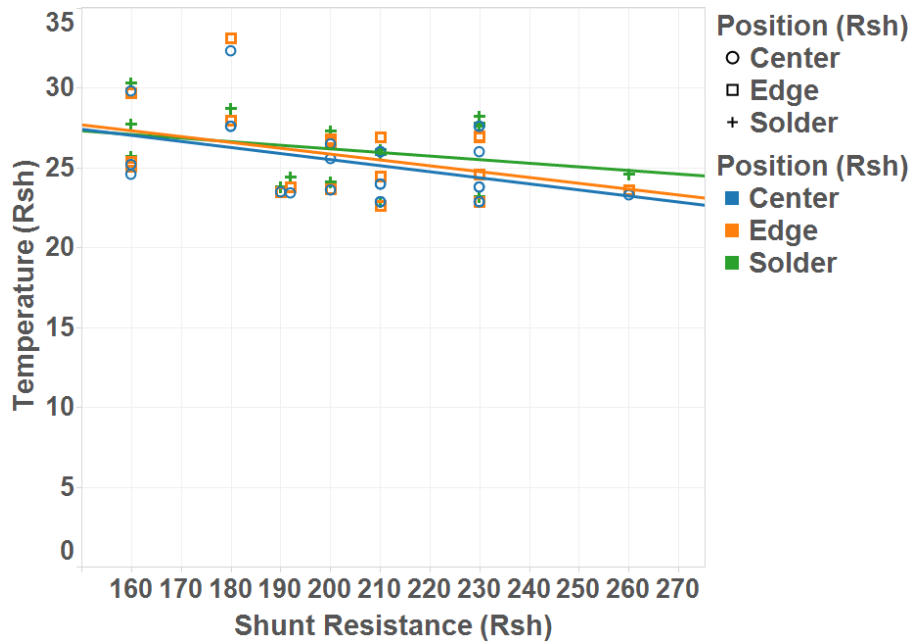
Figure 27: Shunt Resistance Vs Temperature for Mexico Aged Module

From the above figures, it can be observed that the temperature is directly proportional to the series resistance. When the temperatures at three different position of a cell are considered, the temperature at the ribbon of the cell is higher when compared to the temperatures at the center and edge of the cell respectively.

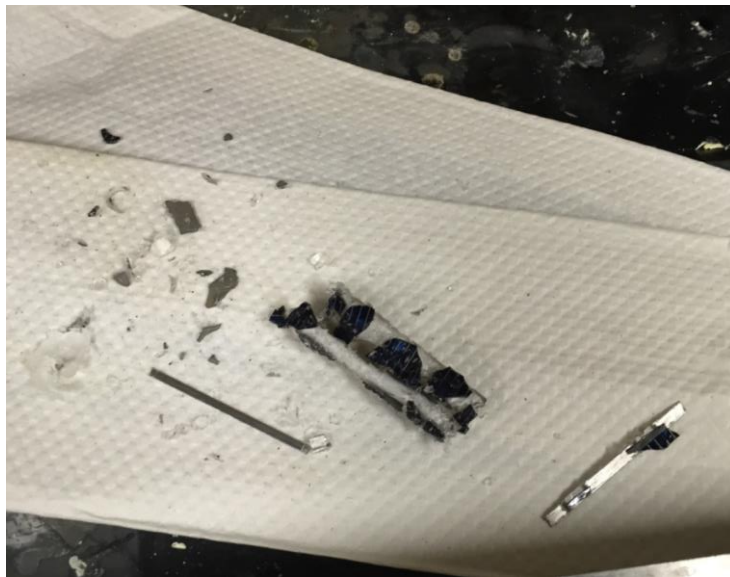
1. The cracked glass separated from the cell.
2. The glass backing was separated from the cell. (The clips were attached to the edge of the cell hence they might have come off once the EVA started to swell)
3. The back sheet crippled as shown in the figure 32.

Figure 32: Sample After the Experiment

1. The clips attached might come off making the back part to cripple.
2. May be 100% TCE is not recommended.
3. Cracked glass might be the problem.

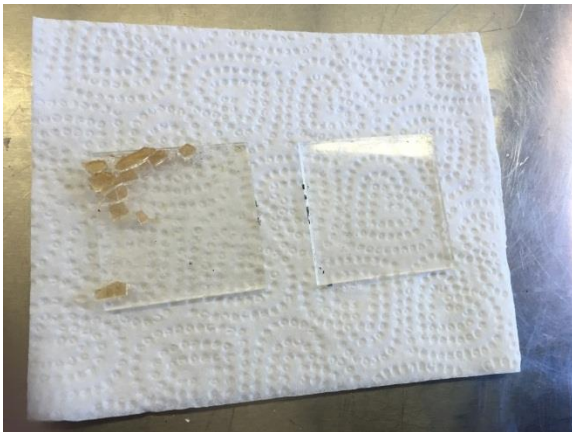
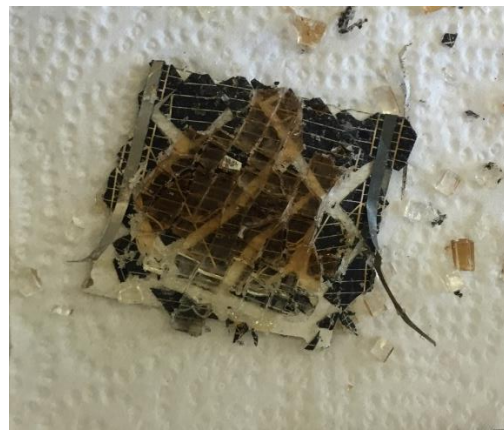
Hence by keeping these issues into consideration, in the next experiment, two glass sheets and larger binder clips were used in order to provide more binding force and to keep the glass intact. The set up was placed in 100% TCE solution and was placed in the apparatus as described above. Again, the sample was left for a day. The observations after the removal of sample from the set up are shown in figures 33-34. From the below figures, it can be observed that,

From these results it can be observed that there was an improvement in the setup but there was no removal of the EVA in the middle of sample.

Figure 33: Front and Back Side of the Glass

Figure 34: Removed Sample from TCE Solution

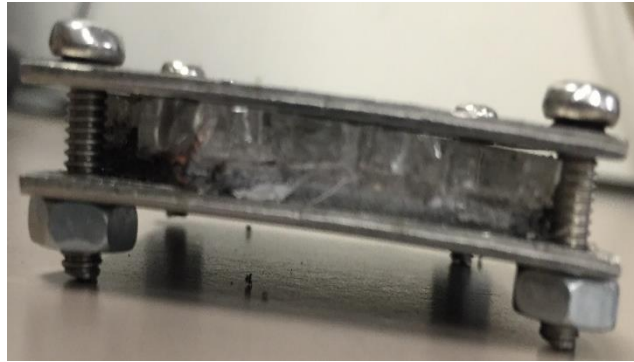
In the next process, a sterner and stronger set up was used so that TCE reaches the center of the sample. In this set up, two stainless steel plates of around 1.5 mm thickness were cut and holes were drilled and were clamped using nuts and bolts as shown in figures 35-37. This set up was immersed in 100% TCE solution and was left for a day at 80°C.

Figure 35: Top View of the Mini Setup

Figure 36: Bottom View of the Mini Setup

Figure 37: Front View of the Mini Setup

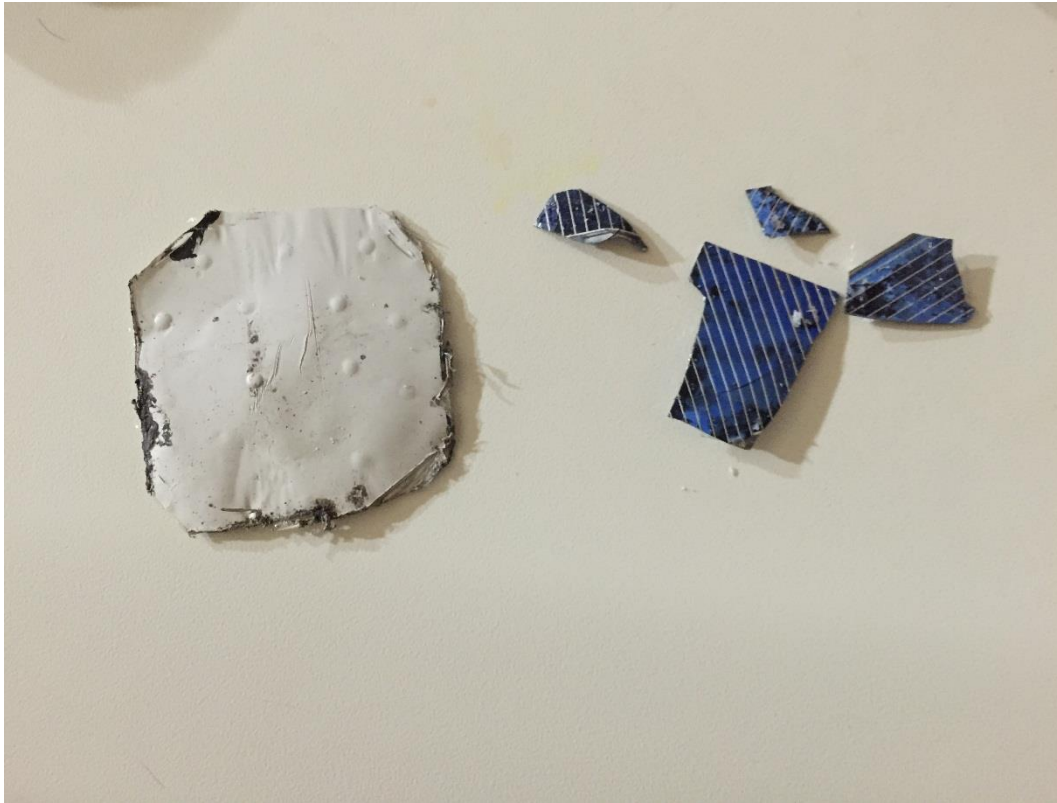
After a day, when removed, it was observed that all the TCE was evaporated and when the set up was unclamped it was observed that all of the EVA was dissolved and the cell and the back sheet were completely separated from one another as shown in figure 38.

Figure 38: Separated Backsheet and Cell After Experiment

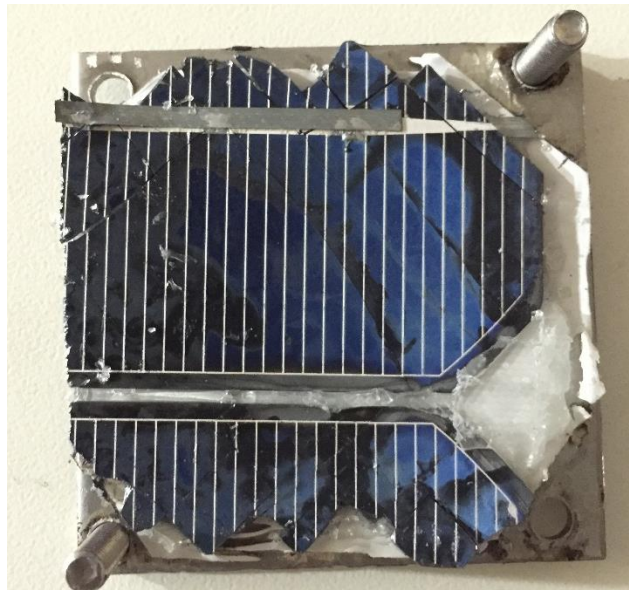
removed from the TCE solution at 11.05 am and the set up was unclamped and the sample was observed. It was observed that all the glass and the EVA was completely separated from the cell and the EVA between the cell and the back sheet remained intact. And after 2 more hours, it was observed that, the EVA between the back sheet and the cell also dissolved. The cell after the first hour is shown in figure 39.

Figure 39: Sample After One Hour in TCE Solution

Hence it can be inferred that, since stainless steel is a far better conductor than glass, the process takes place at a faster rate than usual hence completing the dissolution in an hour. This is a very useful observation and saves a lot of time.

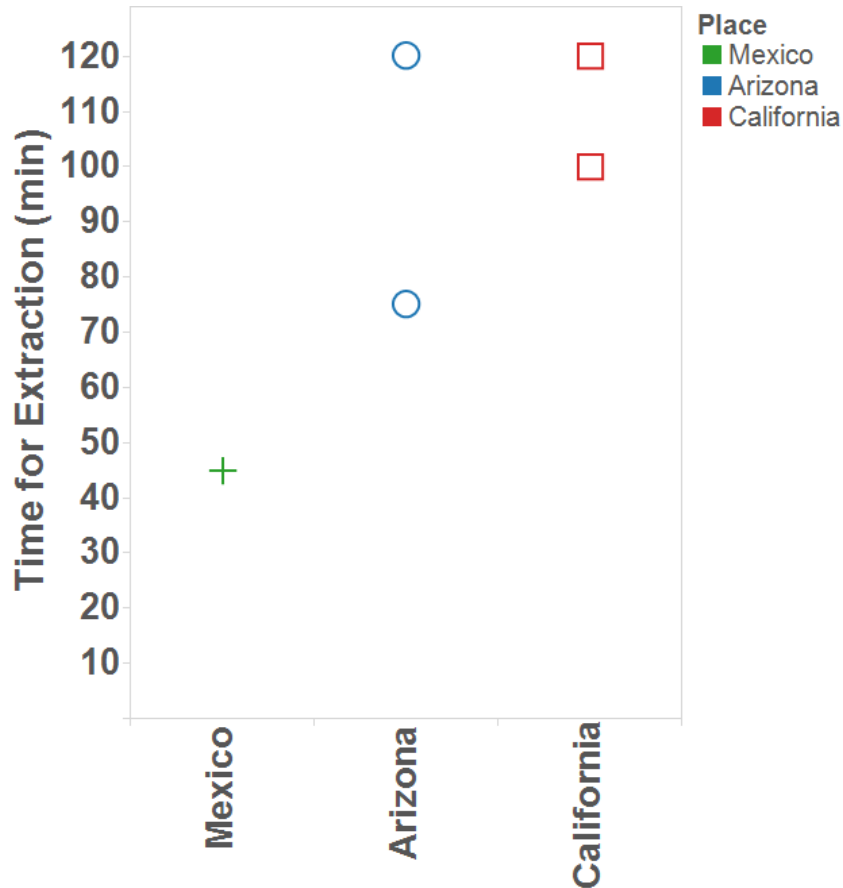
As this process has been finalized, a new stainless steel setup was built as described in the methodology section which could accommodate the size of a regular PV cell. The following figure shows the time taken for extraction of the cell that is the time taken for

the dissolution of Ethyl Vinyl Acetate (EVA, encapsulant) for different modules from different climatic conditions is shown in figure 40.

Figure 40: Time Consumed for The Dissolution of EVA for Various Samples

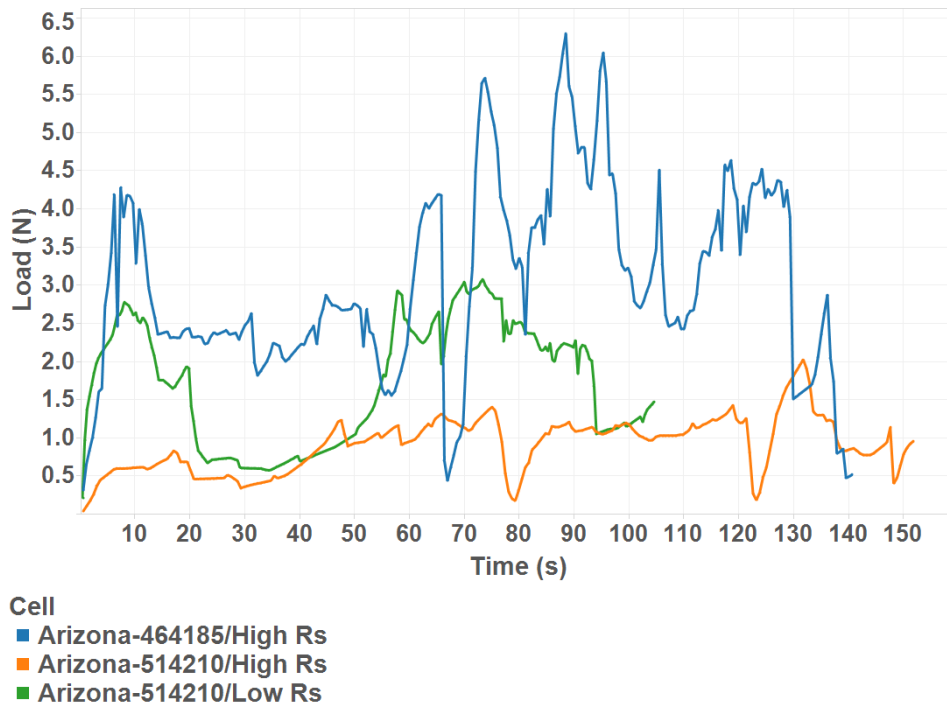
Figure 41: Peel Strength Between Ribbon/Busbar Interface for Cells in Arizona Aged Modules

This section deals with the characterization methods applied to the cells which were extracted using both chemical and mechanical methods. The main characterization method used was the peel test. Figure 41 shows the peel strength between the ribbon/busbar interface for different cells in Arizona aged modules.

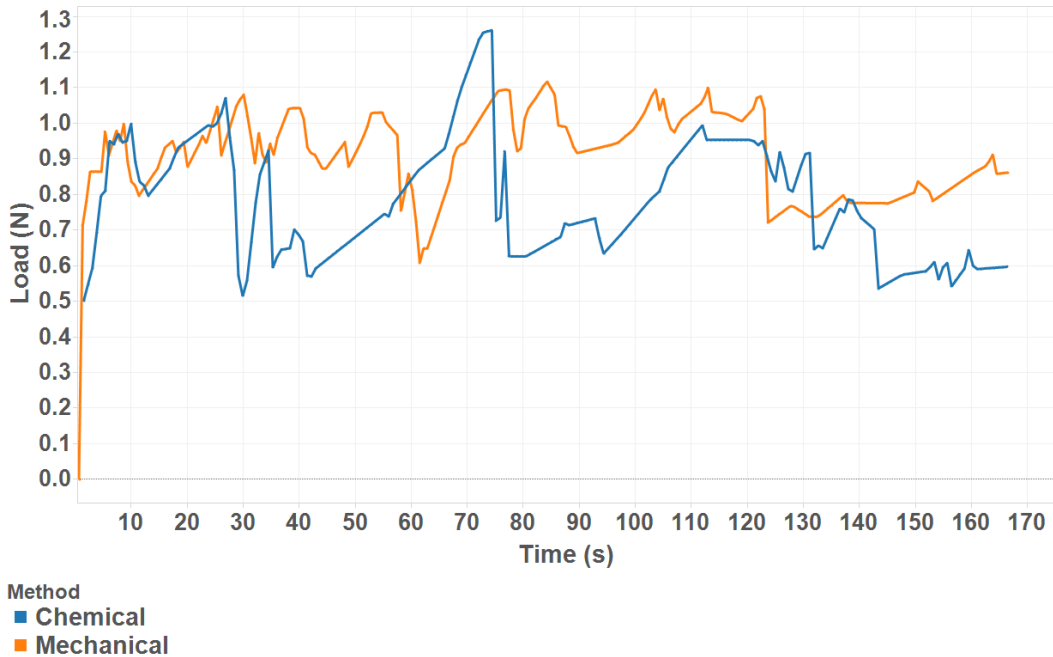
Figure 44 shows the Peel Strength comparison of cells in Mexico aged module using different extraction methods.

Figure 44: Peel Strength Comparison of Cells in Mexico Aged Module Using Different Methods

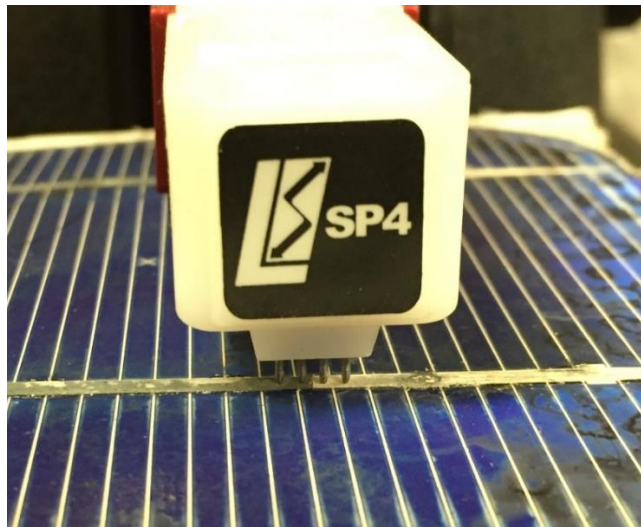
Figure 48: Placement of Four-Point Probe for Ribbon-Busbar Measurement

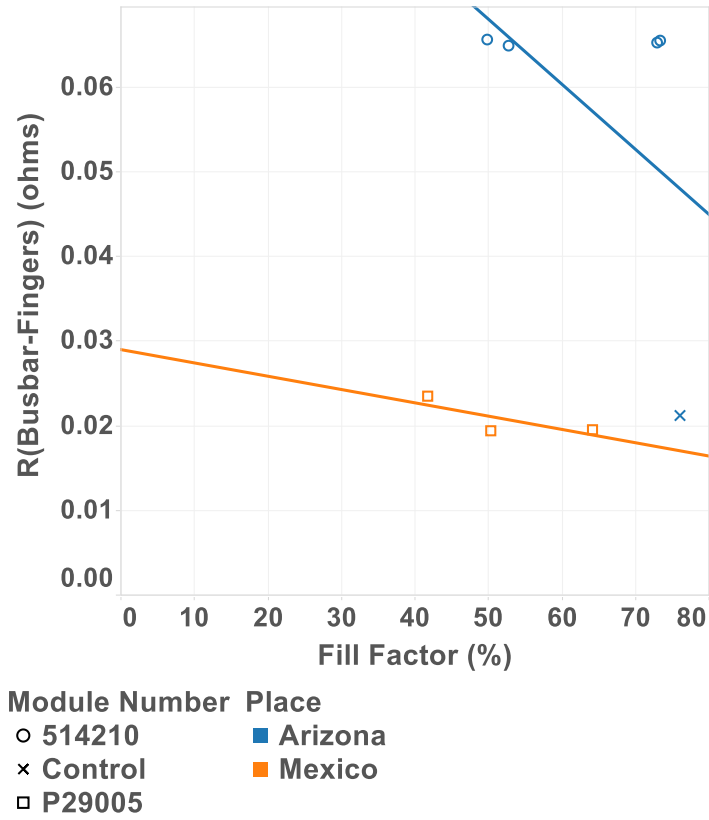
Figure 49 shows the variation of $R_{(\text{Busbar - Fingers})}$ with the Fill Factor for cells from Arizona field aged and Mexico field aged modules. This resistance was obtained by placing two probes on the busbar and the other two probes on the fingers of the cell. From the graph, it can be observed that the Fill Factor of the Arizona aged module doesn't get affected with the increase in resistance whereas for Mexico aged module, a decreasing trend in Fill Factor is observed with increase in in the resistance between busbar and fingers.

Figure 49: R (Busbar - Fingers) Vs Fill Factor of Cells from Arizona and Mexico Aged Modules

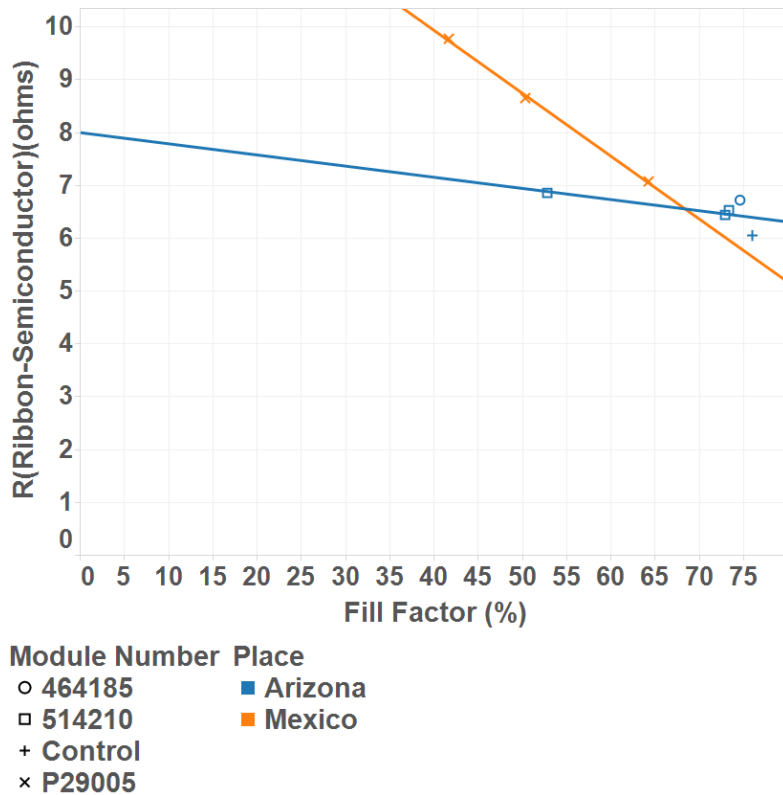
Figures 55 and 57 show the variation of $R_{(Ribbon - Semiconductor)}$ and $R_{(Semiconductor)}$ with fill factor. The resistance values observed are typically very high when compared to others as the contact resistance comes into play. Hence, these resistance values are not of much significance unless the contact resistance is removed.

Figure 55: $R_{(Ribbon - Semiconductor)}$ Vs Fill Factor of Cells from Arizona and Mexico Aged Modules

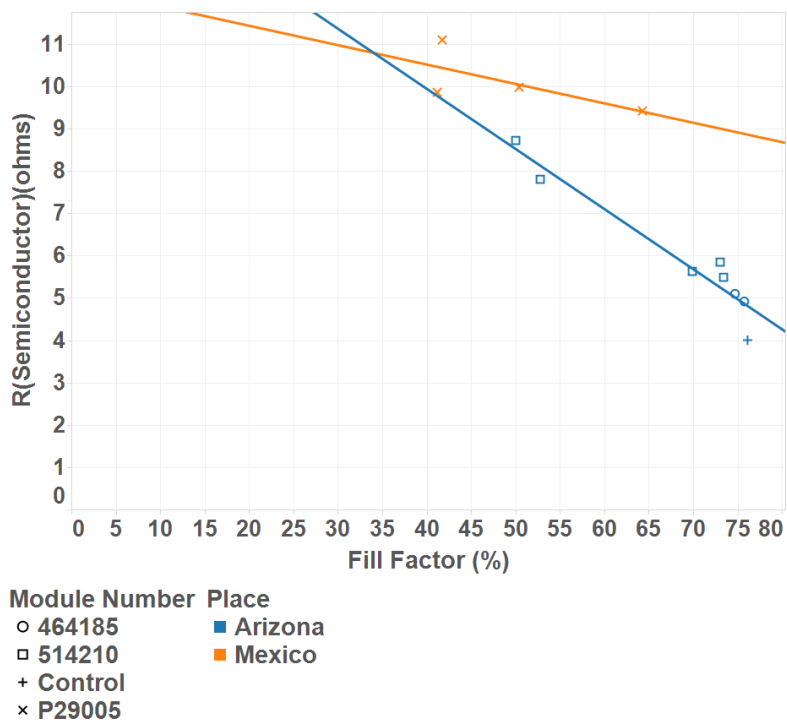
Figure 57: $R_{(Semiconductor)}$ Vs Fill Factor of Cells from Arizona and Mexico Aged Modules
