Series Resistance Increase in Field Degraded PV Modules in
Different Climatic Conditions

A Thesis Presented in Partial Fulfillment
of the Requirements for the Degree
Master of Science

ARIZONA STATE UNIVERSITY

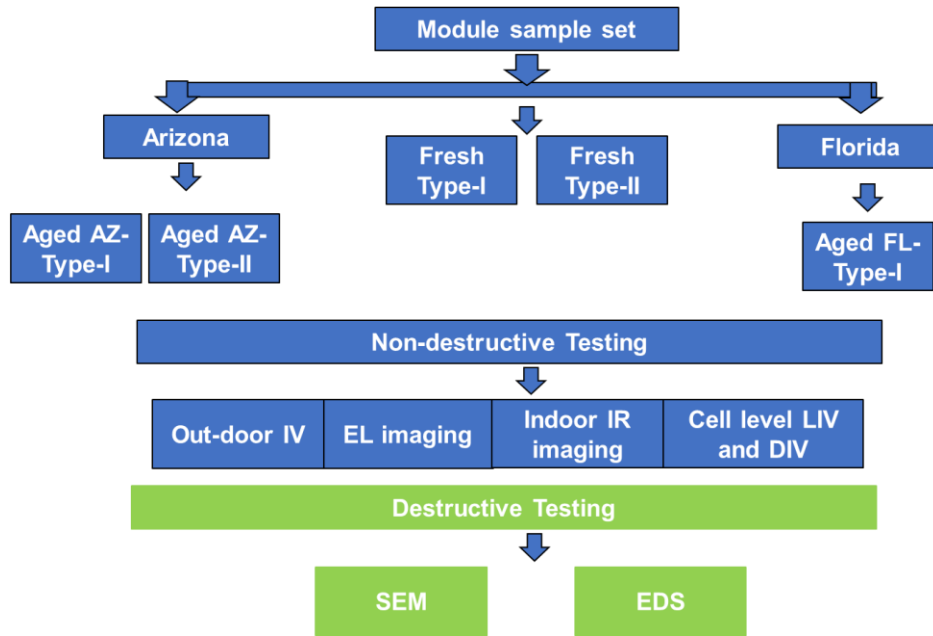
Figure 4 Sample set and thesis flow describing characterization techniques.

The sample set and the process flow of the study can be seen in Figure 4. Two types of modules namely type-I and type-II were selected which are classified based on the use of solder interconnect type. Type-I having Sn-(60%) Pb-(40%) solder and Type-II having Sn-(63%) Pb-(34%) Ag-(3%) solder. The solder compositions are reported by the module manufacturers. Both the modules have the Glass/EVA/c-Si cell/EVA/backsheet construction. Type-I modules are the modules from two different climate locations, one module is Florida (FL) aged and the other one is Arizona (AZ) aged module. Arizona has a hot and dry climate which would typically have high module operating temperatures. Florida has a hot and humid climate with high moisture content in the air and moderate temperatures. Type-I AZ aged modules are 18 years old and will test the effects of temperature cycling on degradation whereas type-I FL module is 10 years old module which will test the effect of moisture ingress and moderate temperature on degradation. Type-II modules are 21 years old AZ field aged module. The modules went through IV curve tracing, Electro luminescence (EL) imaging, Infra-red (IR) imaging and cell level performance testing followed by SEM and EDS destructive analysis.

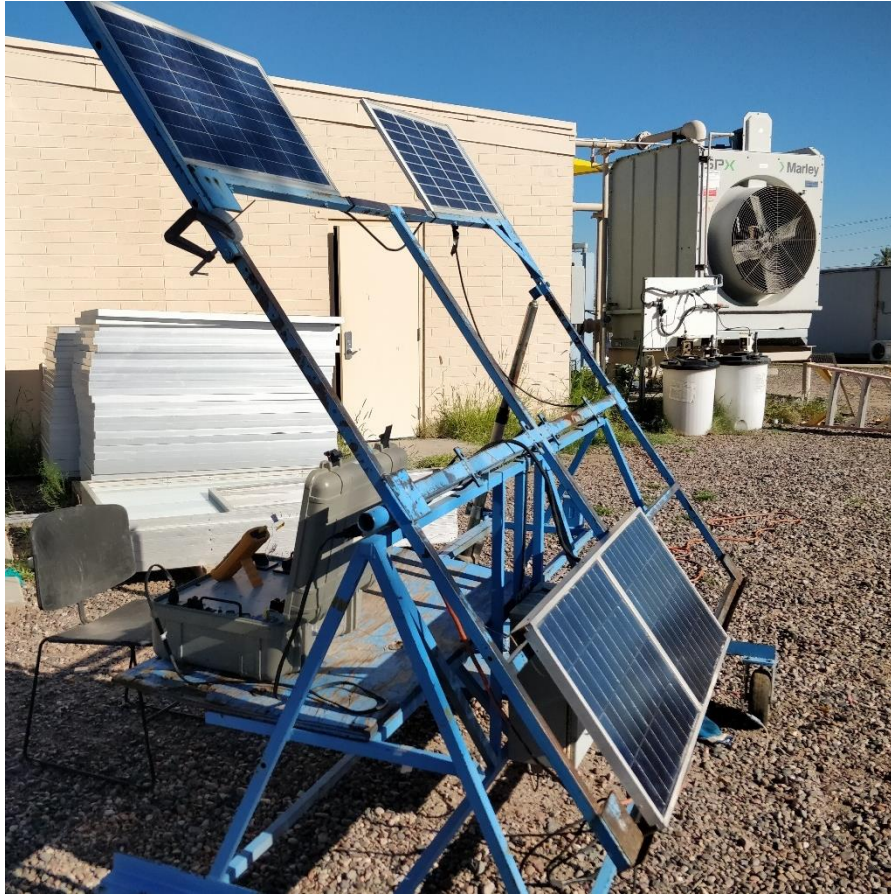
Figure 5. Outdoor IV setup with two axis tracker and PV module connected in forward bias to the curve tracer for measuring IV curves.

IV characterization is done to evaluate the health of the PV module. Daystar outdoor IV curve tracer was used under a clear sunny day with irradiance of $1000\text{W}/\text{m}^2$ and moderate wind speed. The module was placed on a two-axis tracker with the IV tracer connected in series to the module as in Figure 5. A temperature sensor (thermocouple) was connected at the center of the module backsheet to monitor the temperature during the readings. A reference cell was also mounted at the same plane of the module to measure the irradiance. A thermocouple left out open under shade was used to measure the ambient temperature. A solar dial was used to manually set the module plane perpendicular to the sunlight. The measured readings were then translated to STC conditions using a PRL excel template sheet.

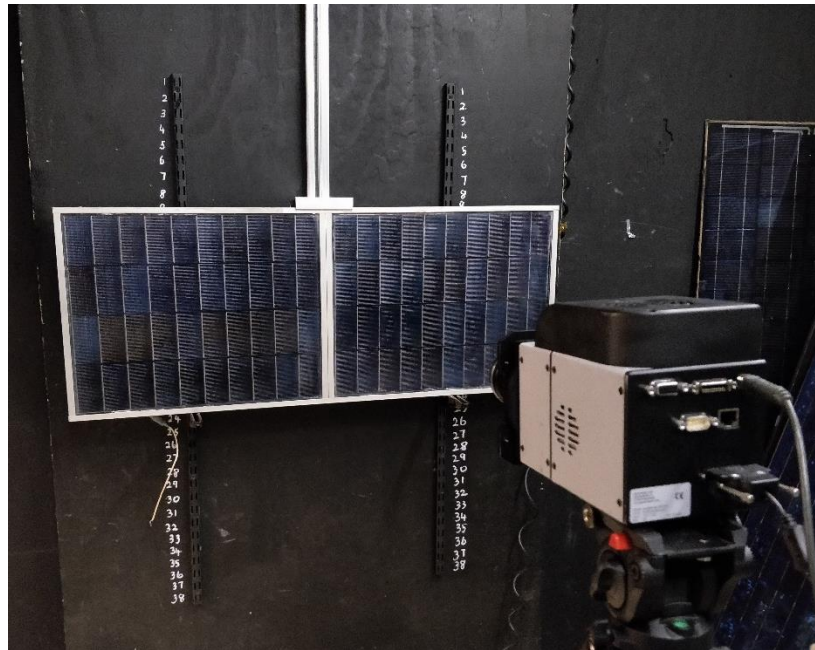
Figure 6. EL imaging setup in a dark room with camera facing the PV module.

detect these 1100 nm waves. The module was mounted using clamps against the wall and the camera is then placed along the line of vision to get the full images as in Figure 6. The current equivalent to I_{sc} was injected into the module under forward bias using a power supply. The exposure time was 60 seconds.

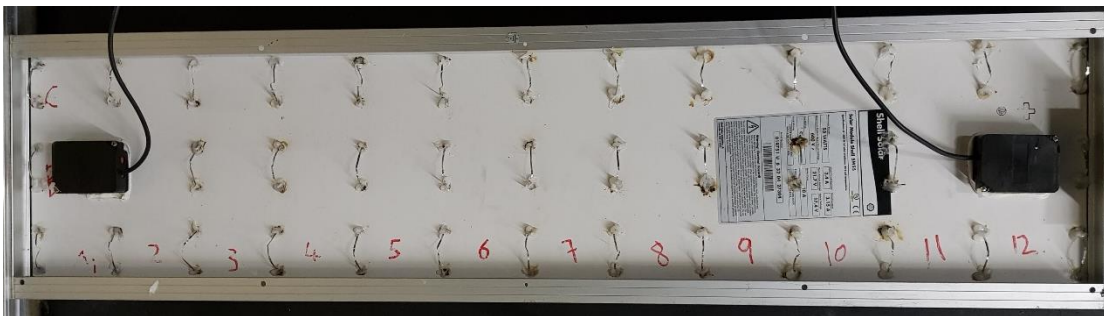
A1	A2	A3	.	.	.		
B1						Junction box	
.							
.

*Figure 7 (a) Module with their cells cut and soldered for cell level DIV and LIV measurements
 (b) Nomenclature used to name the cells in the PV (c) solar simulator setup module*

Cell level IV provides with valuable information about the series resistance of the individual cells in the module which can be used to select the cells that needs to be analyzed for IMC formation and detachment. The backsheet of all the cells were cut using a scalpel at the cell edges along the interconnect. The interconnects were then soldered with a standard tabbing ribbon using a soldering rod in the presence of a water-soluble H-20 paste flux. The soldered regions were then sealed using a Si sealant to prevent moisture and other contaminants from entering. The cut modules as in the Figure 7(a) were measured for cell level dark and light IV measurements. The cells of the module were then named as in Figure 7(b). The module was then mounted on the solar simulator for cell level IV measurements as in Figure 7(c). The temperature of the room was controlled and was set at 25°C. Each cell in the module was then connected to positive and negative probes followed by flashing the simulator lamp for IV measurements. The dark R_s values were then extracted by covering the cell with a black sheet and pumping the I_{sc} current into the cell. These results were then extracted and analyzed.

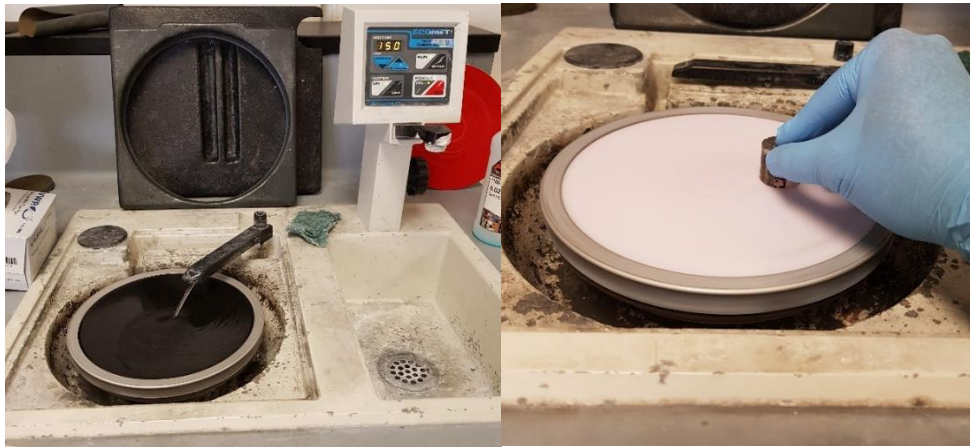
Figure 9 (a) Silicon carbide grinding paper with continuous water supply (b) Polishing cured sample to get a smooth surface for SEM and EDS analysis

Post recovering the capsules are polished with 4 grades (120,240,320,600) of silicon carbide grinding paper on a grinding disc which rotates at 150 RPM. There is continuous water supply while this happens to avoid excessive heating of the samples as in Figure 9(a). The polishing is then followed by 2 grades (6 and 1 micron) of diamond grit paper rotating at 300 RPM which has a water-based lubricant as in Figure 9(b). After each grit the sample is submerged in joy and water

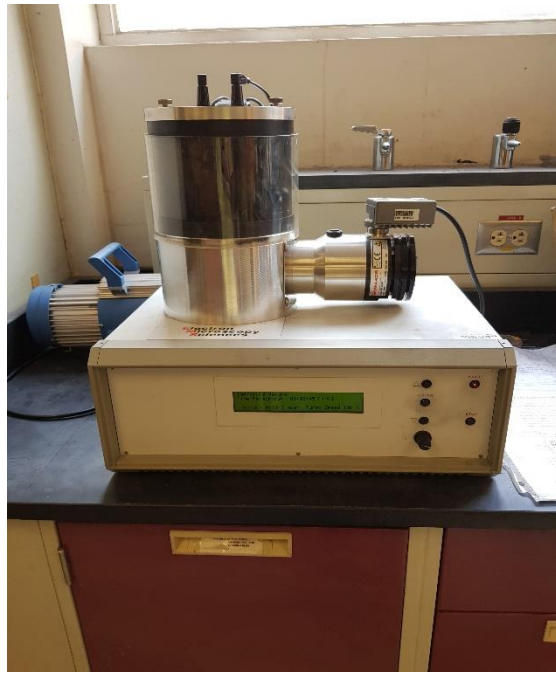
Figure 11 Carbon coating setup used to coat samples with thin carbon layer

The samples are then carbon coated using carbon coater as in Figure 11. A sharpened carbon rod is initially inserted in to a holder such that the sharp side rests on the flat side of the other carbon rod with enough resistance on it. The coater is then set to single pulse, 3000 ms evaporation time. The chamber is then vacuum pumped. This forms an electrically conductive layer over the top which can take away all the electrons from the surface.

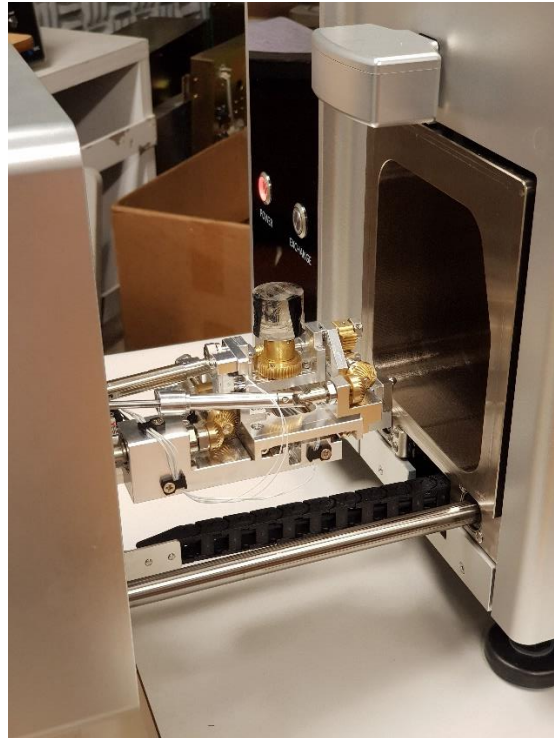
Figure 12 Sample placed inside the SEM holder post calibration.

The samples post sample preparation are mounted over a metallic holder using a carbon tape which forms an electrical contact between the sample head and the bottom holder for the electrons to dissipate. The samples are then put inside the holder and calibrated as in Figure 12. the sample image is then taken using the camera at the top which can later be used to navigate the samples while the electron gun is operating. The samples are then put in vacuum inside the SEM using a vacuum pump. Once the vacuum is built the electron gun is started by applying 15 kV of voltage.

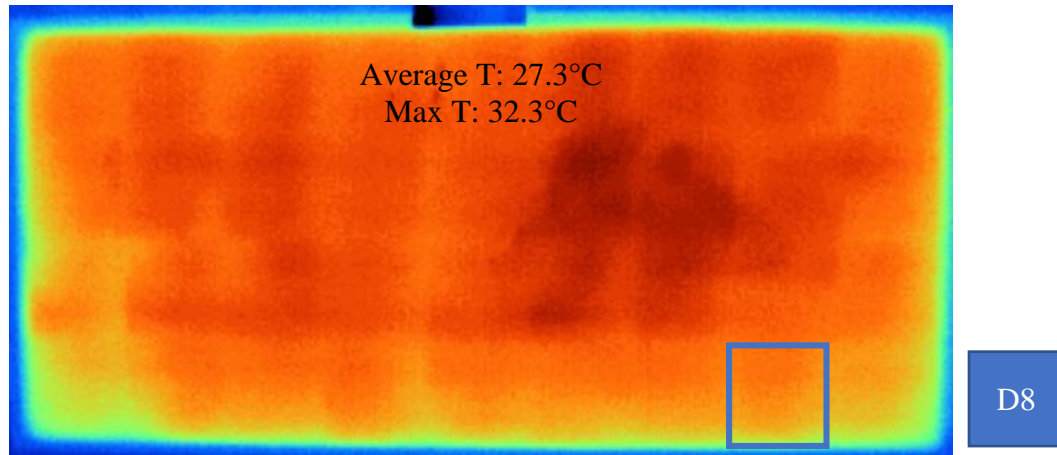
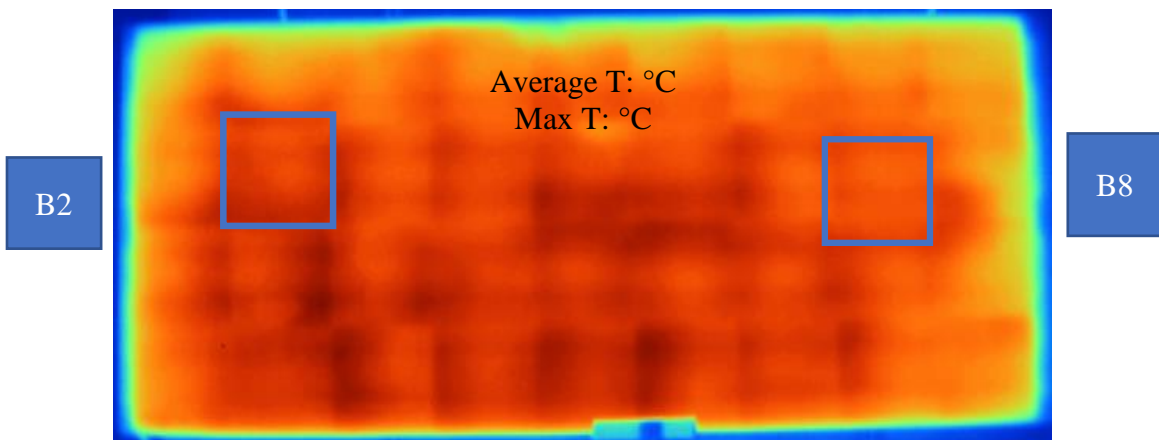
mismatch. These hot regions match with the bright spots from EL images, consolidating our initial understanding of solder bond degradation occurring due to higher current density at these regions.

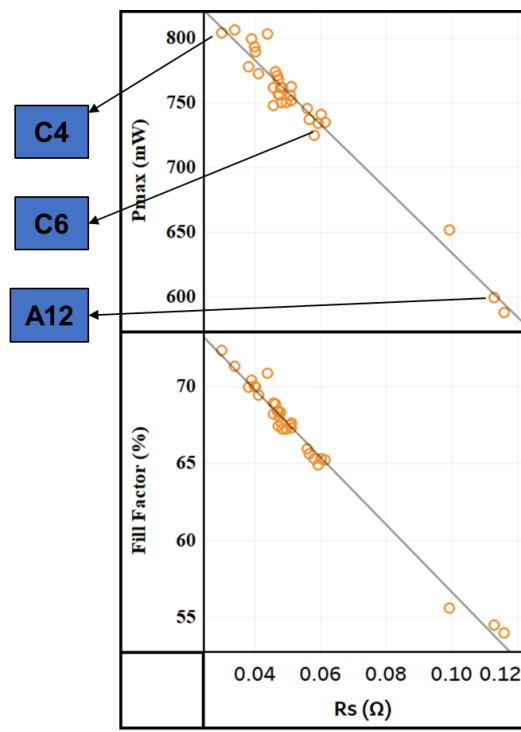
The cell level dark R_s values were plotted with respect to the cell fill factor (FF) and P_{max} values as in the image to find out the correlation coefficient. As in Figure 17(a) For type-1 FL aged modules, coefficient of determination of P_{max} and FF with R_s is 95.99% and 98.30% respectively which indicates the model to be a good fit for the data. In Figure 17(b) for type-1 fresh module the coefficient of determination of P_{max} and FF with R_s is 30% and 82.3% as the module is not degraded resulting in most of the cells being clustered around a uniform R_s value. Similarly, the correlation plots for type-II aged and field aged modules are shown in Figure 17(d) and Figure 17(e). This correlation helps better understand the effect of series resistance on the two performance parameters (R_s and FF). Based on these values the cells with low, medium and high series resistance were then selected in type-1 aged module but only one cell with least R_s is selected from type-1 fresh module.

Figure 17. Maximum power (P_{max}) and Fill Factor (FF) correlation plots with series resistance (R_s) of (a) type-I fresh module (b) type-II FL aged module (c) type-II AZ aged module (d) type-II fresh module (e) type-II AZ aged modules

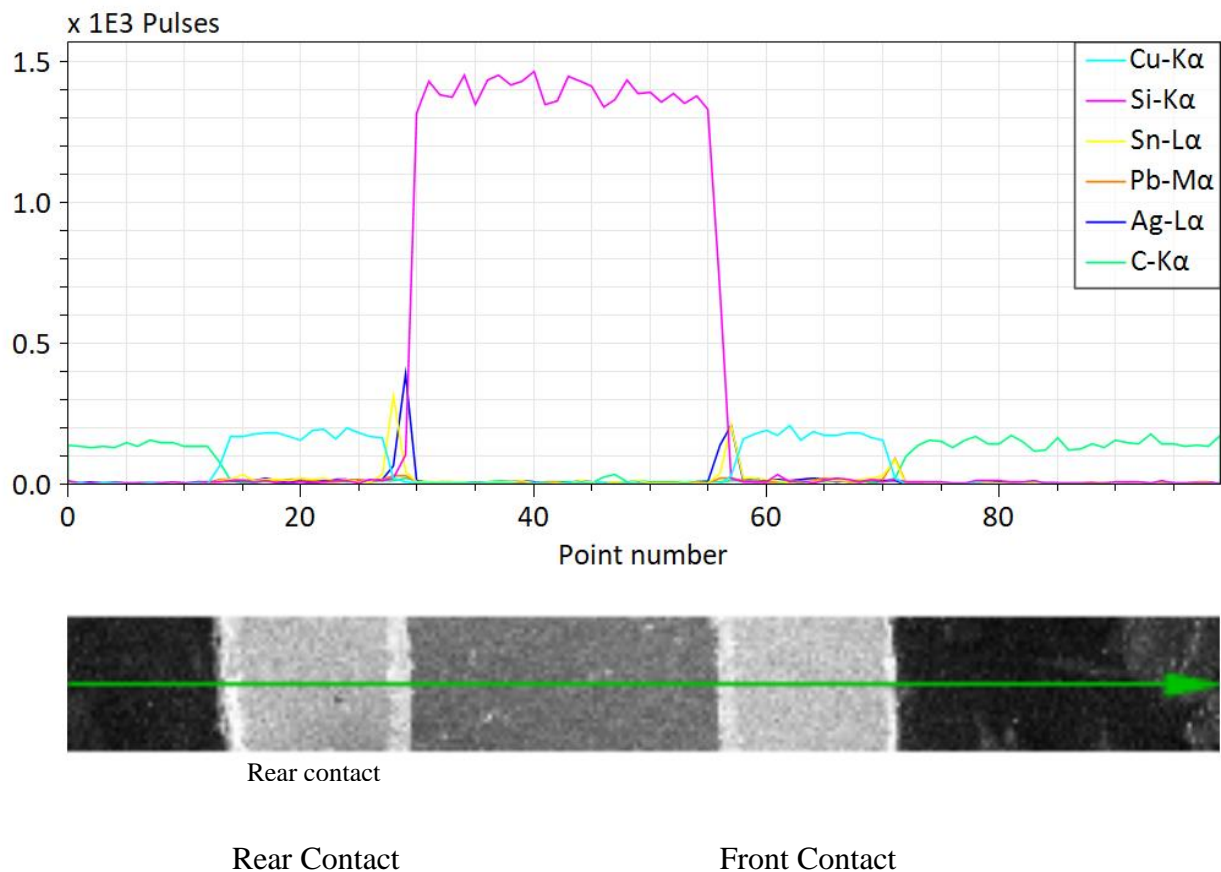
from the line scan graphs of top and bottom contacts as in Figure 20. The overlap of elemental compositions at the interfaces is a normal distribution curve. IMC thickness is calculated using the full width half maximum (FWHM) technique, where the overlapping bell curve between the two elements of interests are identified and the width is calculated at half the maximum height of the bell curve. The X-axis in the line scan graph is a 100-point scale and the length corresponding to these 100 points depending upon the magnification. The full width half maximum length in terms of points can then be converted to actual length. The average Ag_xSn_y thickness in fresh samples is $2.514\mu m$ and Cu_xSn_y IMC IMC is $1.626\mu m$ for both front and back contacts.

Figure 20 Line scan across the interconnect region indicating the intermixing of the adjacent metallic layers.

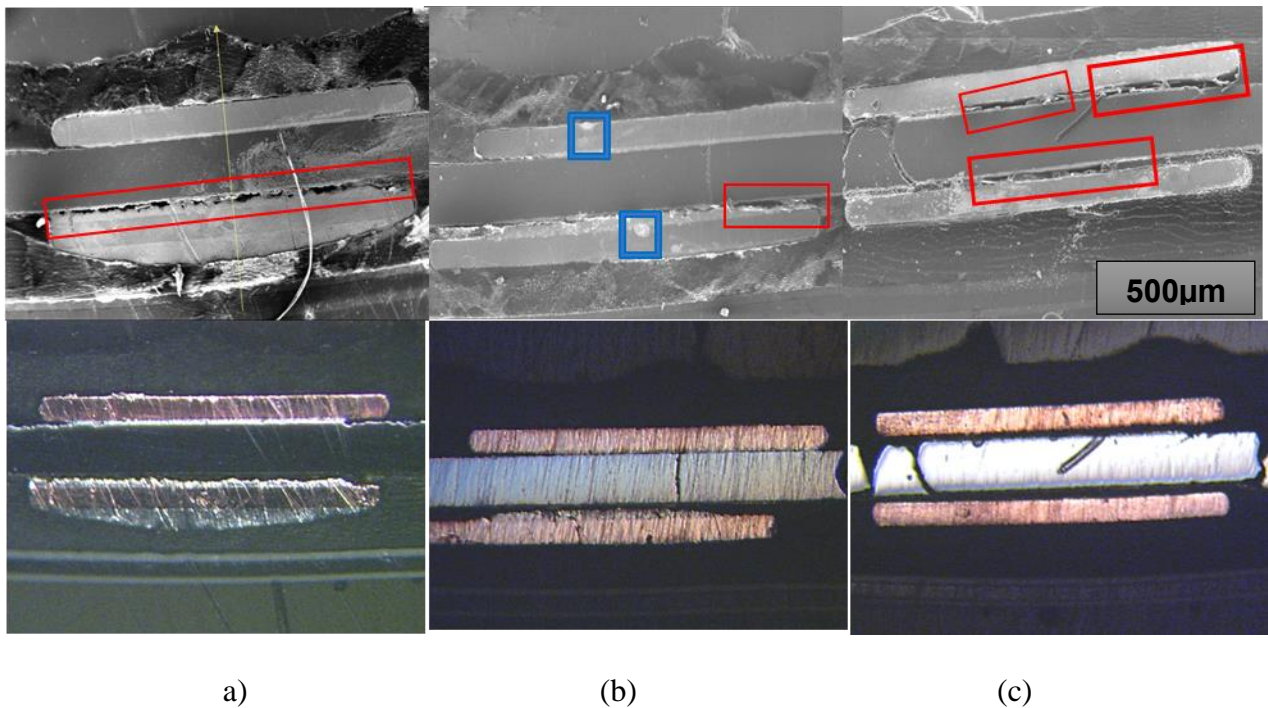
Figure 21 (a), (b), (c) is from Florida aged high resistance cell, it clearly indicates presence of multiple voids at the solder ribbon - Ag busbar interface at top and rear contacts. They formed due to the formation of IMC followed by detachment during thermo-mechanical fatigue. It can be observed that the rear contacts show significantly higher rates of detachment and IMC formation compared to the top contact. As suggested by [21] combination of temperature and humidity leads to higher voids formation compared to isothermal heating this could be a potential reason for this phenomenon as FL climate is humid in nature and typically there is moisture ingress from the

Figure 21 Cross-sectional SEM and optical images of type-I FL aged high resistance cell indicating detachment of interconnects (red box) and lead segregation (blue box)

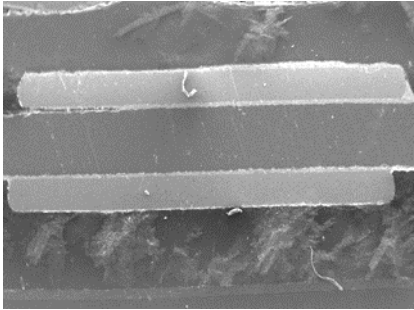
0.019 Ω	The interconnects here have very good contact with the busbars
Type-1 FL aged (10 years)

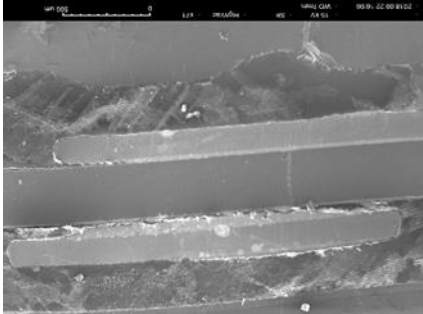
0.059 Ω	The IMC formation and detachment at the rear contact is accelerated due to oxide formation in the presence of moisture.

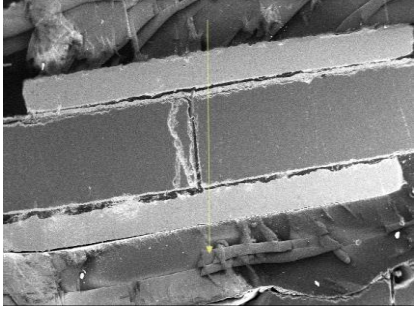
<p>0.104 Ω</p>	<p>Being in a dry climate led to IMC formation and detachment equally on both contacts</p>
<p>Type-2 fresh</p>

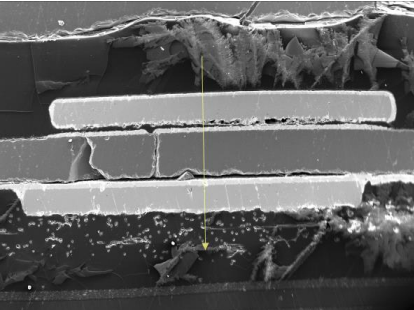
<p>0.0143 Ω</p>	<p>The fresh samples have IMC from manufacturing. The detachment of interconnect is due to broken cell pieces</p>
<p>Type-2 AZ aged (xx years)</p>

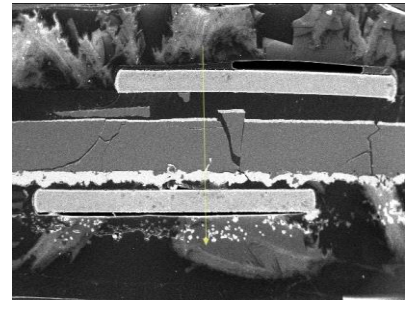
<p>0.0299Ω</p>	<p>The IMC formation and detachment in this case is higher as the module is towards the end of its life.</p>
