Exploratory Study of Distortionary Corrective Modification of Concrete Contraction
Joints Through Infused Polymerized Siloxanes-Based Compounds

A Dissertation Presented in Partial Fulfillment
of the Requirements for the Degree
Doctor of Philosophy

ARIZONA STATE UNIVERSITY

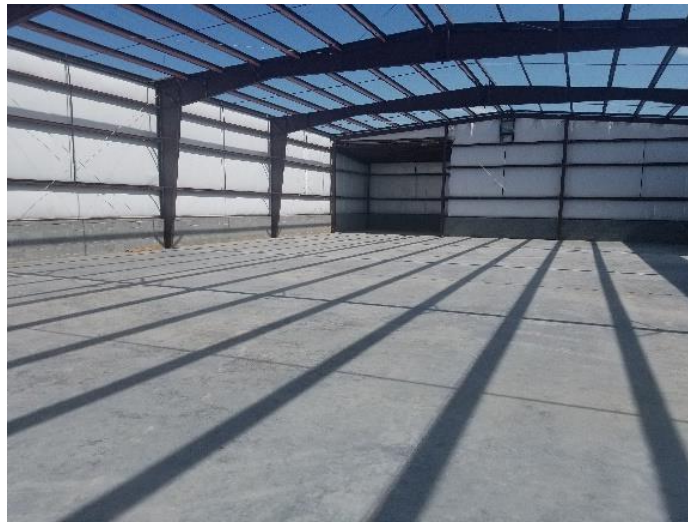
Picture 3.1: Inside Building - Cottonwood, AZ

The two identical slabs placed in Cottonwood, Arizona are two industrial buildings both 8,320 square feet each. The concrete was placed in May of 2018, with a four-inch slab using 3000-psi concrete. There was no vapor barrier placed underneath the concrete, and the contraction joint spacing was 15 feet by 20 feet leaving a square footage of 300 square feet within each space of the contraction joints. This is well over the recommended 36 times the thickness of the concrete slab or 144 square feet (Walker and Holland, 1999, pg. 50) (See Picture 3.1 and 3.4). These pictures were taken at the beginning of August; thus, the concrete slabs were exposed to outside environmental conditions for nearly three months prior to measuring.

Both industrial floors were placed with the use of a concrete pump and a laser screed. This process produces a very flat concrete floor. The concrete was cured with a chemical curing compound. The first floor placed received a silicone-based compound the day after the placement of the concrete and immediately after the sawcut contraction joints were placed.

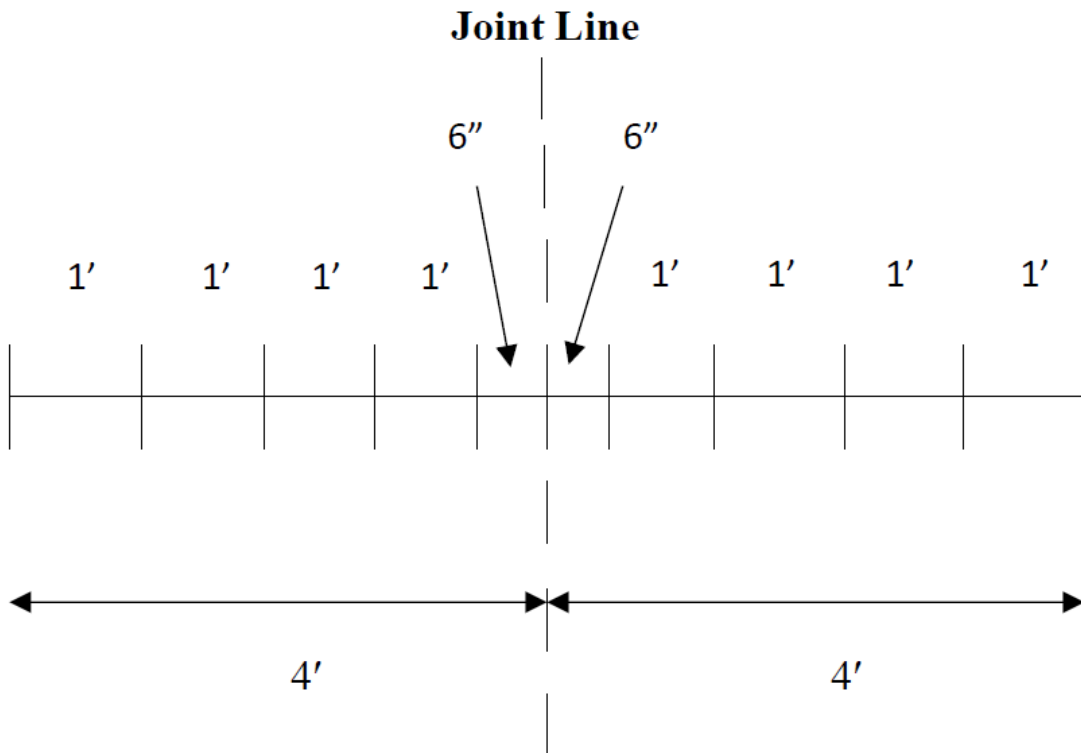
Measurements were taken every foot starting with the one-foot mark. The measurement distances changed when coming closer to the contraction joint. Between the four-foot mark and 6-foot mark measurements were taken every six inches on either side of the contraction joint. After the 6-foot mark the measurement pattern continued to be measured every foot. At each point on the tape measure as described above, elevation measurements were taken with a laser level (Spectra LL300N), which has the capability to measure within 1/100th of a foot. There were approximately 150 measurements were taken within each building (See Figure 3.4).

Figure 3.4 : Typical Measurement Regimen

The measurements were set up into thirteen locations. Both buildings are the same size, and the drawing in Figure 3.4 is representative of both buildings and how both buildings were measured. In Figure 3.4, number 8 or station 8 on the **contraction joint** is the point which establishes the elevation point of 0.00. This is consistent with both buildings, A and B (See Figure 3.5).

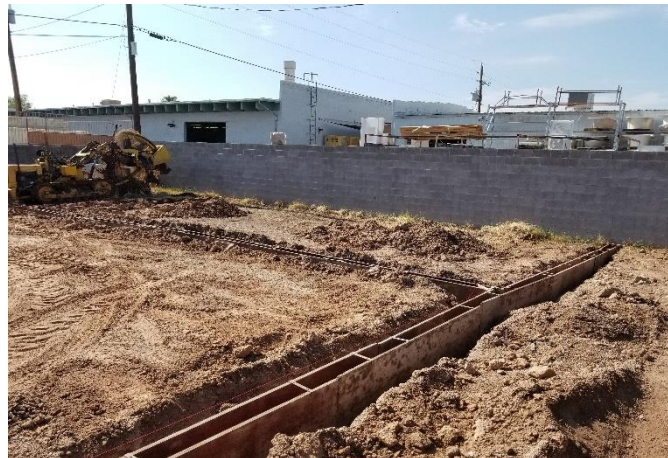
Picture 3.4: Stem Wall Forms for Phoenix Test Slabs

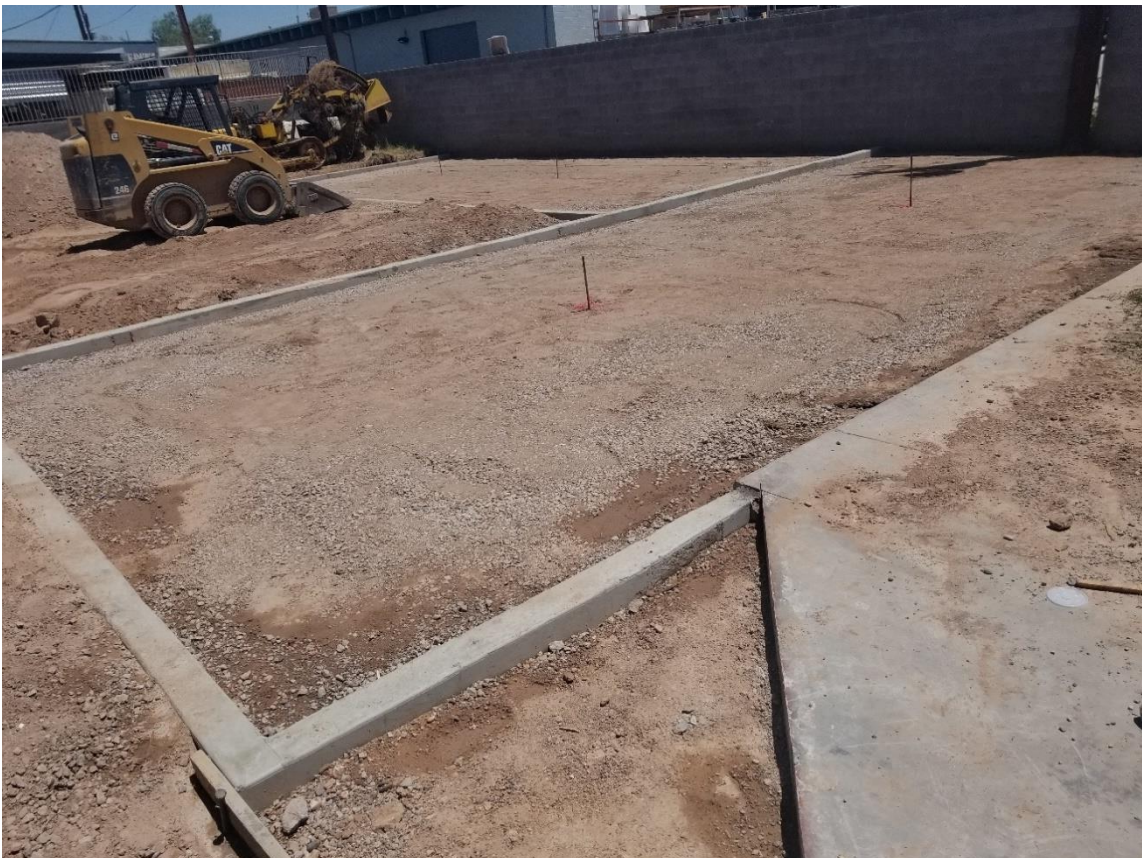
The existing soil was removed eight inches below the finish floor elevation, and four inches of A.B.C. (Aggregate Base Coarse) was introduced to give the necessary compaction needed for the subgrade of the slab. The subbase was then moistened with water and compacted with a plate compactor. This provided a smooth base for the concrete to be placed as shown in Picture 3.5.

Picture 3.5: Foundation Completed and Backfilled for Phoenix Test Slabs

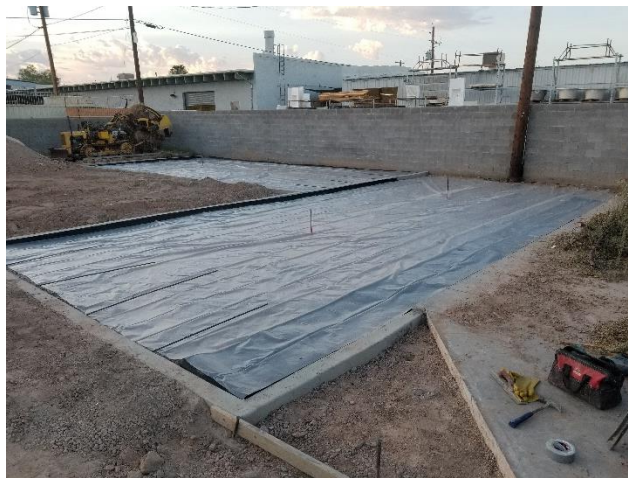
Since the purpose of this test slab was to study the effect of sealing the sawcut joints on the curling, it was decided to increase the probability of its occurrence, and therefore a six-millimeter plastic vapor barrier was placed between the subbase and the concrete. This will force all bleed water to the surface, and the slab with silicone introduced to the saw cut contraction joints would hypothetically minimize the amount of curl in the contraction joint system, as desired. The vapor barrier can be seen in Picture 3.6.

Picture 3.6: Vapor Barrier Installed on Phoenix Test Slabs

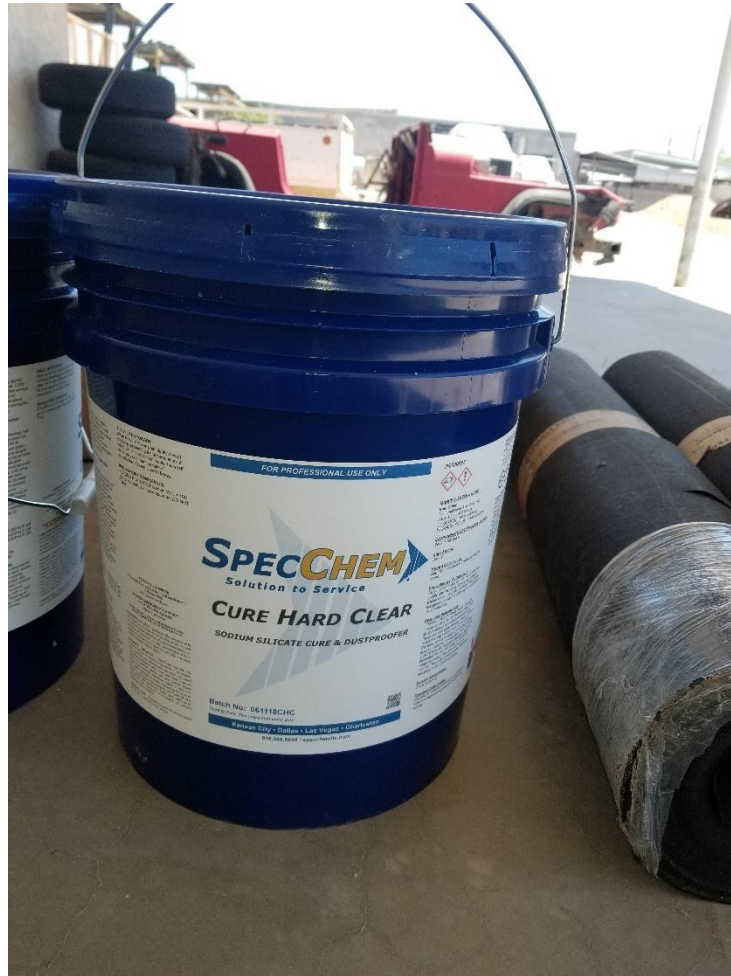
The application of this product is important and was done according to the manufacturer's specification. A new hand spray pump was purchased and applied in one direction. After the cure set up, another application was applied in the perpendicular direction, making sure of ample coverage. The cure then needed to dry prior to the saw cutting of the contraction joints. The type of cure used can be seen in Picture 3.7.

Picture 3.7: Concrete Cure Used for Test Slabs in Phoenix Slabs

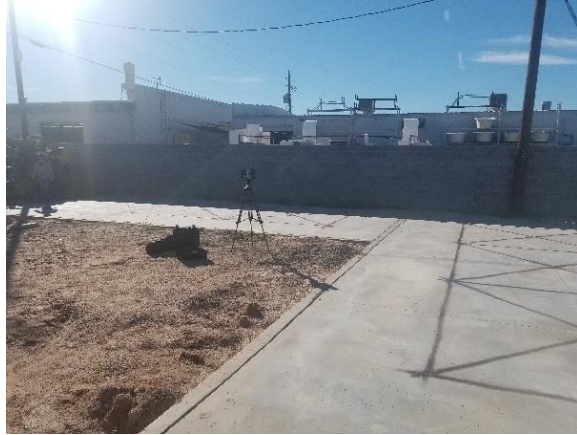
Picture 3.9: 3D Laser Scanning of Test Slabs in the Phoenix Area

The research team from Arizona State University was able to use the data points provided and replicated the information from the initial data points to the end at 60 days. This provided an understanding of how the two slabs are curled during that time.

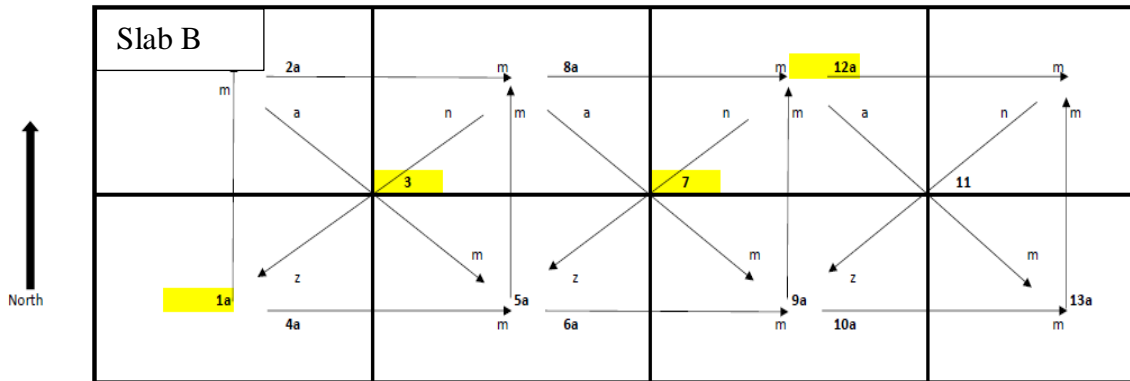
Figure 3.7: Measurement Configuration in Phoenix Test Slab B

As shown, Figure 3.6 is Slab A, and Figure 3.7 is Slab B. Slab A had silicone placed in the contraction joints, whereas Slab B did not. Similar in nature of the Cottonwood slabs, the measurements were taken the same. The process was done by placing a tape measure perpendicular to the sawcut contraction joint placing the 5-foot mark of the tape measure at the center of the contraction joint, measuring for a total of 10 feet across the contraction joint

A benchmark was placed one foot above the concrete slab on an existing telephone pole (See Figure 3.3). This provided a reference point to start from and was established at the very beginning of the measurement process and is displayed as 0.0 in elevation on the figures. Similar to the Cottonwood, Arizona buildings, the same measurement pattern was followed (See Figures 3.6 and 3.7).

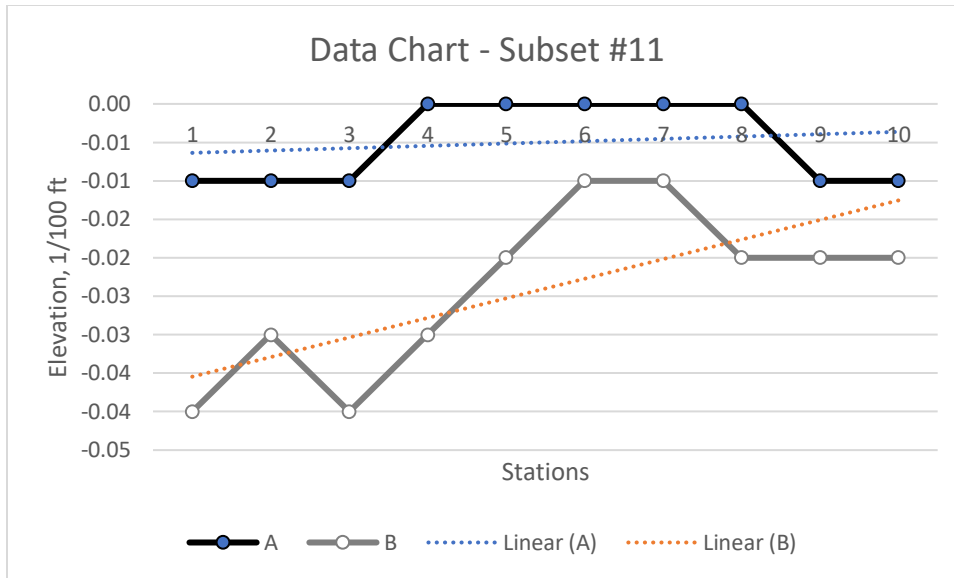
Figure 4.4: Subset #11- Cottonwood

Figure 4.4, across the sawcut joint there is a noticeable difference between the Slab A and Slab B. Slab A has a more uniformity to the slab where Slab B shows peaks and valleys which may have been contributed by the later application of silicone or this data may show there were finishing problems during the placement of the concrete slab.

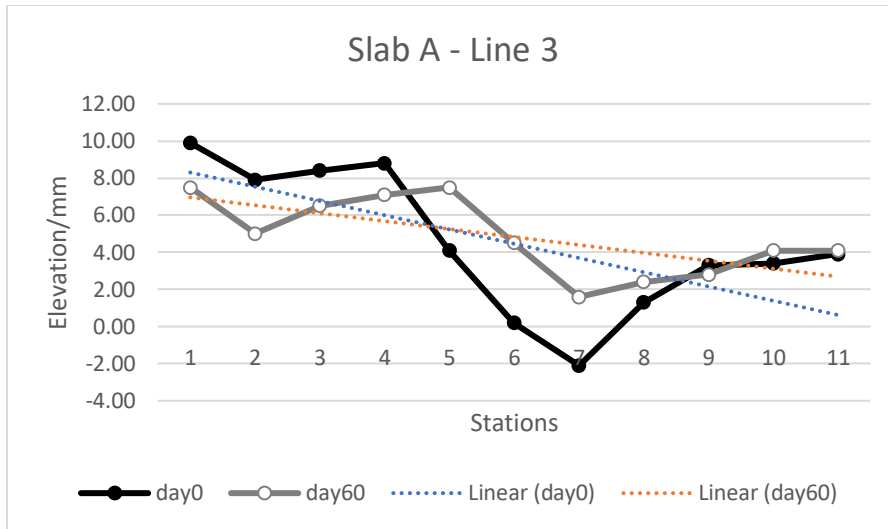
Figure 4.7 shows elevation measurements taken at location 3 on Phoenix Test Slab A on Day 0 and Day 60. Location 3 measurements were made along a line that runs diagonally through the intersection of 2 sawcut joints.

Figure 4.7 indicates the elevations changes were gradual and unnormal between station 1 and 4. Between stations 5 and 9 the volume change reverses with an increase of up to 0.5 mm at station 7, and this is the region where contraction joints divide the slab. This data is difficult to explain as the later age measures indicate curling at some points along the measurement line and then shrinking at other points along the same line.

Figure 4.7: Location #3 – Phoenix Test Elevation Measurements Slab A

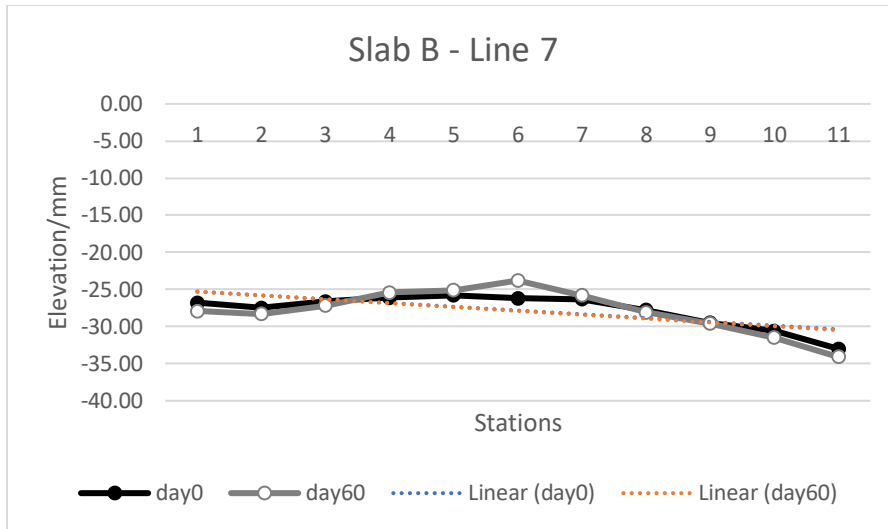
Figure 4.10: Location #7 – Phoenix Test Elevation Measurements Slab B w/o Caulking

In Figure 4.10, both profiles at day 0 and day 60 do not vary, but at the contraction joint; Station 6 an increase of the slab of 2.4 mm can be noticed, probably due to excess moisture loss. One does see an increase in elevation change overtime which would indicate increased curling.

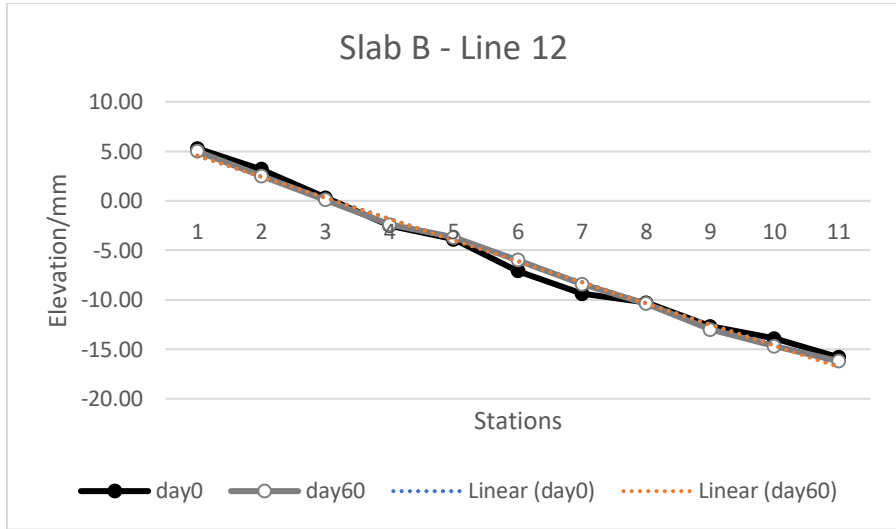
The two profiles shown in Figure 4.11 and 4.12, indicate almost a uniform change in elevation from station 1 to 5. In Figure 4.11, the elevation moves upward from stations 6 to 11. In Figure 4.12, there is little to no change throughout the entire graph. This may be due to the situation where the slabs in both areas are close to the edge and the foundation kept the slabs from making any noticeable changes in elevation.

Figure 4.12: Location #12 – Phoenix Test Elevation Measurements Slab B w/o Caulking
