Exploratory Study of Unmanned Aerial Vehicles for Building Inspections

A Roofing Inspection Case Study

A Thesis Presented in Partial Fulfillment  
of the Requirements for the Degree  
Master of Science

ARIZONA STATE UNIVERSITY

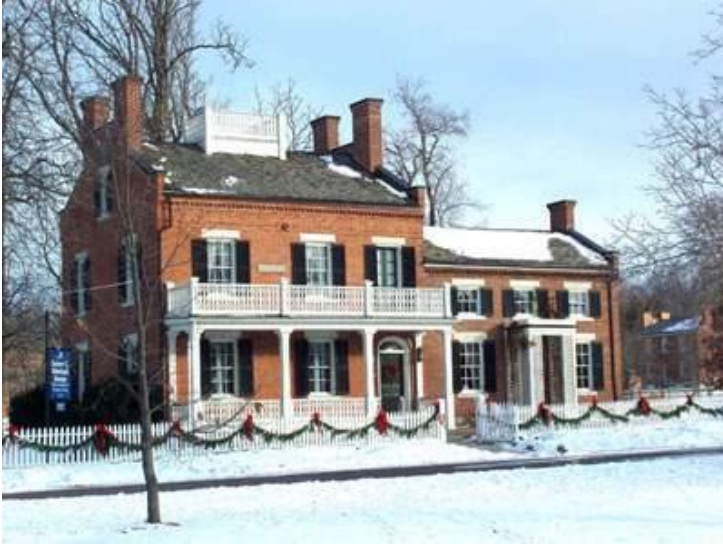
**Figure 2.**

Historic homes require a higher standard of maintenance because of their potential to be damaged. They have original features such as cedar shake roofs, parapet walls, historic brickwork, authentic wooden doors and windows, and brick chimneys. The fragile state of these features makes the inspection process difficult to perform while preserving the integrity of the feature.

*Typical Historic Nauvoo Home.*

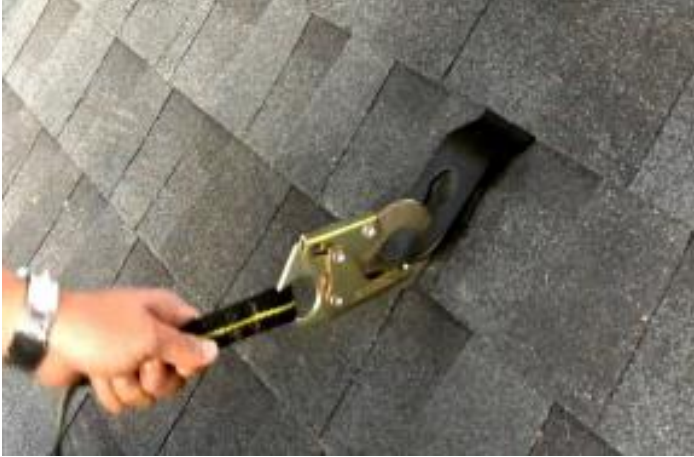
**Figure 5.**

*Example of Roof Anchor.*

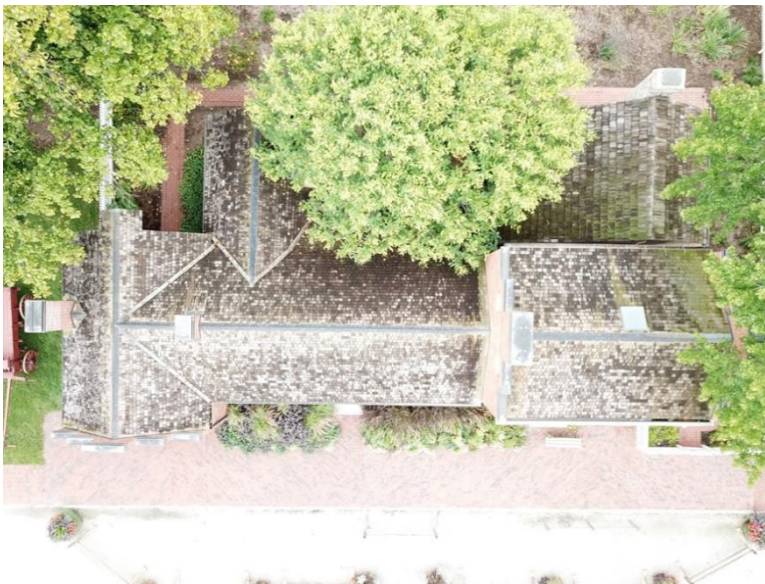
**Figure 6.**

*Top View of Historic Roof.*

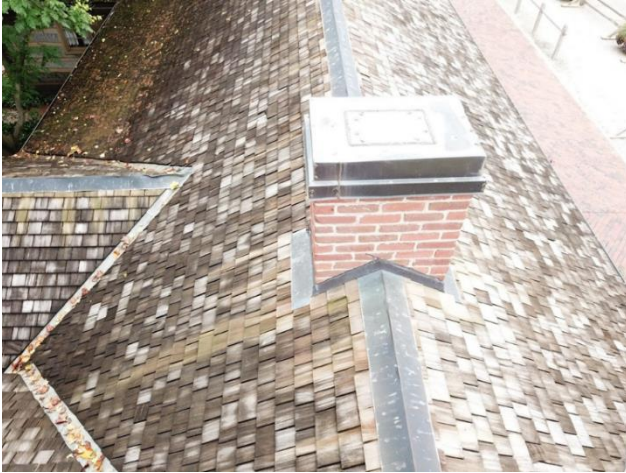
**Figure 7.**

**Picture Set 3:**  
45-degree angle shots of all major penetration points and parapet wall joints to the horizontal roof, vent joints, chimneys, antennae, HVAC-related items, etc. Shots typically were taken at about 5-20 feet from objects and from all four angles (if possible, depending on the structure and surrounding trees).

*45-degree Picture of a Roofline and Chimney.*
