Potential Induced Degradation (PID) of Pre-Stressed Photovoltaic Modules:  
Effect of Glass Surface Conductivity Disruption

A Thesis Presented in Partial Fulfillment  
of the Requirements for the Degree  
Master of Science in Technology

ARIZONA STATE UNIVERSITY

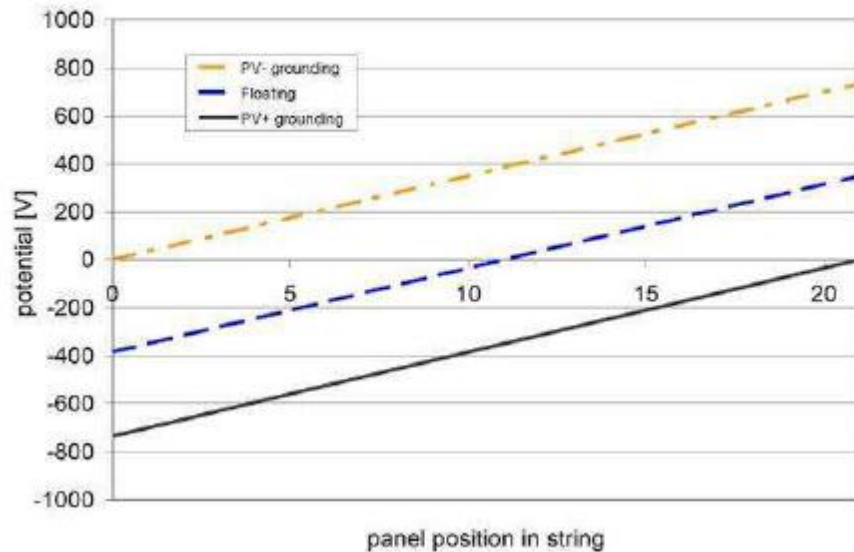
Figure 1.2: Voltage & polarity depending upon its position and grounding [4].

In typical crystalline silicon modules, potential induced degradation (PID) occurs in the modules closest to the negative voltage side of an array. The high potential difference between the cells and frame causes a polarization effect leading to leakage current discharged to the ground. Over a period of time and under the influence of high voltage, temperature and humidity, the leakage current causes potential induced degradation (PID) and reduces the module performance.

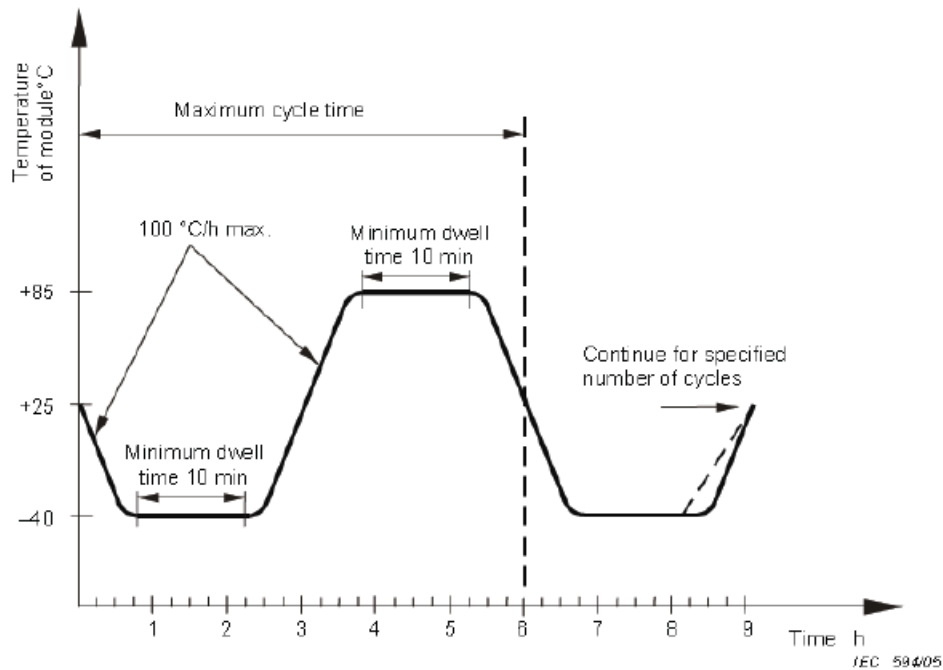
Figure 2.2: Temperature (°C) Vs. Time (h) for a thermal cycling stress test [13].

To determine the ability of the module to withstand thermal mismatch, fatigue and other stresses caused by repeated changes of temperature. Modules are connected to a power supply (positive to positive and negative to negative) and are thermally stressed for 200 cycles. The rate of change of temperature between the low and high

extremes shall not exceed 100 °C/h and the module temperature shall remain stable at each extreme for a period of at least 10 min. The cycle time shall not exceed 6 h unless the module has such a high heat capacity that a longer cycle is required [13] [12]. The number of cycles shall be as shown in the relevant blocks in the figure 2.2.

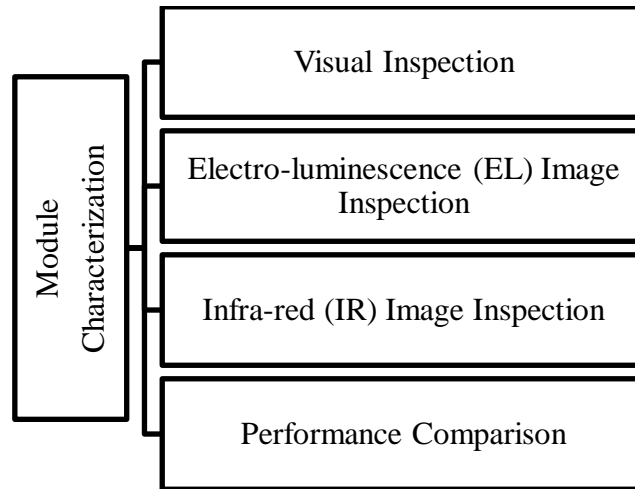
Figure 3.3: Characterization of modules.

As shown in Figure 3.3, four characterizations were carried on every test modules before PID, during PID and after PID. Additionally, they were carried out after potential induced recovery (PIR).

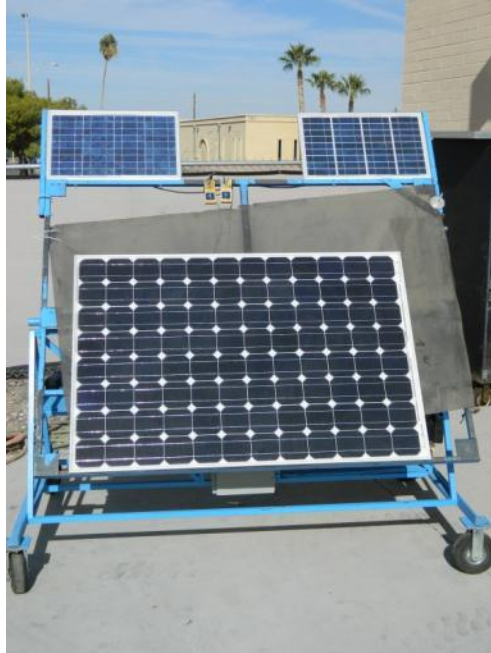
Figure 3.4: Visual inspection was performed under natural sunlight

The above figure 3.3 shows a module undergoing visual inspection under natural sunlight to identify any visual defects mentioned earlier.

Modules were visually inspected for any physical defects according to *Crystalline silicon terrestrial photovoltaic modules- Design qualification and type approval*, IEC 61215-2: 2005 [13]. Modules are inspected under natural sunlight for the following major defects.

- Broken/ cracked cells
- Broken superstrate or substrate
- Bubbles or delamination

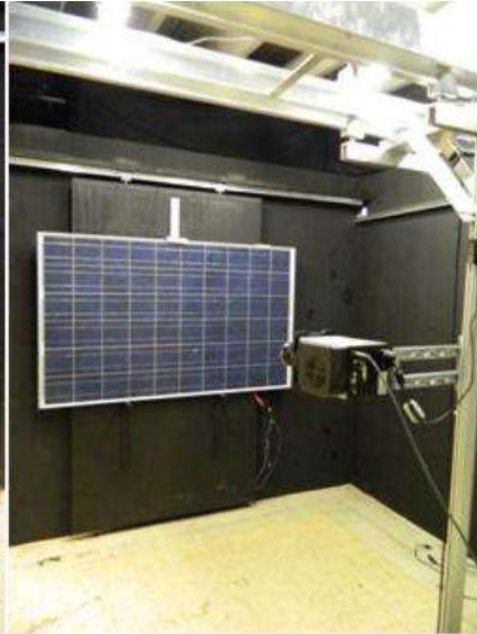
Figure 3.6: A module is shown on an adjustable rack in front of the EL camera.

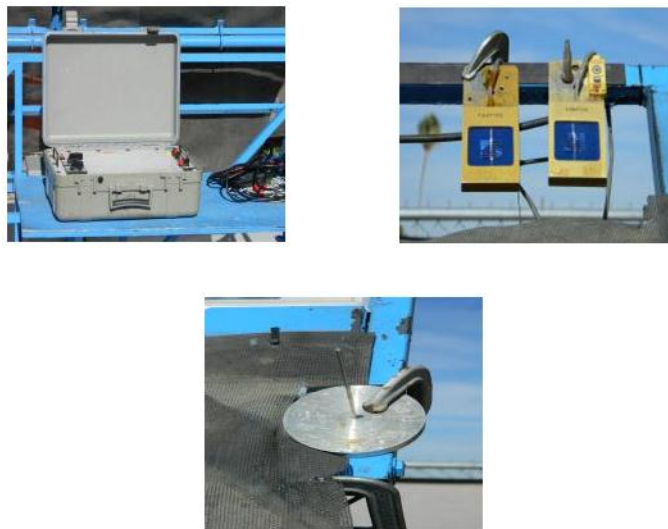
Figure 3.11: Daystar DS 100 IV curve tracer (top-left), Reference cells (top-right), Sundial (bottom).

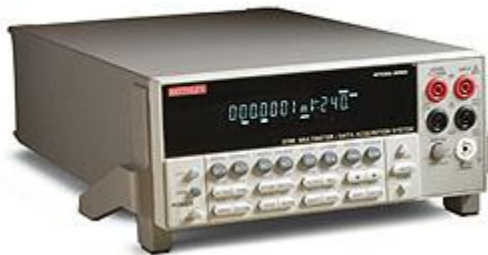
Figure 3.13: A keithley 2700 data logger used in the experiments. [24]

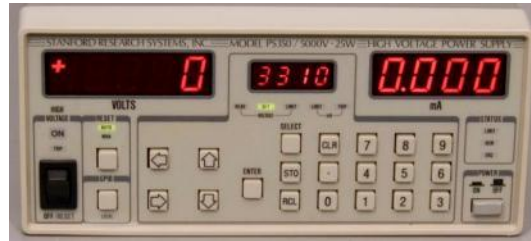
Figure 3.14: Front side control panel of the PS350 power supply.

A power supply having a range of  $\pm 50$  V to  $\pm 5$  kV and a maximum current of 5 mA is used to induce high voltage on the samples. Figure 3.9 shows the front control panel of the Stanford Research Systems, PS350 power supply. It is capable of producing 25 Watts at a maximum voltage of 5000 V.

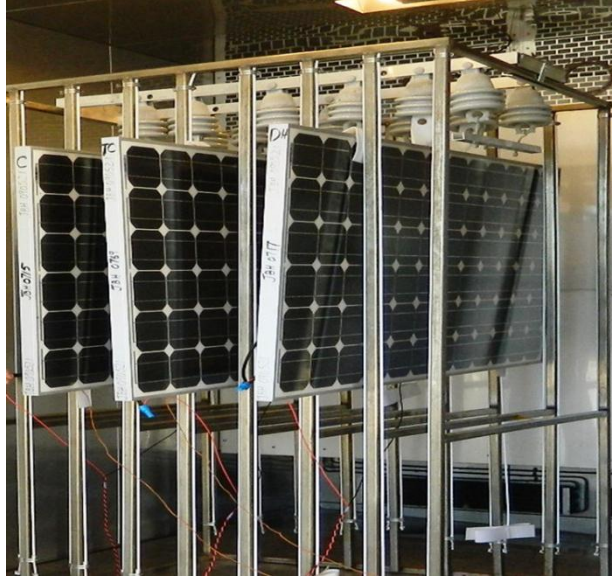
Figure 3.16: Modules hanging from ceramic insulators on a rack.

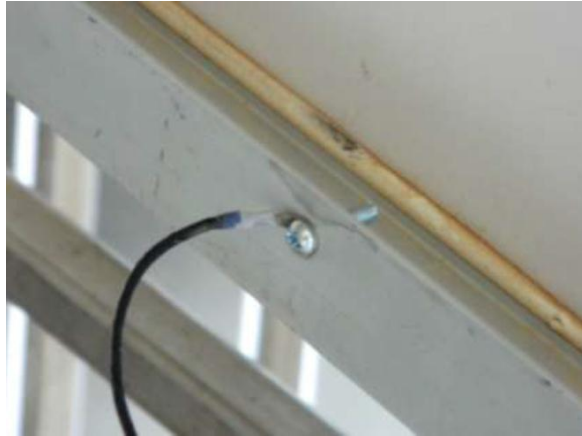
Figure 3.17: Positive from the power supply is connected to the grounding point.

connected to the grounding point on the module as shown in figure 3.13.

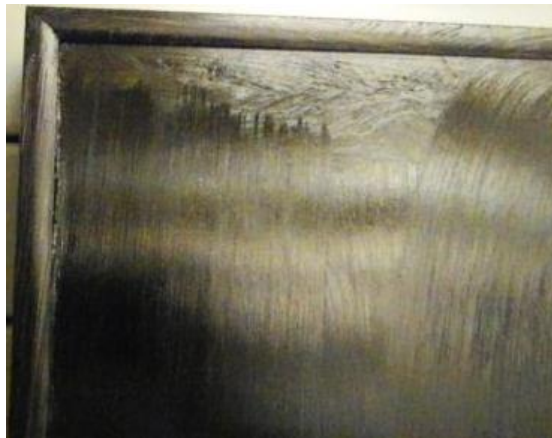
Figure 4.4: Frame with carbon coating; glass with carbon

In the full carbon condition, the modules were completely coated with a thin layer of carbon paste to increase their surface conductivity, unlike the partial carbon condition, where the paste did not come into contact with the module frame. The photograph shown in Figure 4.4 provides a view of a module completely (both glass and frame) coated with carbon paste. It should be noted that these modules from manufacturer 7 (mfg 7) already underwent 70 hours of PID stress under partial carbon coating condition testing and they were reused to see the effect of full carbon coating on the glass and frame.

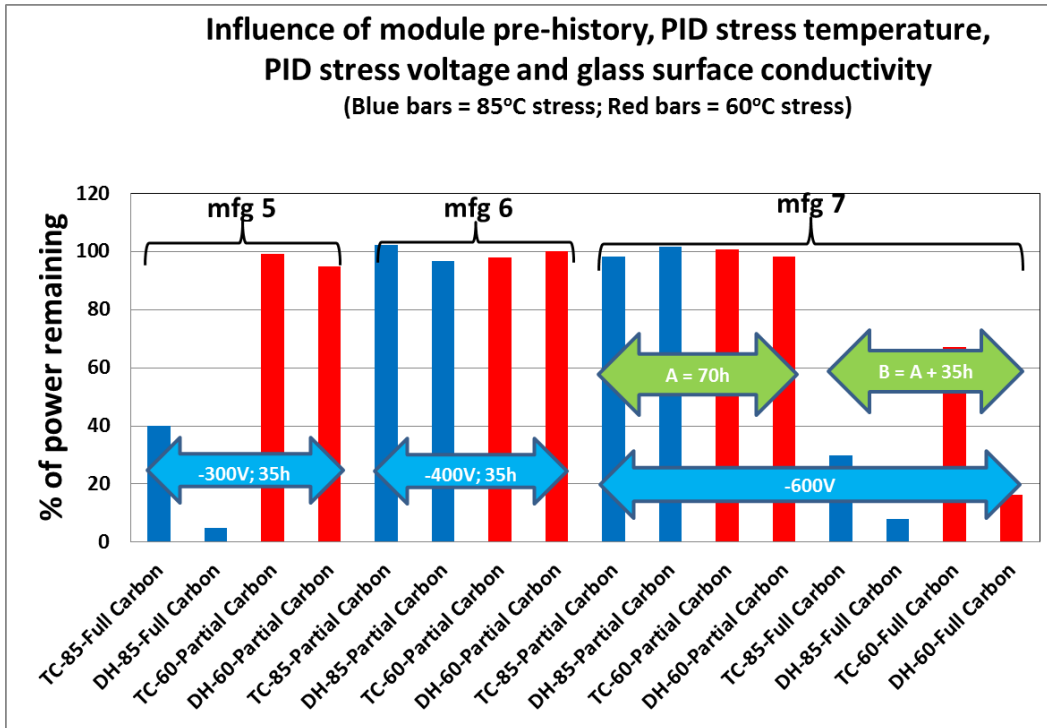
Figure 4.7: Performance degradation due to PID for all the modules.

Figure 4.7 shows the remaining power of all the modules tested in this thesis work.

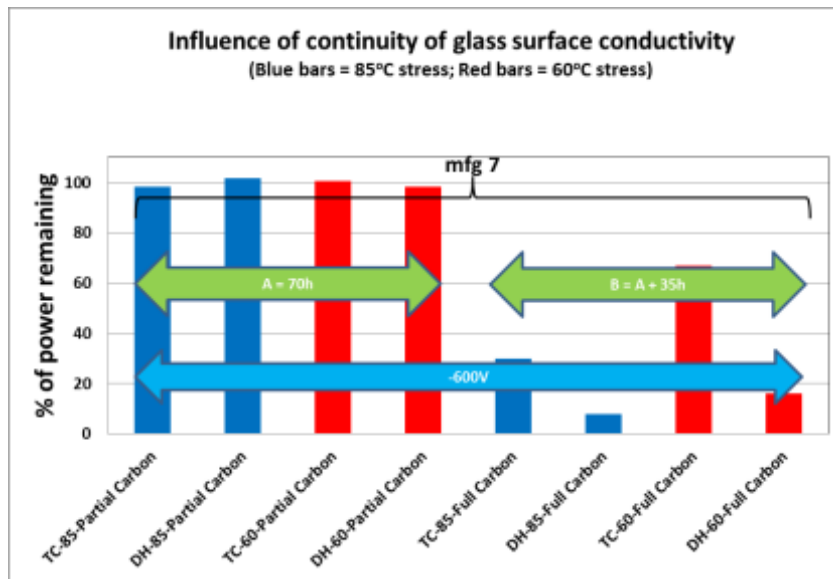
Figure 4.8: Influence of continuity of glass surface conductivity on PID

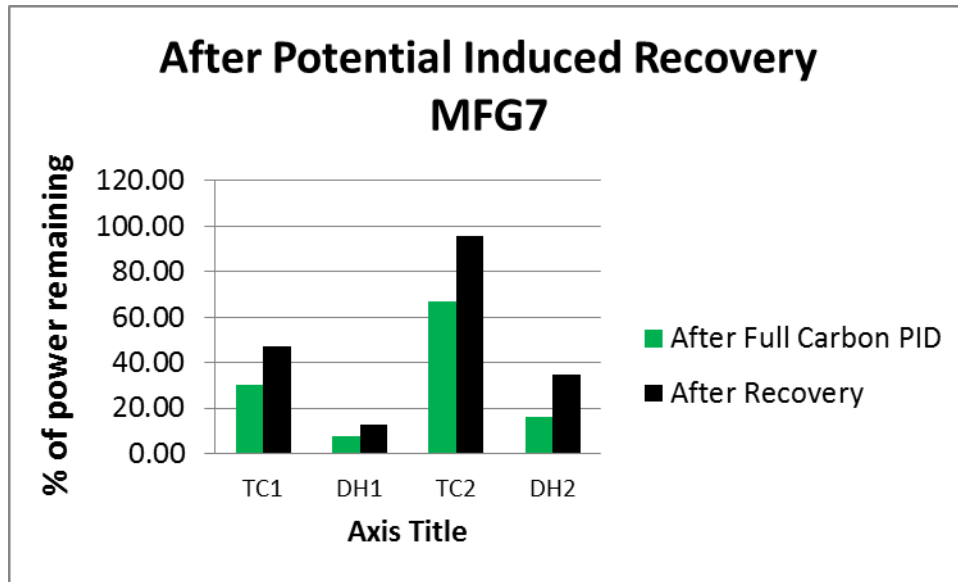
Figure 4.10: Performance comparison before and after potential induced recovery.

Table 4.10 shows the power recovered by the modules after recovery testing. It can be seen that the modules have recovered a significant amount of power after only 35 hours of recovery. Further recovery testing may enhance the power recovered.

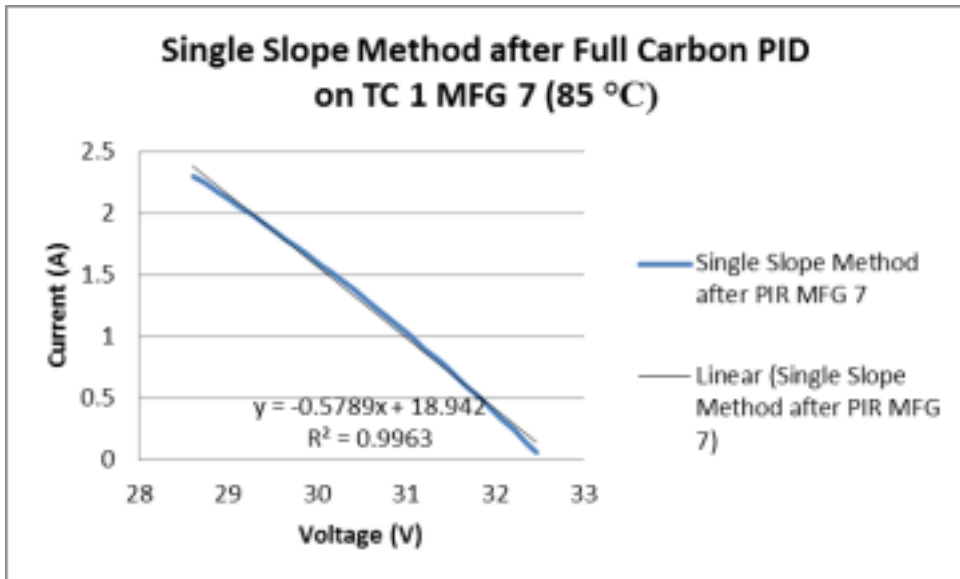
Figure 4.12: Calculating  $R_s$  of TC1 MFG7 module after PIR by single slope method.

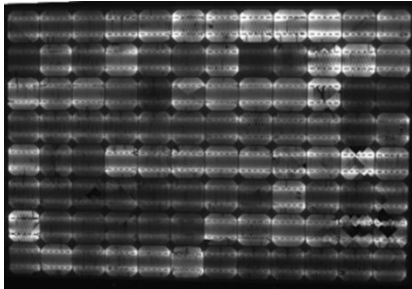
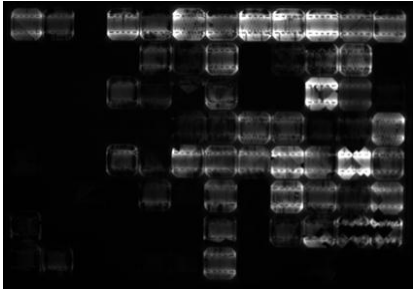
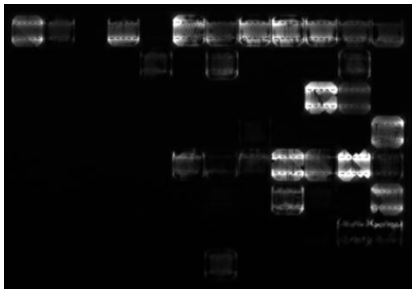
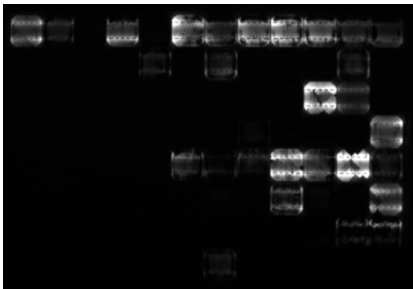
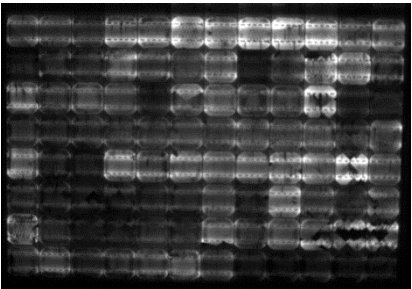
Pre-PID Stressed	5 hrs. into PID (Full Carbon)

10 hrs. into PID (Partial Carbon)	35 hrs. into PID (Partial Carbon)

35 hrs. into PIR (Full Carbon)

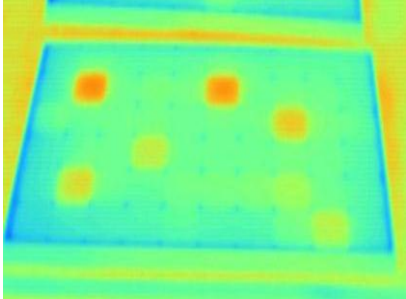
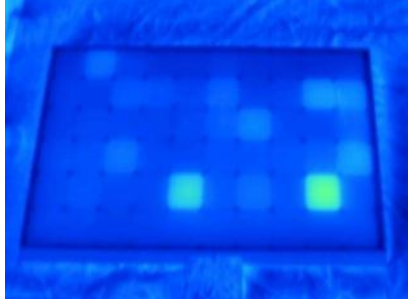
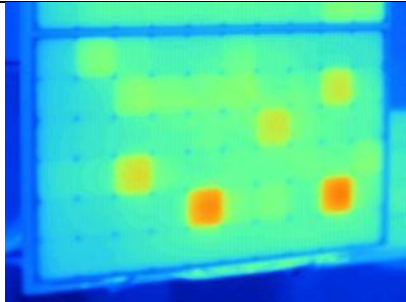
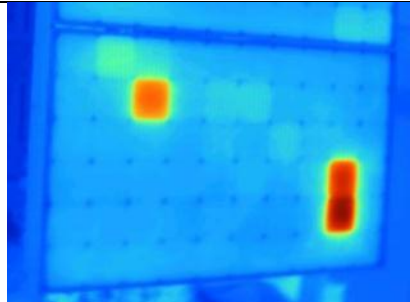
From the following IR images (Table 4.13) of a DH module, it is observed that the module post recovery has three extreme hot spots which are about 35 °C to 40 °C hotter than the rest of the module. In addition there were three other hot

Before PID	After 10 Hrs. of PID (Partial Carbon)

After 35 Hrs. of PID (Partial Carbon)	After 35 Hrs. of PIR (Full Carbon)

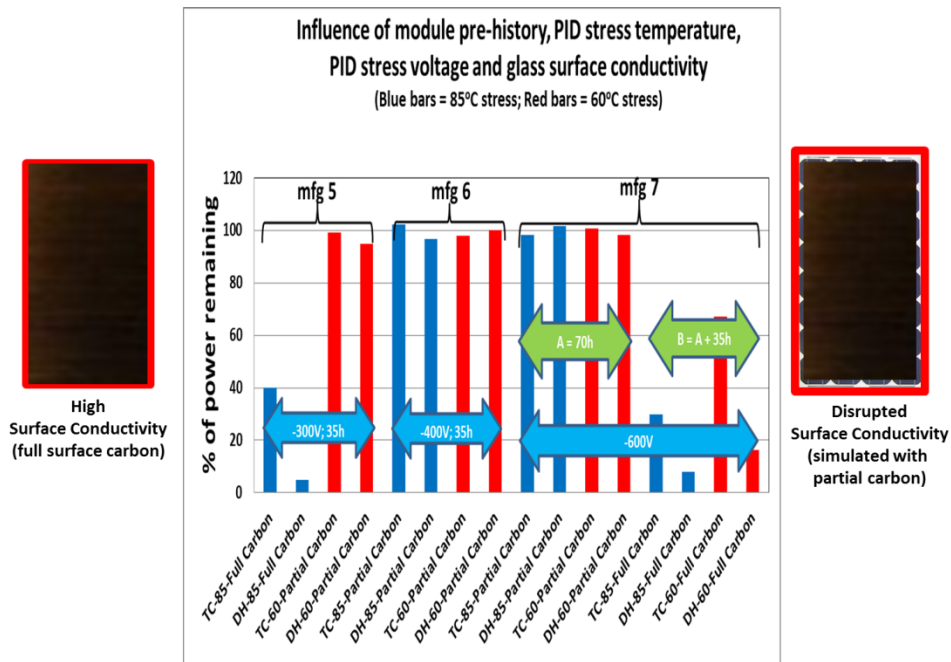
Figure 4.17: Influence of module history, PID stress temperature and glass surface conductivity.

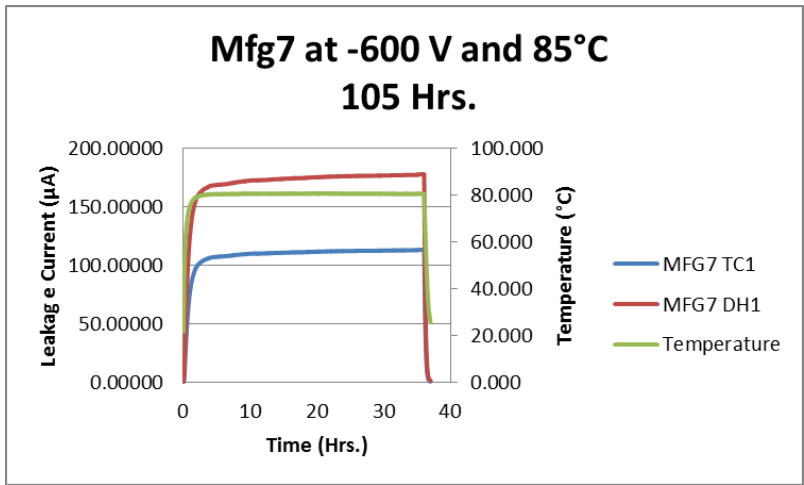
Figure C 1 Leakage current (µA) versus time (Hrs.) for TC1 and DH1 (Mfg7) during third stage (35 hours of PID under full carbon condition).

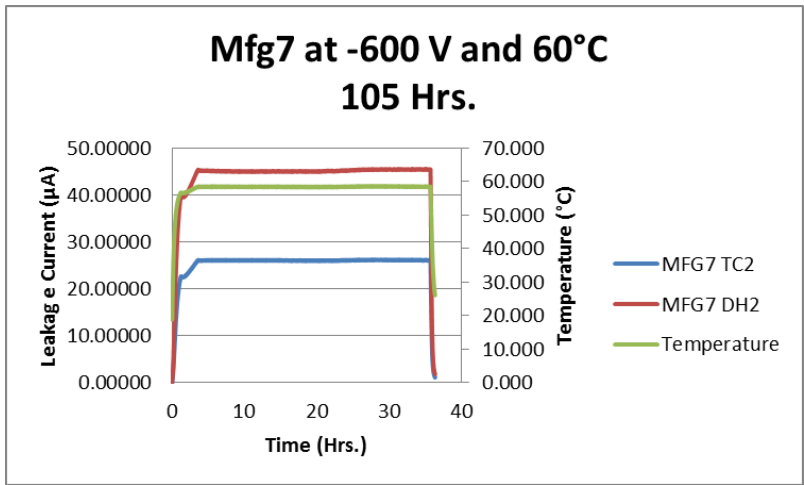
Figure C 2 Leakage current (µA) versus time (Hrs.) for TC2 and DH2 (Mfg7) during third stage (35 hours of PID under full carbon condition).
