Environmental Controls on Clogging in Effluent-Dominated Waterways

A Thesis Presented in Partial Fulfillment
of the Requirements for the Degree
Master of Science

ARIZONA STATE UNIVERSITY

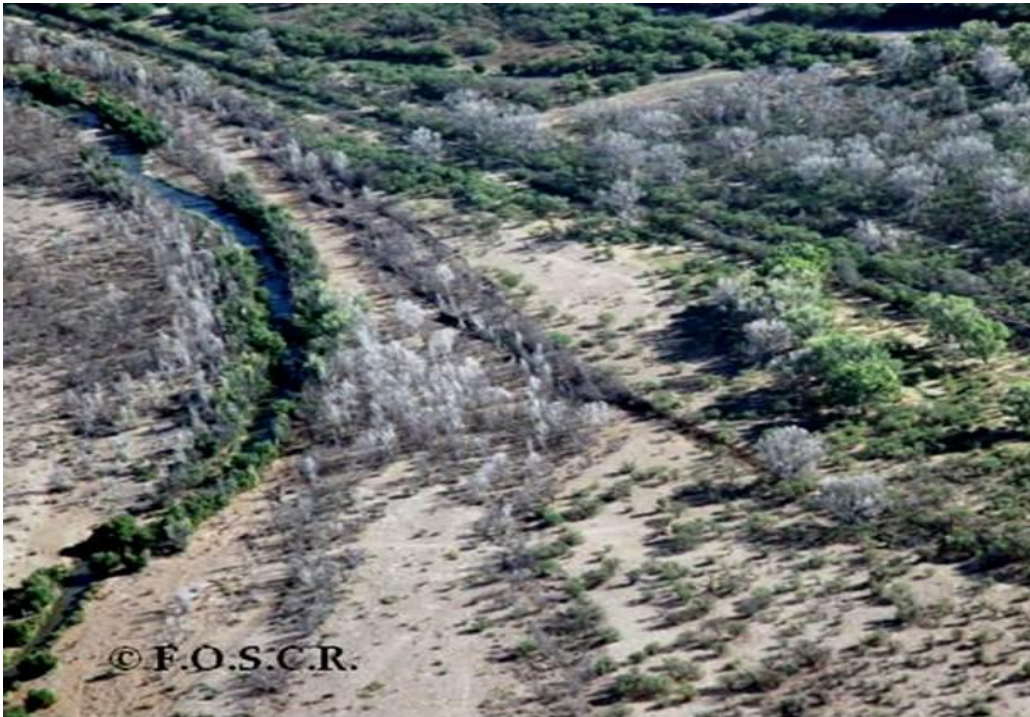
Figure 1 Aerial photo of the Upper Santa Cruz River near Rio Rico showing riparian forest die-off during the spring of 2005. Affected species include cottonwood, willow, hackberry, seepwillow, and mesquite. Photo provided by the Friends of the Santa Cruz River.

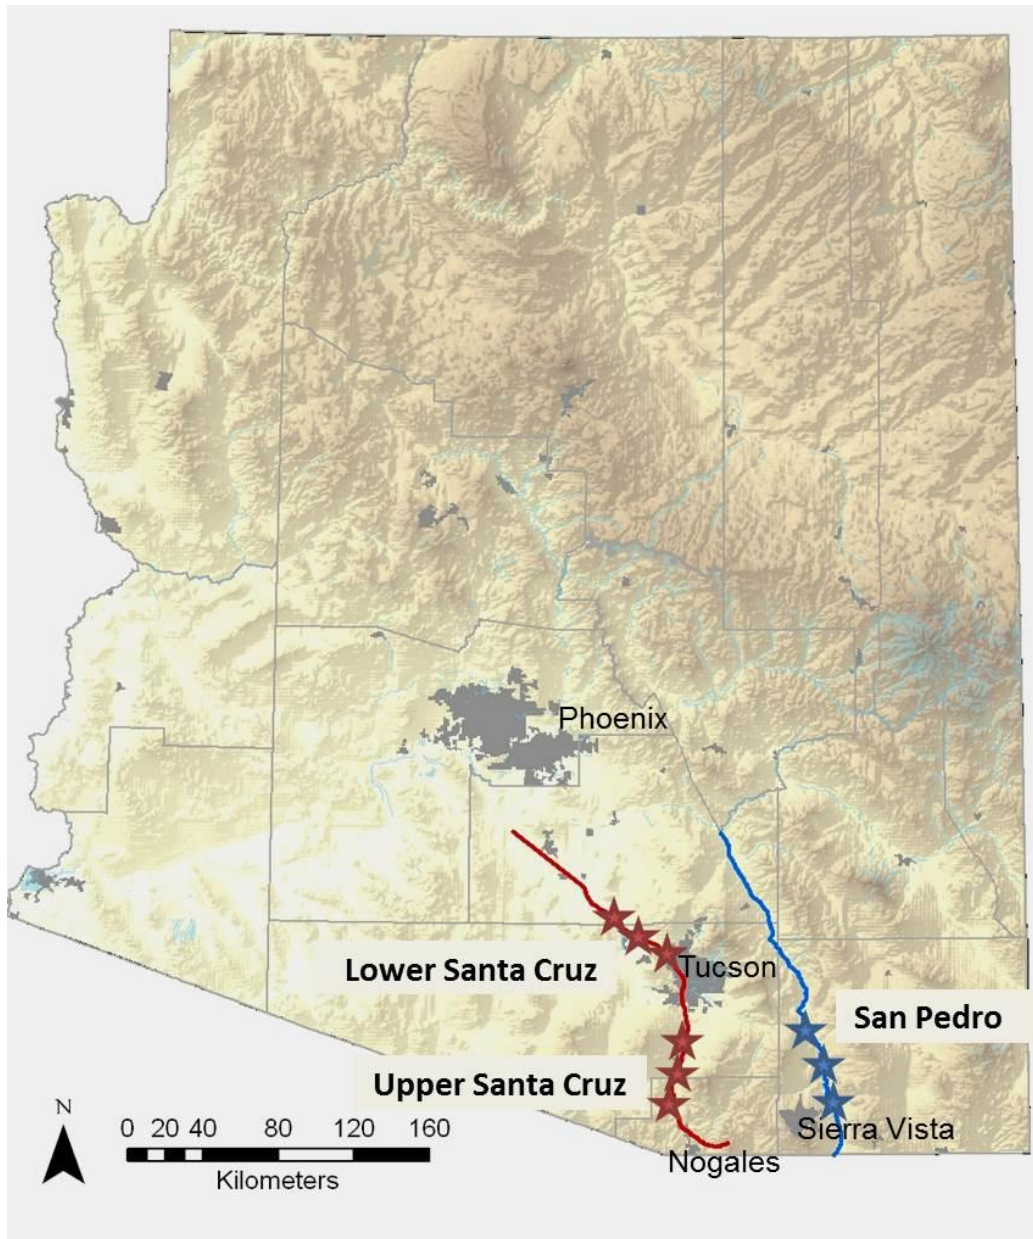
Figure 4 Study area showing nine sample sites. On the Santa Cruz River, three were located downstream of the B class Tucson treatment facility, and three were downstream of the A+ class Nogales treatment facility. Three control sites were spaced along the San Pedro River.

The study river (Santa Cruz) and its spatial control (San Pedro) are located within arid to semi-arid basins of southern Arizona (Figure 4). The

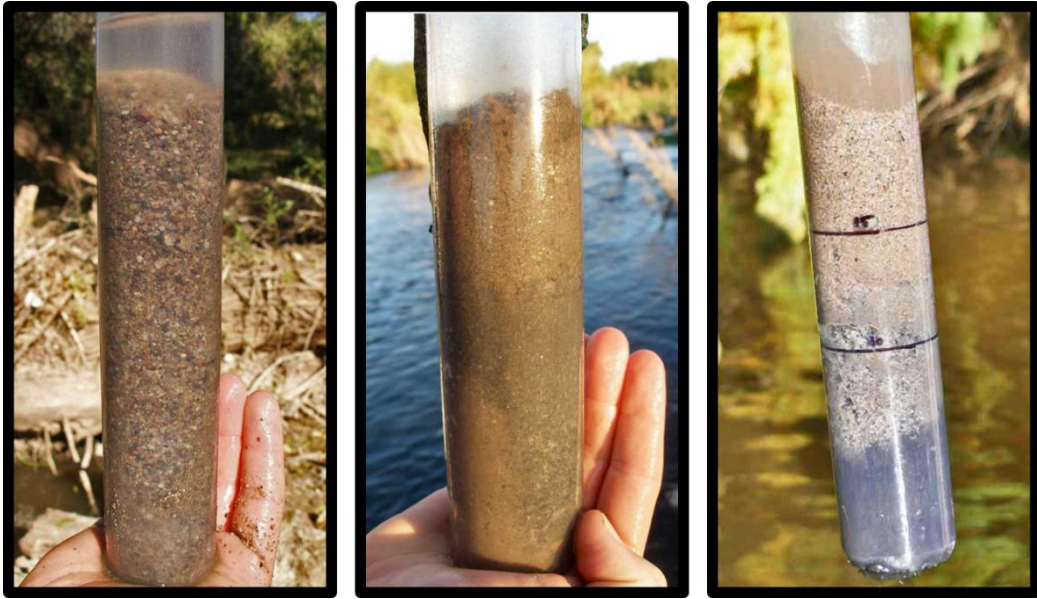
Figure 5 Examples of sediment cores collected on the Santa Cruz River range from coarse unconsolidated sand (left), to tightly-packed fine sediments (middle), and sediments with clear signs of biological activity like black FeS deposits and buildup of metabolic gases (right).

Visual indications of microbial activity were frequent at sites that had stagnant flow and lower conductivity measurements. Sediment cores from such sites had dark layers of iron sulfide that occur in strongly reducing, anaerobic zones (Figure 5). These sediments and their porewater smelled strongly of sulfur. Some samples contained clumps of organic matter that caused the sediments to clump together, and oftentimes porewater could not be extracted. A few cores contained large gas

bubbles from microbial metabolism that became trapped in the sediments (Figure 5). The B class reach, especially the 0.5 km site, was notorious for these types of sediments that appeared to be microbial hotspots of activity. On two occasions, large areas of the streambed had become saturated with gases and the pressure of walking through the river would cause streams of bubbles to pour out of exit points like geysers. Aside from the occasional pocket of clayey, black sediments, such unusual observations were never noted on the SPR.

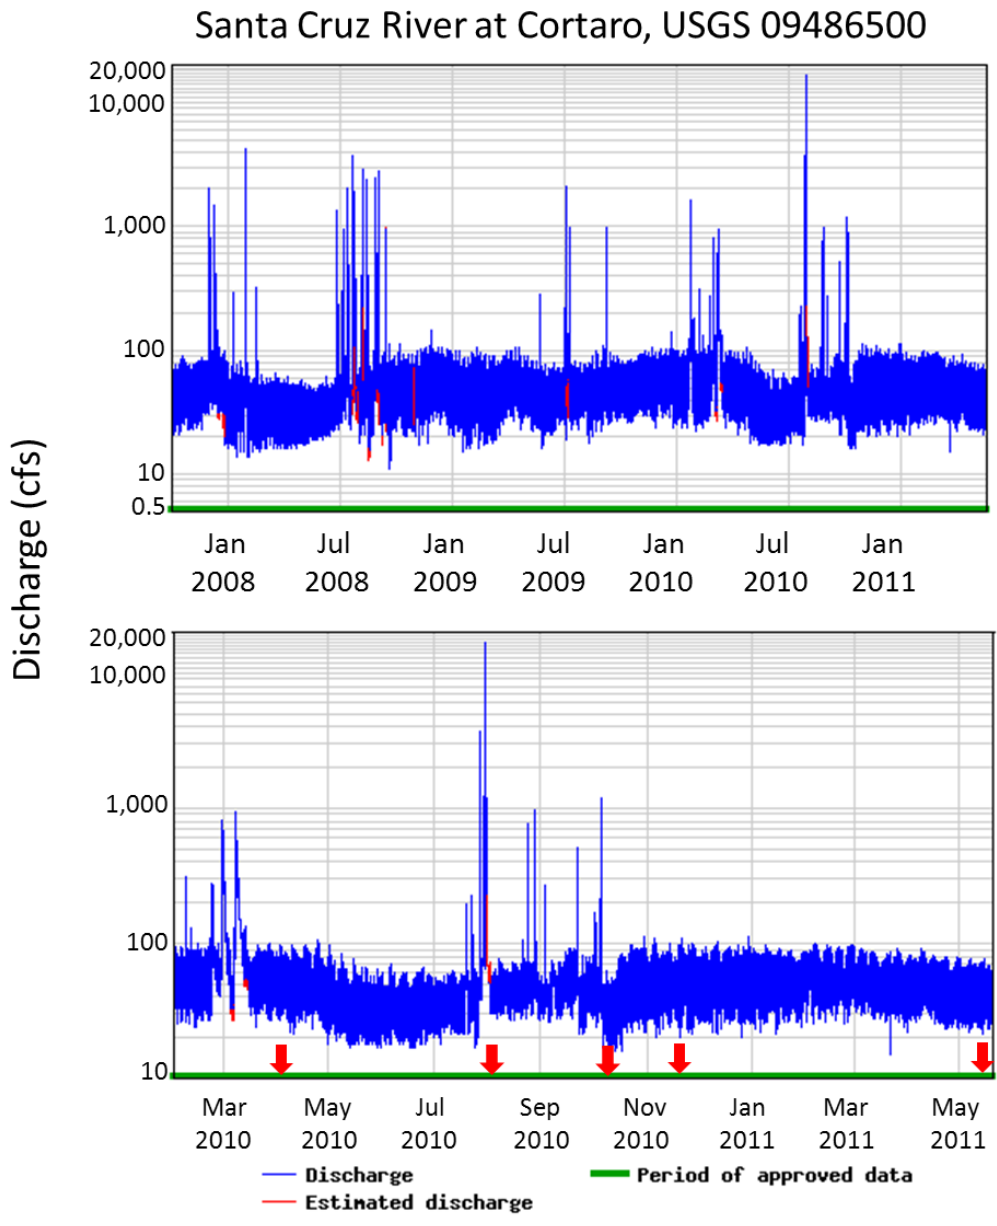
Figure 7 Flood events on the Lower Santa Cruz River (B class) over the last 5 years (top) and during the study period (bottom). Red arrows indicate sampling times.

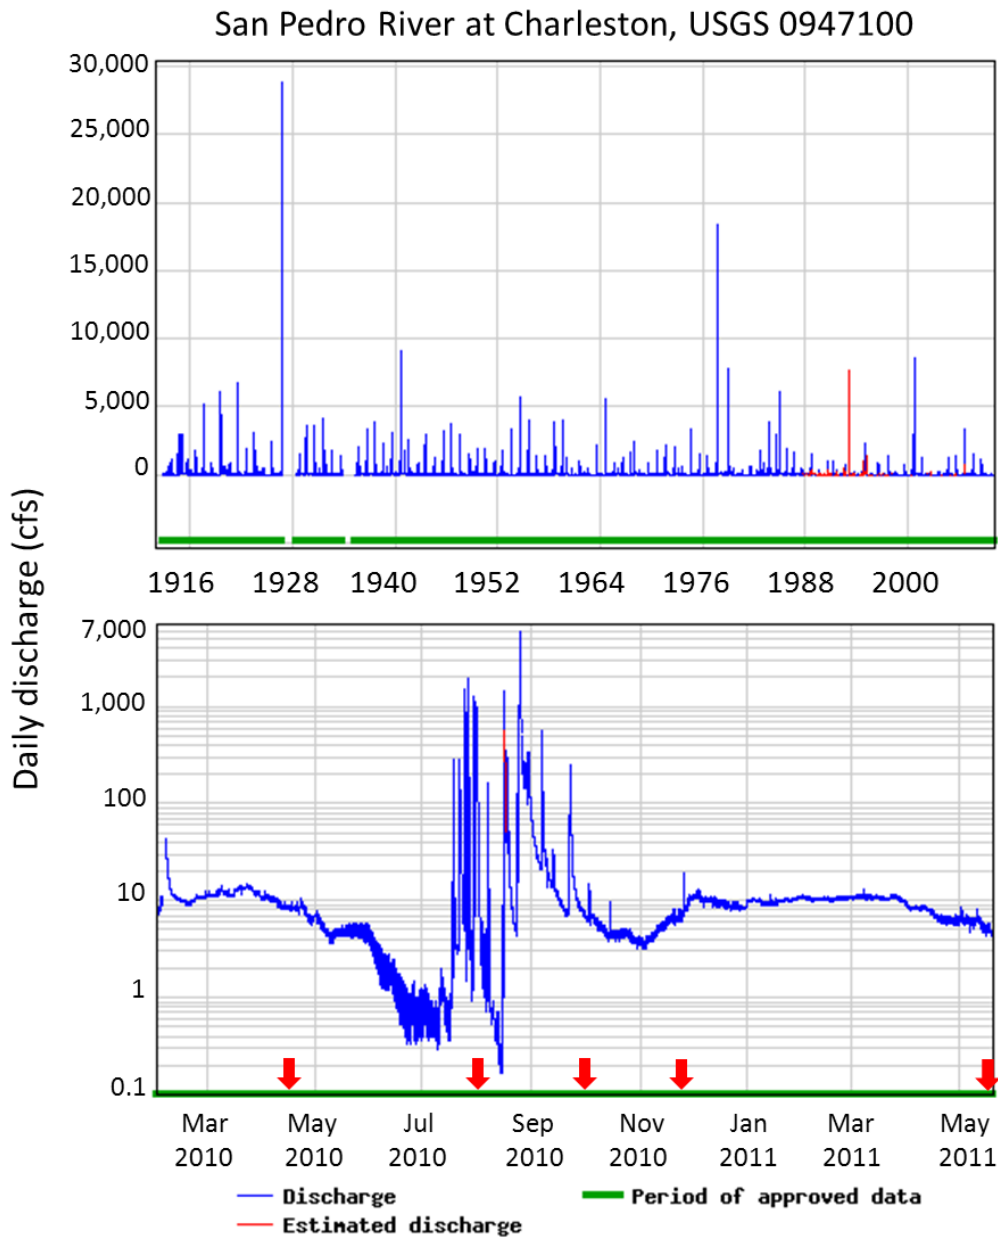
Figure 9 Flood events on the San Pedro River (control) over the last 96 years (top) and during the study period (bottom). Red arrows indicate sampling times.

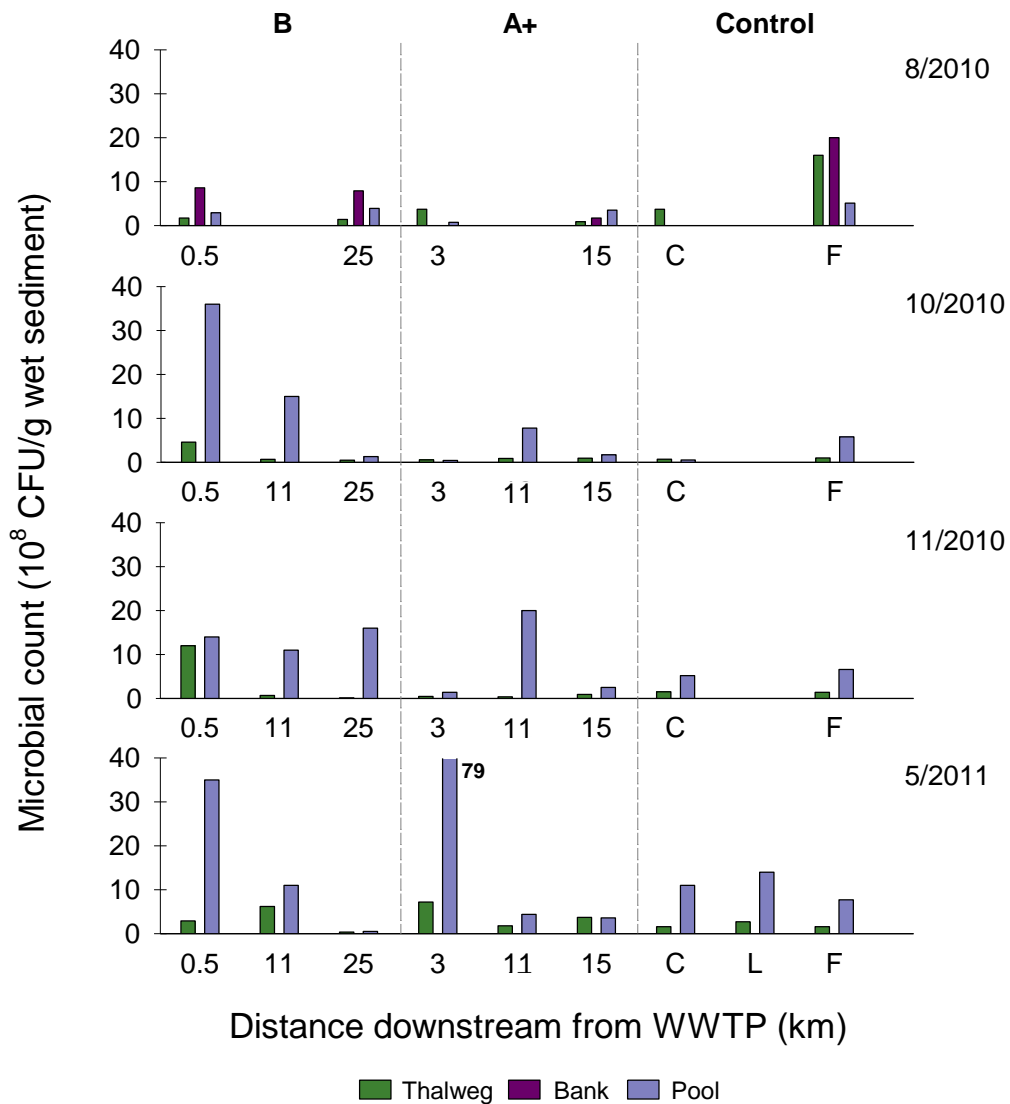
Figure 10 Heterotrophic plate counts from 20cm sediment cores collected at thalwegs (blue), banks (red), and pools (green). Cores were taken from thalwegs, banks, and pools, in the B class Lower Santa Cruz, and A+ Upper Santa Cruz at increasing distance from effluent discharge. Non-effluent control sites on the San Pedro included Charleston (C), Lewis Springs (L), and Fairbank (F)

Plate counts from the B class reach were highest near the effluent outfall, and decreased with distance downstream (Figure 10). This trend was not as clearly observed on the A+ reach. Pool numbers were higher than thalwegs as well. Between October and May, B class pool counts were 20 times higher (8 times if the November 25km site is removed), A+ counts were 10 times higher, and SPR counts were only 4.5 times higher.

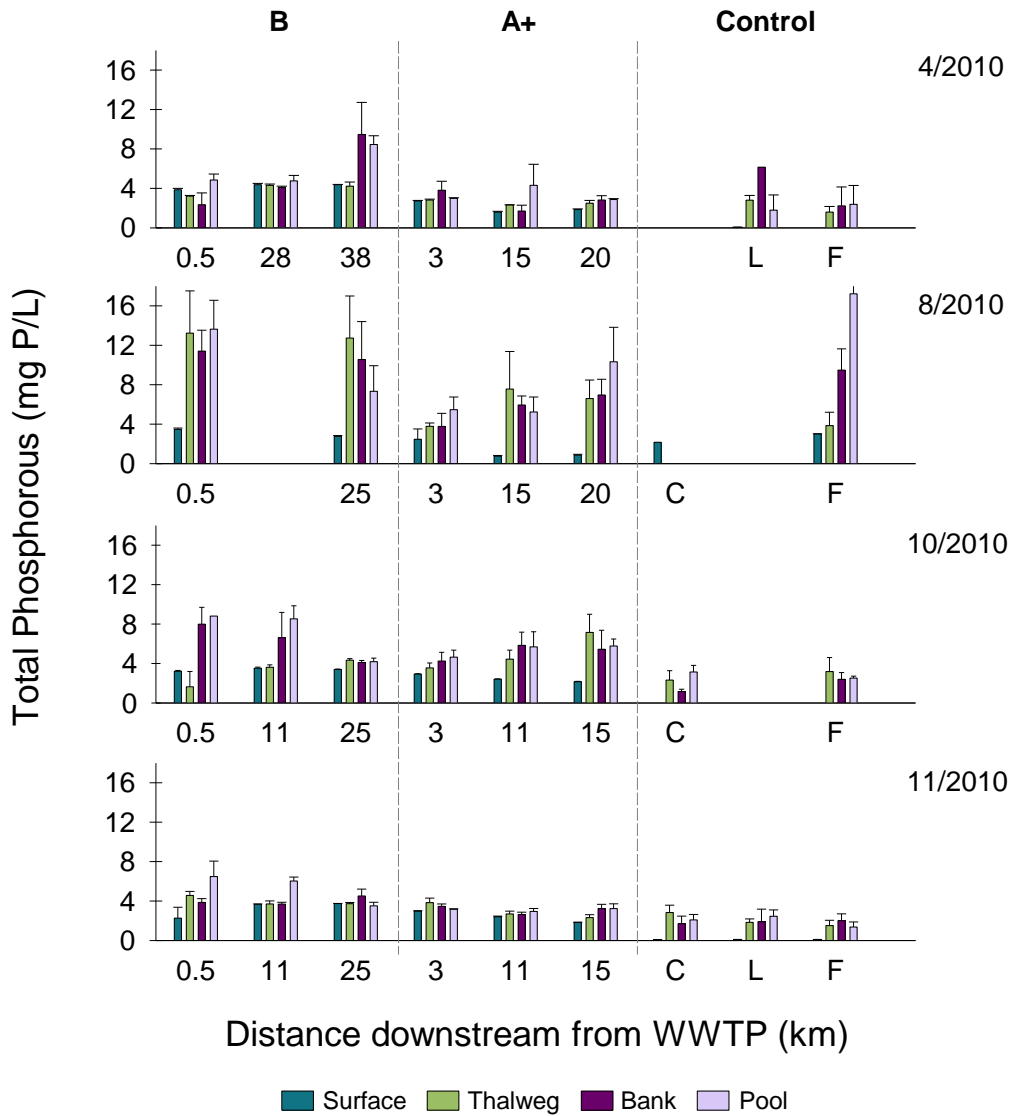
Figure 14 Total phosphorous concentrations in surface and pore water (thalweg, bank, and pool) of the effluent-dominated B and A+ class reaches on the Santa Cruz River. Non-effluent controls sites on the San Pedro River included Charleston (C), Lewis Springs (L), and Fairbank (F). Error bars represent 1 standard error. Missing distances/letters were not sampled.

concentrations equalized with surface water concentrations on the effluent dominated sites. Flood events appeared to cause large spikes of TP in sediment water, but not surface water (Figure 14, 8/2012), and the residual effects were still present 2 months later. TP concentrations in the surface water did not strongly decrease with distance downstream of the effluent outfall.

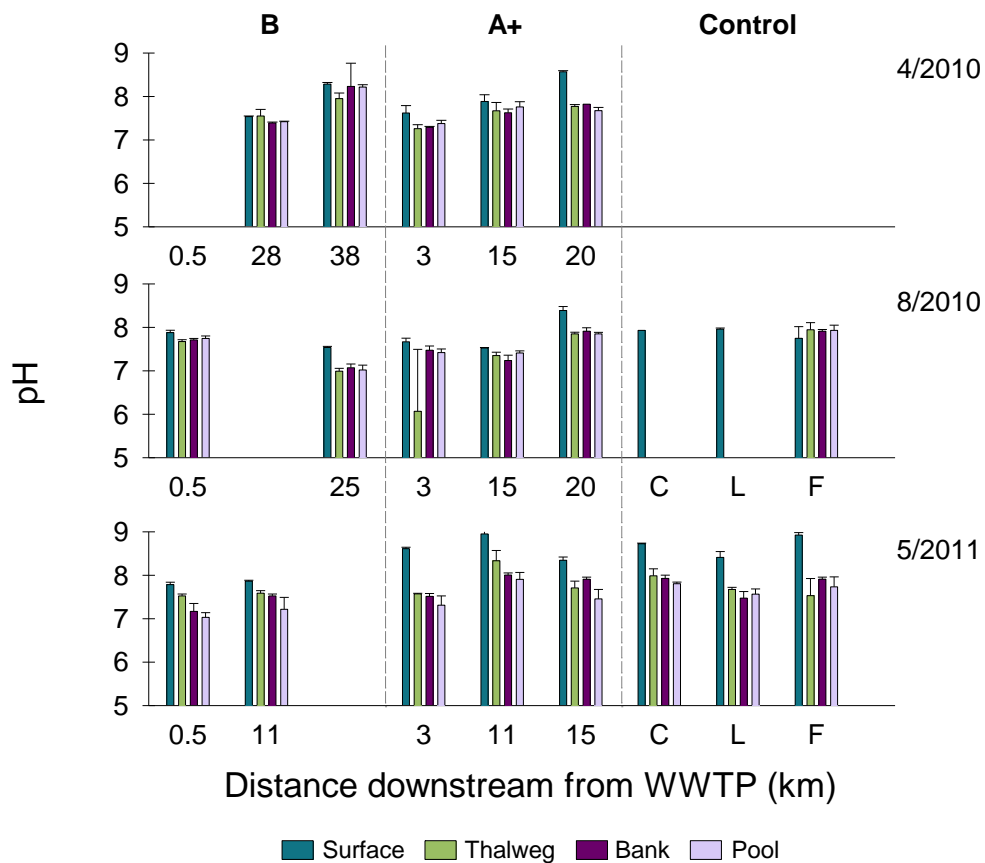
Figure 19 pH measured in surface and pore water (thalweg, bank, and pool) of the effluent-dominated B and A+ class reaches on the Santa Cruz River. Non-effluent controls sites on the San Pedro River included Charleston (C), Lewis Springs (L), and Fairbank (F). Error bars represent 1 standard error. Missing distances/letters were not sampled.

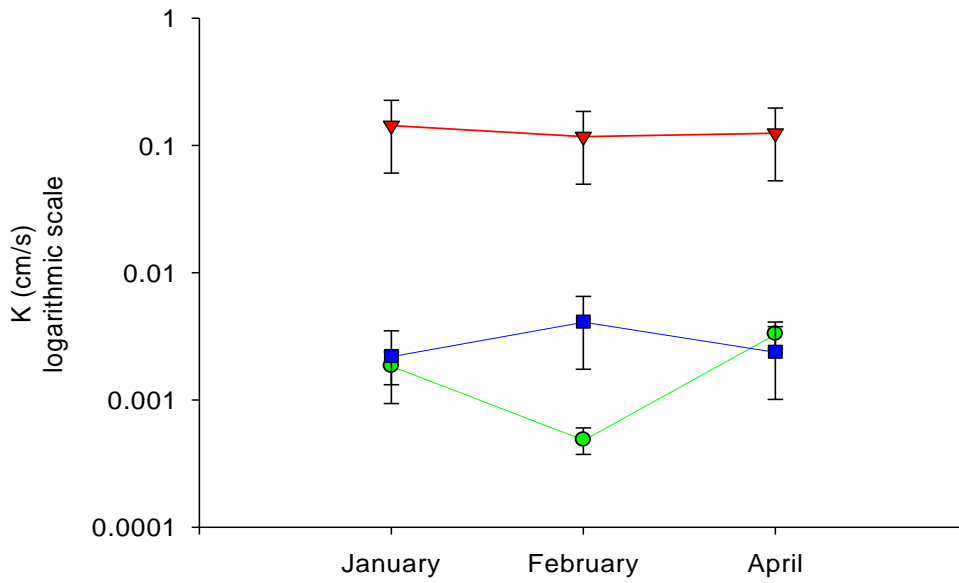
Figure 23 Average hydraulic conductivity of the ERP channel ●, SCR bank ■, and SCR thalweg ▼ during 2011. Log scale is used because the thalweg conductivity was much larger than the bank and ERP. Error bars ± 1 standard error.

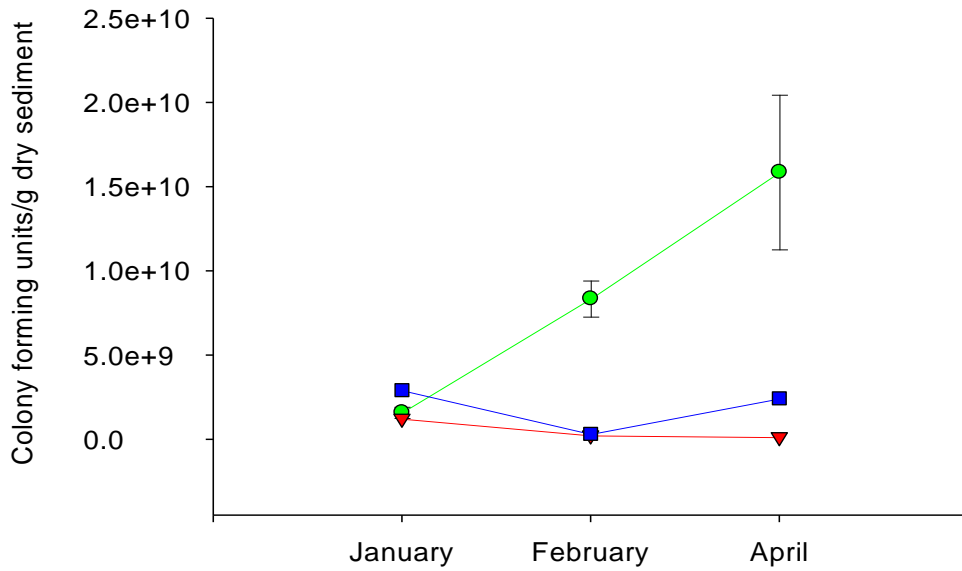
Figure 25 Heterotrophic plate counts of colony forming units of sediment bacteria from the ERP channel ●, SCR bank ■, and SCR thalweg ▼ during 2011. ERP is averaged from six 20cm sediment cores spanning the three transects, while one core was taken for each SCR site. Error bars \pm 1 standard error.

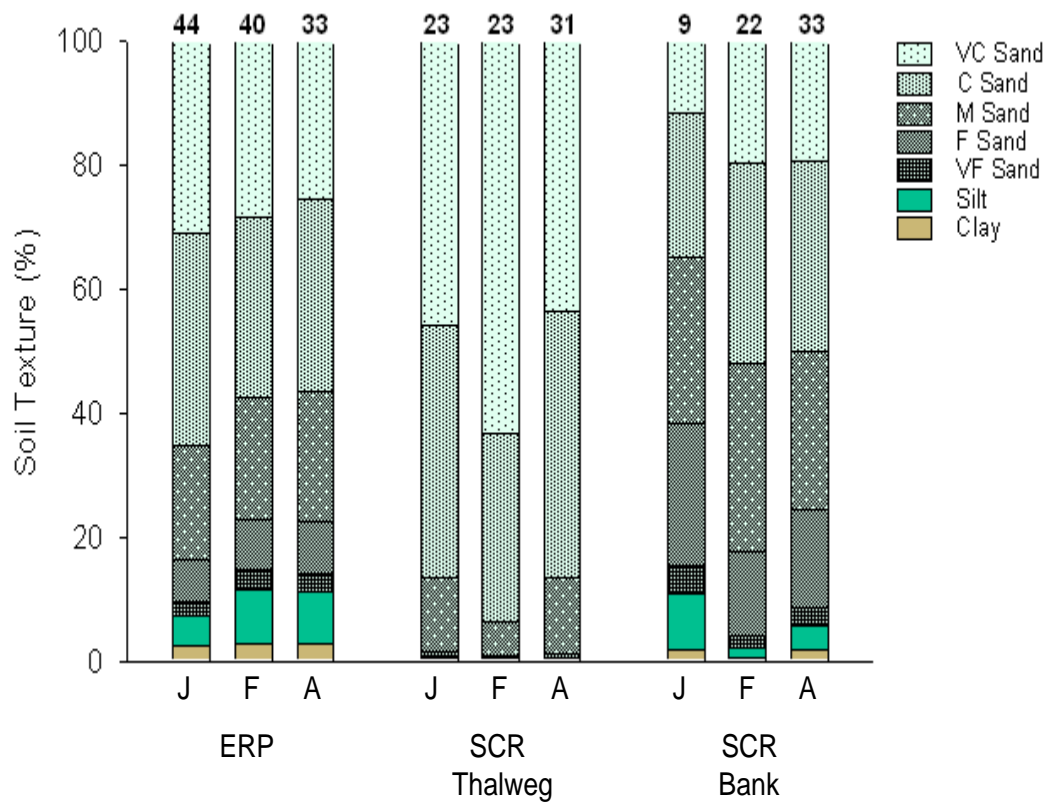
Figure 26 Sediment texture composition from the three sites during January (J), February (F), and April (A) of 2011. Numbers above each bar represent percent gravel of the sample.
