Evaluating the Effectiveness of a Pavement

Preservation Program: A Case Study

A Dissertation Presented in Partial Fulfillment  
of the Requirements for the Degree  
Doctor of Philosophy

ARIZONA STATE UNIVERSITY

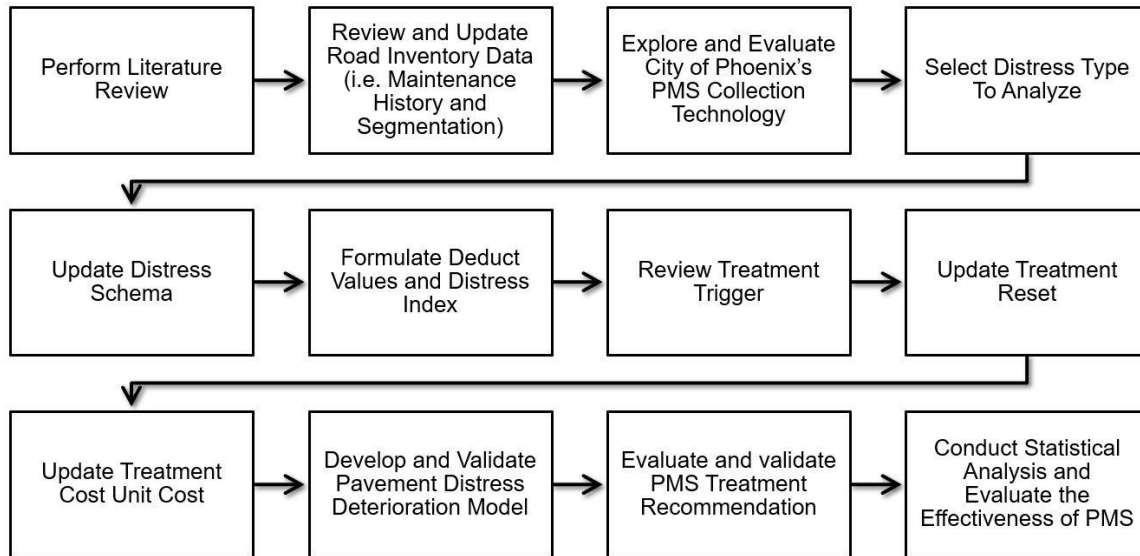
Figure 1-2: Research Approach Workflow Chart

Figure 1-2 depicts the workflow chart of the above-mentioned tasks which are adopted to achieve the research objectives to improve the current City of Phoenix PMS and evaluate the effectiveness of the PMS.

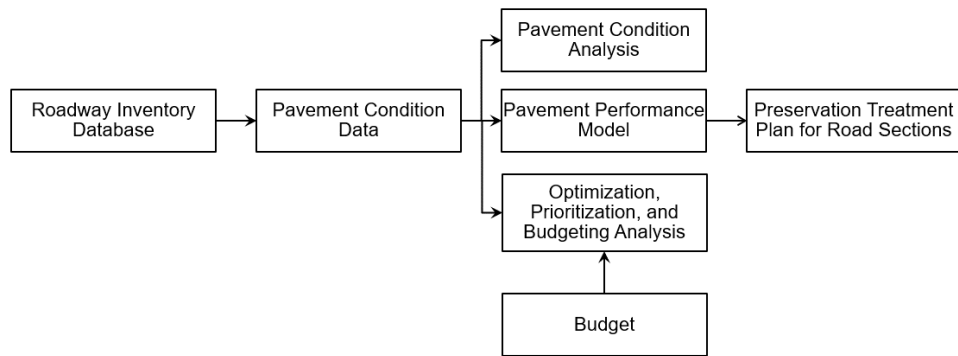
Figure 3-1: Overview of City of Phoenix Pavement Management System Workflow

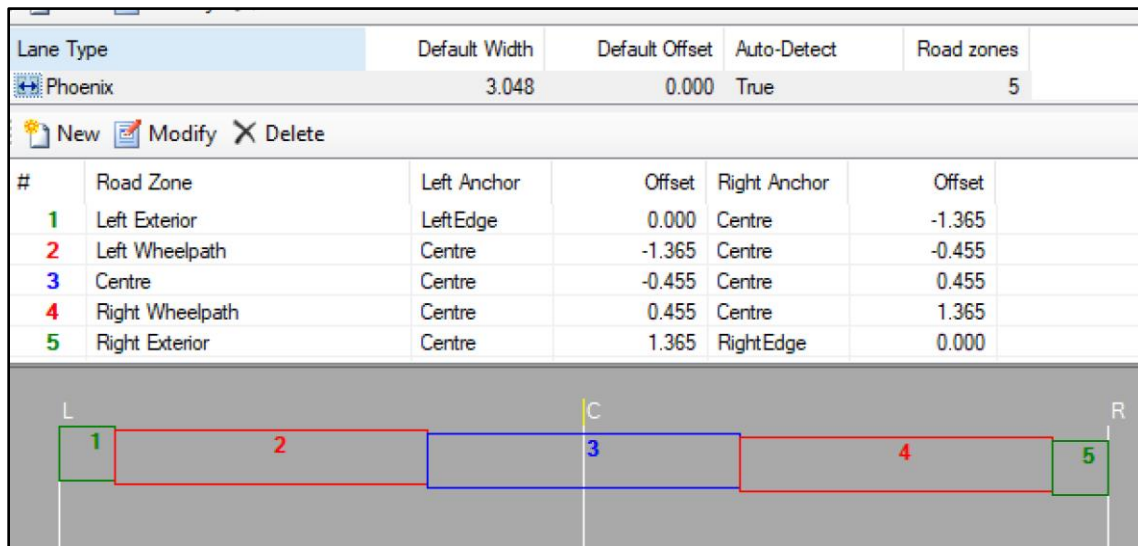
Figure 3-4: Pavement Condition Assessment Road Zones

Based on the pavement distresses prevalent in the City of Phoenix network and LCMS capability, pavement distresses including fatigue cracks in the wheel path, fatigue cracks in non-wheel path, longitudinal cracks in wheel path, longitudinal cracks in non-wheel path, transverse cracks, macrotexture in wheel path, and IRI in wheel path are collected. Although the ARAN van can scan up to 4 m (13 ft) of pavement in the direction of travel, for the purpose of analyzing distresses within a single lane, distresses within the 3 m (10 ft) width on the driven lane are rated. The 3 m (10 ft) pavement condition assessment cross section is divided into five zones. Figure 3-4 illustrates five road zones: left exterior, left wheel path, center, right wheel path, and right exterior. The wheel paths and the center between the wheel paths are 0.9 m (3 ft) and the space outside of the wheel paths to the left or the right edge of the pavement detection zone are 0.15 m (6 in).

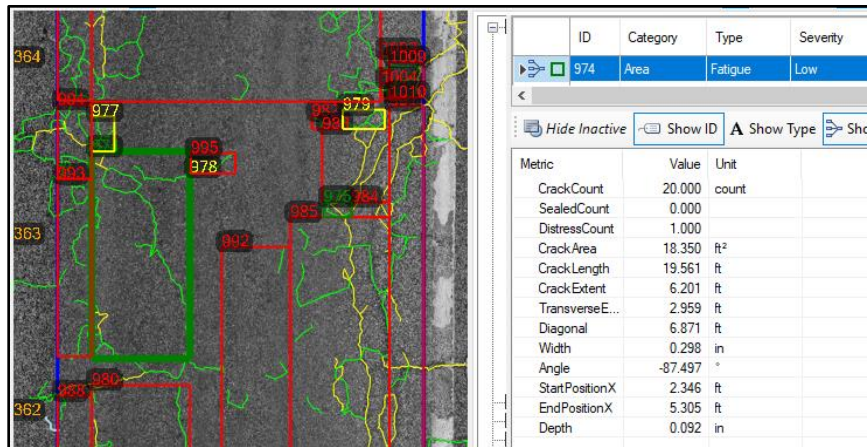
Figure 3-5: Low Severity Fatigue Crack Area Inside the Green Rectangle

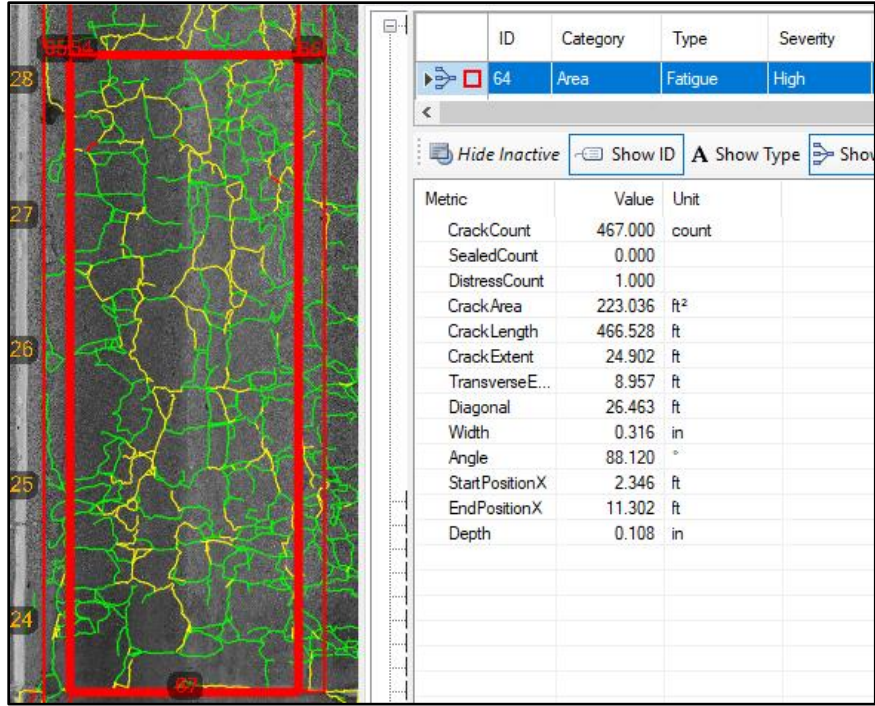
Figure 3-7: High Severity Fatigue Crack Area Inside the Red Rectangle

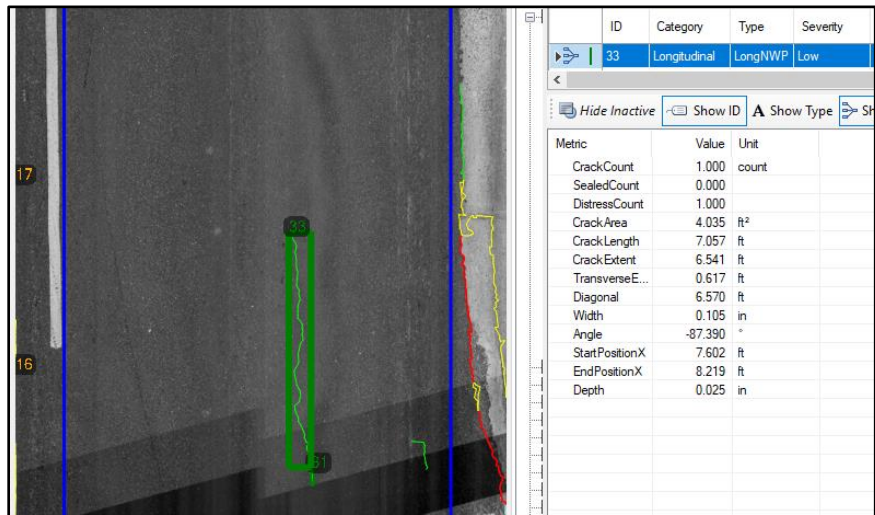
Figure 3-9: Longitudinal Non-Wheel Path Crack

Longitudinal cracks are further separated into the wheel path or non-wheel path depending on whether the crack is in the wheel path or outside of the wheel path.

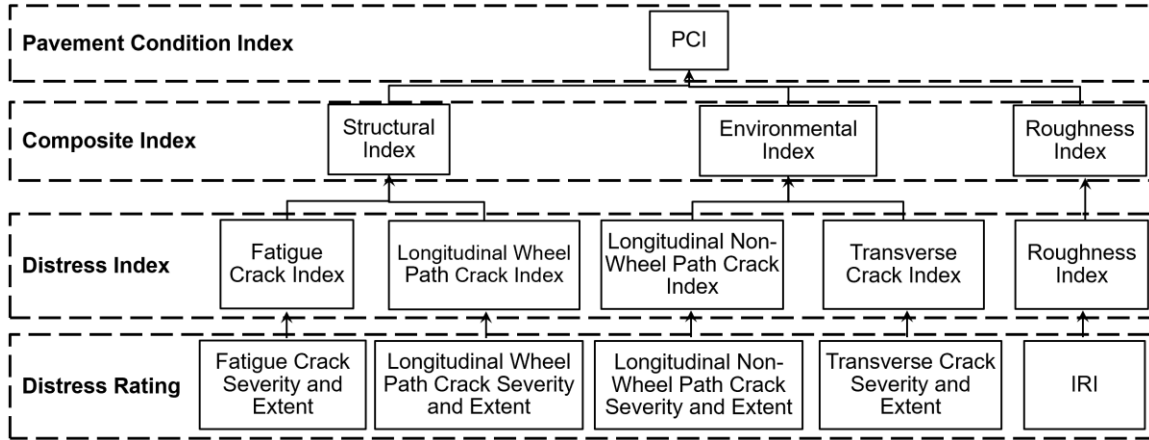
Figure 3-12: Current PCI Derivation

Figure 3-11: City of Phoenix Distress Deduct Charts by Distress Type, Severity, and Extent  
 Figure 3-12 illustrates how PCI is derived currently. The individual distress severity and extent data is exported to dTIMS and where deduct values are assigned to generate the individual distress index. Similar to the PCI concept, fatigue crack index of 100 means no fatigue crack was detected. Three composite indexes: structural, environmental and roughness conditions are computed by combining different distresses as indicated by Equations 3-1 through 3-3. The PCI formula is shown in Equation 3-4.

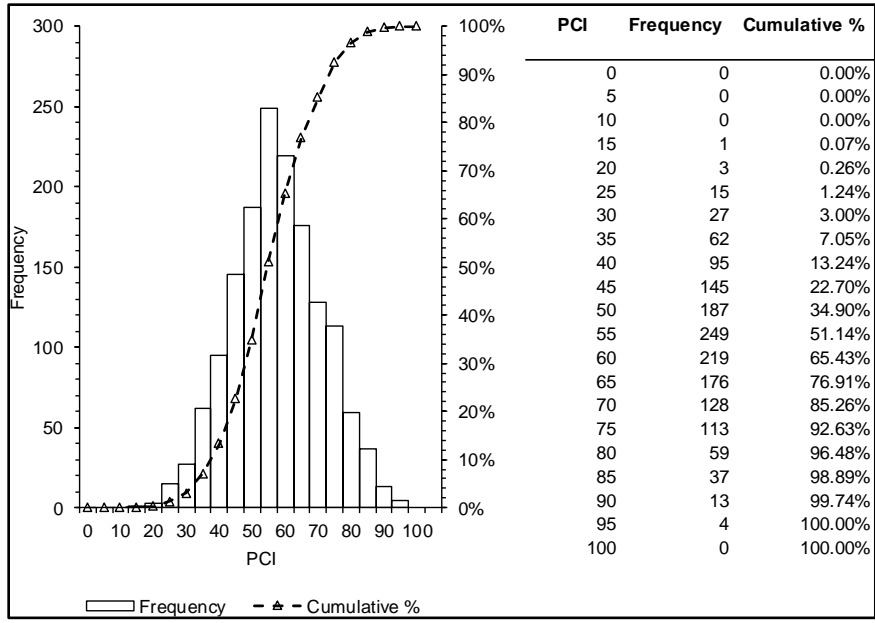
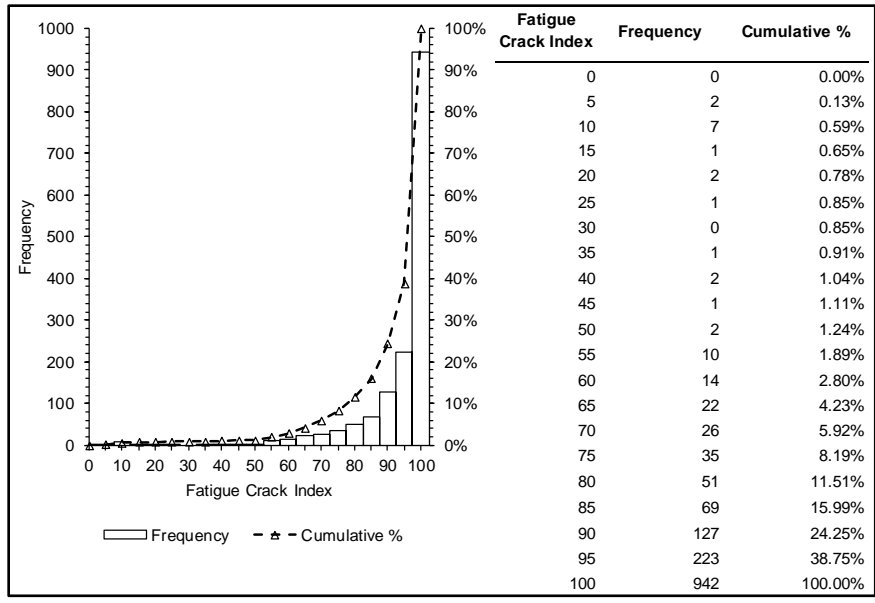
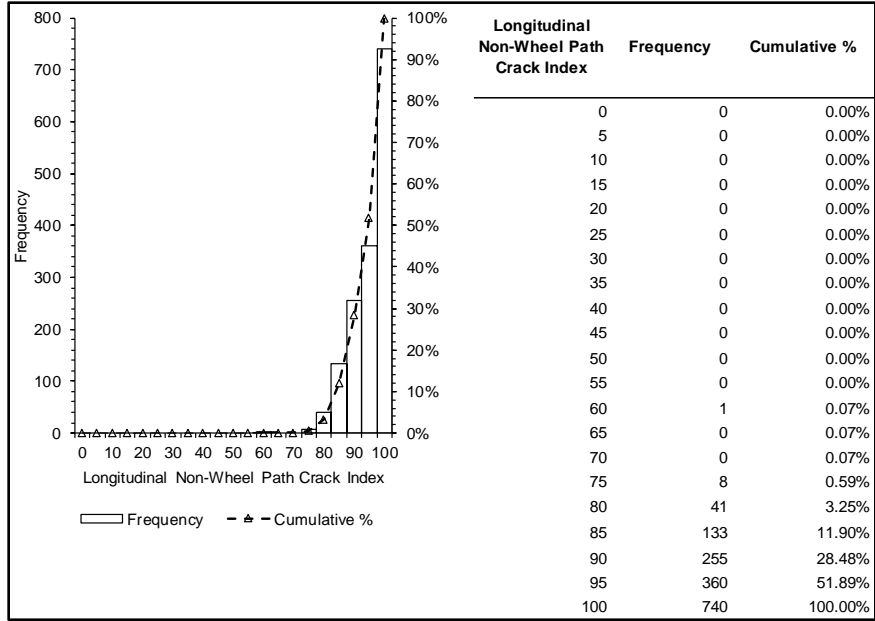
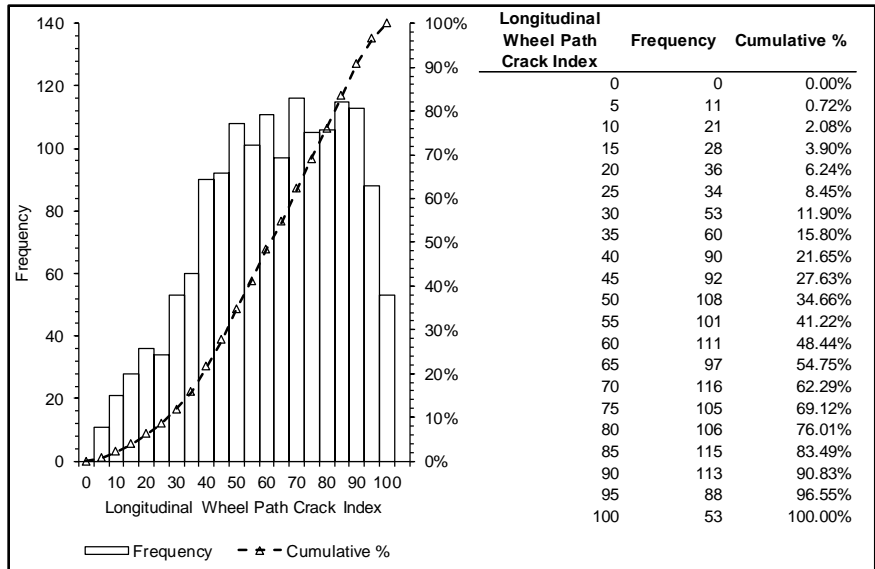
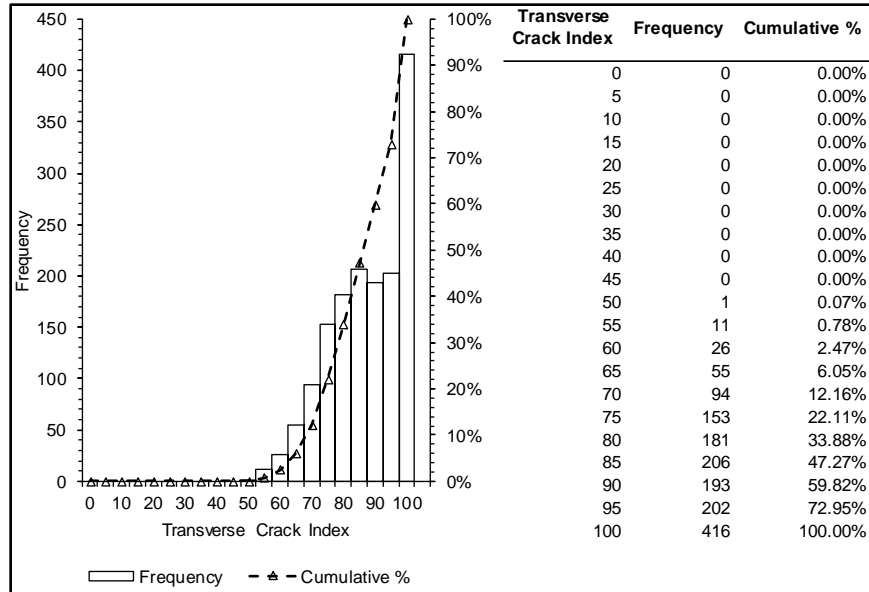
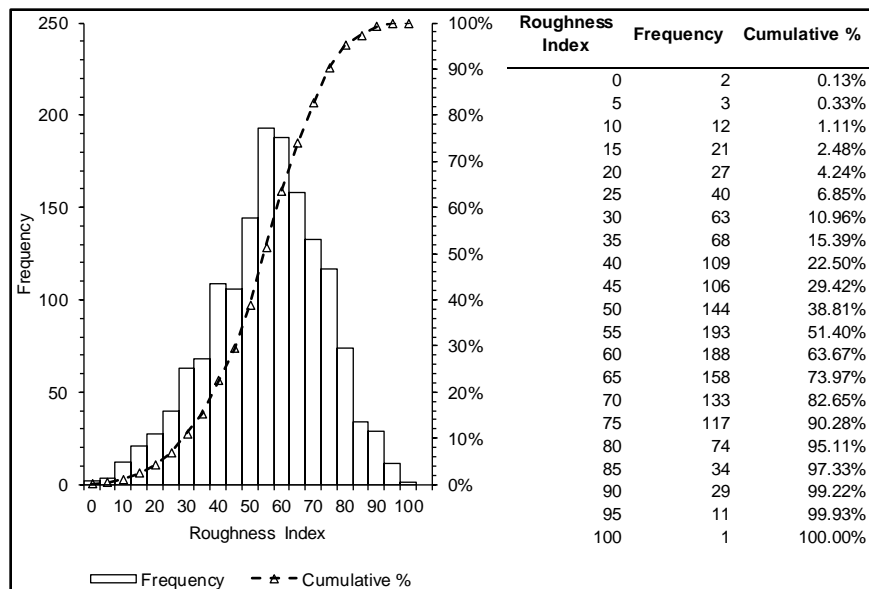
Figure 3-13: 10% Sample Street Network PCI

Figure 3-14: Sample Street Network Fatigue Crack Index

Figure 3-15: Sample Street Network Longitudinal Non-Wheel Path Index

Figure 3-16: 10% Sample Street Network Longitudinal Wheel Path Index

Figure 3-17: 10% Sample Street Network Transverse Index

Figure 3-18: 10% Sample Street Network Roughness Index

Figures 3-13 to 3-18 show histograms of 10% of the overall network individual distress indices currently considered in calculating PCI. The fatigue crack index, longitudinal non-wheel path crack index, and transverse crack index histograms are J-shaped while longitudinal wheel path crack index is almost normally distributed, and roughness index is normally distributed. Approximately 61% of the sections have fatigue crack index greater than 95, 72% of the sections have longitudinal non-wheel path crack index greater than 90, and 53% of the sections have transverse crack index greater than 85. Therefore, for these three distress indices, most of the streets have fatigue crack index, longitudinal non-wheel path crack index, and transverse crack index greater than 85. Most of the streets have a much lower longitudinal wheel path crack index and roughness index. Approximately 55% of the streets have longitudinal wheel path crack index less than 65 while approximately 51% of the streets have roughness index less than 55. Referring to the PCI equation 3-5, roughness index contribution to the PCI calculation is greatest.

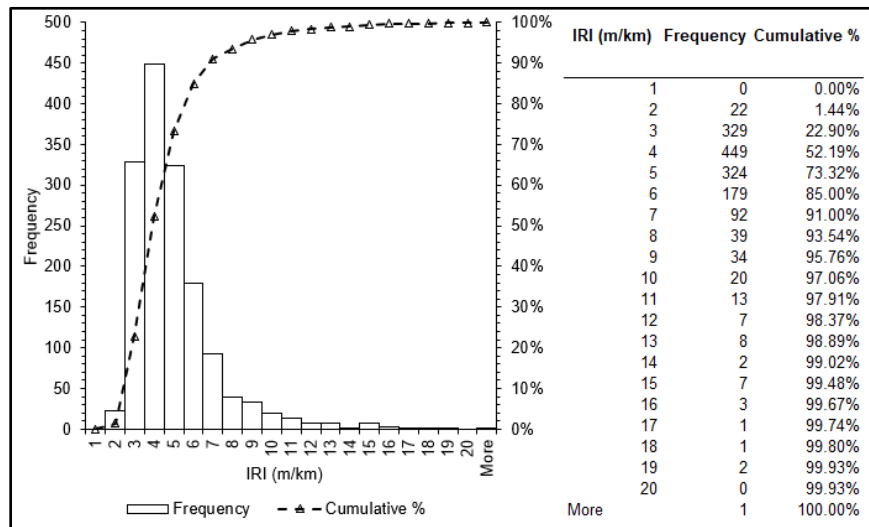
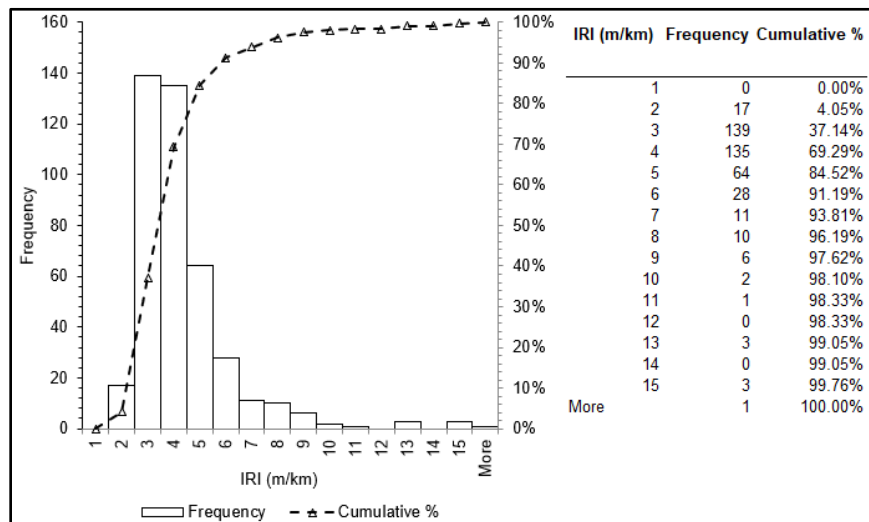
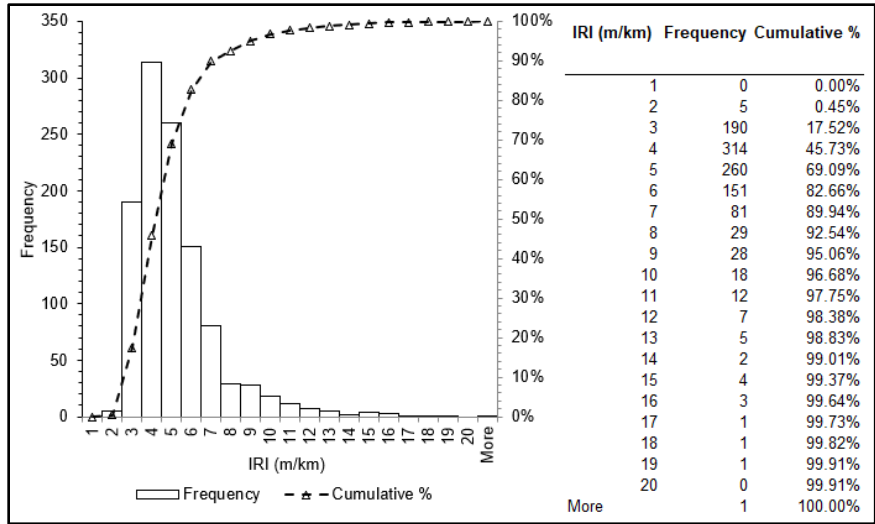
Figure 3-19: 10% Sample Street Network IRI (m/km)

Figure 3-20: Non-Residential Streets IRI (m/km)

Figure 3-21: Residential Streets IRI (m/km)

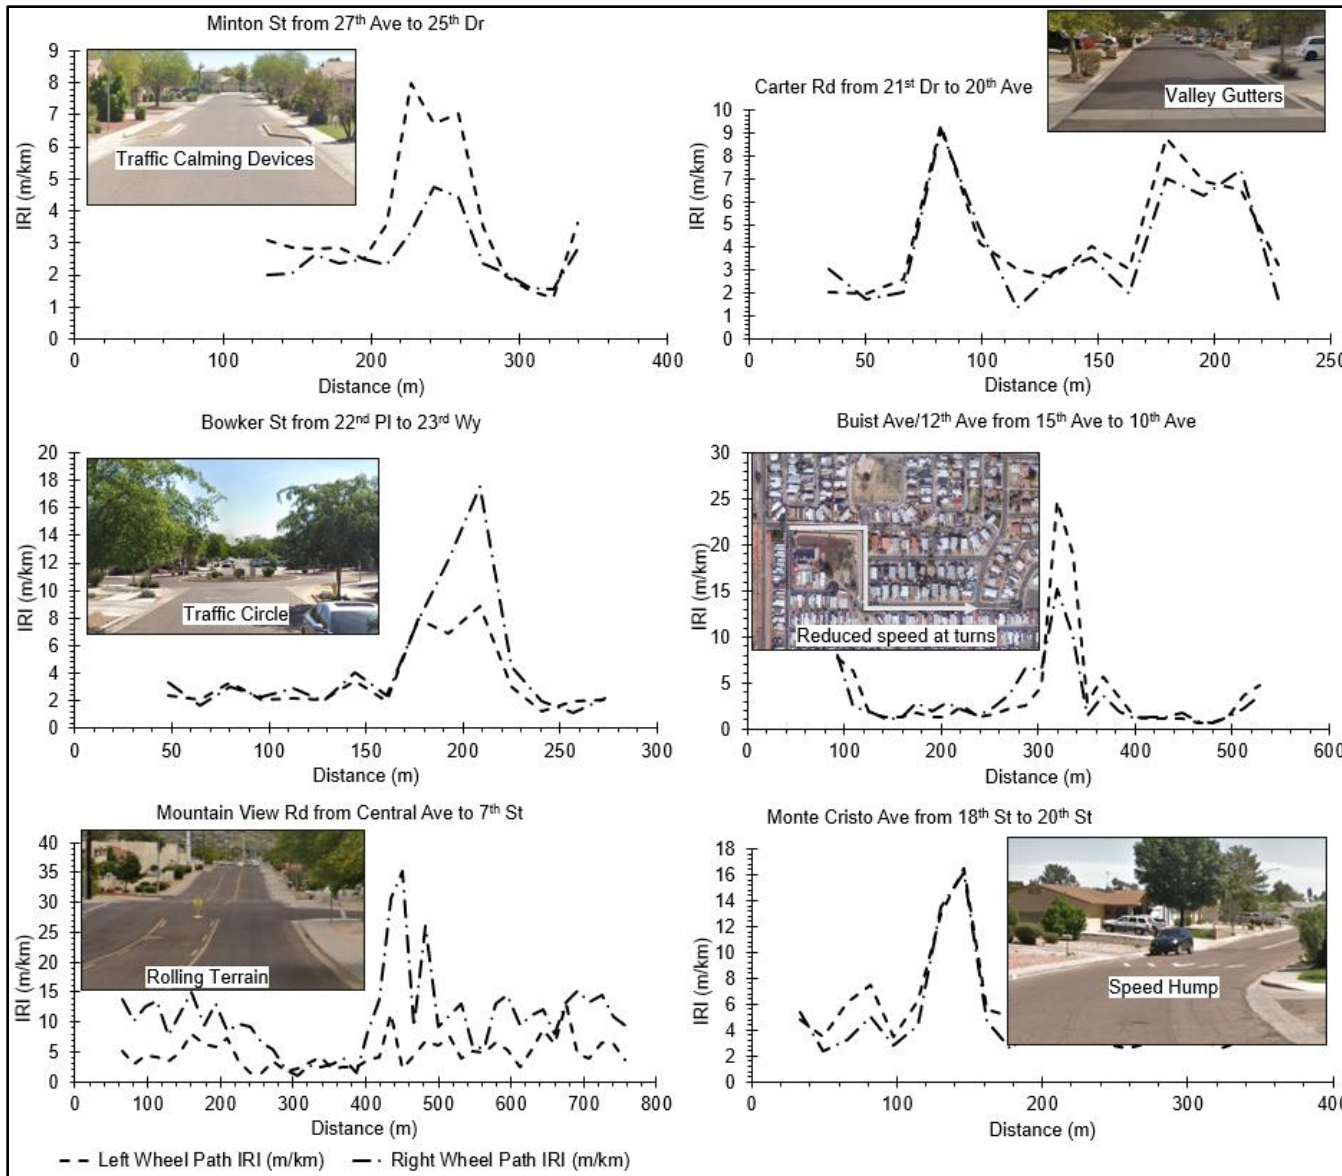
Figure 3-22: Factors Affecting IRI

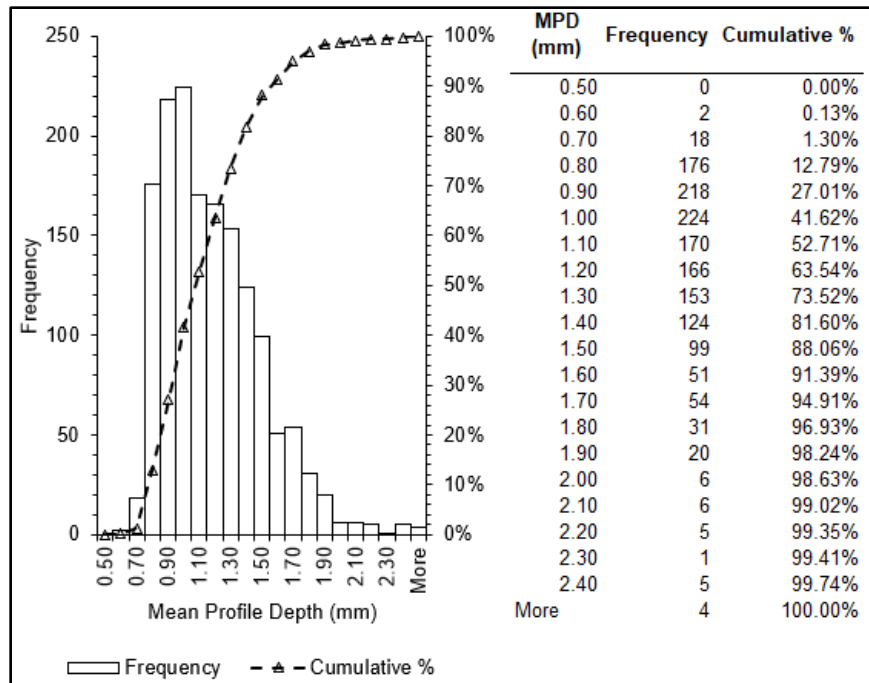
Figure 3-23: 10% Sample Street Network Mean Profile Depth (mm)

Figure 3-24: Non-Residential Streets Mean Profile Depth (mm)

Figure 3-25: Residential Streets Mean Profile Depth (mm)

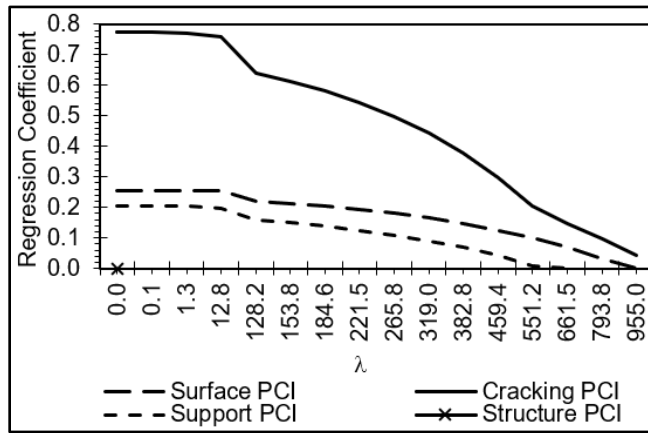
Figure 4-1: LASSO Trace for Springdale, Ohio Flexible Pavement Condition Data

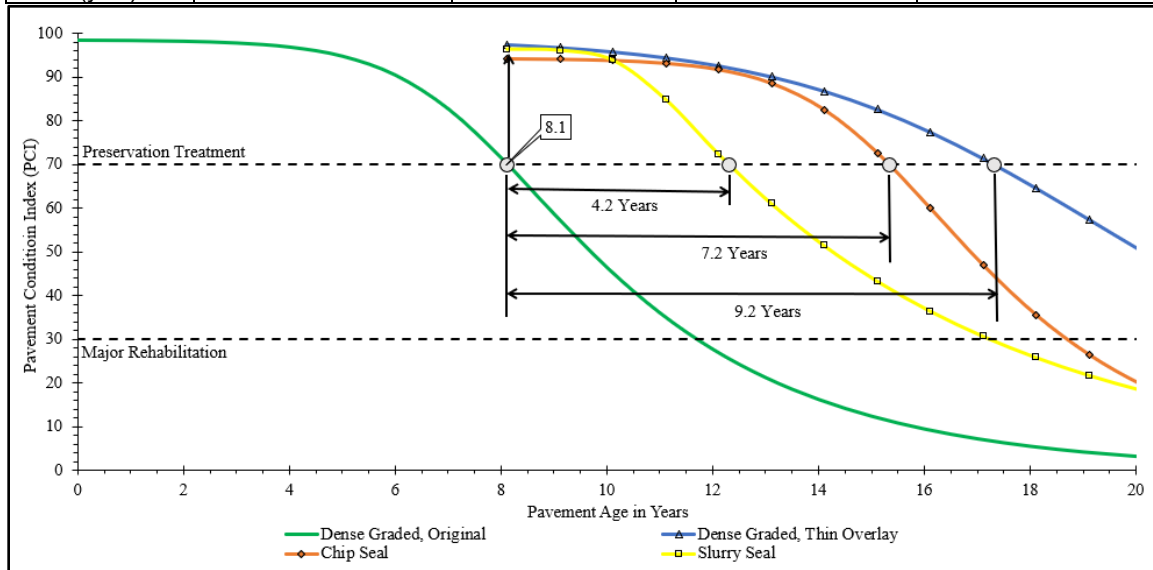
Figure 4-2: Pavement Condition Index (PCI) Based Pavement Performance Curves

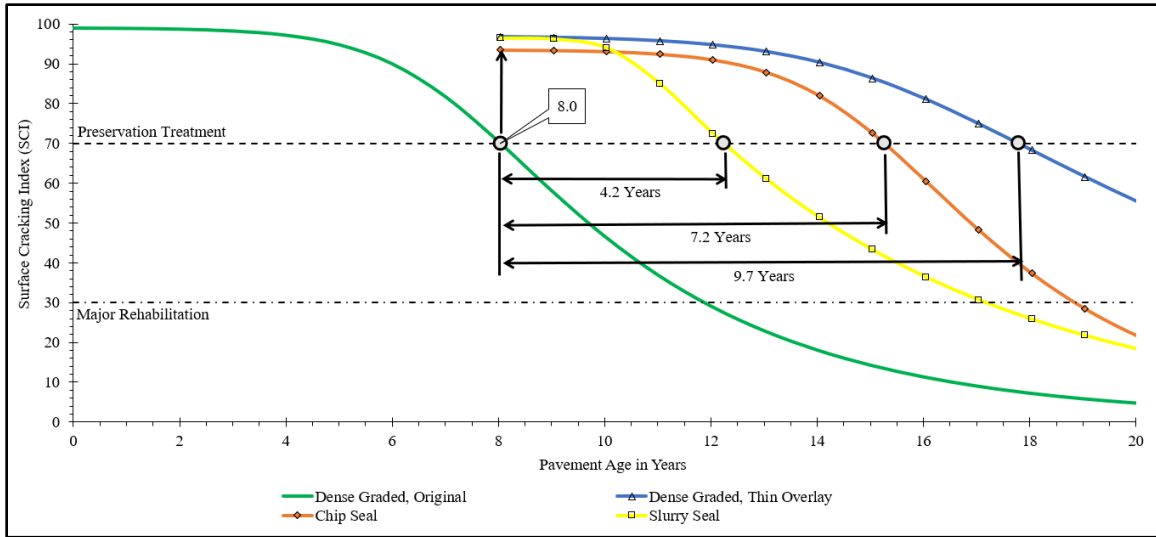
Figure 4-3: Surface Cracking Index (SCI) Based Pavement Performance Curves

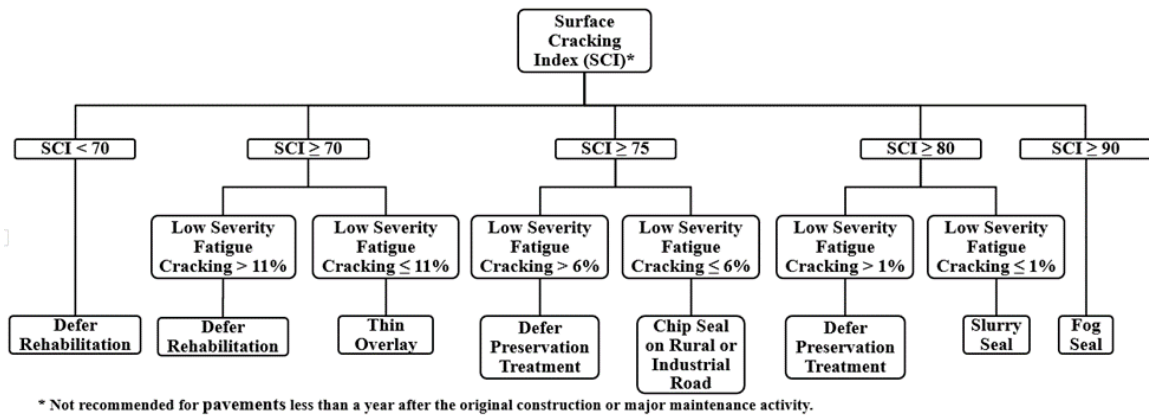
Figure 4-7: Preservation Treatment Selection Decision Tree

A review of thin overlay, chip seal, and slurry seal projects located in the City of Phoenix which were completed between 2018 and 2021 were performed to detect the first visible pavement surface distress. The earliest appearance of reflective cracking was observed as little as 3 months after chip seal and slurry seal and slightly under ten months after thin overlay. Dhakal et al. (2016) and Nam et al. (2014) noted the reflection cracking propagation rate of 25 mm per year on hot-mix asphalt overlay. Common practices to prevent reflective crack initiation are milling to the crack depth and crack sealing. However, based on the field observations, on heavily fatigued cracking pavement sections, crack depth can be greater than 38 mm, which is the thickness of the thin overlay. Full depth patching as a pretreatment for preservation treatment is not cost effective for consideration for a large area. The sections with extremely high fatigue cracking areas with a lower SCI affecting the pavement structural capacity were removed before the fatigue cracking limits were established. The fatigue cracking limits were developed as the percent of fatigue cracking by severity for the corresponding optimum SCI range for the specific preservation treatment and reviewing distress images.

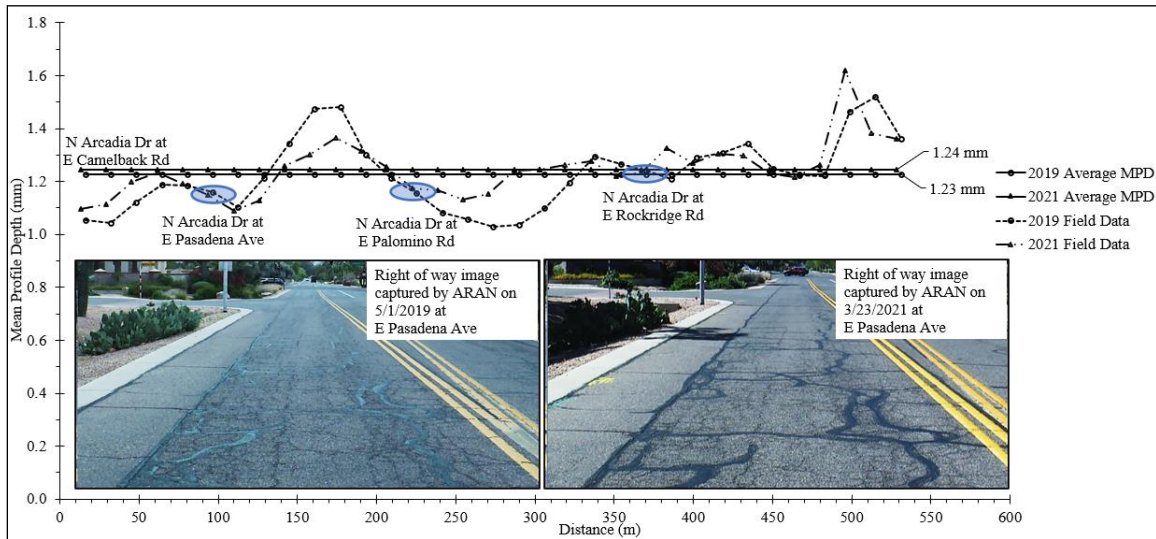
Figure 6-8: Comparison of 2019 and 2021 Field MPD Values for a Fatigue Section

The pavement section shown in Figure 6-8 was widened in 1998 with no additional maintenance activity performed on the existing pavement. The macrotexture condition assessments were performed on the fatigue section and the average MPD was 1.23 mm in 2019 and 1.24 mm in 2021 respectively. The change in pavement macrotexture depth is negligible, less than 1%, for the fatigue section. The average rate of change of MPD within the 23-month period is about 0.01 mm/yr.

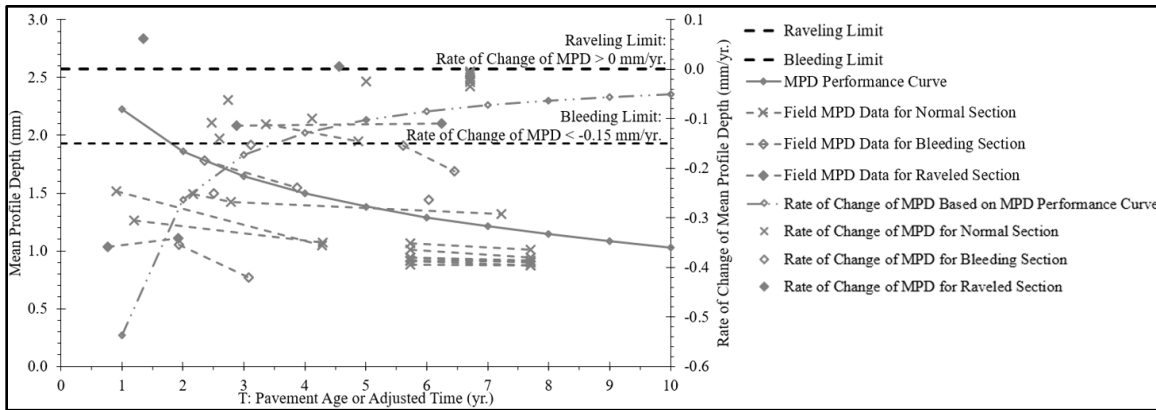
Figure 6-14: Pavement Surface Texture Thresholds for Chip Seal

set as the threshold for raveling. Based on the field MPD data and a review of the distress survey, the bleeding limit was established as the rate of change of MPD lower than  $-0.15$  mm/yr.

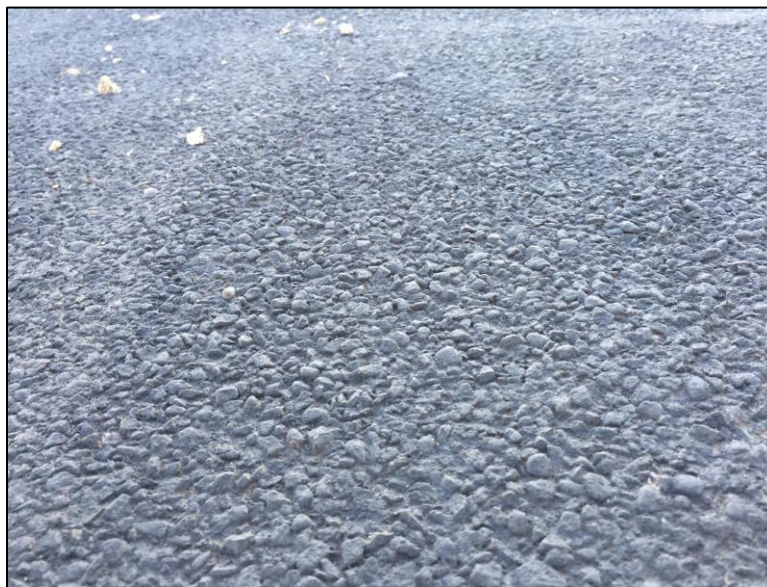
Figure 7-8: Low Volume FAST Capped with a Single Coating of Liquid Road Application

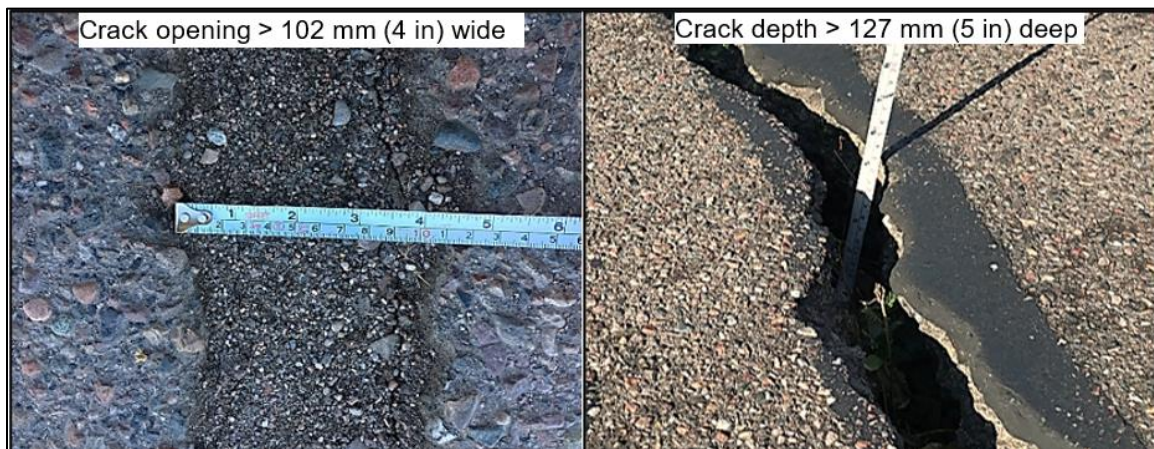
Figure 7-9: Transverse Cracking

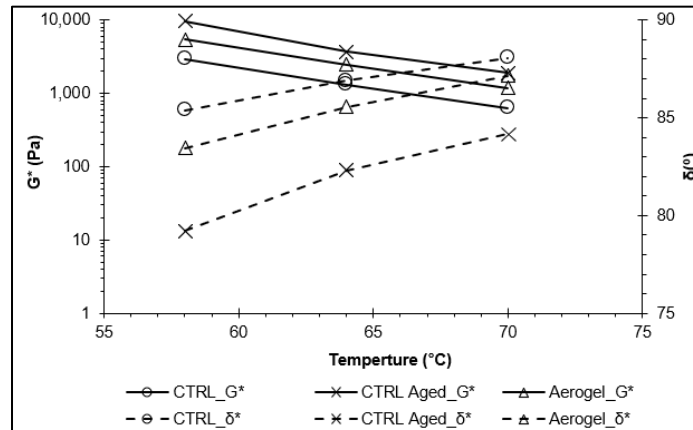
Figure 7-11:  $G^*$  versus Temperature and  $\delta$  versus Temperature Plot

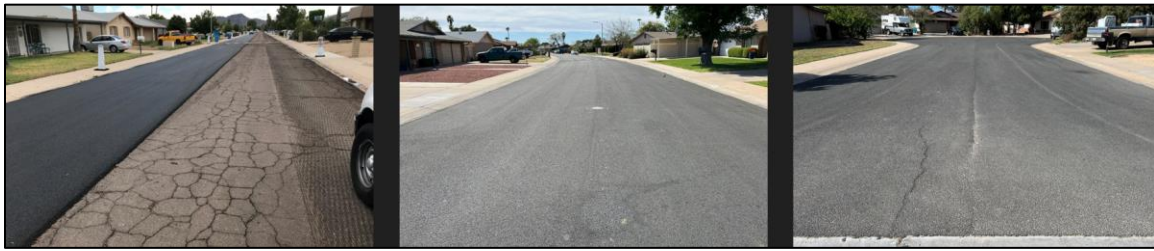
Figure 7-15: Pavement Condition Before, During, and After UTBWC Treatment in QS 30-20

months after the application, it is the recommended treatment method to mitigate reflective cracking.

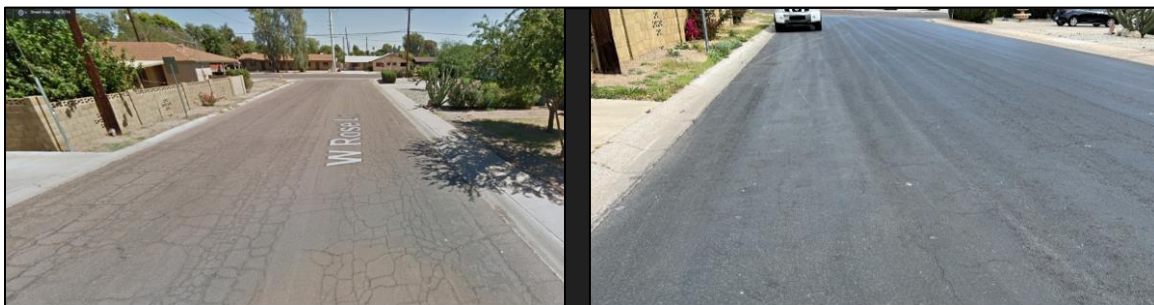
Figure 7-16: Pavement Condition Before and After Thin Overlay on Rose Ln between Black Canyon Frwy (I-17) and 23<sup>rd</sup> Ave

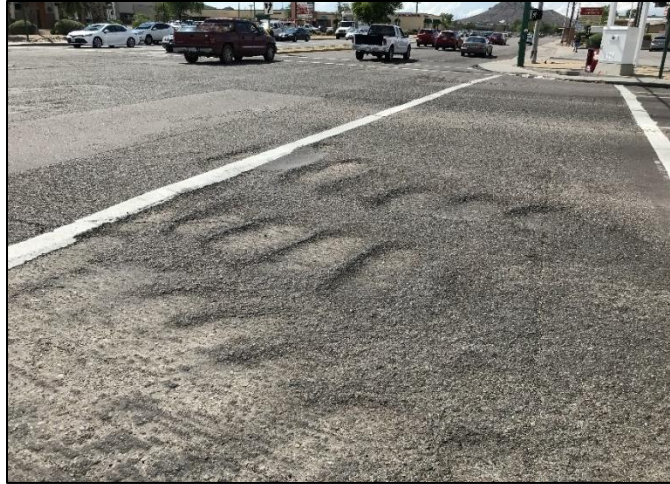
Figure 7-17: Raveling at Intersection
