Application of Non-Contact Electrostatic Voltmeter for
Solar Photovoltaic Device Characterization

A Dissertation Prospectus Presented in Partial Fulfillment
of the Requirements for the Degree
Doctor of Philosophy

ARIZONA STATE UNIVERSITY

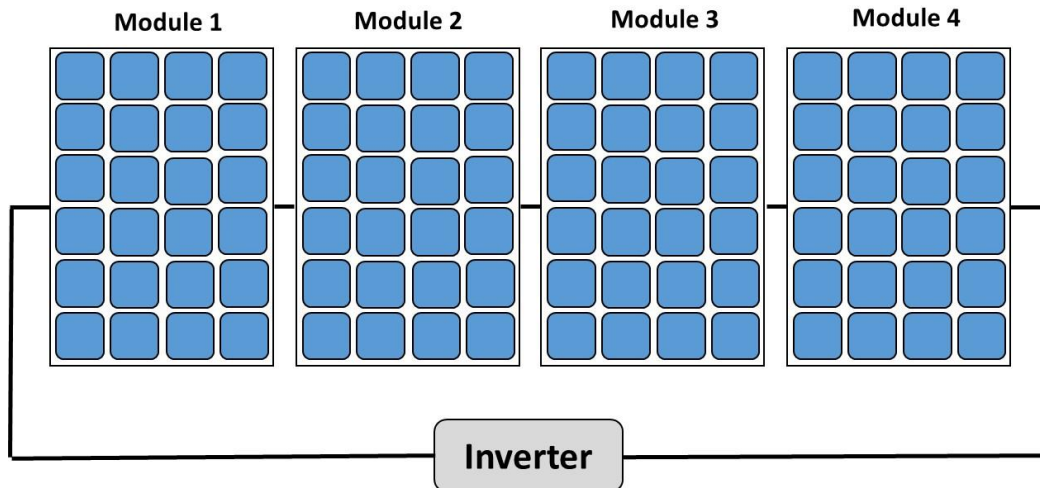
Figure 3: Four PV Modules, Each Having Twenty-Four Cells Connected in Series with Each Other and Inverter to Make a PV System.

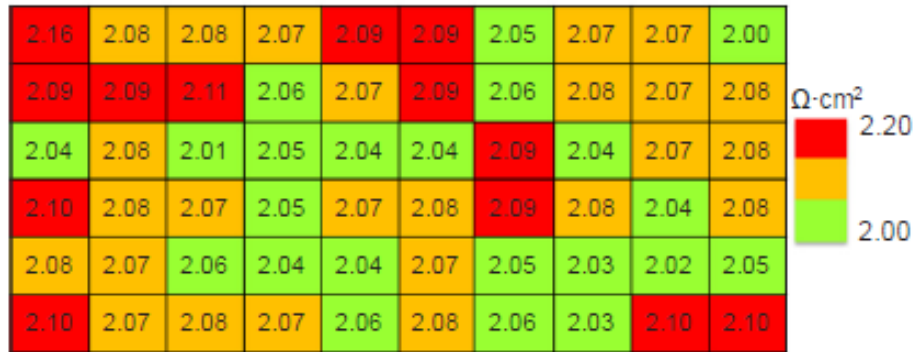
Figure 8: Quantitative Analysis of EL Image [55]

performance analysis is a hot topic. These maps provide data to detect bad-performing cells in a module with high resistance and power drop, and Figure 8 shows the series resistance

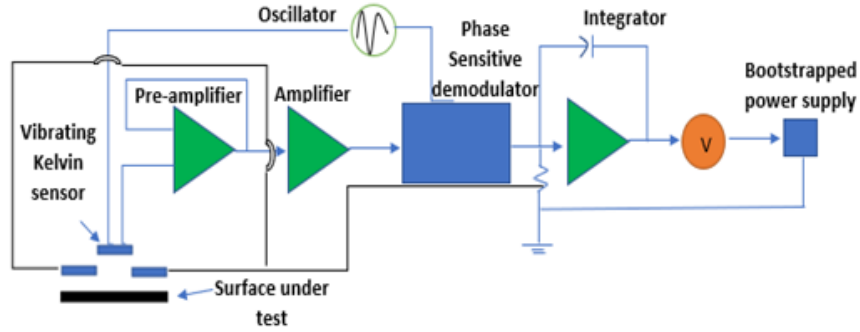
Figure 12: The Essential Components of an ESV, Including the Probe Sensor and the Surface under Test

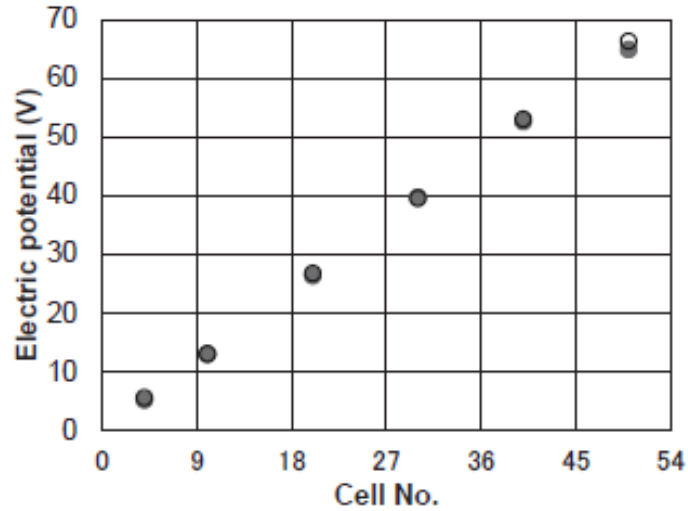
Figure 14: Measurement of Voltage by ESV on Every Cell of a Module

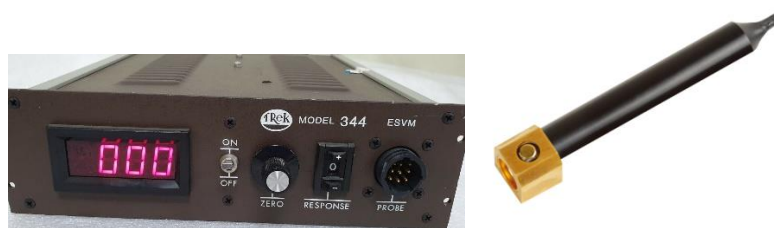
Figure 20: TREK ESV model 344 on the left side and probe PD1215 on the right side

The multicell module (shown in Figure 21) had higher open circuit voltage than a single cell, requiring TREK ESV model 344, along with the probe PD1215, due to its high voltage sensing capabilities. Figure 20 shows the ESV and probe used in this experiment. This experiment used a field-aged multicell module of ninety-six cells to explore the ESV technique identifying the defective cells in the multicell commercial module. In section 3.1.3, the ESV probe sensor was placed in the cell's middle area (between two bus bars), and voltage was sensed. In this section, initially, the ESV sensor was placed on multiple positions (middle part, edges, corners) of a clean cell with no defects. Later, the probe sensor was placed on a defective cracked cell.

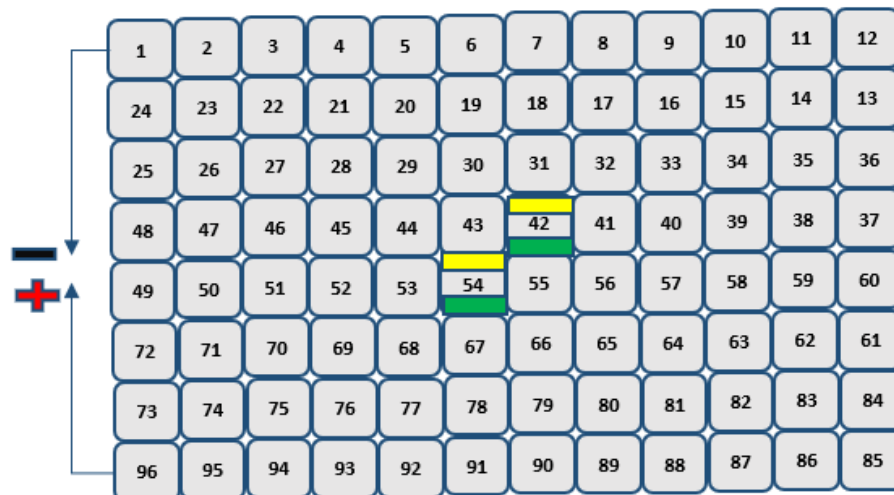
Figure 23: Sketch of a 96 Cells Module Showing Selected 42nd And 54th Cell

Figure 23 shows the sketch of the cell.

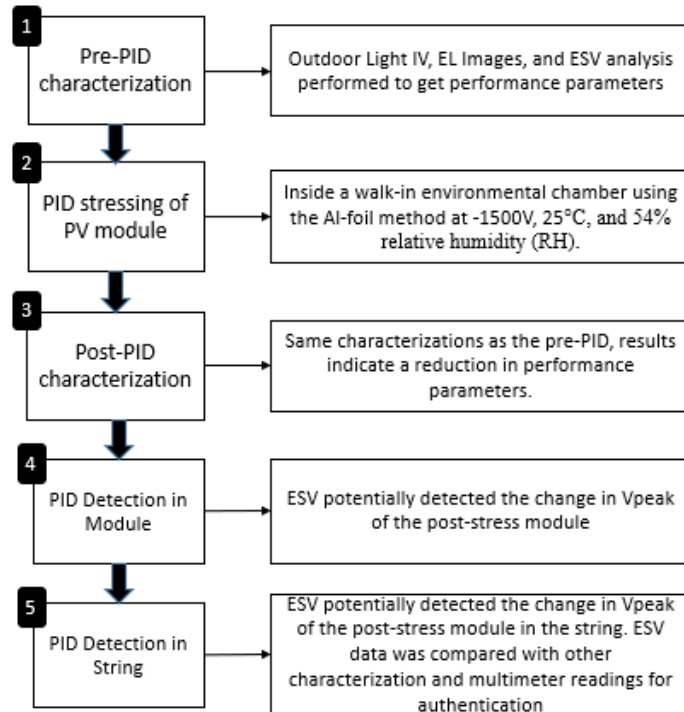
Figure 28: Methodology for the PID Stressed Module Identification

After the pre-stress characterization, the module was subjected to PID stress in a walk-in environmental chamber. The Al-foil method was opted for, and the rear and front of the module were covered in Al-foil. The cell was kept at a negative bias to the front side of the module under stress, and the rear side was at the same potential as the cell (the rear side did not matter for this module as the cell was monofacial), and the stress testing was carried out at -1500V, 25°C, and 54% RH. In the post-stress testing, the procedure of pre-stress testing was followed. The methodology of the experiment is summarized in Figure 28.

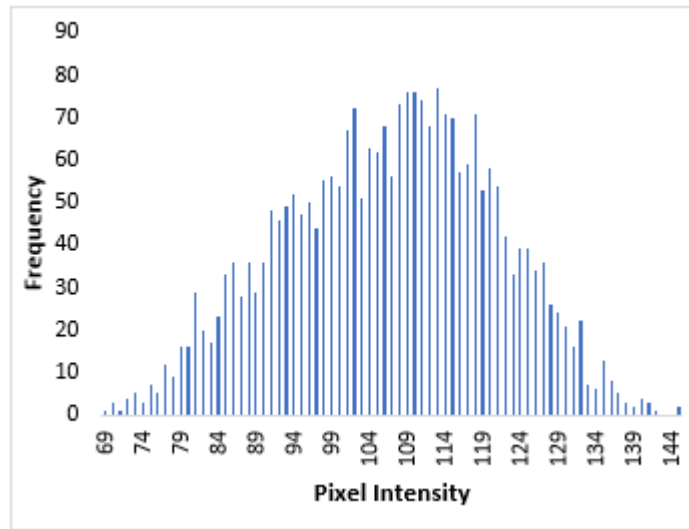
Figure 40: The pixel intensity occurrence rate on a selected position on the EL image. The probe on the cell covers 3165 pixels, and the graph shows how many times a specific pixel value appears under it.
