Failure and Degradation Modes of PV modules in a Hot Dry Climate:

Results after 16 years of field exposure

Karan Rao Yedidi

ARIZONA STATE UNIVERSITY

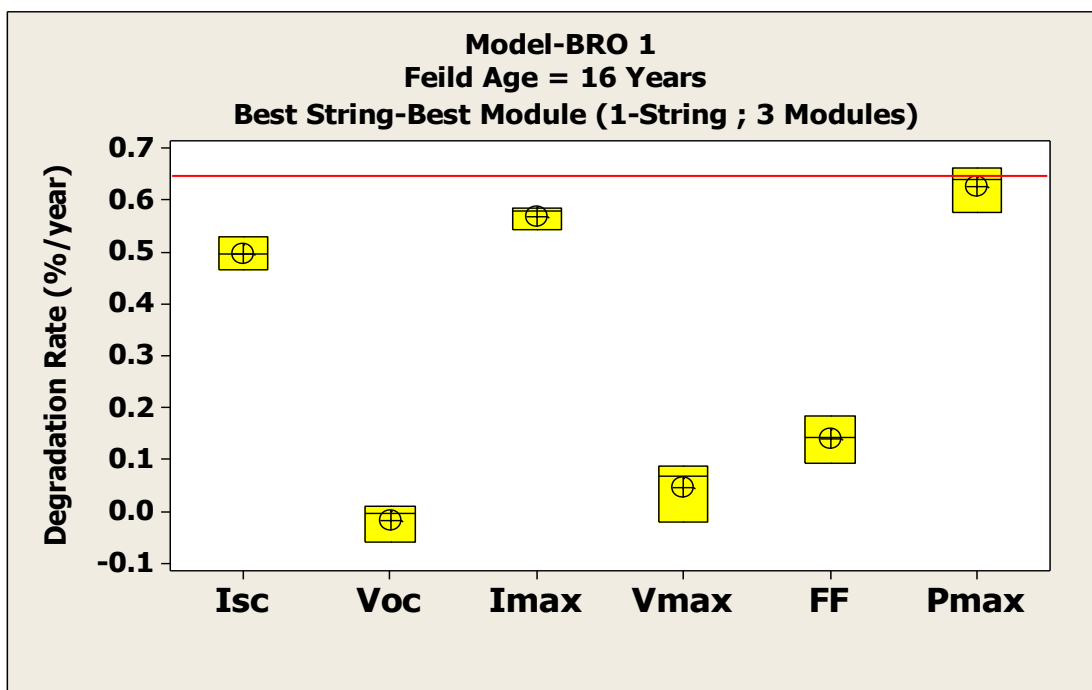
Figure 22 Plot for various I-V parameters degradation (%/Year) for the best string-best modules

The plots from Figure 22 and Figure 24 show that I_{max} and I_{sc} have contributed to the overall degradation in P_{max} . The median of the P_{max} degradation rate is close to the median of I_{max} and I_{sc} . This is due to significant levels of encapsulant browning which causes optical losses. A slight increase in series resistance is indicated by a drop in V_{max} . The histogram in Figure 23 shows a normal distribution for the series resistance values (R_s) for the 30 best modules in Site 4A and 2. These modules experienced drop in power mainly due to optical losses, their low series resistance did not play a substantial role.

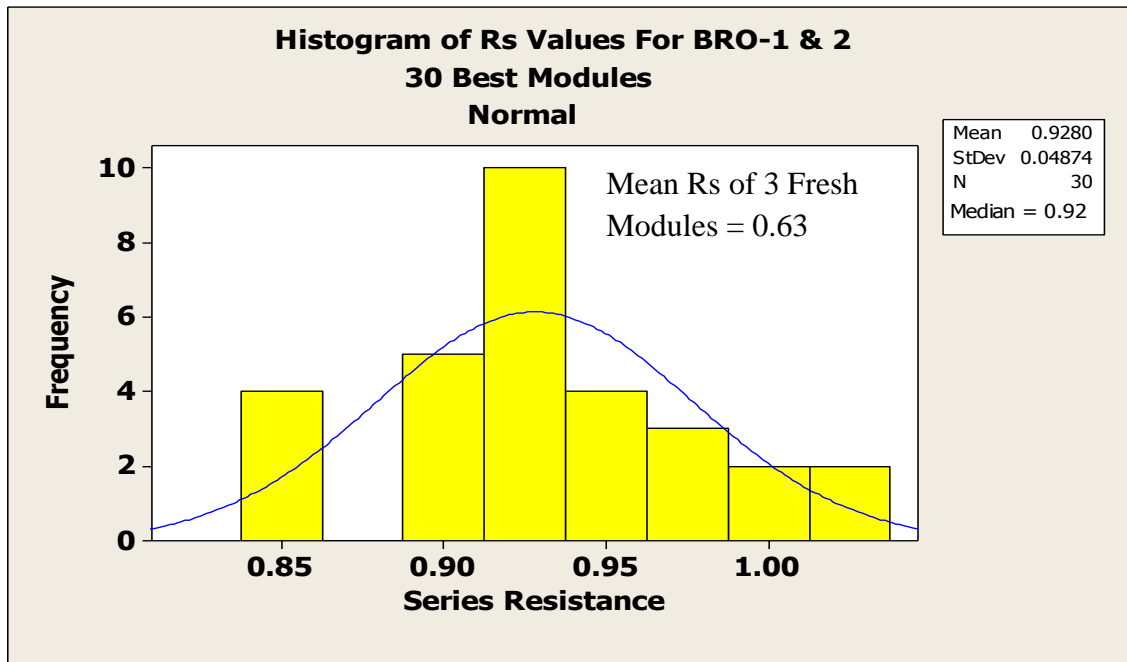
Figure 23 Histogram on R_s values for 30 best modules

Fresh Modules	Best 30 Modules
Mean R_s	0.63	0.93
Median R_s	0.63	0.93
% increase	N/A	30.30%

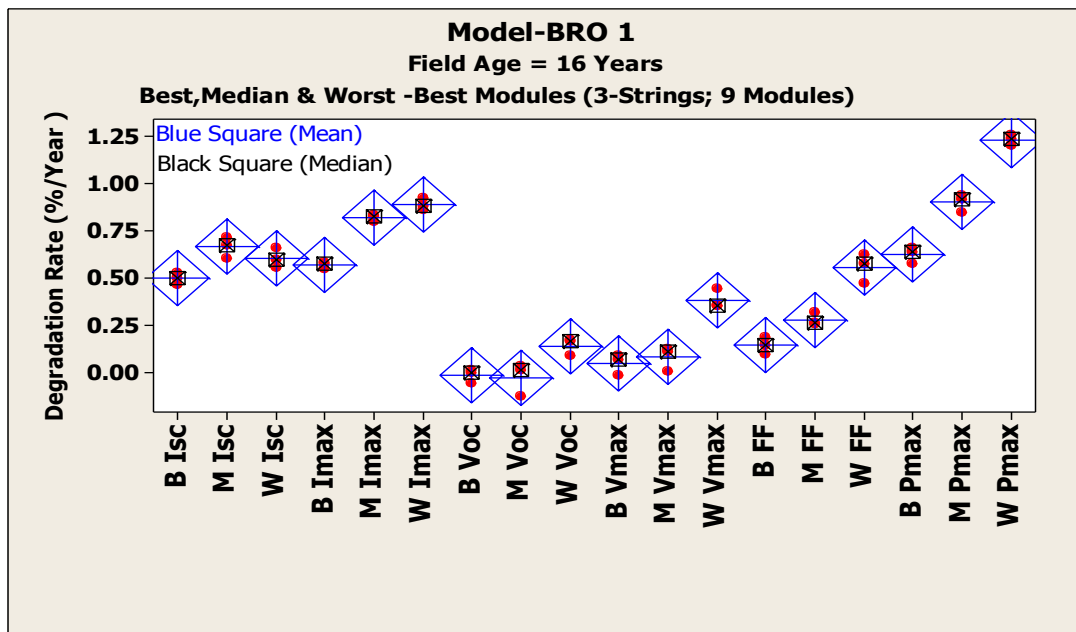
Figure 25 Summary plots for various I-V parameter degradation (%/year) for best modules in Best, Median and worst strings in Site 4A.

The plot in figure 25 shows a summary of the best modules performance degradation rate for various parameters in the best, median, and worst strings. It can be seen once again that the I_{max} and I_{sc} are observed to be the major contributors for P_{max} degradation in these strings due to a combined effect of encapsulant browning and an increase of more than 30 % in series resistance shown by the degradation in V_{max}

A steep drop in I_{max} and I_{sc} are the parameters responsible for the degradation of P_{max} , due to encapsulant browning. Drop in V_{max} and FF is attributed to the series resistance increase.

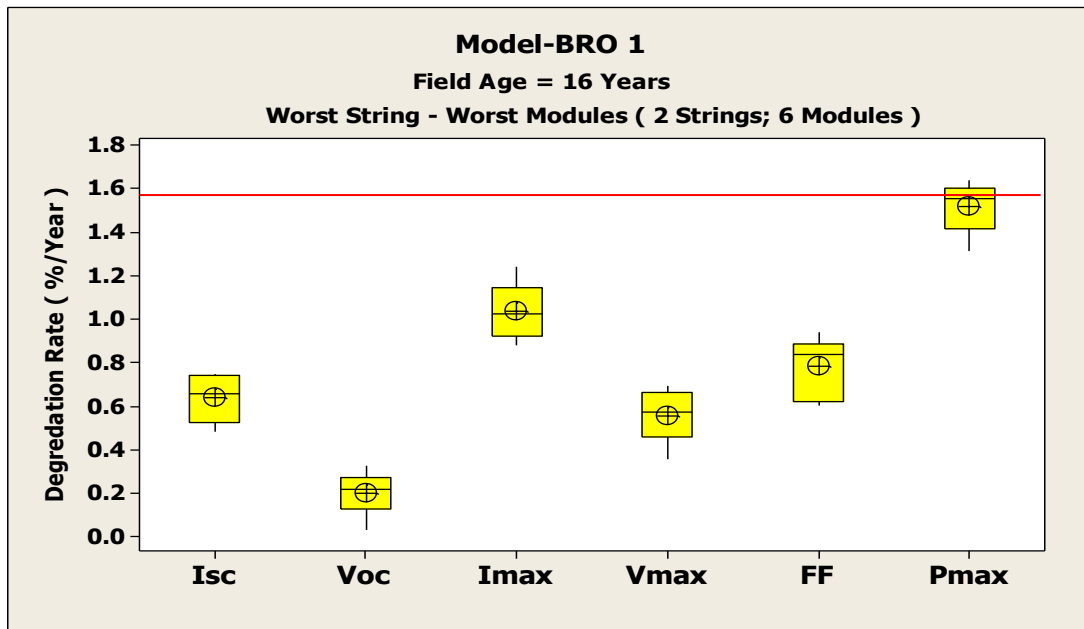
Figure 26 Plot for various I-V parameter degradation (%/year) for worst string-worst modules.

I_{max} , I_{sc} are the major contributors for P_{max} degradation, this is because these modules have encapsulant browning indicated by a higher drop in I_{max} and I_{sc} .

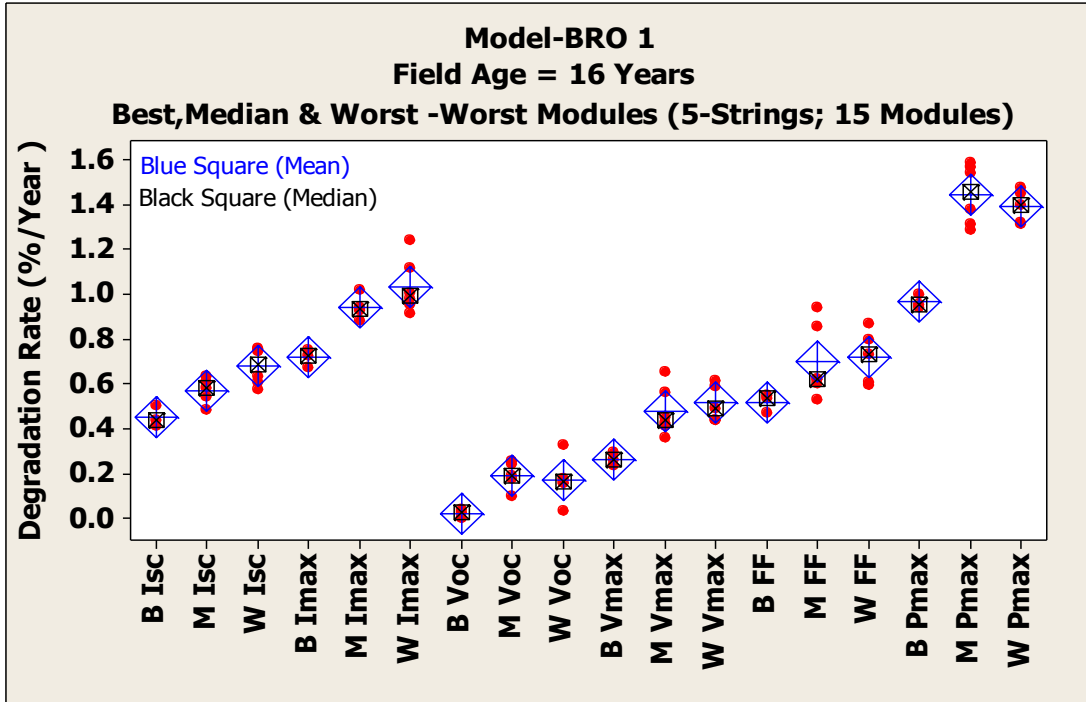
Figure 27 Summary plots for various I-V parameter degradation (%/year) for worst modules in Best, Median and worst strings.

The plot in figure 27 shows a summary of the worst performing modules degradation rate from the best, median, and the worst strings. A drop in Imax and Isc along with FF and Vmax signifies encapsulant browning coupled with high series resistance.

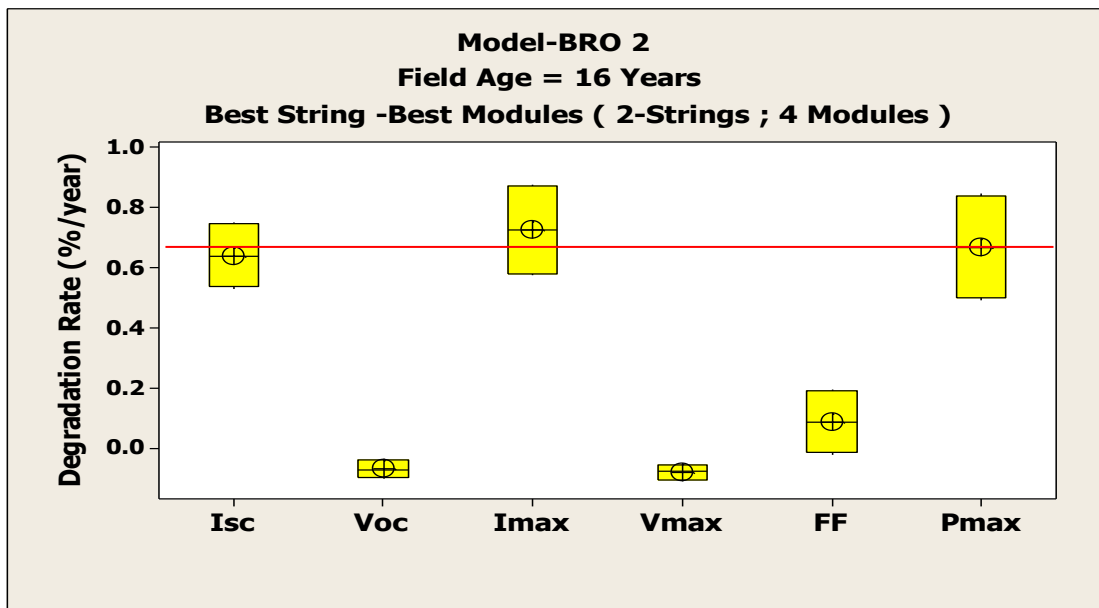
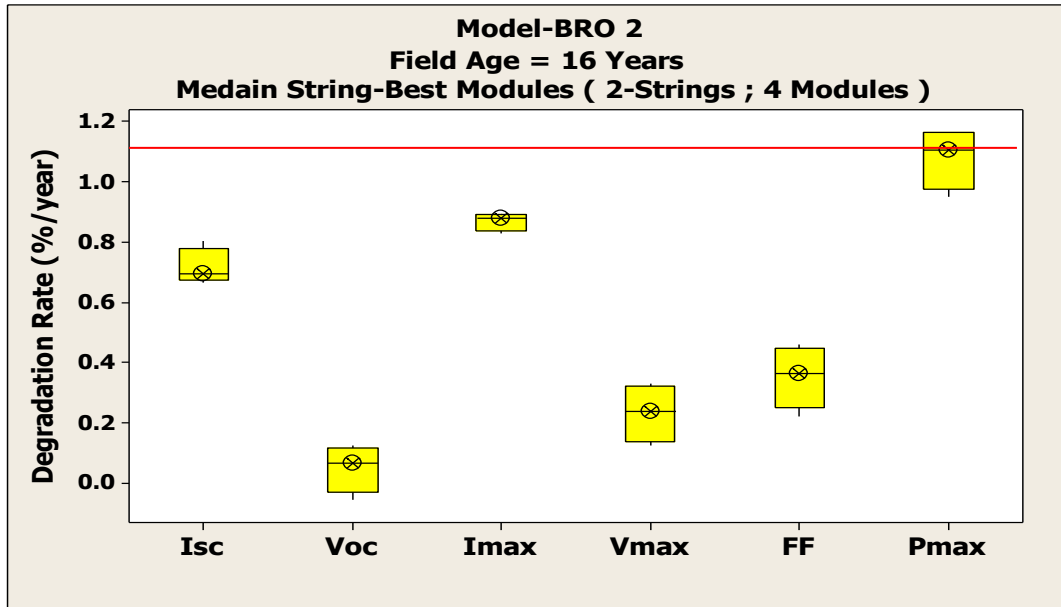
The effect of transmittance issues can be seen due to drop in Imax and Isc in the best and median modules as shown in Figure 29 and Figure 30.

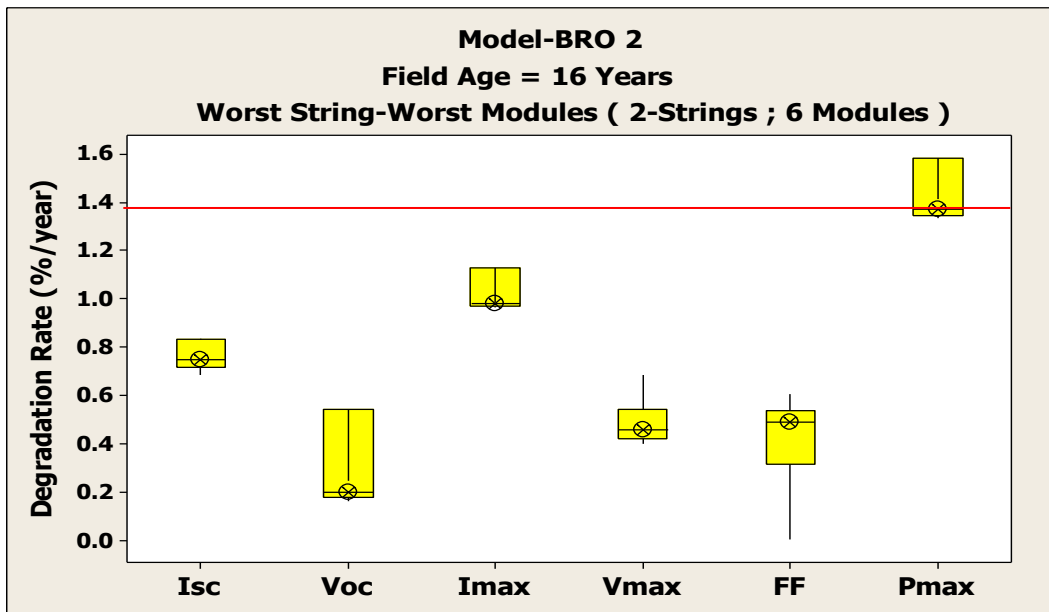
Figure 31 Plot for various I-V parameter degradation (%/year) for worst string- worst modules

The drop in Imax and Isc indicates high levels of encapsulant browning the increase in Imax and FF indicates increased level of series resistance.

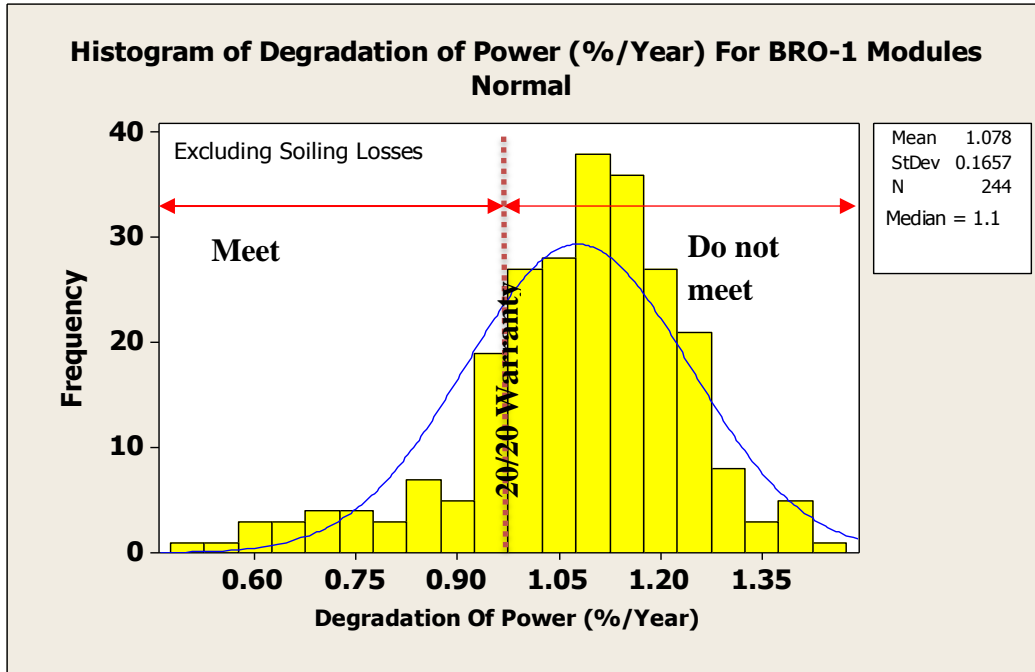
Figure 32 Histogram of Power Degradation (%/year) for all BRO 1 modules

The histogram shown in Figure 32 indicates the mean and median degradation rate of modules in Site 4A as 1.078%/year and 1.1%/year respectively. The degradation values used for these plots were computed after considering a soiling loss of 11% based on Figure 52 .The red dotted line indicates the 20/20 warranty line which is inserted at 1%/year; modules /strings on the left of this line will meet warranty requirements whereas modules/strings on the right of the line will not and are entitled for replacement.

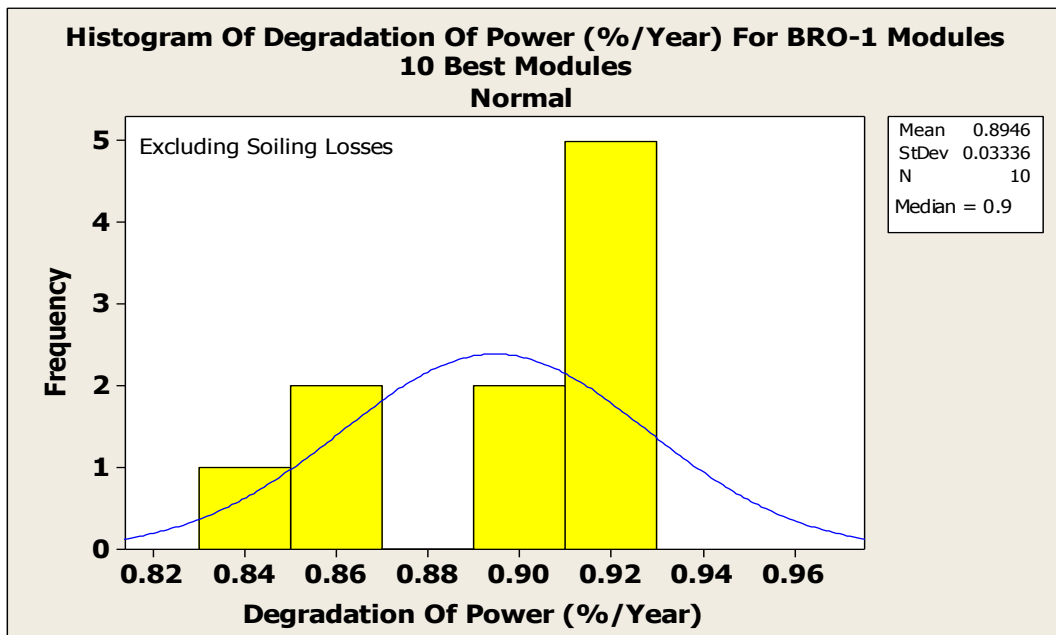
Figure 33 Histogram of Power Degradation (%/year) for 10 Best modules for BRO 1

The histogram shown in Figure 33 indicates a mean and median value of 0.89%/year and 0.9%/year respectively, for the 10 best modules selected from the best string. This indicates that all the best modules are still producing enough power to meet the warranty requirements. This module's Pmax is primarily affected by encapsulant browning and very low series resistance; same is the case for the 10 best modules in Site 4B.

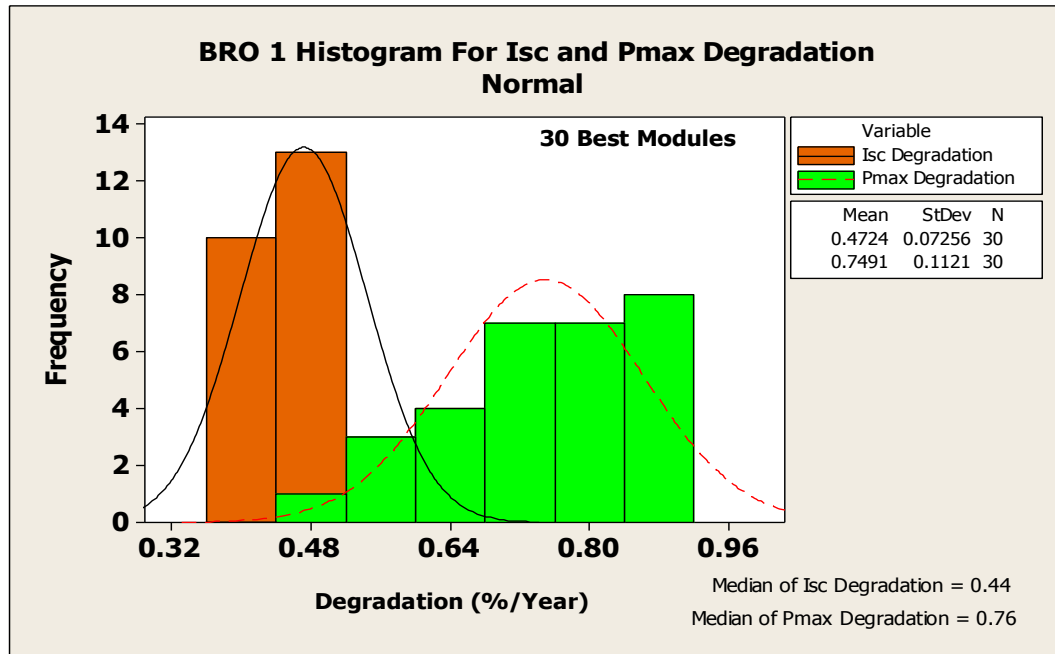
Figure 34 Histogram on Isc and Pmax degradation for 30 best modules in BRO 1. Since, Pmax, FF, Voc and Isc are related through the equation $P_{max} = V_{oc} \cdot FF \cdot I_{sc}$, drop in any one of these parameters can cause a drop in power. Therefore, in the case of the best modules the encapsulant browning causes an optical loss which affects the Isc causing a drop in power. If the Voc drop is considered zero, and the drop in Isc is equal to the drop in I_{max} 60% of the contribution to the drop is seen due to encapsulant browning and the remaining percentage can be calculated to obtain the contribution made by increase in series resistance.

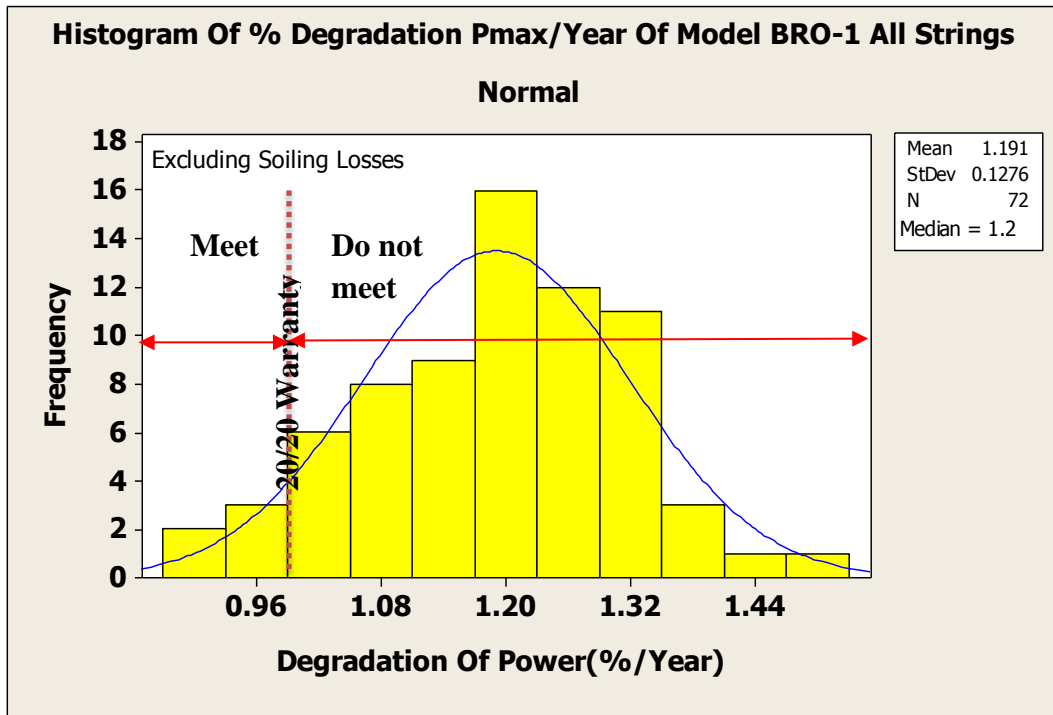
Figure 35 Histogram of Power Degradation (%/year) for all strings with BRO 1 modules.

The histogram in Figure 35 shows a mean degradation rate of 1.19%/year and a median degradation rate of 1.2%/year. A slightly higher degradation rate of strings as compared to the modules may be attributed to soiling losses, intermodule cable losses, and mismatch of modules within the string.

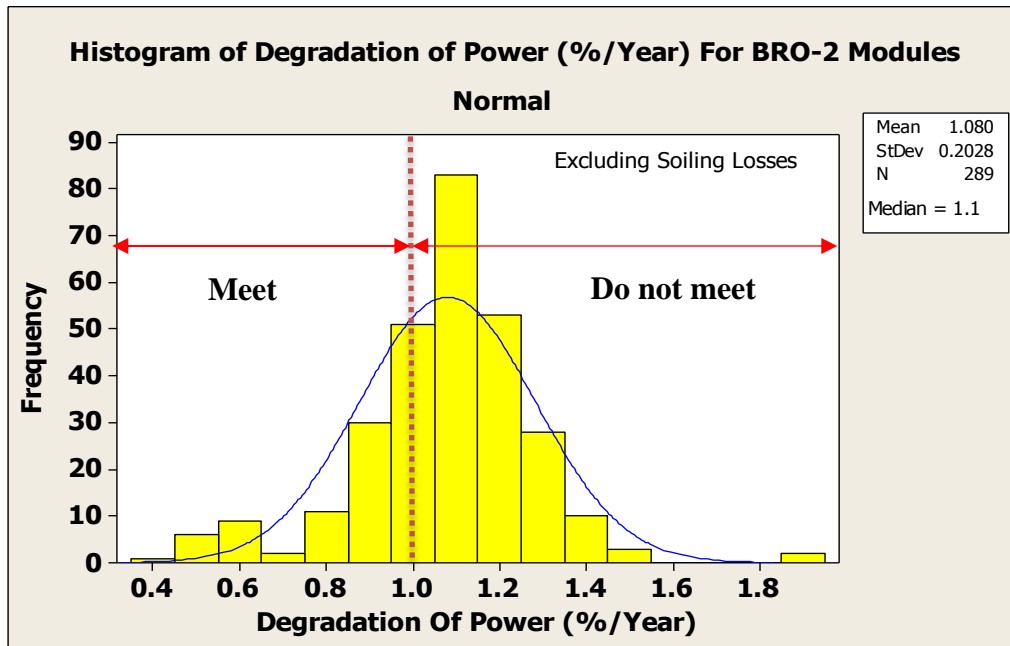
Figure 36 Histogram of Power Degradation (%/year) for all BRO 2 modules.

The plot shown in Figure 36 indicates a mean degradation rate of 1.08%/year and a median degradation rate of 1.1%/year.

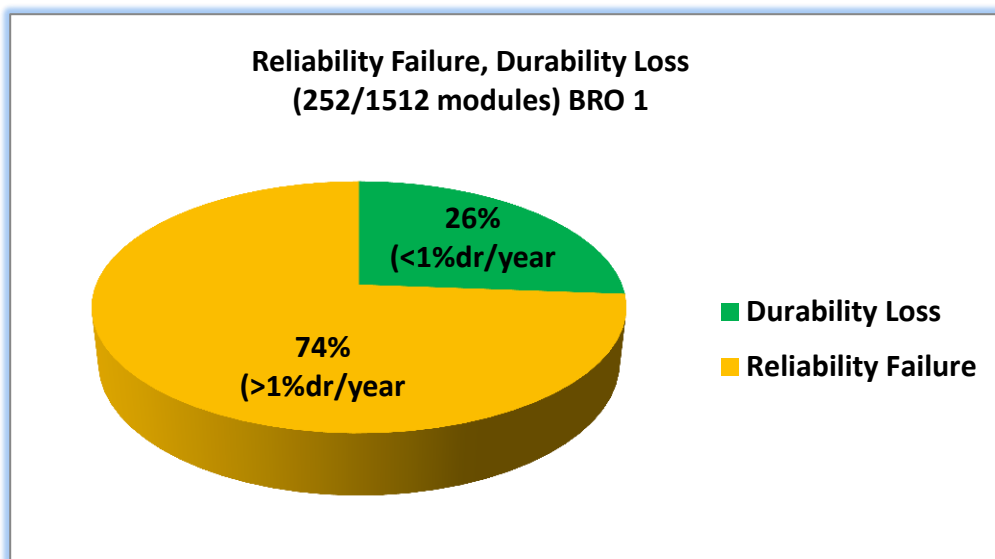
Figure 42 Reliability failure and Durability Loss site-4A

The pie chart in figure 42 indicates that 74% of the modules in Site 4A have a Pmax degradation rate of above 1%/year, this drop categorizes them under modules with reliability failures because they fail to meet the warranty terms. A vast percentage of

modules are in yellow region of the pie chart because of a combined effect of high series resistance due to solder bond fatigue and optical losses due to encapsulant browning. The 0.5% safety failure is due to one failed bypass diode, one broken module and 6 modules with back sheet delamination. The 26% of the total modules in the red region constitute durability loss because of only encapsulant browning and very low series resistance.

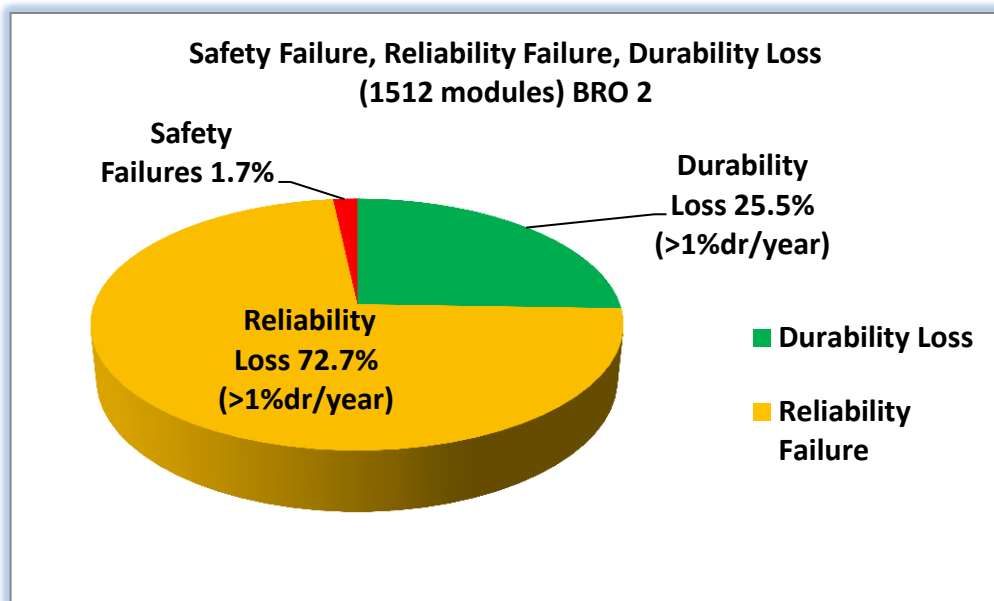
Figure 44 Durability loss, safety and reliability failure percentage for all modules in Site 4B

The pie charts in Figure 44 and Figure 45 indicate a durability loss and reliability failure percentage similar to that of modules in site 4A, but a higher safety failure percentage of 1.7 because of 5 modules with back sheet delamination and one bypass diode failure.

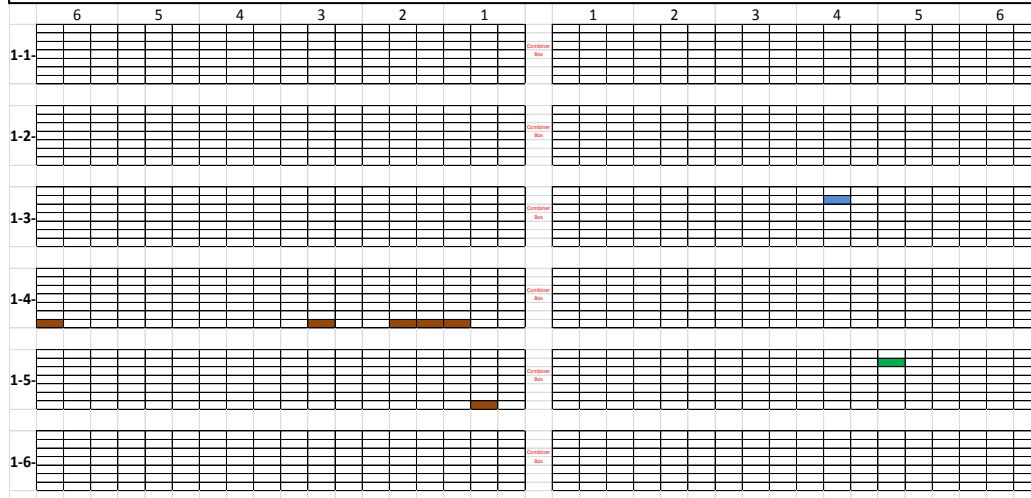
Site 4A: Safety failure rate at the plant level = $8/1512 = 0.5\%$

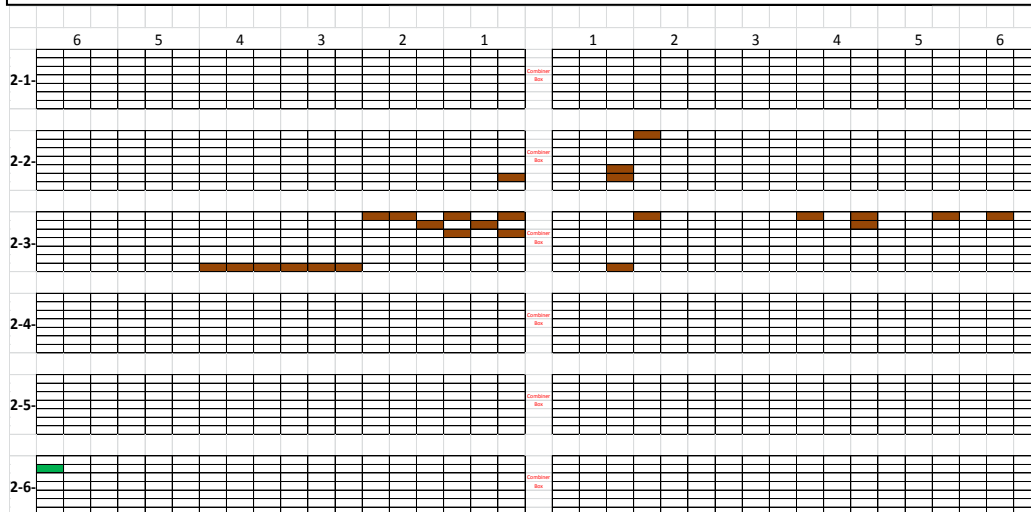
Figure 46 Safety Failure distribution In Site 4A&4B

Site 4B: Safety failure rate at the plant level = $26/1512 = 1.7\%$
