26+ Year Old Photovoltaic Power Plant: Degradation and Reliability

Evaluation of Crystalline Silicon Modules – South Array

A Thesis Presented in Partial Fulfillment
of the Requirements for the Degree
Master of Science in Technology

ARIZONA STATE UNIVERSITY

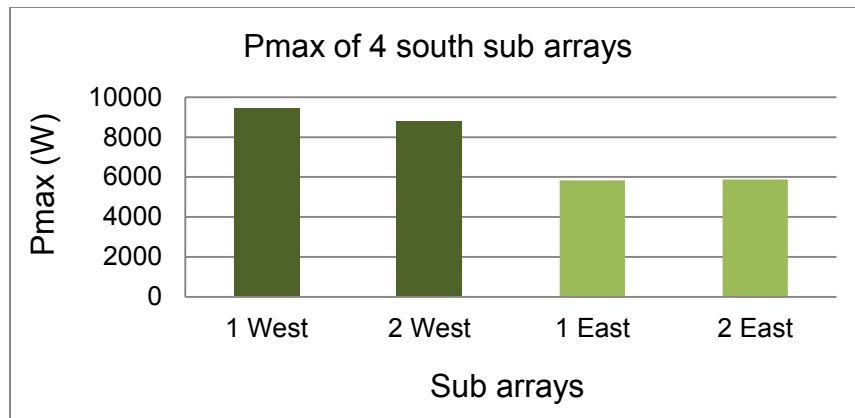
Figure 4.1 West and east south sub arrays output power summary

It has been observed that more degradation occurred on the east sub arrays than the west sub arrays as shown in Figure 4.1. In order to understand the reasons for this unusual difference between east and west sub arrays, various measurements and tests which are given below, were carried out and the discussions that follow help in analyzing the data obtained. This thesis work from this point shall concentrate on the south array, with results presented hereafter.

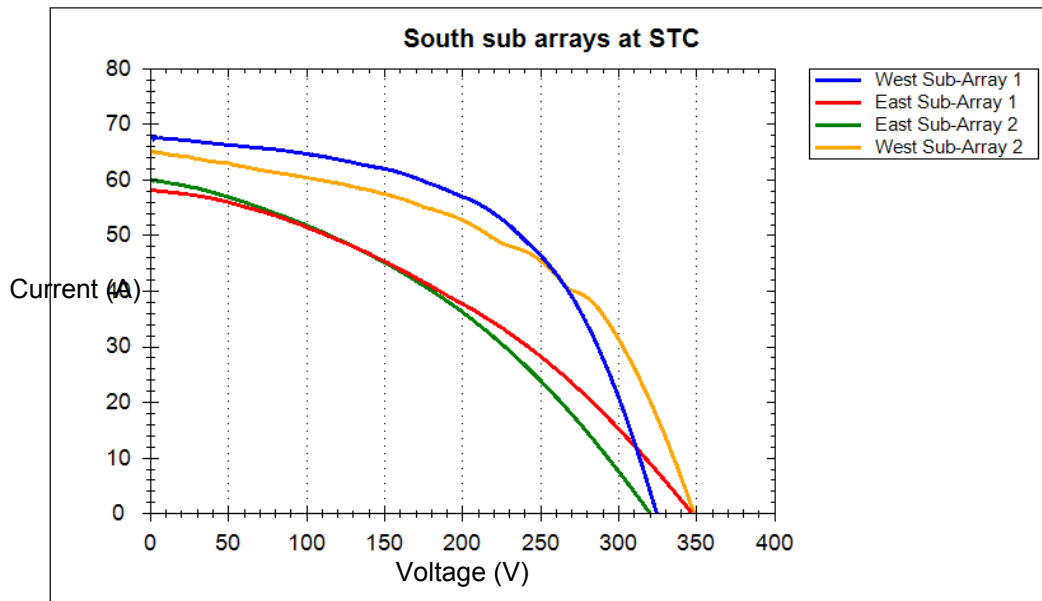
Figure 4.2 South sub arrays I-V curves summary [IVPC3]

- West sub arrays have similar I-V curves
- East sub arrays have similar I-V curves
- Positive sub arrays have higher Voc because of one additional panel group
- Lower Isc in east sub arrays due to more module interconnect breakage
- High operating cell temperatures on east sub arrays to be discussed later

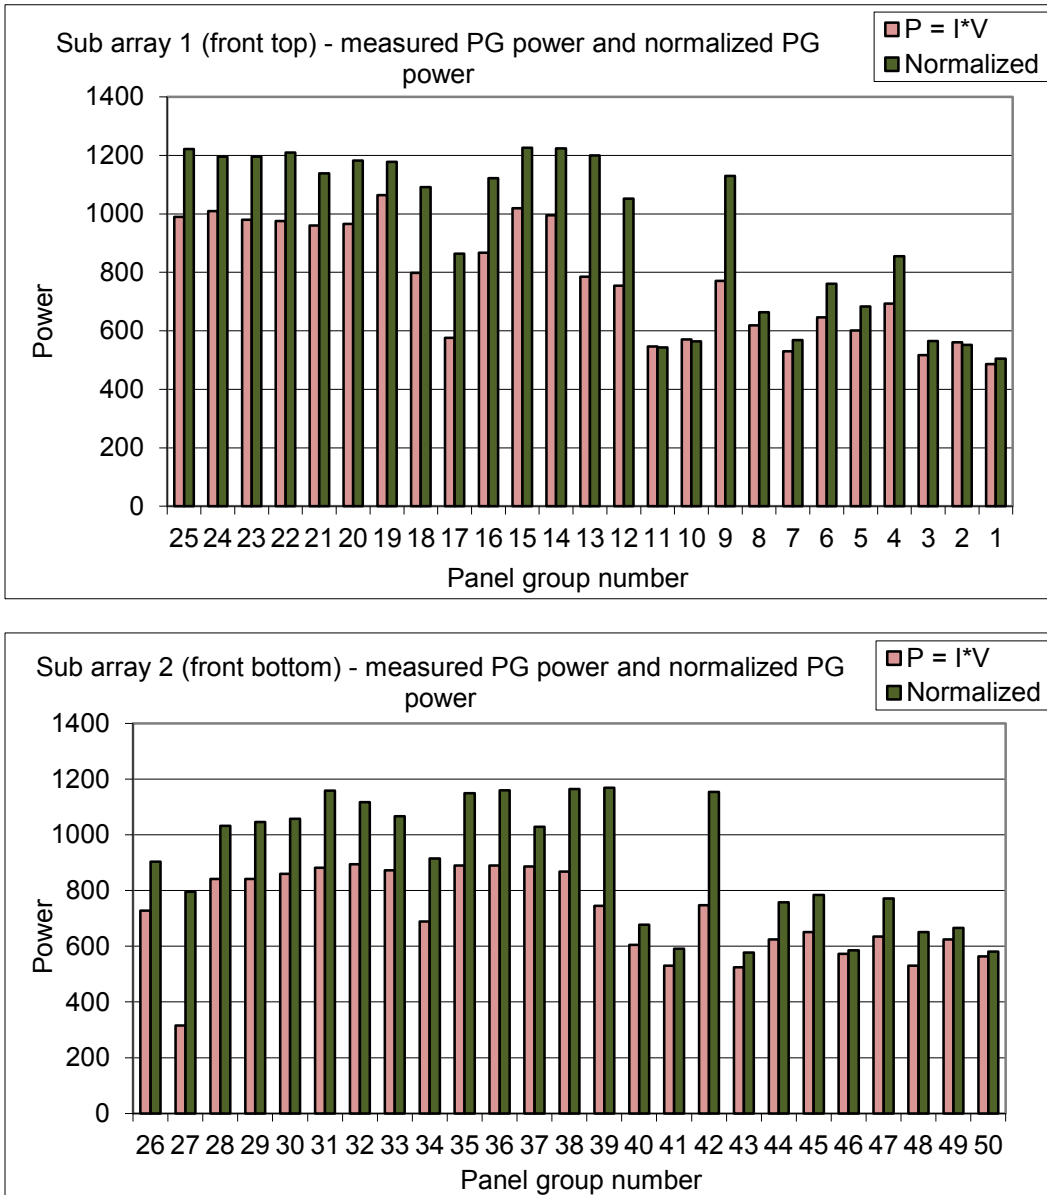
Figure 4.4 South array measured and normalized power summary

- Pmax sum of all 100 panel groups at STC = 88 kW

- Pmax sum of all 8 sub arrays at STC = 76 kW
- Panel group mismatch loss = $[(88 - 76) / 88] = 13.6\%$
- Lowest performing panel group PG 91 = 325 W (east)
- Highest performing panel group PG 15 = 1225 W (west)

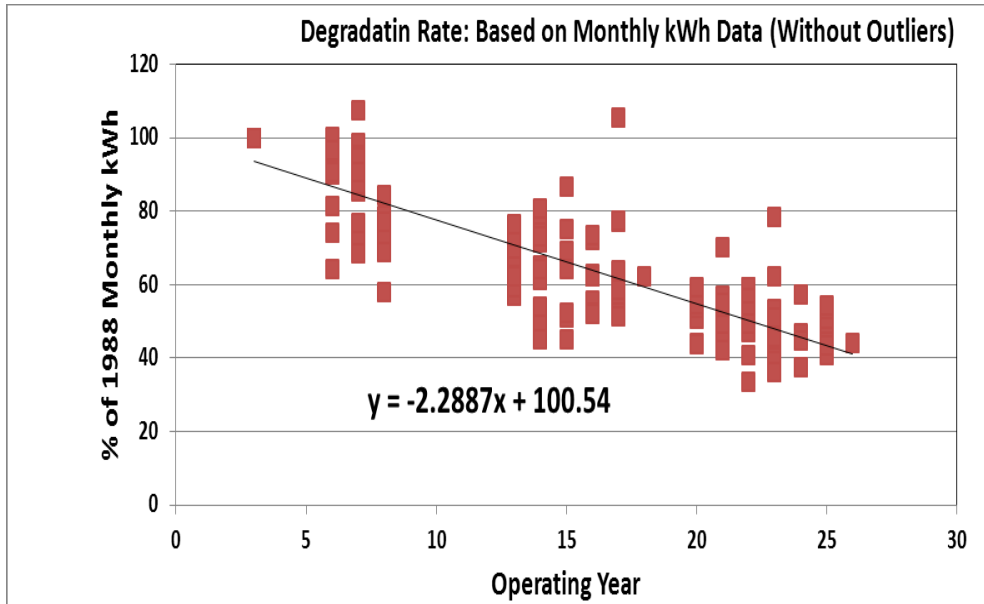
Figure 4.5 Degradation rate is 2.29% per year (outliers excluded) [10]

- Annual average energy production is about 112 MWh for the past 10 years (1988 = 321 MWh)

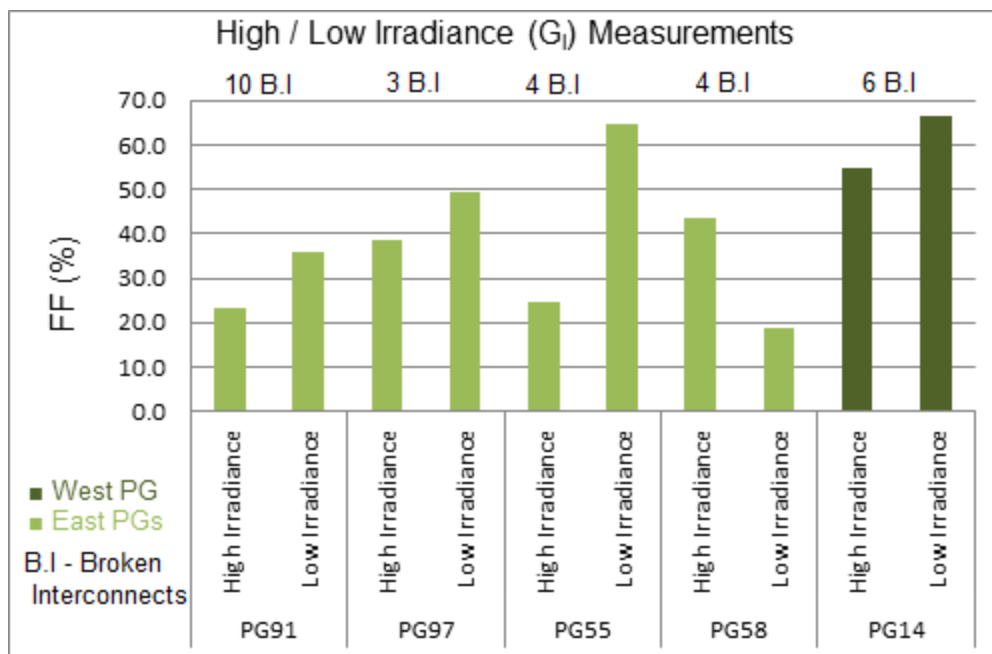
Figure 4.7 Effect of low irradiance on the PGs fill factor

- Increased fill factor with reduced series resistance effect at low irradiance
- PG58 has unusually high I_{sc} at low irradiance responsible for fill factor drop
- Fill factor is better for high interconnect failure modules due to reduced series resistance issue.

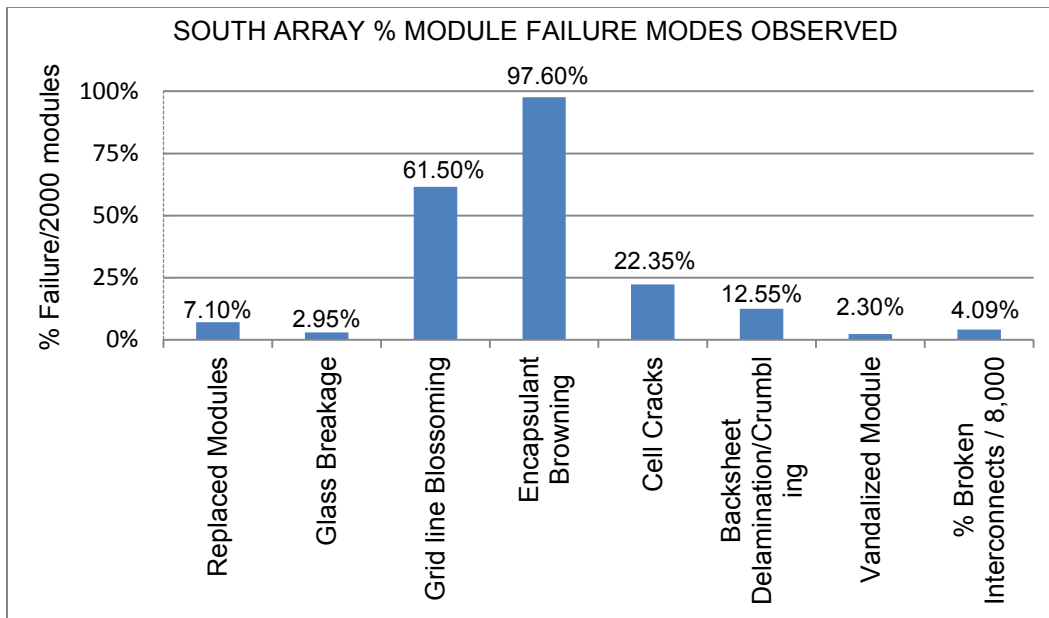
Figure 4.8 Summary of physical defects counted on PV array

Physical observations on the PV array included the following:
Replaced modules, glass breakage, cell/metallization corrosion, encapsulant browning, cell cracks, back sheet delamination, broken interconnects, hotspots etc. Figure 4.8 gives a quantitative analysis of failure modes on the PV array.

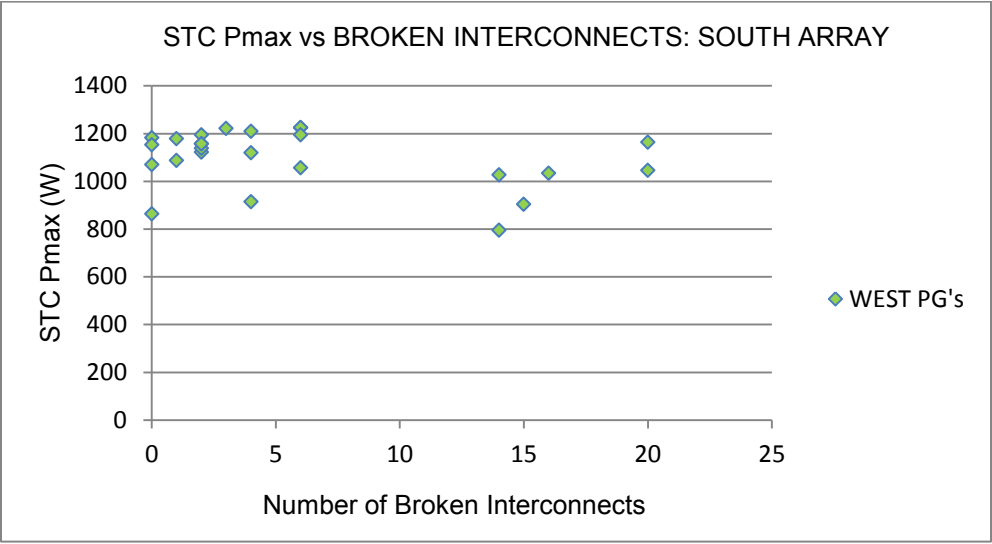
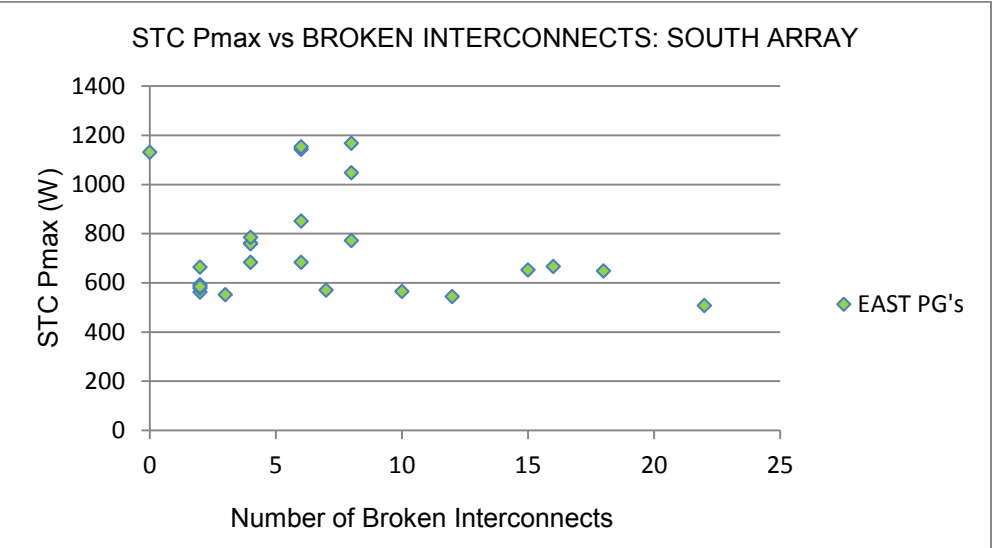
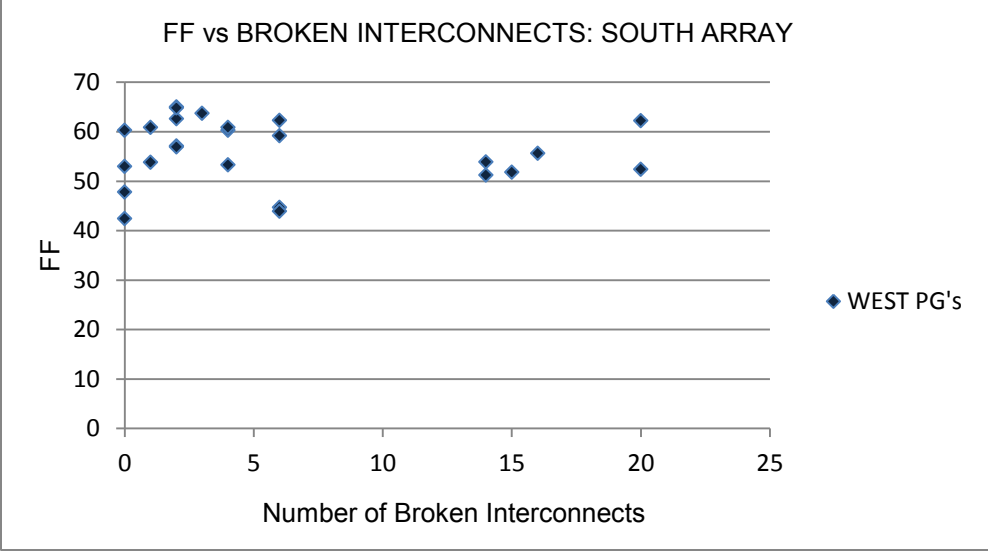
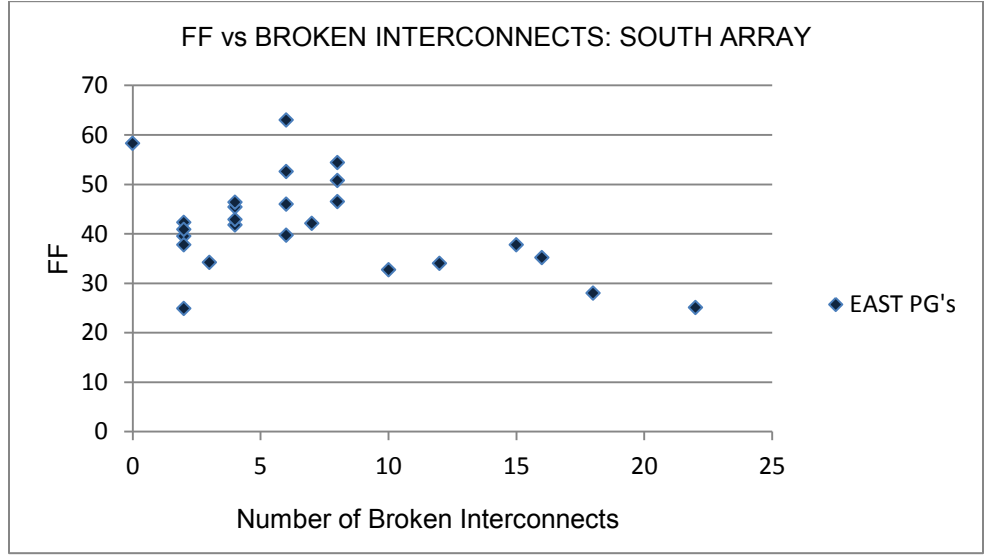
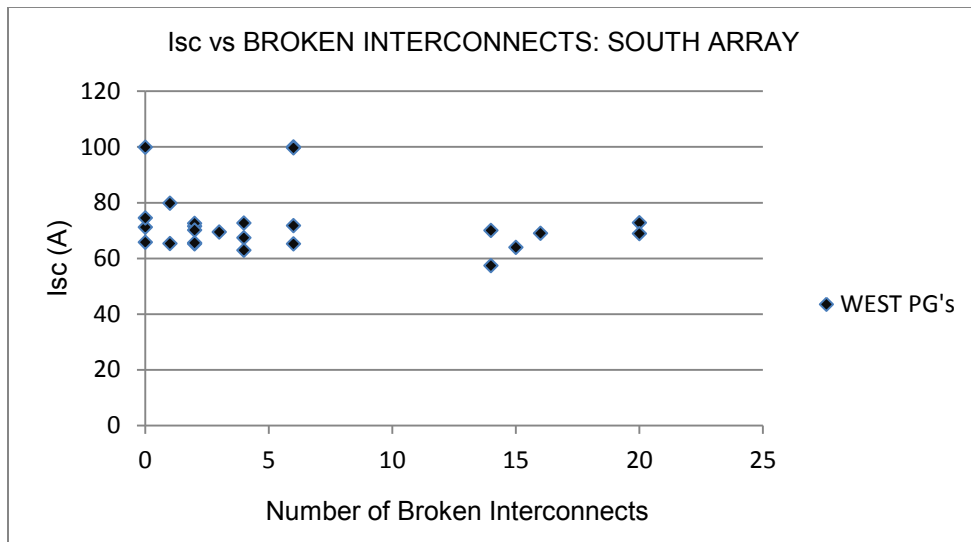
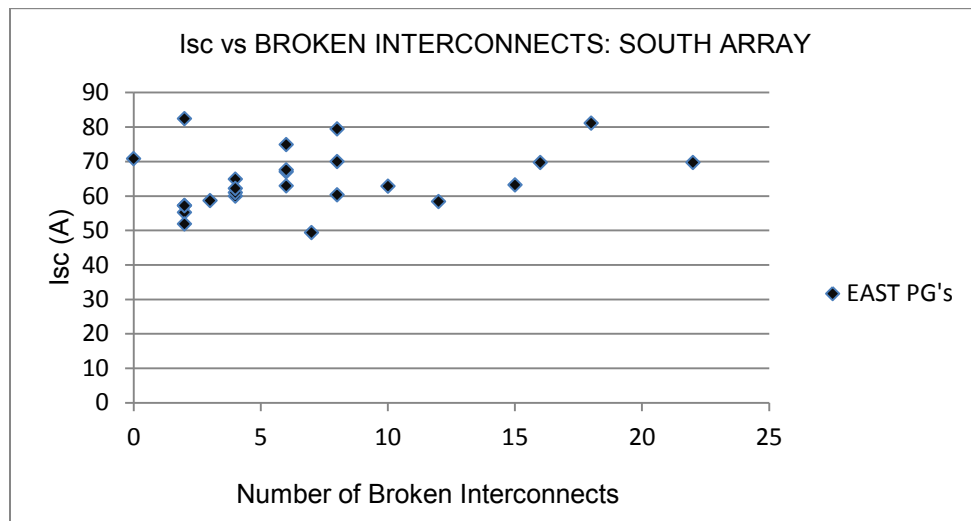
Figure 4.11 Failure modes interactions on PV array

A summary of total broken interconnects is shown in the Figure 4.10 below. The east sub arrays have more detected broken interconnects. Performance degradation increases when more current is forced through fewer interconnections causing higher series resistances in the affected panel groups. The panel groups in the east array have lower fill factors than the panel groups in the west side of the array.

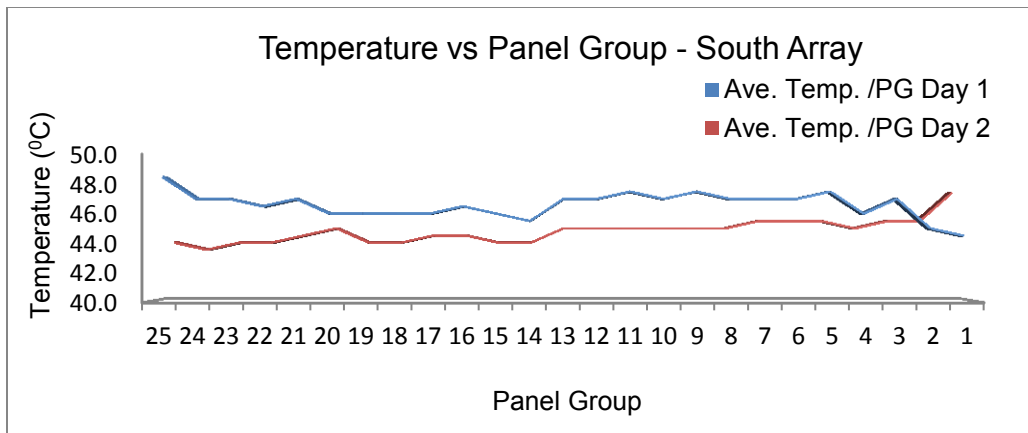
Figure 4.14 Temperature distribution pattern on the south array

Existing data from Luke Air force base in west Phoenix near the Solar One power plant showed that prevalent wind direction is from the south west. See Figure 3.3. Measurements made under the array during summer of 2012 agree with the existing data. There is a slight increase in the temperature of panel groups on the east side than the west side of the PV array. The approach used was a walk through while holding a multimeter with thermocouple and measuring ambient temperature under the PG's.

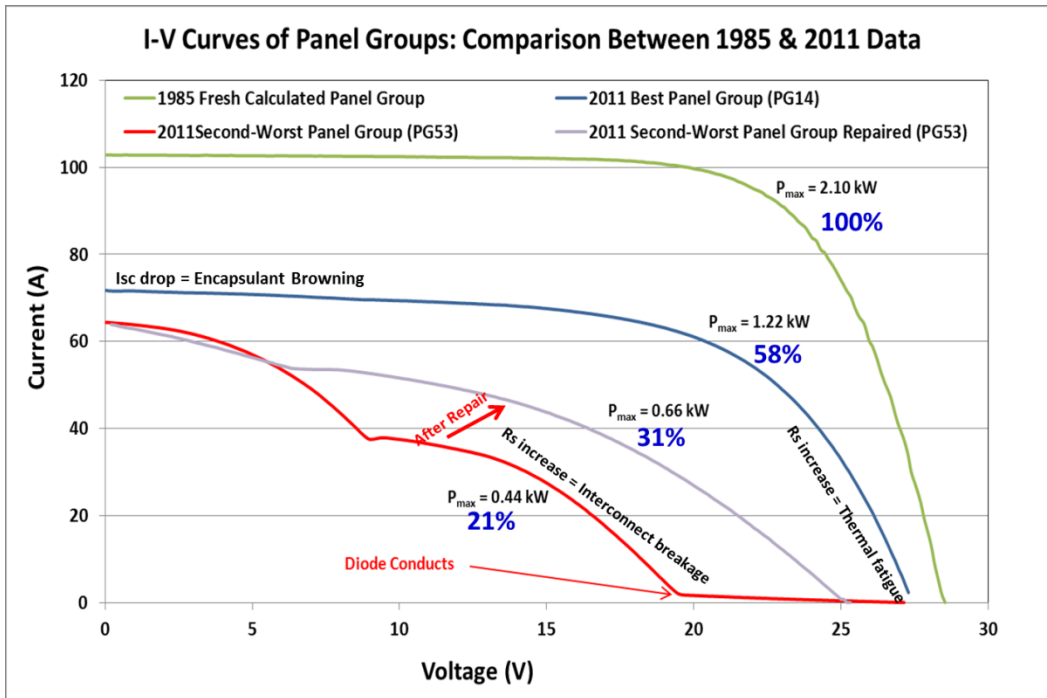
Figure 4.18 I-V comparison of PG from new to degraded condition

Figure 4.18 above shows what the IV curve of the original panel group characteristic is in 1985 when installed. After 26+ years, the best measured performing panel group (PG 14) has 58% of original power. One of the worst measured performing panel group (PG 53) had 21% of original power. Some interconnect repairs made to PG53 which contained many open circuit modules restored 50% of the 21% original power measured.

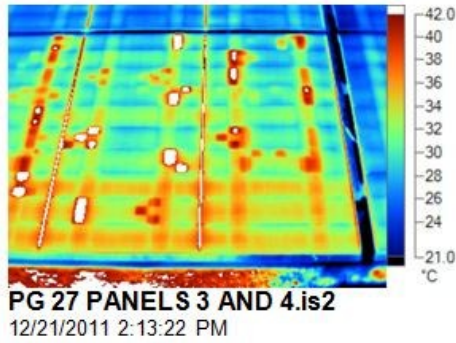
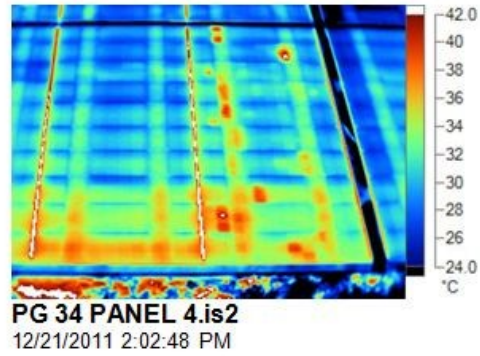
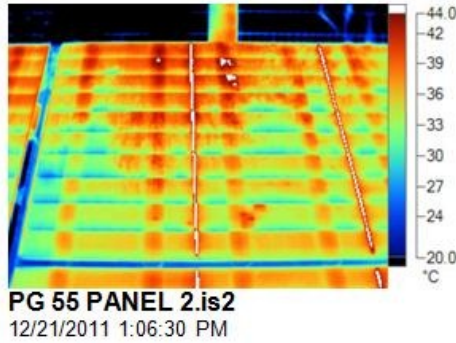
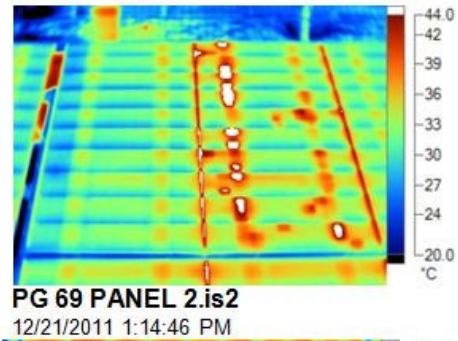
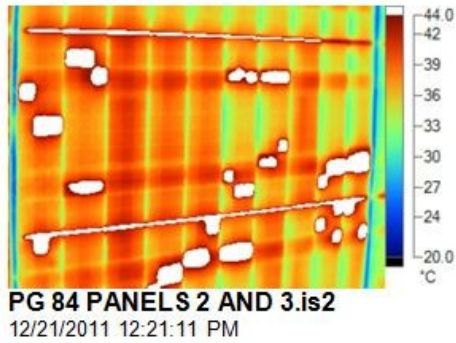
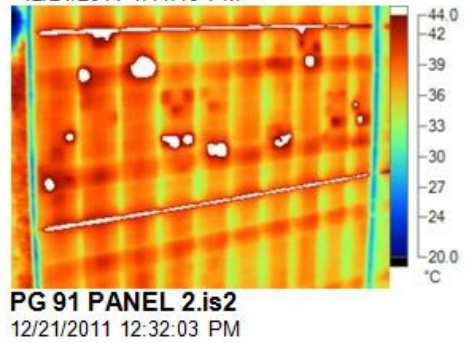
Hotspot effects on PV array

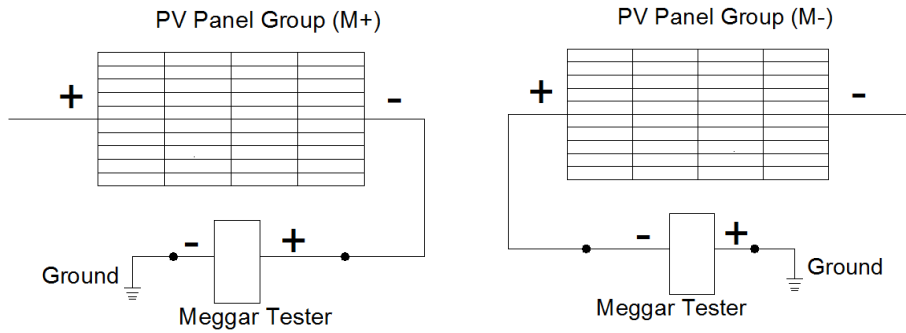
Hi-Pot Insulation Test wiring for positive (left) and negative (right) polarities above ground

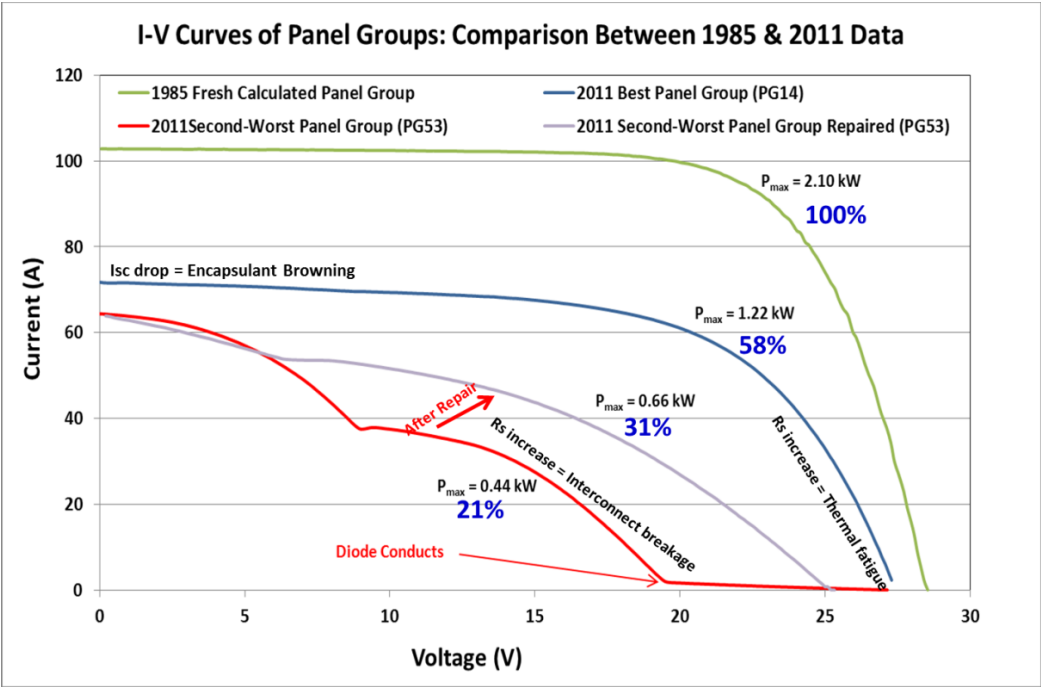
I-V comparison of PG from new to degraded condition

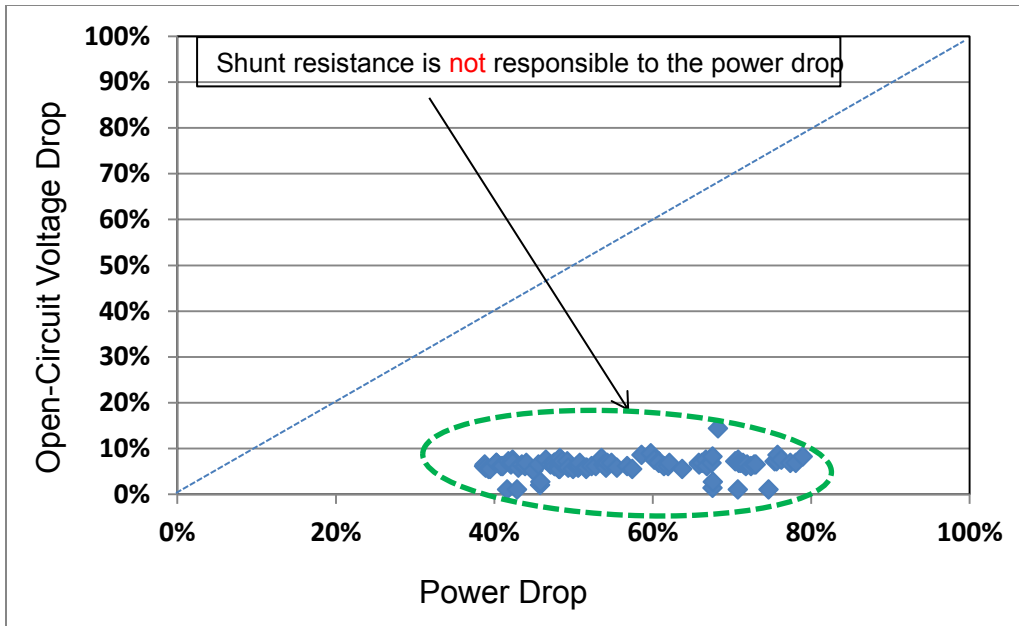
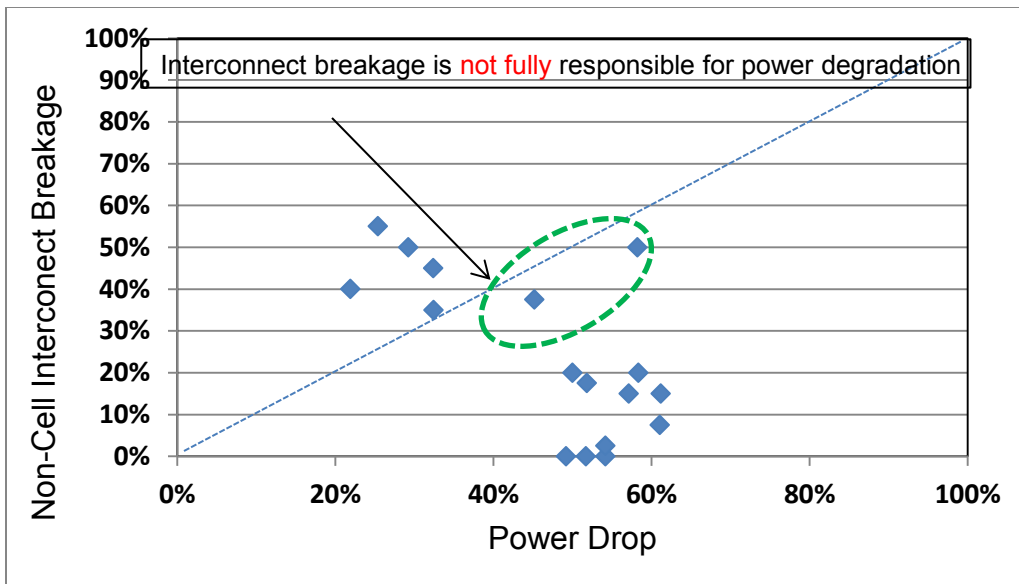
Corrosion of panel group
