26+ Year Old Photovoltaic Power Plant: Degradation and Reliability

Evaluation of Crystalline Silicon Modules – North Array

Jonathan Belmont

A Thesis Presented in Partial Fulfillment  
Of the Requirements for the Degree  
Master of Science in Technology

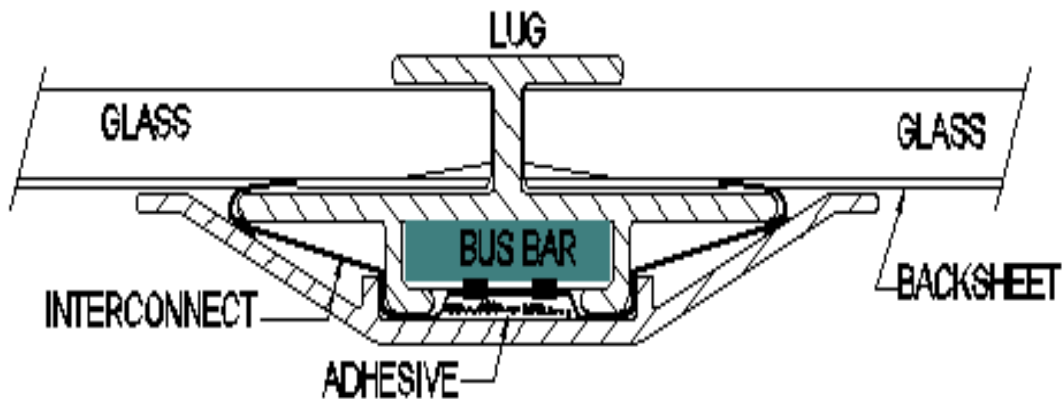
Figure 8- Cross Section of Busbar and Module Connection

The design of the panel group assembly has some inherent design issues involving the conducting ribbons [4]. Figures 20-22 show the layout of the “panel group”(PG) and how these conducting ribbons are connected. Each PV module is bonded and glued to the busbar shown in Figure 8. This glue held the conducting ribbon causing it to tear as the busbar thermally elongated. The Austin report indicated this assembly issue was a major contributor to a 30% failure rate in the first few months of operation for the Austin array.

The damaged modules on the array were replaced in the field. They had to be removed by cutting busbar seals and the glue holding the module in place. Correct reapplication of a new module to the panel group is important in terms of safety and premature failure. The conductive ribbon alignment is critical since thermal expansion [7] has an impact, potentially causing the ribbons to crack and eventually break into an open circuit.

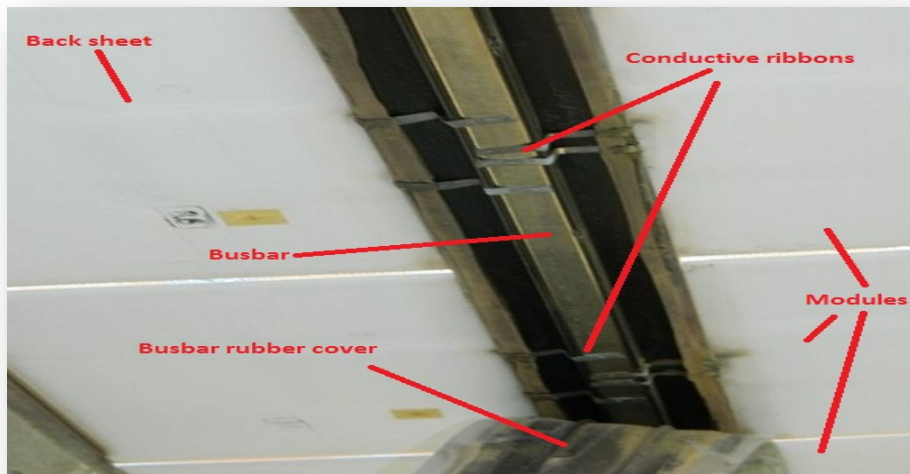
Figure 9 – A View From Under Panel Group

Figure 9 below shows details of the backside of the typical Solar One Panel Group. The busbar can be seen running down the center connecting the modules in parallel. The ribbons at the end of each panel connect to the busbar.

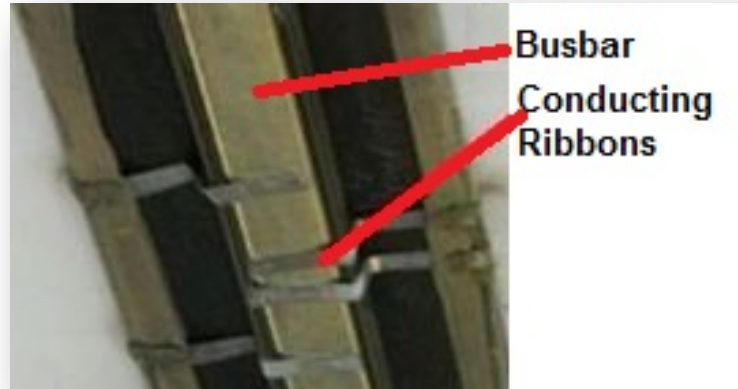
Figure 24 – Module Power Conducting Ribbons Connected To Busbar

Each module end has two flat power conducting ribbons. These copper ribbons are 0.300" wide by 0.005" thick for a cross section of 0.0015 in<sup>2</sup>.

Ampacity is the measure of the amperes that can flow through a wire. This would be the limiting factor for maximum current going through each of the conducting ribbons for the entire string. Each module has two ribbons. The total amps that can be carried is about 7.4 amps. This is less than the amp loads produced by the module of 8.6 amps at STC. The result of this is an immediate limitation of current flow at the design level. There would be no allowance for any interrupted interconnects resulting in reducing the power plant output.

The ribbons are mechanically connected to a busbar. Connections to the busbar are either rivet from factory assembly or by spot welding shown in Figure 24.

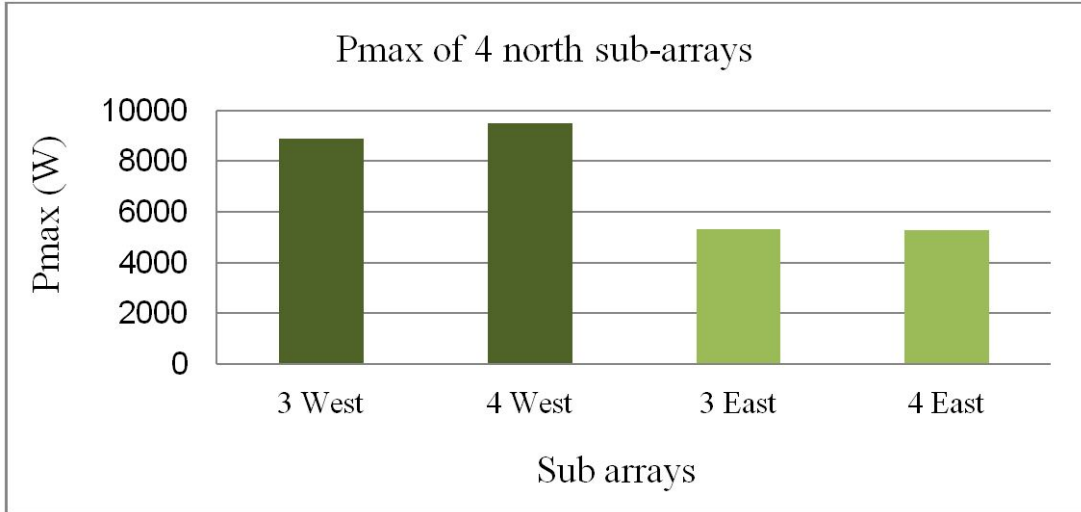
Figure 28 – I-V Power of Four North Sub-Arrays

The first step of our investigation was to take I-V curves of 4 north sub-arrays. This led us to an interesting first finding. These first tests show that there was less power being produced in the east array compared to the west. Figure 28 summarizes the sub-array differences. The case was similar for the four south sub-array. This early discovery helped propel our search and helped direct our research.

- We recorded greater power output from the west sub-array than east sub-array

- North array output = 37 kW
- Northwest sub-array = 24 kW
- Northeast sub-array = 13 kW
- Northeast sub-array = 54% of northwest sub-array power output
- South array output = 39 kW
- Combined total Solar One array output =  $[37+39] = 76$  kW
- Inverter reading for total array STC output = 62.1 kW
- The total eight sub-arrays mismatch losses =  $[76 - 62.1 / 76] = 18\%$

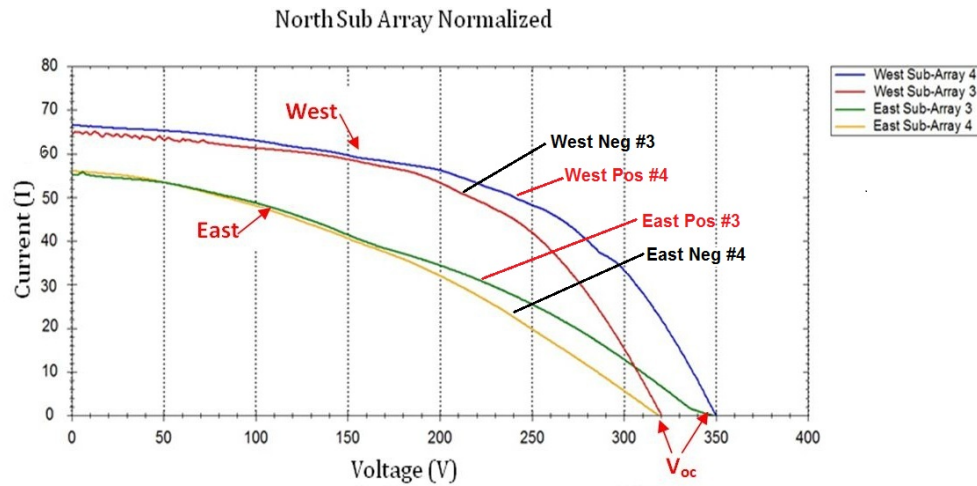
Figure 29 – North Sub-Array Normalized I-V Curves

Figure 29 above shows some interesting effects. The current on the Y-axis shows that west sub-arrays have more current and a resulting greater power. Reviewing the figure we see:

- West sub-arrays have similar higher  $I_{sc}$  values
- East sub-arrays have similar reduced  $I_{sc}$  curves
- Negative sub-arrays have lower  $V_{oc}$  because of one less panel group
- Lower  $I_{sc}$  in east sub-arrays is due to a greater number of broken module ribbons

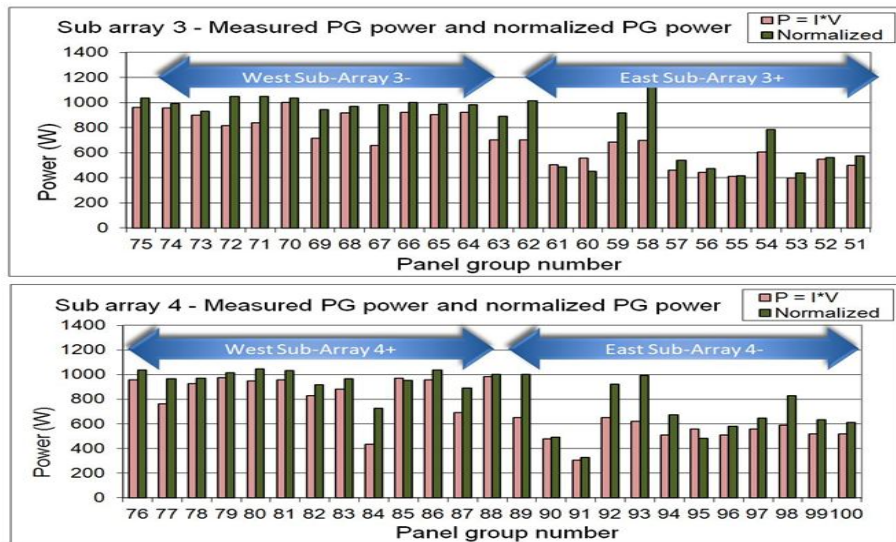
Figure 31 – North Array Measured and Normalized Power Summary

Studying Figure 31 above results in the summary of:

- Pmax total of all 50 panel groups at STC = 41 kW
- Pmax total of 4 sub-arrays at STC = 37 kW
- Panel group mismatch loss =  $[(41 - 37) / 41] = 11\%$
- Lowest performing panel group PG 91 = 325 W [north east]
- Most panel groups in the west performing close to 1kW
- Most panel groups in the east perform close to 0.6kW

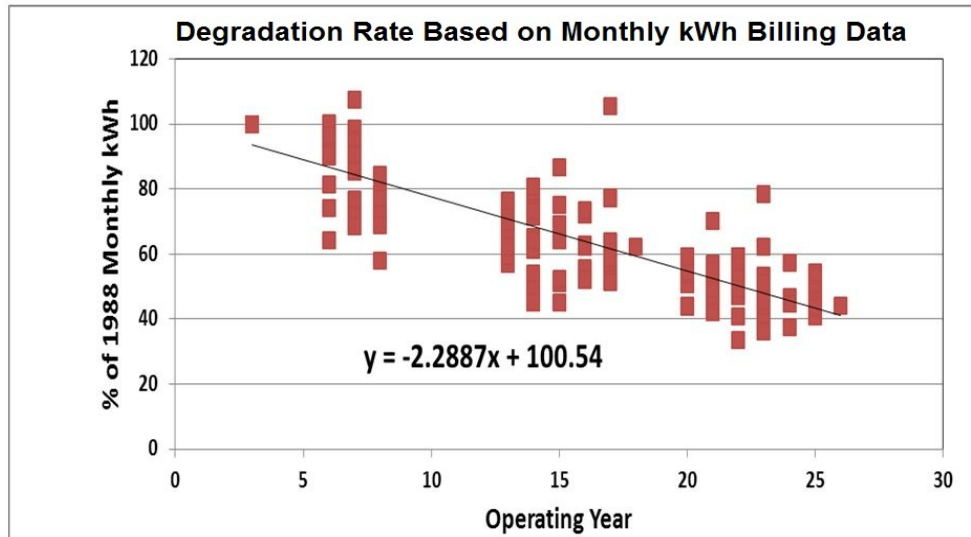
Figure 32 – Solar One Array Degradation Rate is 2.3% Per Year

Figure 32 above is derived from accumulated utility bills. A linear equation was derived from the scatter plot showing approximately a negative 2.3 slope. This degradation of 2.3% is almost three-four times greater than average degradation rates typically reported in literature for the current modules.

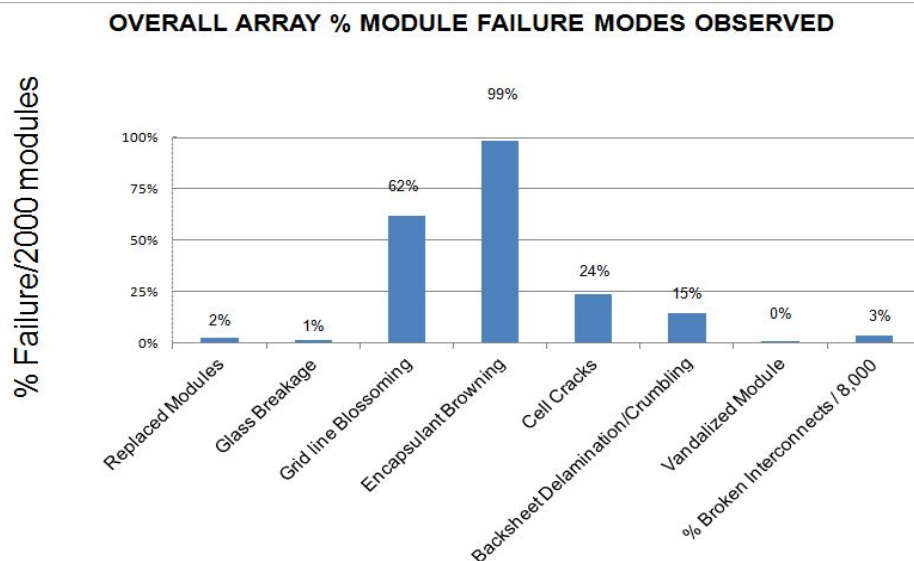
Figure 34 – Summary of Physical Defects

- Replaced modules (7% in south array)
- Glass breakage
- Cell/metallization corrosion
- Encapsulant browning
- Cell cracks
- Back sheet delamination
- Broken interconnects

Figure 34 below shows the failure modes from the north array.

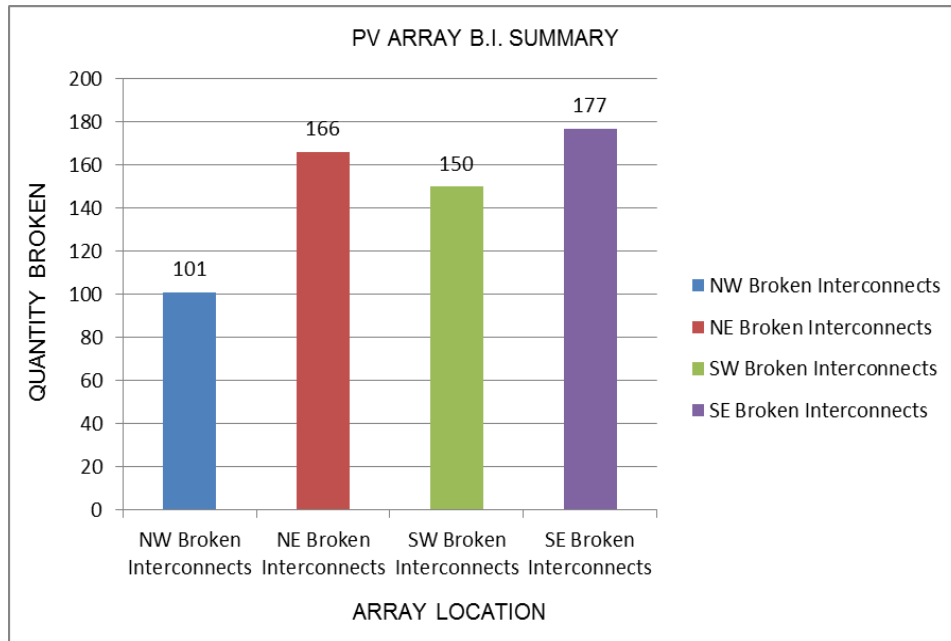
Figure 37- Summary of Broken Interconnects on PV Array

During our inspection, we found that some busbar covers were hanging loose, making the module interconnecting ribbons visible. Some ribbons were completely or partially broken. A non-intrusive IR scanning image pinpointed broken ribbons. If a ribbon was connected, the resulting heat from current flow would show up in the IR images as a hotspot. Conversely, an open circuit would not show up on an IR image. After the entire array was captured in the IR images, it was found that the east sub-arrays have more broken interconnects than the west sub-arrays. The cause for this imbalance in ribbon breakage was not clear. Since vandals have broken a greater number of modules in the east it is possible that the method of module replacement with intrusive repair (onsite soldering the ribbons-instead of factory riveting-along with onsite workmanship issue during site repairing) could have accelerated the failure. A possible explanation could be due to improper sealing of the back cover, since the sealing cement would accelerate the ribbon shear. Additionally, since alignment of the ribbons would be critical, any field work would be more difficult to properly adjust the components. Also an improper seal would expose the ribbon to moisture and the associated corrosive effects of heat and electricity. There would also be a compounding effect when greater current is forced through fewer interconnections causing higher series resistances.

The broken interconnect summary below shows the results of the IR count. The high number of broken east ribbons explains the reason why the west array is performing better than the east array as subsections of the north array. It was found that this was also the case for the east and west subsections of the south array.

Figure 37 shows that panel groups in the east array have lower fill factors than the panel groups in the west side of the array. The following figures show various comparisons of the broken interconnects within each panel group. It can be observed that the trend declines as the quantity of the broken interconnects increases.

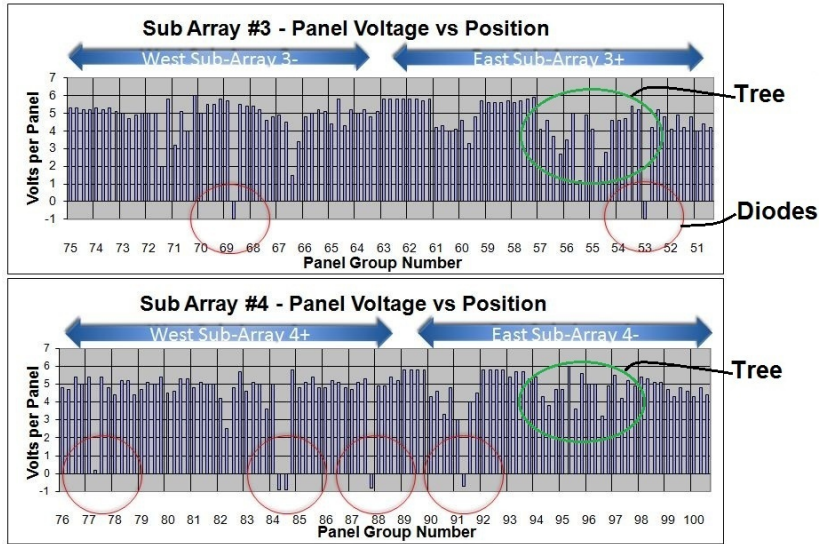
Figure 42- North Array Panel Voltages and Possible Turbulent Effect

The recorded voltages can be seen on Figure 42. Each circled panel voltage in the table shows where a diode has triggered a bypass. Notice that there is an unusual voltage

drop, including a triggered diode, for Panel Groups from 52 to 57. A possible explanation is reviewed in section 4.6

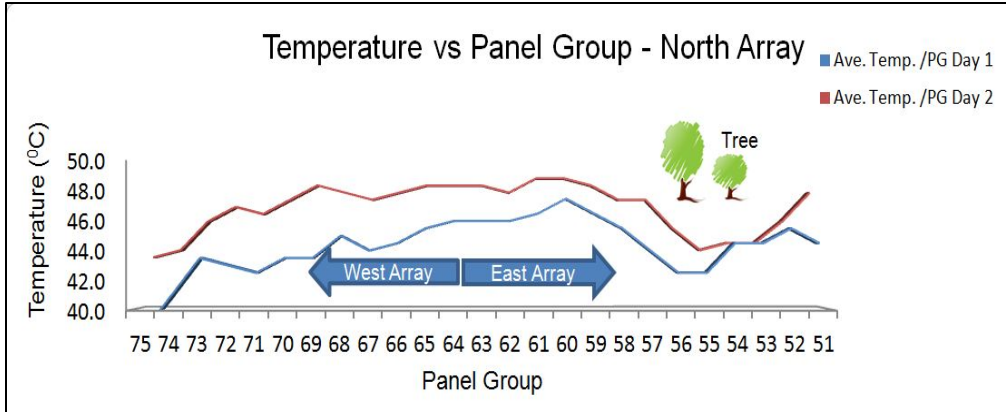
Figure 43- North Array Temperatures

The graphs below show the results of the measurements taken for the successive two day period. The two days of temperatures along the array are similar implying a repeatable trend. The temperature measurements were taken on:

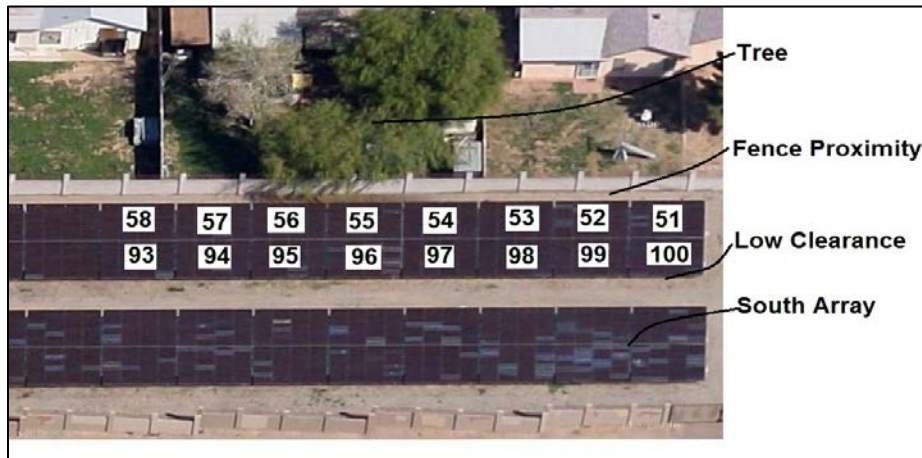
Figure 44- North Array Temperature and Tree Area

The construction of the north array has some air flow restrictions with Figures 44 and 45 showing details of these restrictions. Low ground clearance to the south, a 17° tilt and a wall on the north with trees all affect the air flow in different ways.

This gradient increase drops suddenly as a result of the trees located behind Panel Group 56-54. It seems that turbulent air surrounding the trees may have an effect on the ambient air temperature on several east modules.

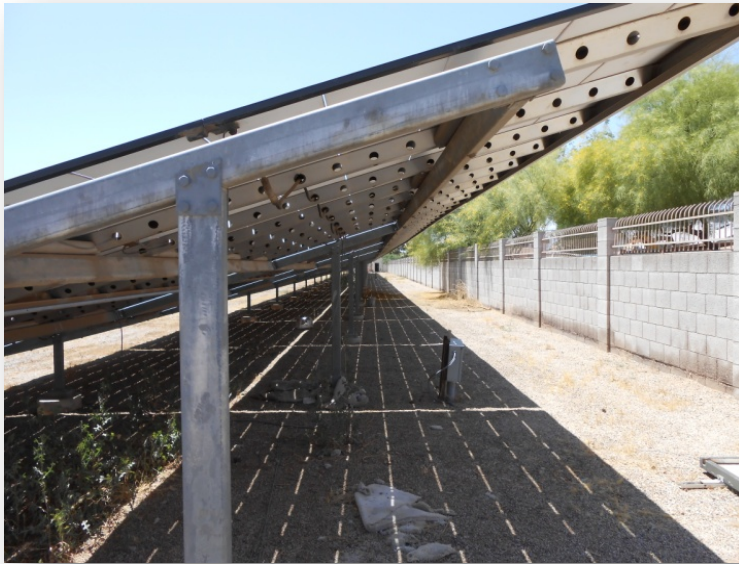
Figure 45- East End View of North Array

The side view of the north array is shown in Figure 45. Notice the wall, the one foot gap at the bottom of the array and how the trees overhang the wall.

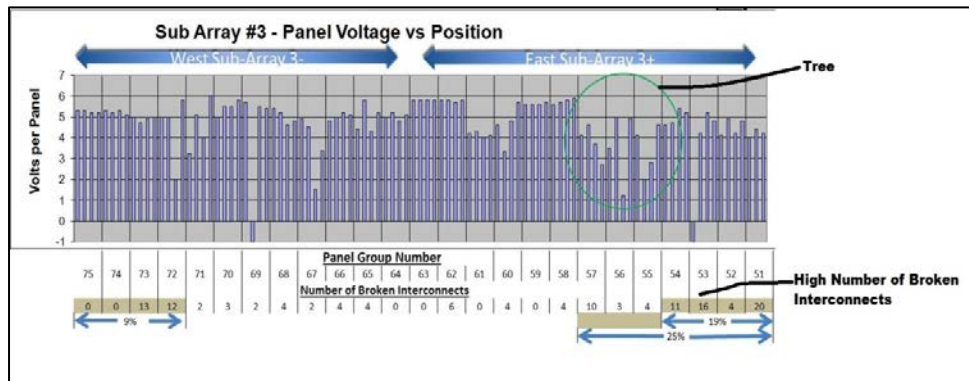
Figure 46- Panel Group Voltage Broken Interconnect Comparison

Figure 46 shows a possibility that the turbulent air flow is associated with increasing interconnect failure. See how the voltage reduces while the broken interconnects increase with the suspect Panel Group locations. Notice the large percentage of broken interconnects associated with these turbulent wind regions.

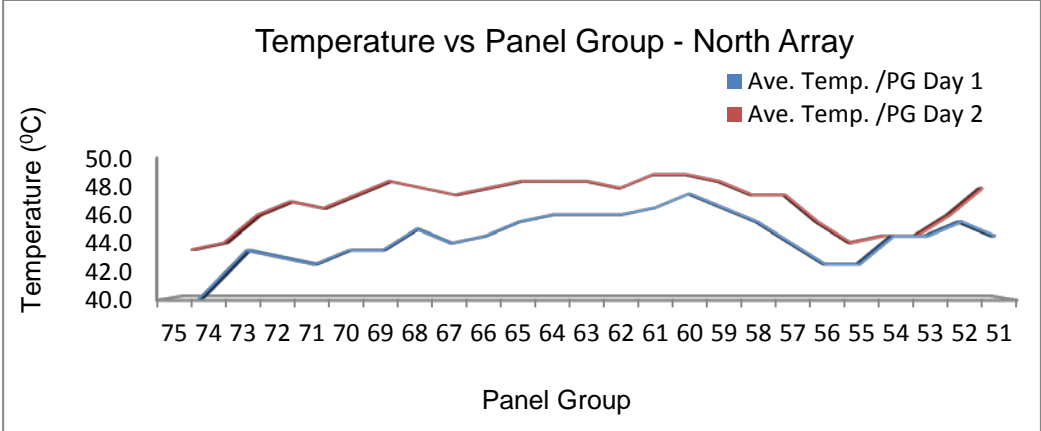
Figure A37 Temperature vs Panel Group - North Array

We observed some unusual array cooling effects resulting from turbulent flow around trees on the north side. The normal gradient temperature increase on the east was interrupted in this tree zone. In the early days, trees were absent from the fence line. Turbulent cooling effects could have accelerated the ribbon metal fatigue. Array protection from vandalism is important since it was the cause of module replacement. A fence that conceals the array might have reduced the number of occurrences of broken modules. It is very important also to consider the location and the possible effect from increased vandalism from high traffic and highly visibility.

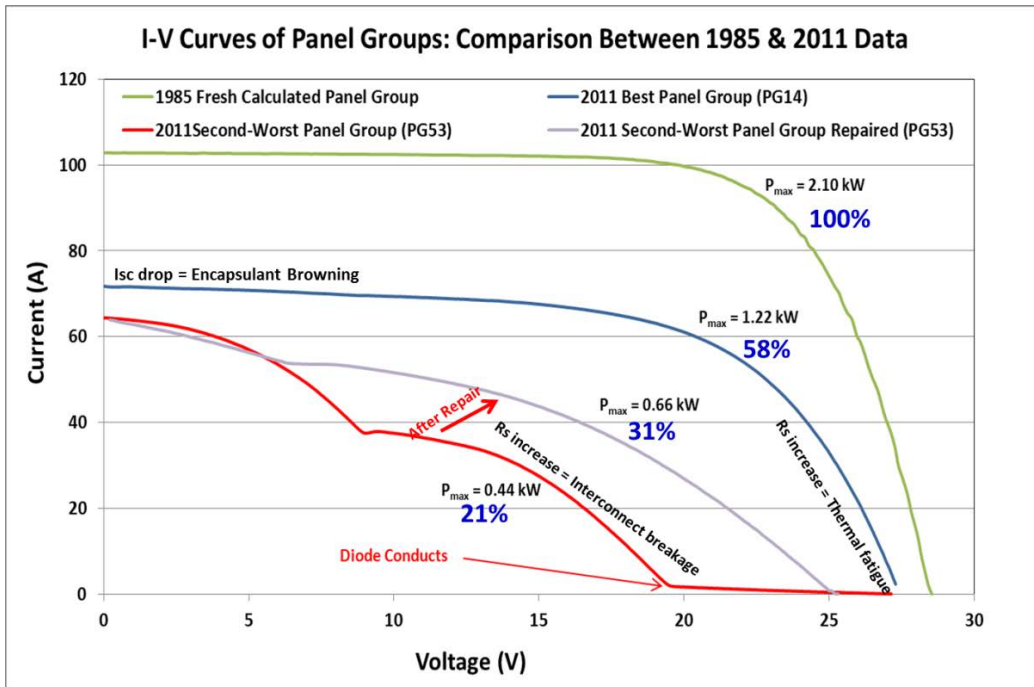
Figure A41 I-V Before and After Interconnect Repair

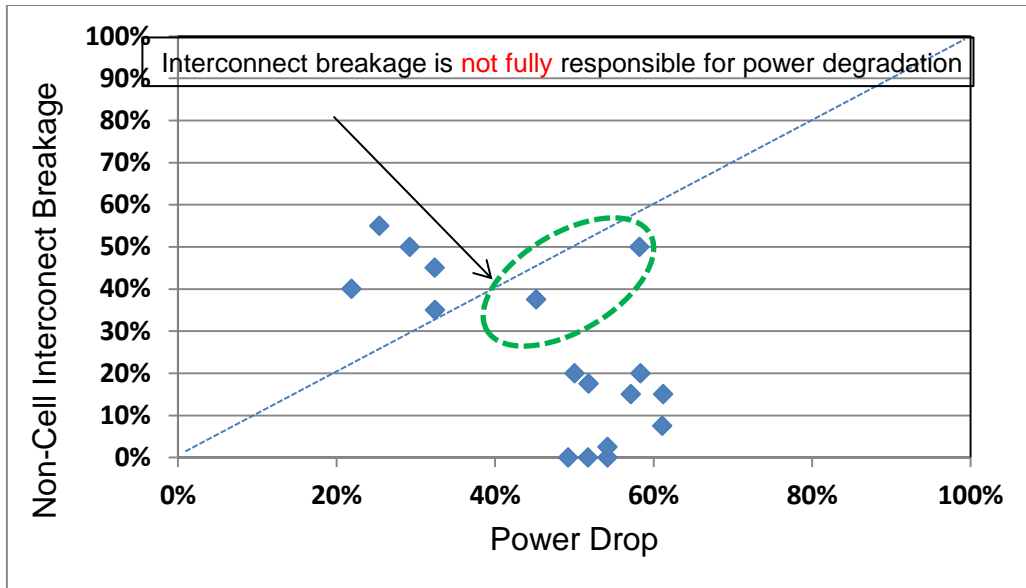
Ribbon reliability failure was primarily responsible for the reduction of output power for the entire array. Many modules were replaced due to vandalism. It is believed that

Figure A45 Power One Array Interconnect Breakage vs Power Drop
