Four Dimensional (4D) Microstructural and Electrochemical Characterization of
Dissimilar-metal Corrosion in Naval Structural Joints

A Dissertation Presented in Partial Fulfillment
of the Requirements for the Degree
Doctor of Philosophy

ARIZONA STATE UNIVERSITY

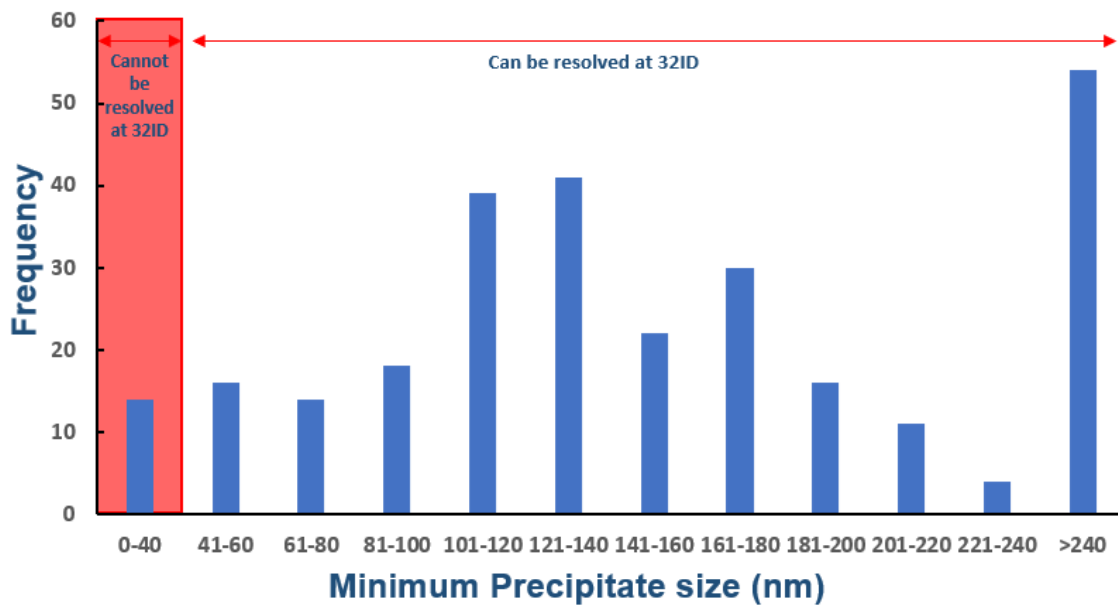
Total precipitates measured = 279 % of precipitates with size < 100 nm = 22%

Figure 22: Size distribution of resolvable precipitates observed using the SEM. Precipitates below 40 nm could not be resolved during the TXM experiment.

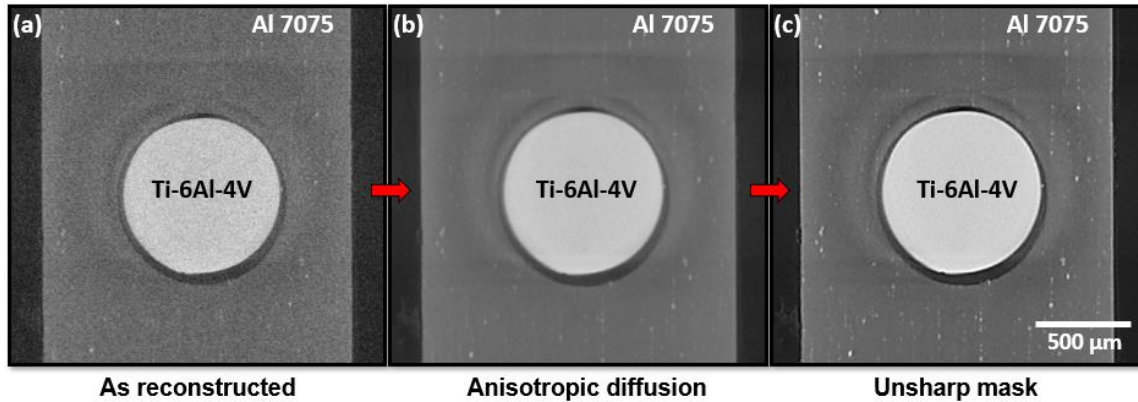
Figure 36. Vertical cross section of the AA 7075-T651 plate and Ti-6Al-4V screw. a) As reconstructed tomography dataset b) Dataset after anisotropic diffusion c) Dataset after anisotropic diffusion + Unsharp mask.

The reconstructed datasets were corrected for beam hardening during the reconstruction procedure and filtered for denoising and sharpening features of interest as a part of the post-processing operation using imageJ. Figure 36 shows the post processing workflow that was employed on a virtual vertical cross section of the specimen geometry.

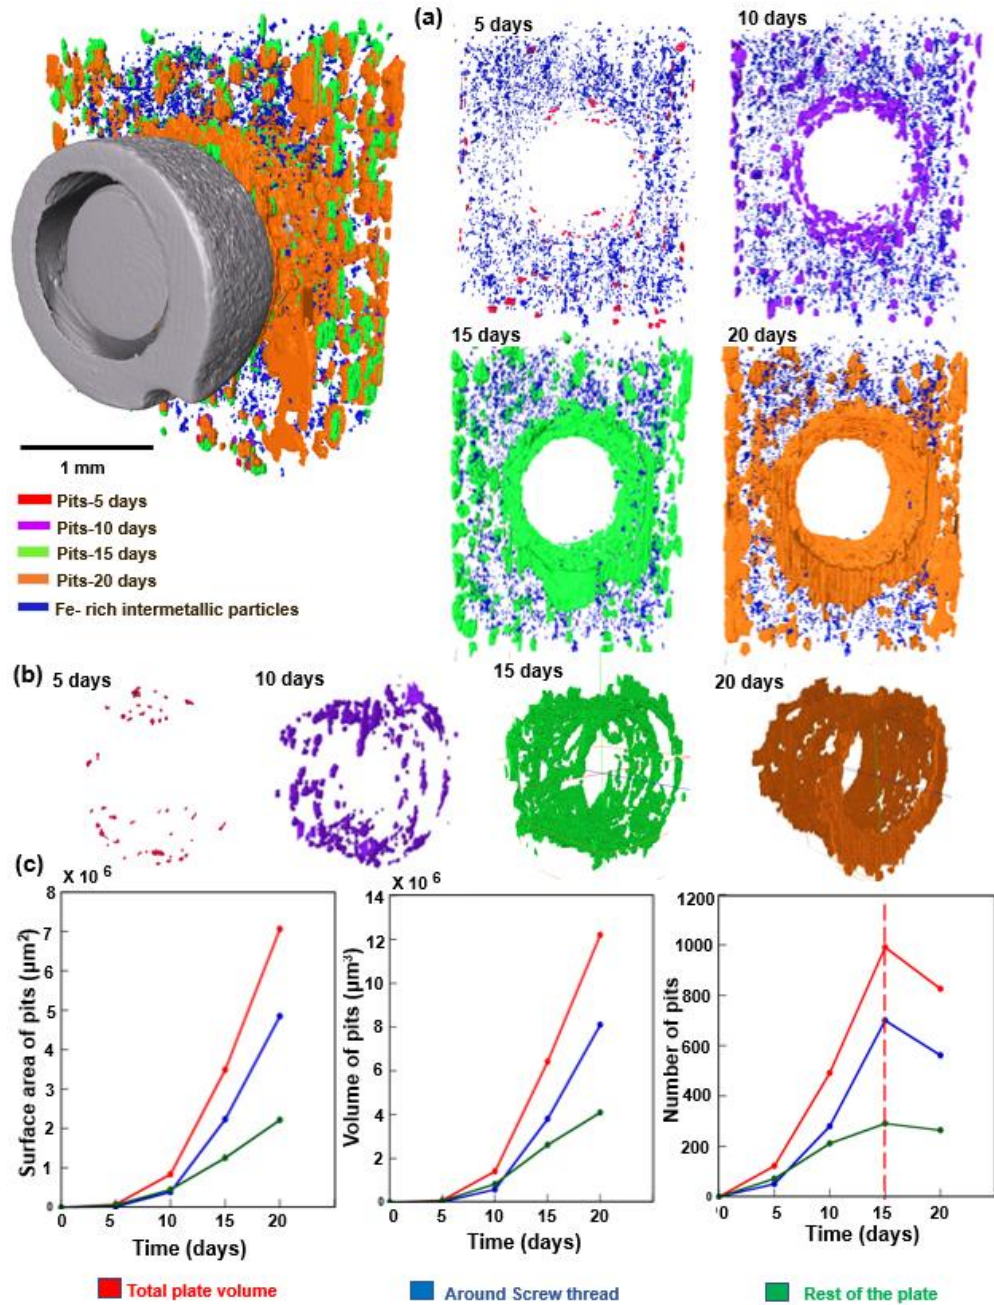
Figure 37: Evolution of the AA 7075 microstructure with increase in corrosion time. (a) Formation of pits on the AA 7075 plate during the corrosion experiment. (b) Pits only around the threading of the plate. (c) Plots of surface area of pits, volume of pits and number of pits as a function of corrosion duration.

Figure 37 shows the evolution of corrosion damage in the AA 7075 alloy plate due to contact with the Ti-6Al-4V screw. For ease of visualization, Figure 4(a) depicts only the segmented Fe-rich inclusions and pits (the outline of the AA 7075 plate and the segmented Ti-6Al-4V screw are not included in this image to better view the pits around the threads) as a function of corrosion time of AA 7075-T651 plate ranging from 5 days to 20 days. After 5 days of corrosion, the segmented profile shows the very beginnings of corrosion on the aluminum alloy plate.

The corrosion in the form of pitting is largely restricted to the outer surface of the AA 7075 specimen while the regions around the threading of the fastener show little to no resolvable pitting. Most of these pits initiate at sites containing Fe-rich inclusions. The likelihood that these pits initiate at Mg_2Si particles is low due to the fact that these particles undergo selective dissolution of Mg to leave behind a Si-rich remnant[147]. This remnant has been observed to not contribute to further corrosion propagation in the form of pitting. On the other hand, the Al_2CuMg dispersoid particles undergo dissolution of Al and Mg to leave behind a Cu-rich spongy structure that is reported to behave as a local cathode and lead to dissolution of the matrix in the form of trenching around itself. However, due to continued matrix dissolution, once the remnant particle electrically disconnects from the matrix, it can leave behind a shallow pit (that can be resolved using x-ray tomography) and arrest continued corrosion attack[21,127,174]. However, due to the relatively high x-ray energy used for scanning the specimen, the contrast between these particles (Al_2CuMg and Mg_2Si) and the matrix was poor and hence the precise location of Mg_2Si and Al_2CuMg particles could not be determined.

Figure 37(c) shows plots of surface area of pitting, volume of pitting and number of pits plotted against time of corrosion. The lines in blue on all the plots indicate data from pits segmented in regions around the screw threading and on the plate surface underneath the head of the screw. The green lines in each plot is data from pits segmented in regions of the plate that do not include regions around the threading or under the head of the screw, i.e., regions on the outer surface of the plate. Lastly, the lines in red on all the plots indicate total plate volume, i.e., sum of the data represented in blue and green. The plots representing the surface area and volume of pits for all timesteps show an identical trend. Regions around the threading and underneath the head show a large increase in pit surface area and volume compared to the pits in the rest of the plate which show a linear increase. Interestingly, the number of pits around the threading and underneath the head of the screw show an increase until 15 days, similar to the surface area and volume plots, and then exhibit a decrease. The number of pits in the rest of the plate remains approximately the same for the 15 day and 20 day corrosion timestep.

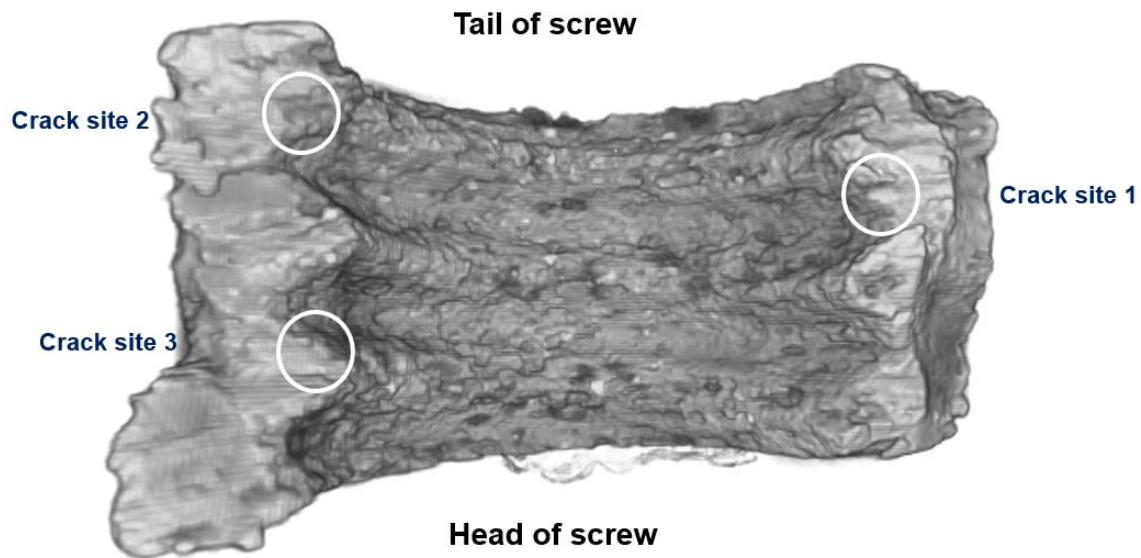
Figure 44: Top down view of one fractured surface highlighting crack initiation site locations.

Figure 44 details the exact location of the three crack initiation sites with the help of a top-down view of the 3D rendering of a fractured half of the specimen. Also included in the schematic is the orientation of the screw as it would have been in the couple during corrosion and fatiguing process. For each crack initiating pit, post-fracture images yield limited information pertaining the crack initiation site before pitting and the conditions that led to crack initiation locally. Hence, it is important to use a combination of fractography and tomography data to physically trace the locations of each site. The trace of the pit from 20 days to 0 days corrosion has been shown in the following figures. Figure 45 show that site 1 had an Fe-rich inclusion at the initiation site.
