Robert Dolan  
Alan Howard  
Arthur Gallenson

# Man's Impact on the Colorado River in the Grand Canyon

*The Grand Canyon is being affected both by the vastly changed Colorado River and by the increased presence of man*

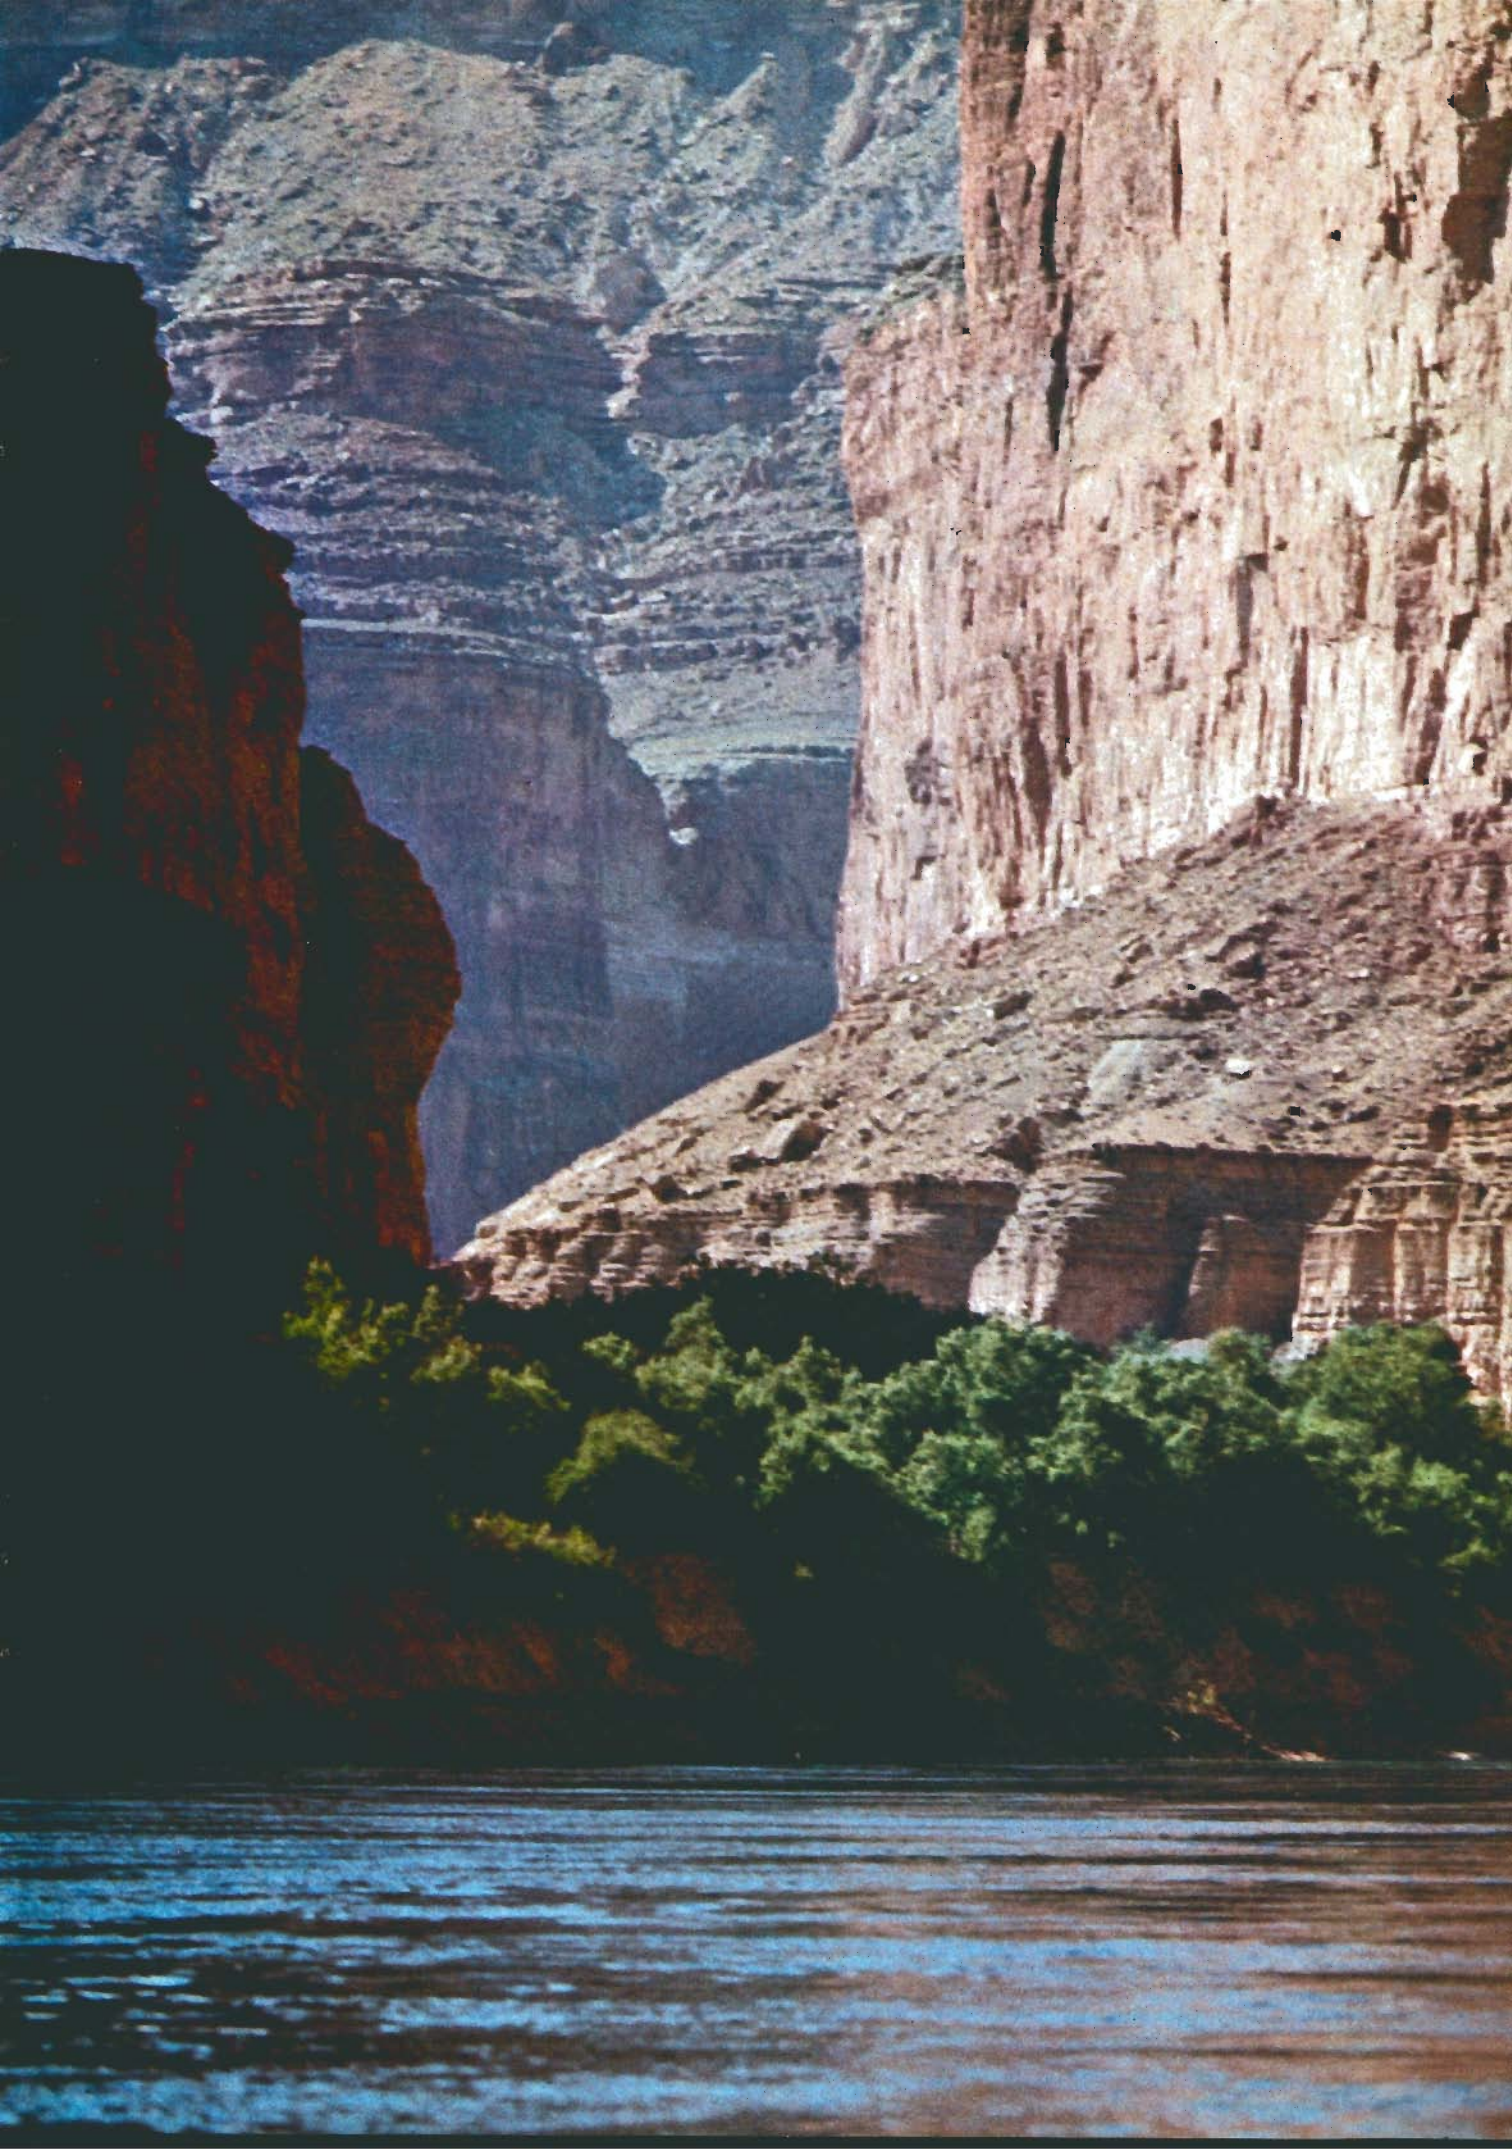
Figure 1. This steep beach face near Nankoweap Rapids in Marble Canyon was produced by rapid undercutting of fine-grained terrace deposits. Such examples of very rapid erosion are uncommon; elsewhere the widespread removal of pre-dam fluvial deposits by backcutting becomes apparent only through photographic comparison of the present riverfront with pre-dam conditions. (Photo by Alan Howard.)

With the present controlled flow, the higher terraces are no longer flooded, and the lower terraces and bars are eroding (see Fig. 1). At the

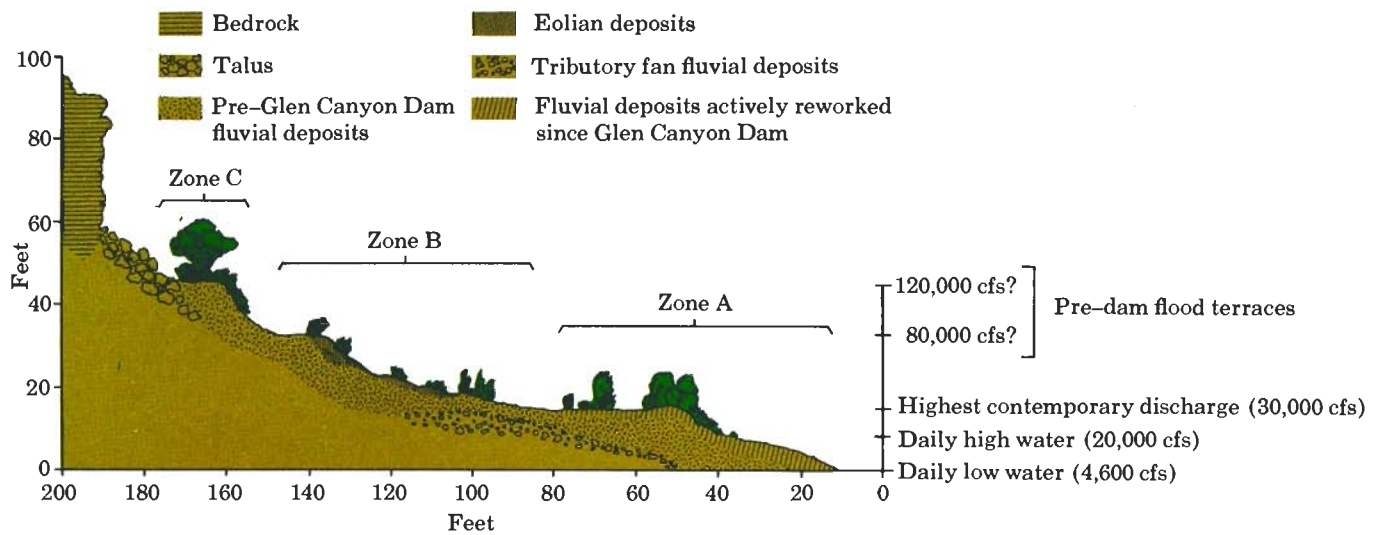
Figure 4. The cross section shows an idealized river deposit under post-dam conditions. The characteristics of the vegetation, sediments, and human use of the 3 zones are listed in Table 2.

Most pre-dam fluvial deposits along the channel are fine-grained terraces, although bars of pebble-to cobble-sized particles do occur locally and may underlie the finer sand and silt terraces. Floods with low-sediment concentration resulted in the net erosion of these fine-grained terraces, whereas the occasional summer peaks resulted in deposition. This alternating erosion and deposition produced a time-varying, fluvial-terrace morphology. Measurements of pre-dam flood-terrace heights taken in 1973 indicate that the terraces in the narrower portions of the canyon are 18 and 30 feet above the present high water. The height of these terraces corresponds to the pre-dam mean annual flood of 80,000 cfs (Fig. 4) and the frequent 120,000 cfs peaks.

A conspicuous line of hardwood vegetation (Fig. 4, Zone C; see also Fig. 5) is associated with the higher terraces. Below them, there was little permanent vegetation under pre-dam conditions, because the cycle of erosion and deposition during floods presented an unstable substrate, either uprooting or burying seedlings. Furthermore, growth of phreatophytes on higher terraces was discouraged by the vertical distance to the water table during summer low water.

The terrace and eolian deposits above the present high-water level (Fig. 4, Zones B and C) are primarily modified by the wind. Much of this sand will eventually be lost ei-

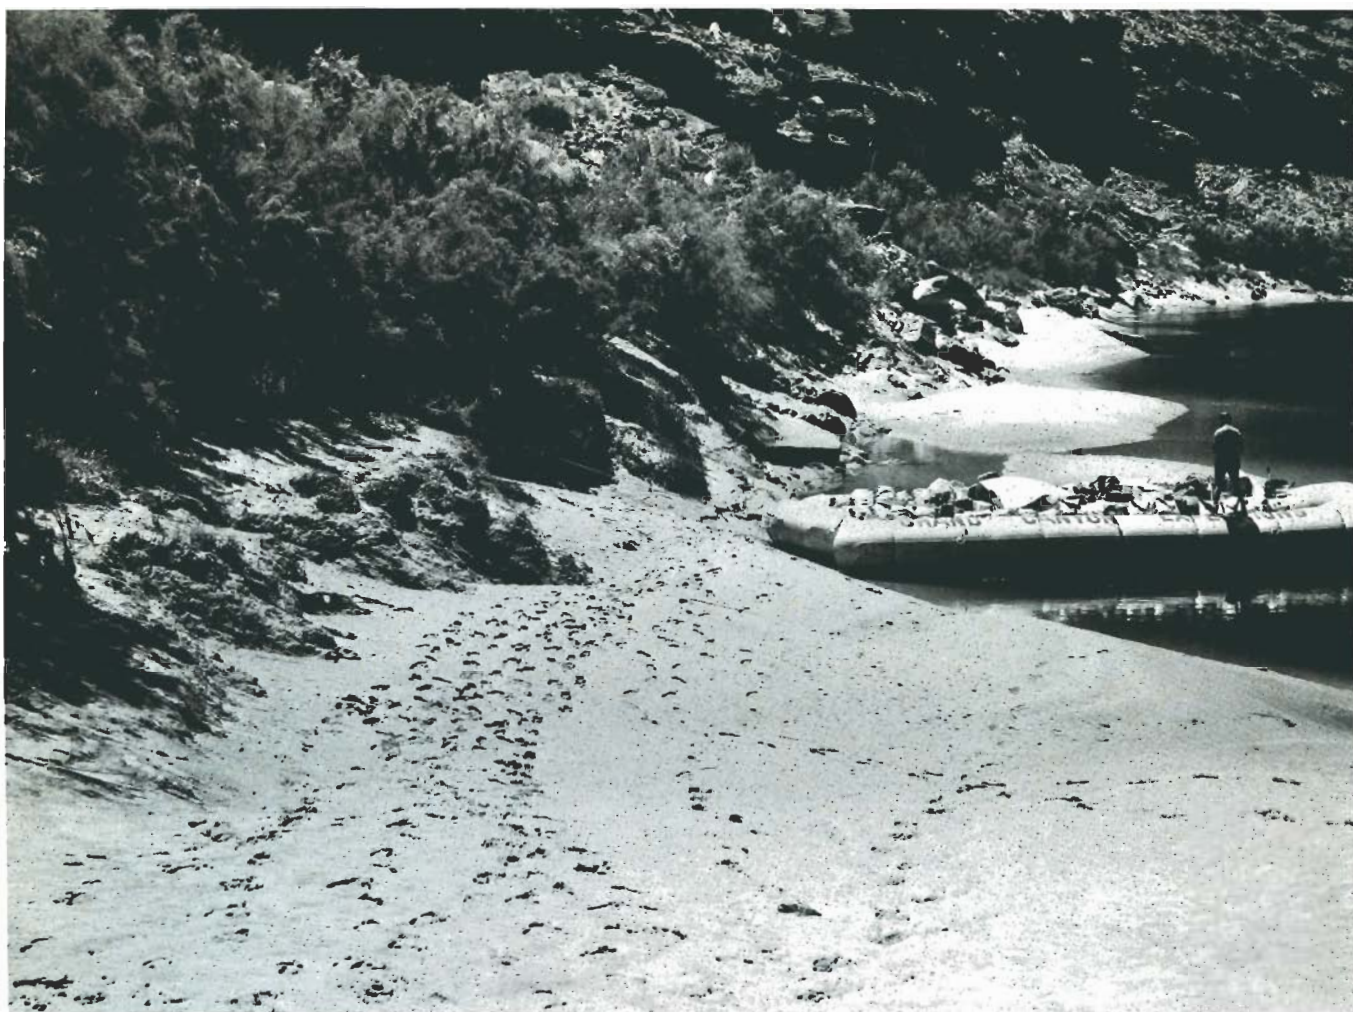
Figure 3. Beachfront along a wide, calm section of the Colorado at low water. Note the dense vegetation and eroded, silty fluvial

deposits to the left at the level of high water. The rubber raft is one of the larger motorized rigs. (Photo by Alan Howard.)

same time, elimination of high-water discharges has resulted in the rapid development of dense flood-plain vegetation in areas which were formerly inundated (Fig. 3), and wind deflation is removing large quantities of fluvial sediment above the current high-water levels.

from two to twelve passengers with a crew of one or two, and the larger outboard-motor-powered rubber boats can accommodate between seventeen and twenty passengers and a crew of two (see Fig. 3). The outfitters usually run two or more boats together, for a party of forty passengers, the maximum permitted by the National Park Service. These people remain together throughout the five- to eighteen-day trip.

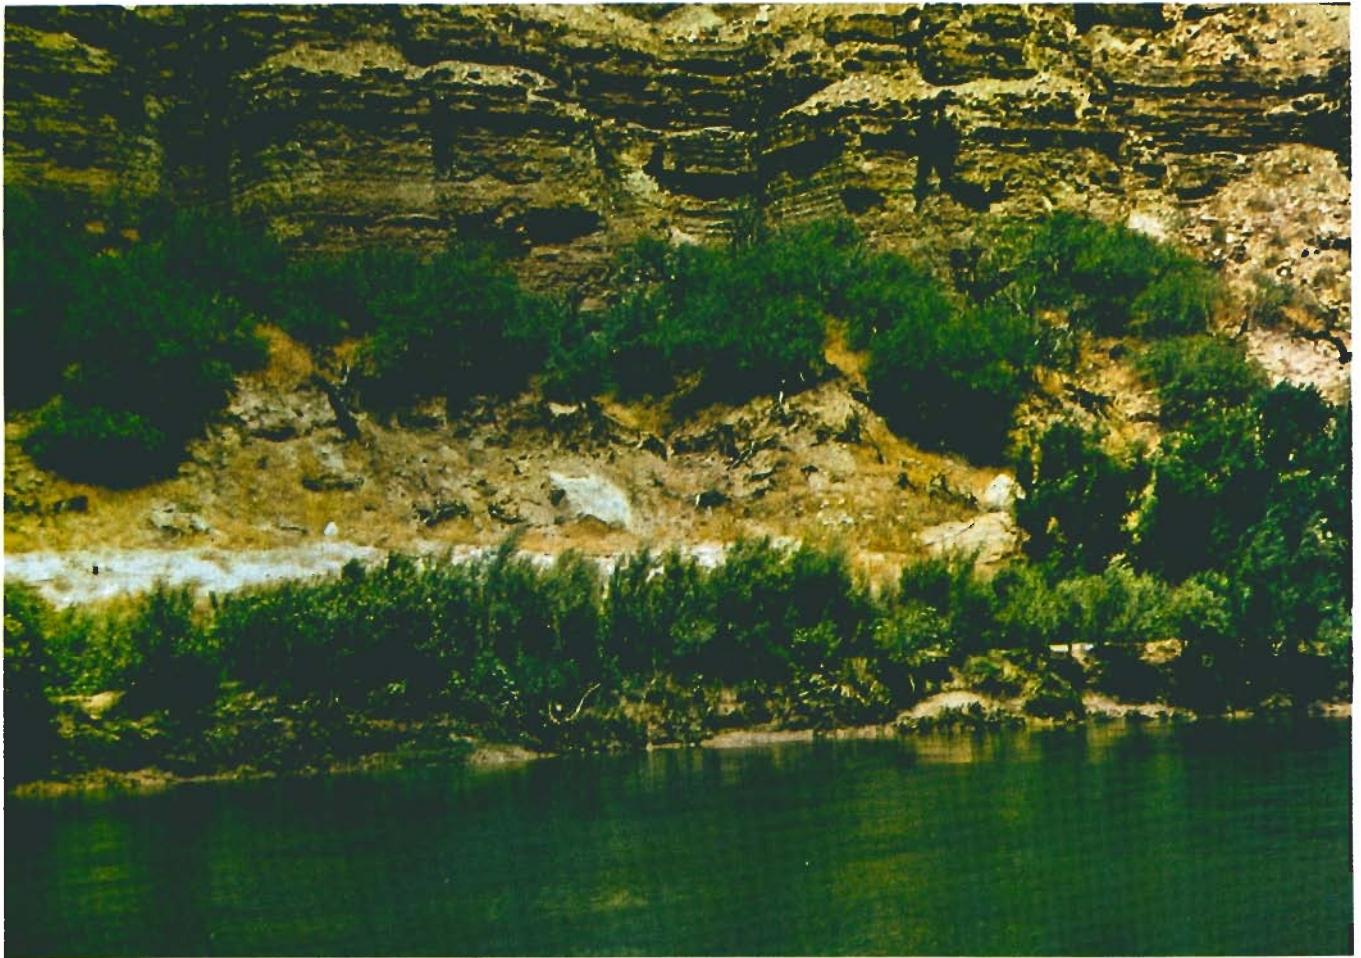
Figure 5. The line of hardwood vegetation marks the pre-dam flood level (120,000 cfs?). The lower terrace is at the present

high-water mark (24,000 cfs). (Photo by Robert Dolan.)

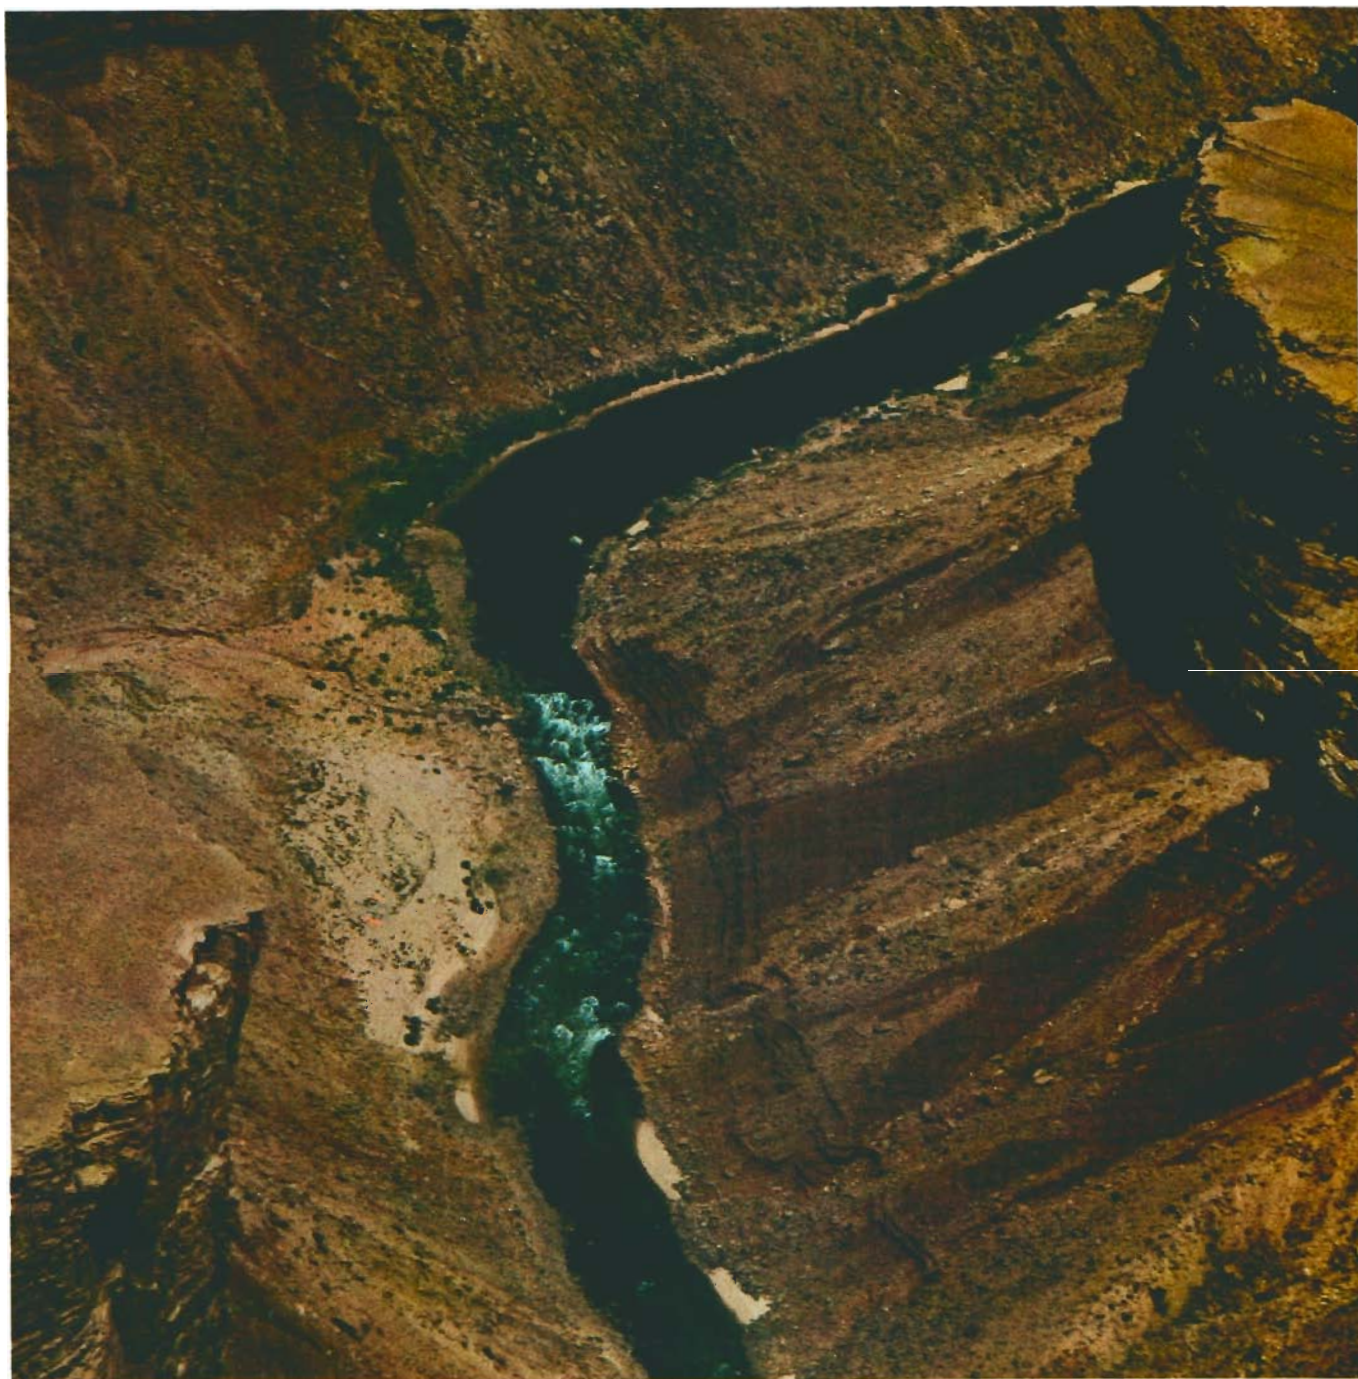
Figure 6. This oblique aerial view, looking upstream, shows the alluvial fan and terrace deposits at Soap Creek Rapids (Mile 11). The river above the rapids is approximately 200 feet wide. The triangular alluvial fan

deposited by Soap Creek enters from the left, constricting the channel and forming rapids. Severe erosion since Glen Canyon Dam has removed most of the shorefront sand and silt. The terrace deposits covering

the fan have also been reworked by the wind into sparsely vegetated dunes. (Photo by Alan Howard.)

points where the river is constricted by the debris fans of tributary washes (Fig. 6). Immediately above and below the falls, a lower-velocity reverse eddy caused deposition of fluvial terraces that mantled the debris fans.

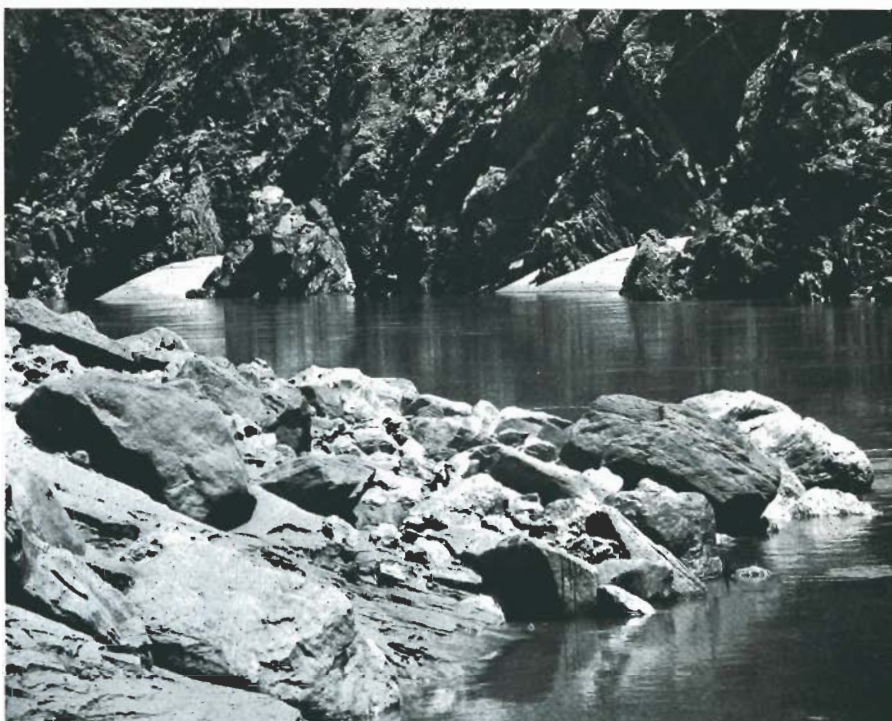
Figure 7. Beaches in the narrow Granite Gorge section of the river are small, infrequent, and very susceptible to erosion, which exposes the underlying coarse rock debris, making camping and mooring difficult. (Photo by Alan Howard.)
